# Inspection and rehabilitation of the marquee of the Ibirapuera Park in Brazil

Marcelo Henrique Farias de Medeiros<sup>1</sup> · Paulo Helene<sup>2</sup>

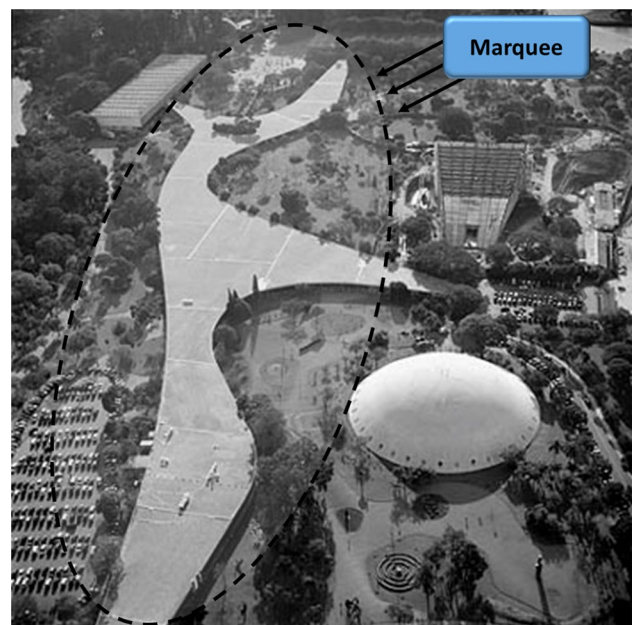
**Fig. 2** Aerial view of the Marquee in 2004. Photo kindly provided by Nelson Kon (Preliminary Project for the Exhibition of the IV Centenary of São Paulo. 1952) [12]

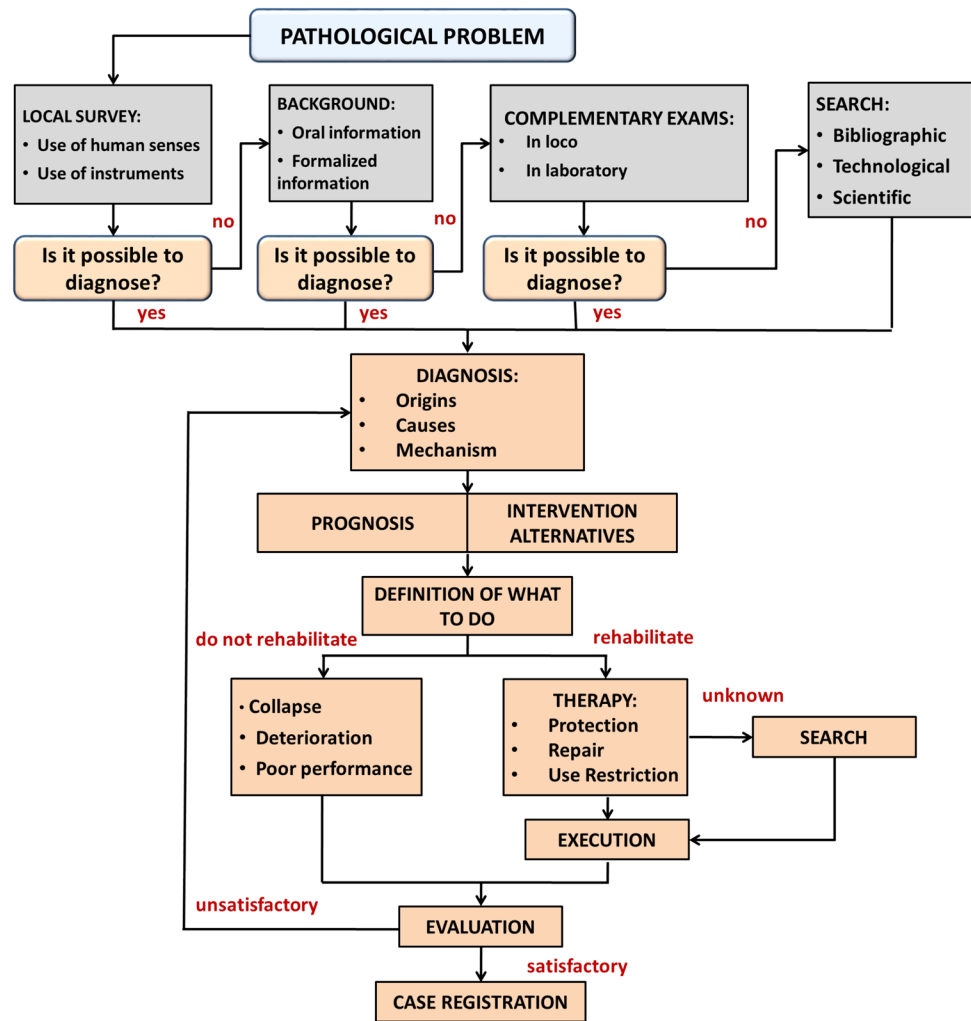
### 3.1 Compressive strength, water absorption and void ratio

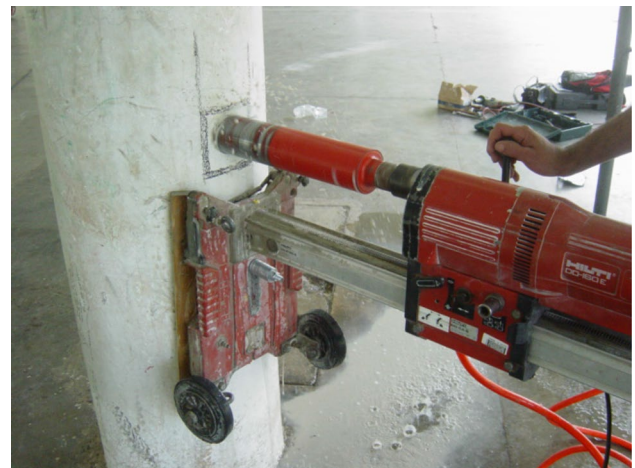
**Fig. 5** Core extraction of one of the pillars of the Ibirapuera Park marquee

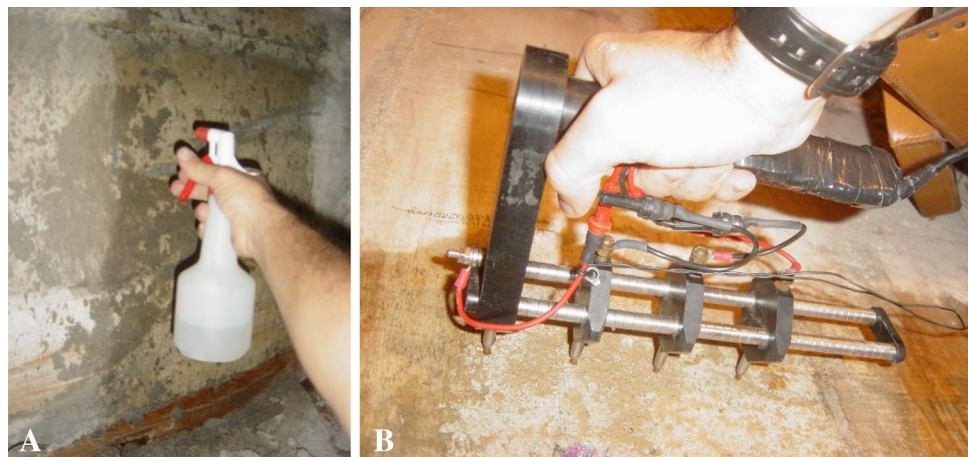
The electrical resistivity of concrete is an important parameter for the corrosion kinetics of reinforcements, since electrical resistivity is the main regulator of the corrosion rate [23]; that is, it controls the kinetics of the process. Thus, since reinforced concrete is already in the corrosion propagation period, electrical resistivity has an important relationship with the regulation of the corrosion process, having a direct influence on the construction's residual service life.

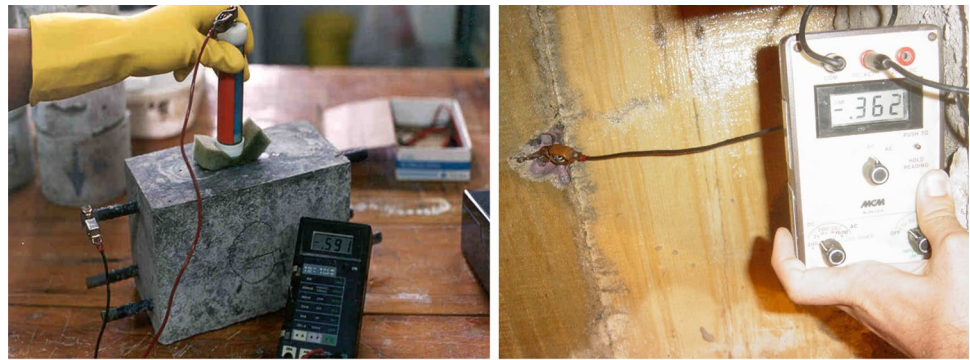
**Fig. 7** Corrosion potential test using Cu/CuSO<sub>4</sub> electrode—ASTM C 876 [25]

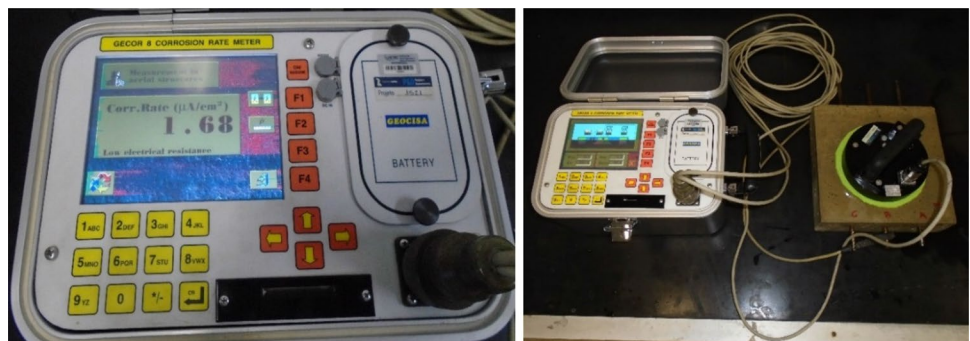
a test that has been applied regularly since the 1990s by Andrade and González [26], who adapted and developed the techniques originally used in the late 50 s by Kaesche and Baumel and Engell for reinforcements embedded in mortar and concrete.

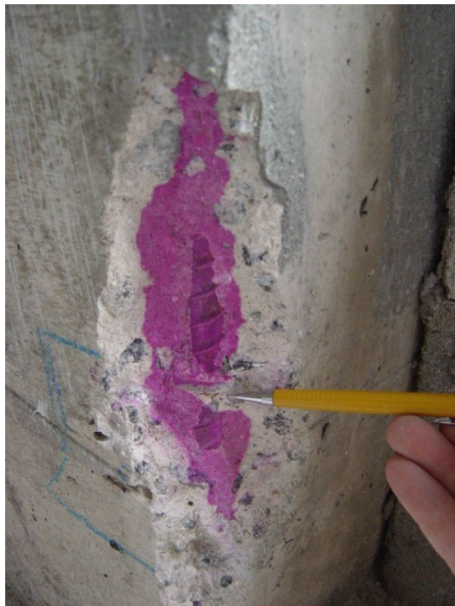
**Fig. 9** Carbonation depth test in reinforced concrete inspection work at the Marquee of the Ibirapuera Park

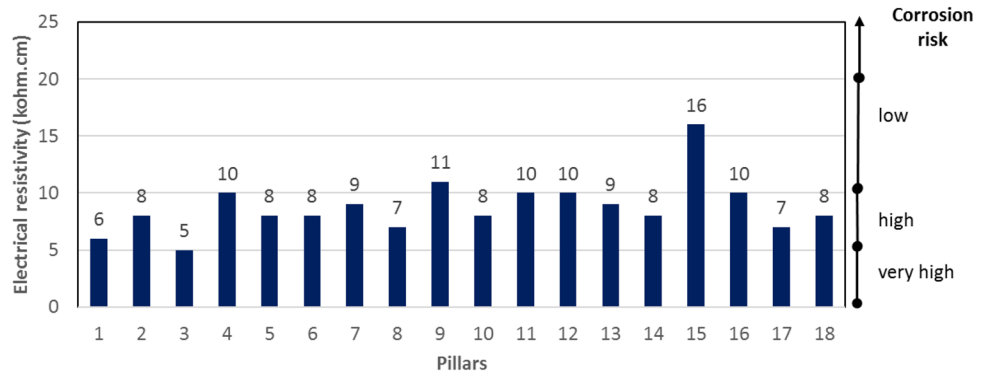
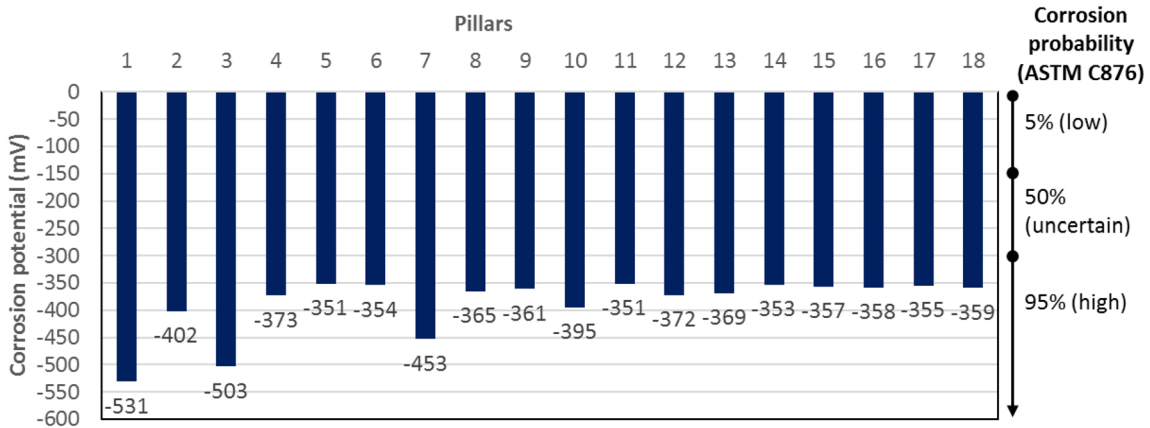
Fig. 12 Corrosion potential of the pillars sampled in the inspection

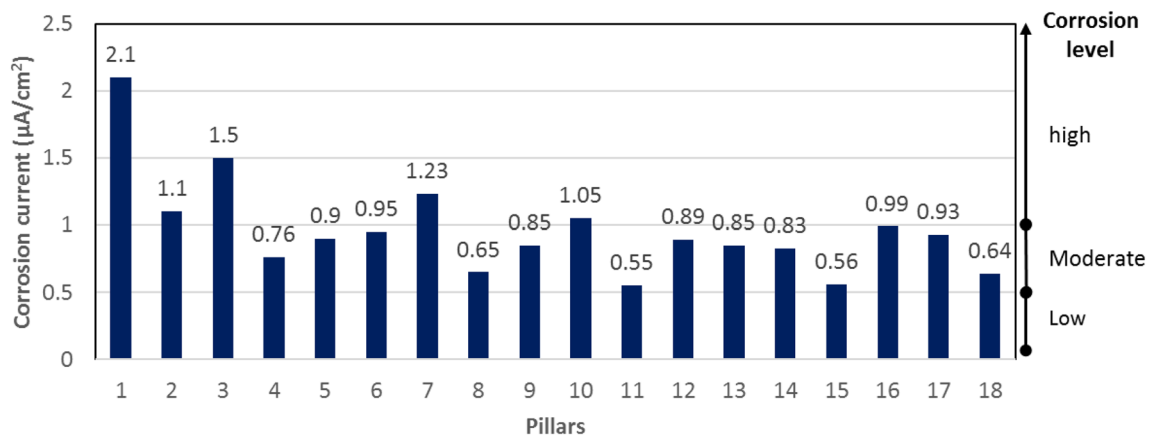
**Fig. 13** Corrosion current of the pillars sampled in the inspection

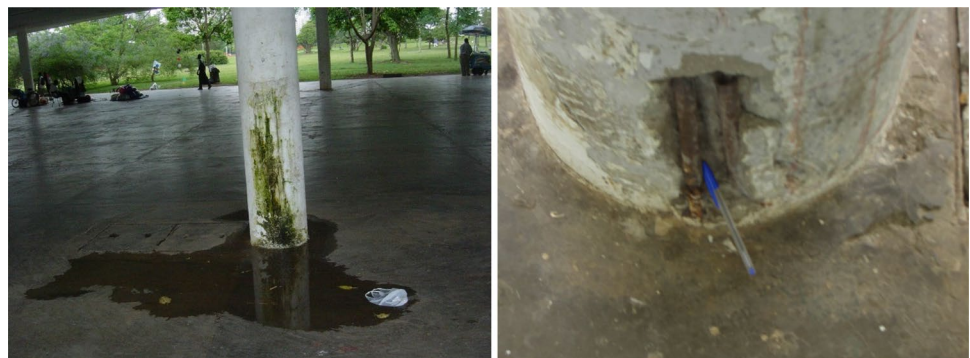
**Fig. 15** End pillar of the marquee: **a** V-shaped geometry; **b** Cracking and partial rupture of the pillar head by thermal expansion of the slab

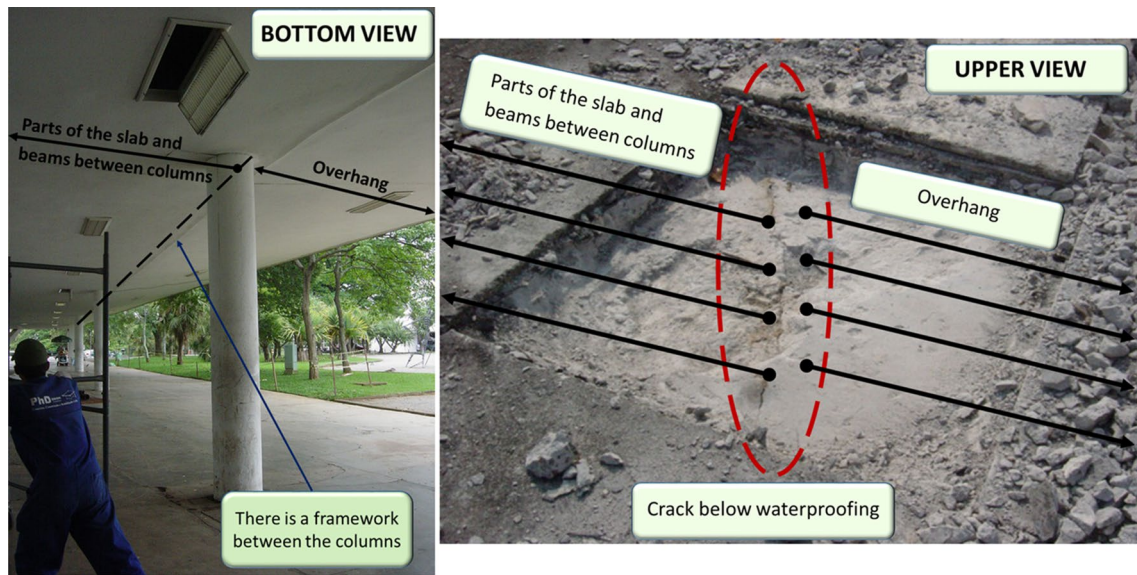
Fig. 16 Location of the cantilevered area and example of cantilevered slab crack (upper surface of the roof)

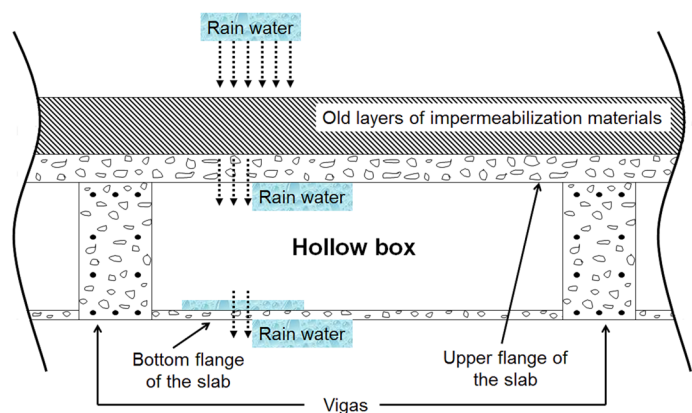
**Fig. 18** Slab leakage deficiency, with rainwater infiltration and reinforcement corrosion

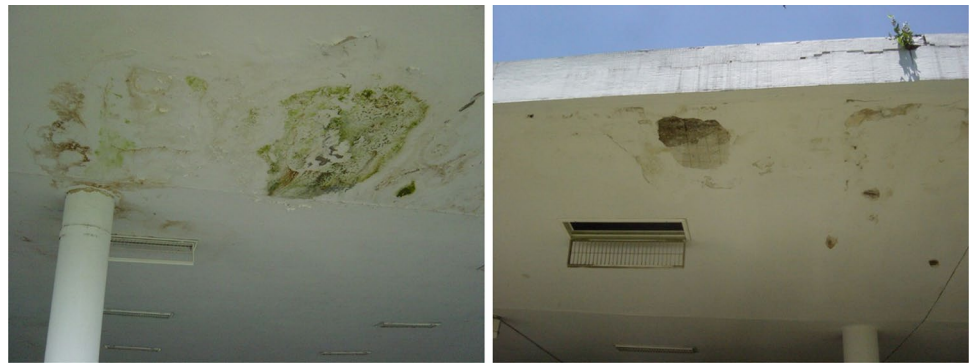
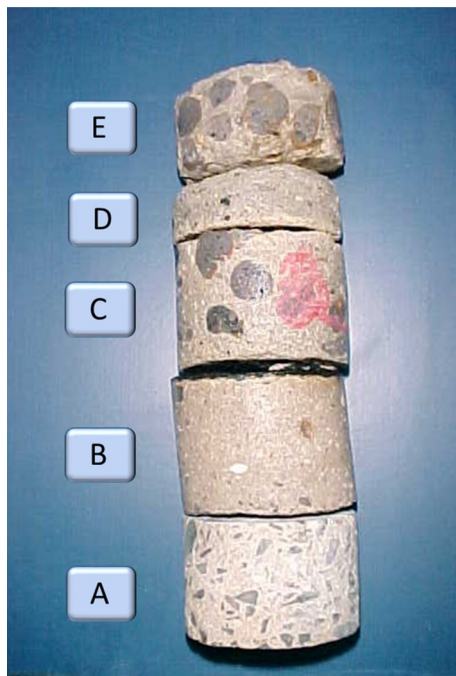
**Fig. 19** Overlapping layers in the upper table of the covering slab due to overlapping layers of waterproofing systems: **a** upper structural table of the slab (4–7 cm); **b** mortar for smoothing and draining the first waterproofing system (3–10 cm); **c** mechanical protection mortar for the first waterproofing system (5–7 cm); **d** mortar for smoothing and draining the second waterproofing system (2–3 cm); **e** mechanical protection mortar for the second waterproofing system (3–6 cm)

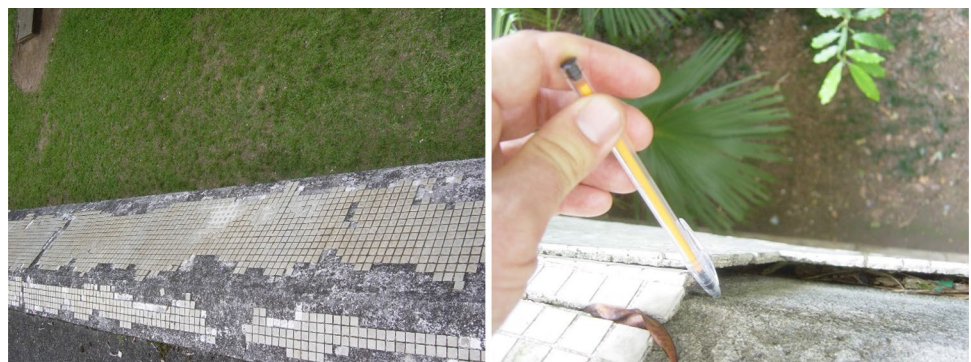
## 5 Solution to the main problems

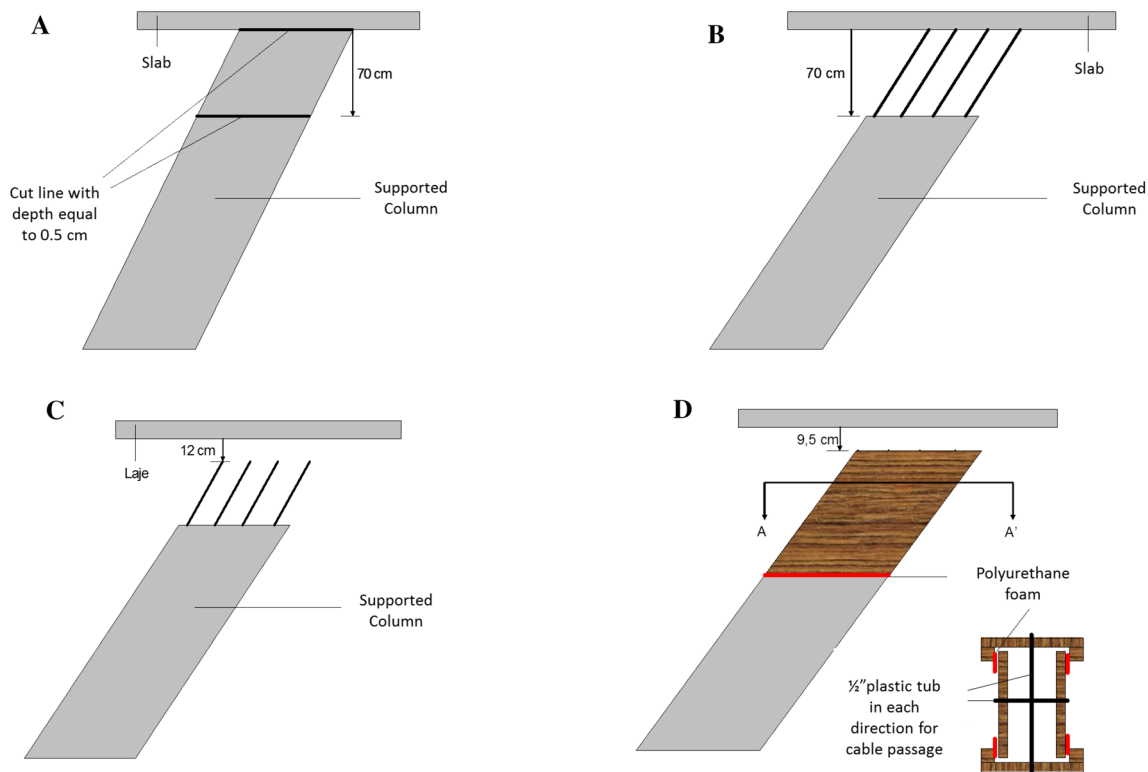
**Fig. 21** a Illustrative drawing of the cut that precedes scarification; b Illustrative drawing of the pillar scarification; c Cutting the reinforcement; d Detail of the mold for grouting
