Surface deformations of 24 January 2020 Sivrice (Elazığ)–Doğanyol (Malatya) earthquake ($M_w = 6.8$) along the Pütürge segment of the East Anatolian Fault Zone and its comparison with Turkey's 100-year-surface ruptures

Orhan Tatar¹ · Hasan Sözbilir^{2,3} · Fikret Koçbulut¹ · Erdin Bozkurt^{4,5} · Ercan Aksoy⁶ · Semih Eski³ · Bülent Özmen⁷ · Hüseyin Alan^{8,9} · Yüksel Metin¹⁰

Received: 31 July 2020 / Revised: 27 September 2020 / Accepted: 30 September 2020 / Published online: 27 October 2020
© Springer Nature Switzerland AG 2020

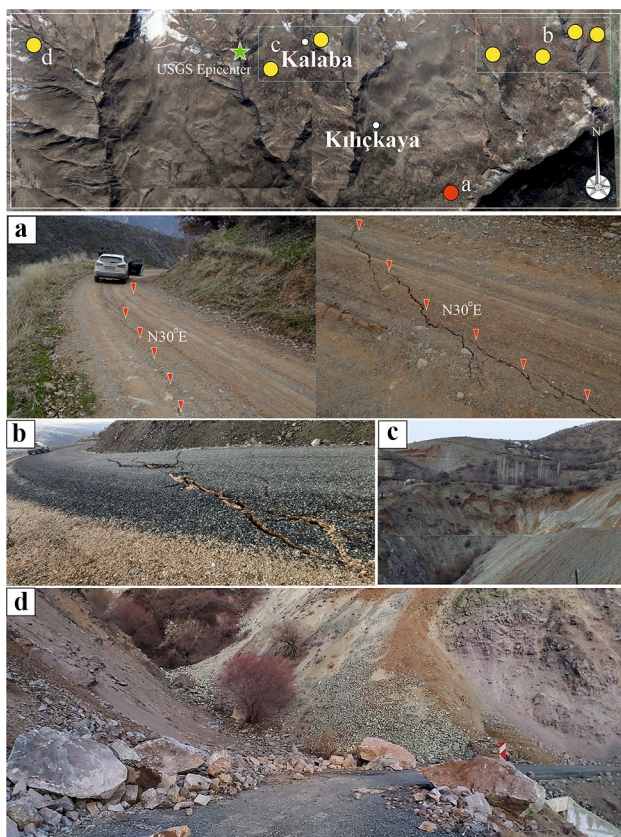
Fig. 5 a GoogleEarth image showing the location of seismo-gravitational landforms around Kalaba-Kılıçkaya villages. b–d Field views illustrating ground defeats and small-scale mass movements (e.g. rock fall)

Ground defeats up to 300 m in length developed in many sections along the road between Sivrice and Doğanbağı village. Such deformation features are particularly common on the east-southeast free slope of the road where vertical movements of up to 50 cm are observed. The ground defeats are mostly parallel to the slope direction but biased directions are also observed. These features caused the road to become unusable at many points (Figs. 5 and 6).

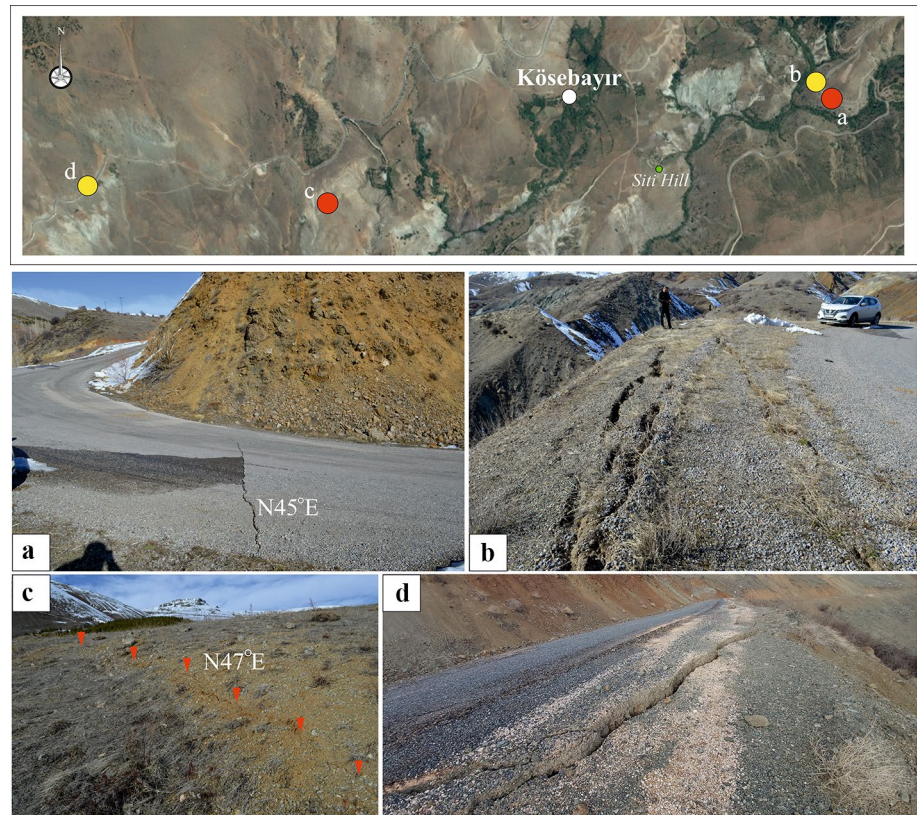
Fig. 6 **a** Google Earth image showing the location of seismo-gravitational landforms around Kösebayır village. **b–d** Field views illustrating ground defeats, such as capillary cracks and small-scale mass movements with down-slope surface deformation

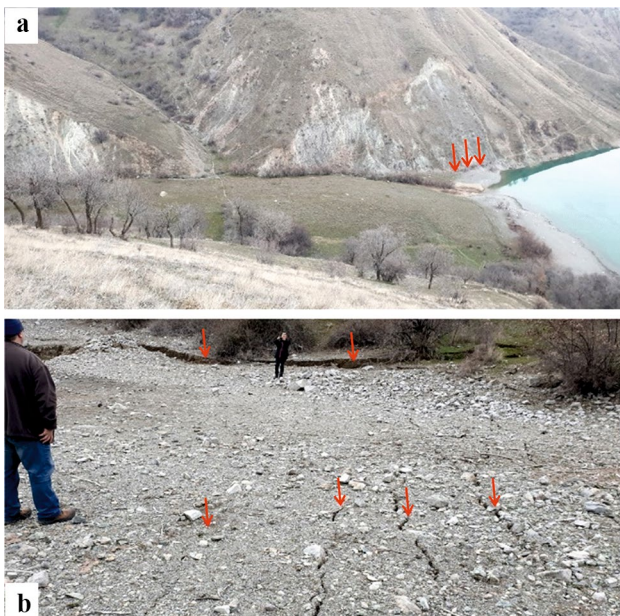
Lateral spreading and liquefaction structures are common in the alluvial fan-fan (delta) areas where streams flowing perpendicular to the deformation zone along the Doğanbağı–Çevrimtaş–Ilıncak line meet/interact the Karakaya Dam lake. Deformation of lateral spreading are represented by cracks normal and parallel to the fan axis, and display a step-like pattern towards the dam lake (Fig. 7). The slope debris and colluvial wedge materials stably located along high slopes were mobilized to form small-scale mass movements by sliding down the slope during shaking. Surface deformation features caused by this kind of seismo-gravitation are common especially on the slopes of Karakaya Dam Lake where the Fırat River valley is cut and displaced sinistrally by about 11 km along the Pütürge segment of the East Anatolian Fault Zone. These features suggest that materials, which are in critical balance on high slope, slid down and flowed during or immediately after the earthquake and caused the dam lake to narrow at certain rates (Fig. 7).

Fig. 7 **a** Seismo-gravitational surface deformation features that developed along the roads between Sivrice and Doğanbağı village; **b** lateral spreading structures formed in the alluvial fan deposits between Doğanbağı and Çevrimtaş villages

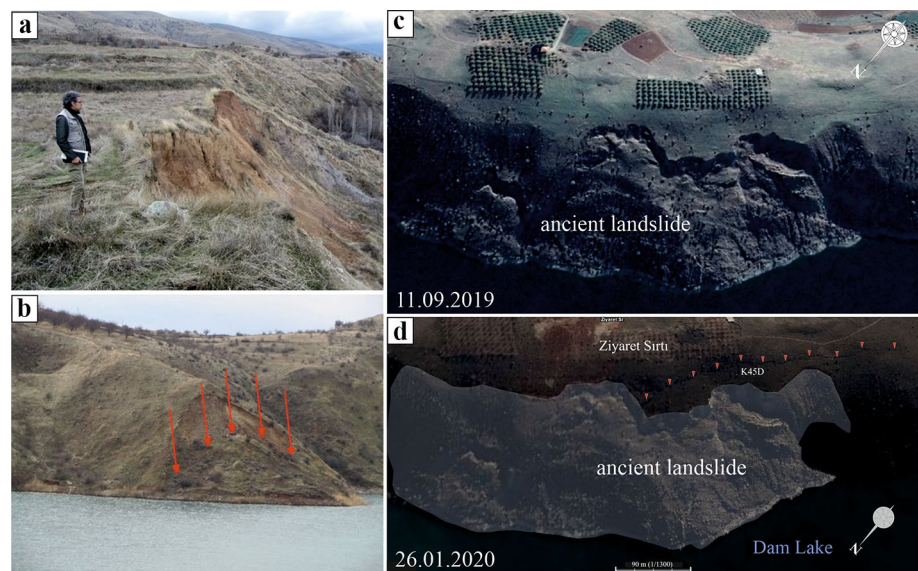
Detailed studies on the GoogleEarth and HGM Küre images taken at different times, it is understood that a number of fossil landslides became active during or after seismic shaking (Fig. 8a, b, red arrows). A surface fracture crack, which can be traced at short intervals along the ridge axis to the south of the mass movements, was observed (see red arrows in Fig. 8d). Vertical and steep capillary cracks developed on some parts of Sivrice–Doğanbağı road. These cracks pinch out laterally and show no vertical and horizontal movement but occur as open fractures with apertures ranging between 1 and 5 cm.

Fig. 8 **a, b** Field views from the undurable materials moving down slope towards Karakaya Dam Lake during seismic shaking in the east of Ilıncak village, **c** GoogleEarth image and **d** HGM KÜRE orthophoto show that the fossil landslides on the dam lake slopes were reactivated during Sivrice (Elazığ)–Doğanyol (Malatya) earthquake

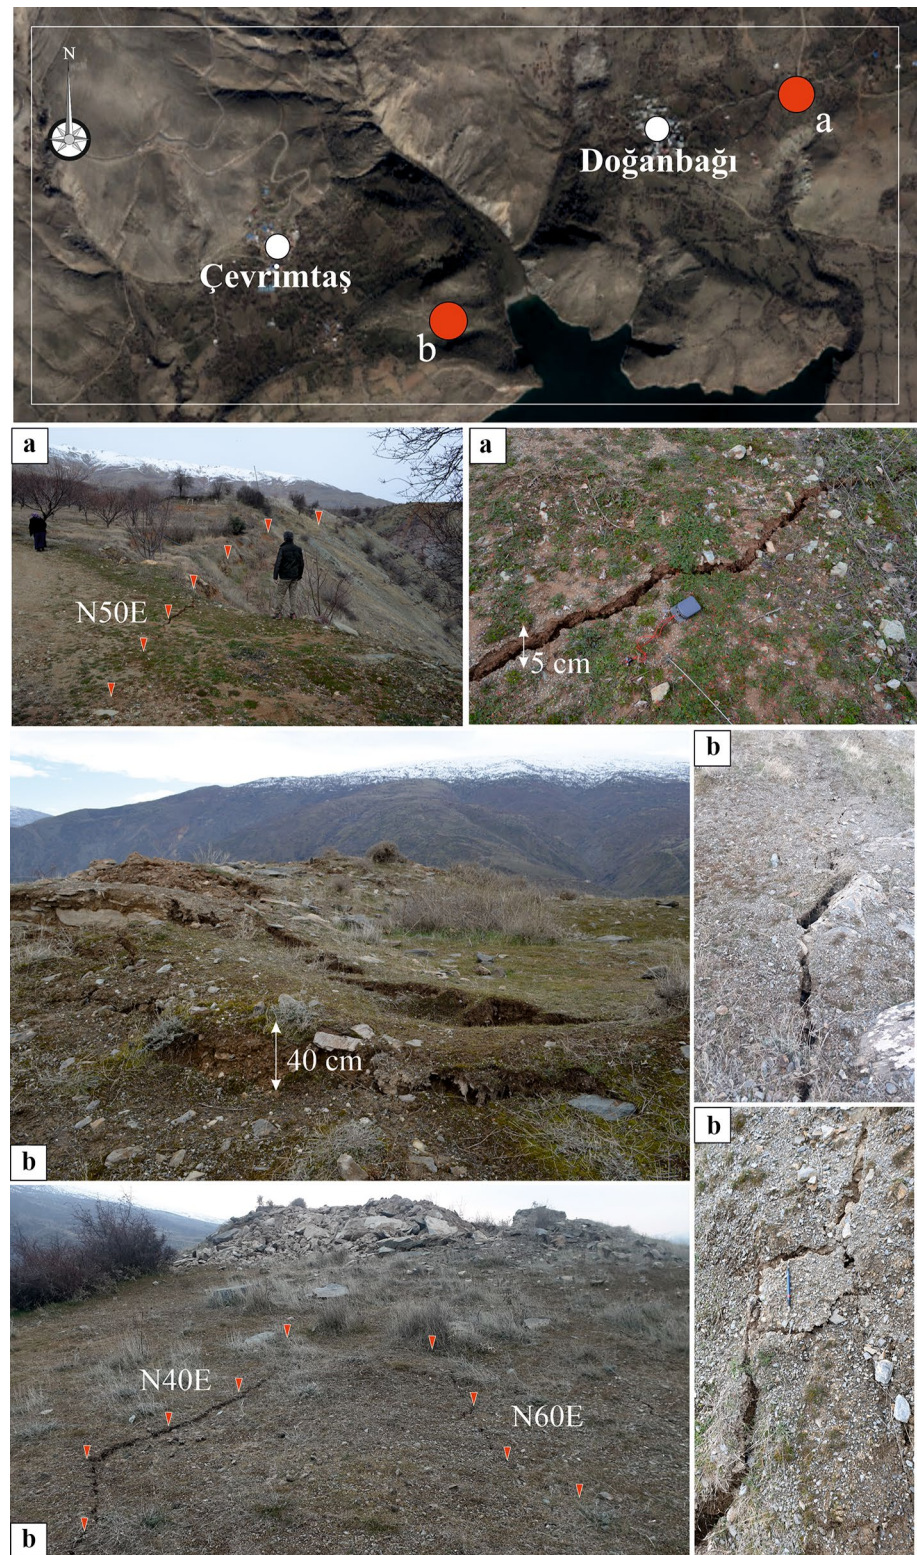
Surface cracks are aligned parallel to the slope of the pressure ridges and define pop-up structures. These structures are compatible with the restraining bend/overlap geometry tracked throughout the Pütürge segment. The surface cracks observed between Çevrimtaş and Doğanbağı can be traced for about 500 m along the axis of the NE–SW-trending ridge. There is no observable horizontal displacement along these the surface cracks. They rather show vertical displacements on both sides of the ridges and define pressure ridges resembling a positive flower structures (Fig. 9).

Fig. 9 GoogleEarth image showing the location of surface cracks around Doğanbağı (a) and Çevrimtaş (b). Field views showing surface rupture/cracks. Note the right-stepping capillary fractures in photo right b

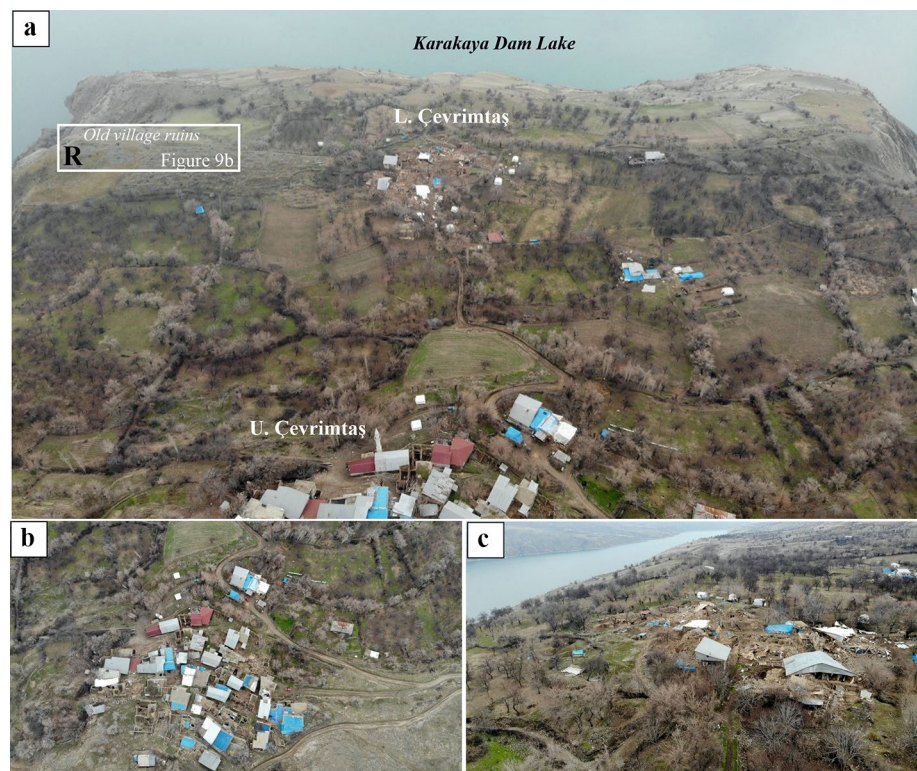
ridge to the northeast of lower neighbourhood belong to the previous residential area of the village, and that it was destroyed by the earthquake in 1875. Local have then moved the village to the new location to southwest tip of the same ridge. It was observed that the surface fracture formed in the last earthquake also pass through the old settlement area (Fig. 10).

Fig. 10 Field view from unmanned aerial vehicle (UAV) **a** showing the surface fracture passing through the east-south-east of the Çevrimtaş village. Note the extension of the fracture from the old village ruins (R) to the lower neighbourhood (Aşağı Çevrimtaş) and **b**, **c** from the upper neighborhood and lower neighborhood areas. Pay attention to the abundance of houses damaged in the lower neighborhood which is located on the surface deformation zone

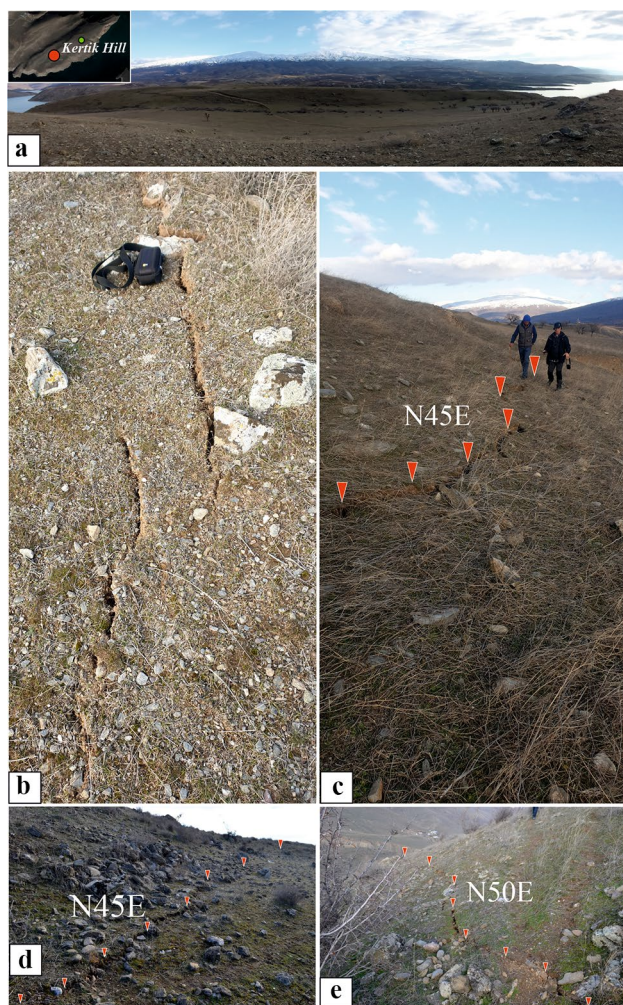
To the 4.5 km northwest of Doğanyol where 1.7-km-long NE–SW-trending elongated pressure ridge occurs. There, several surface cracks are developed during the earthquake. These deformation features are observed along the Kertik Tepe as right-stepping surface cracks and laterally discontinuous small-scale surface ruptures with reverse-slip component (Fig. 11).

Fig. 11 **a** GoogleEarth image showing the location of surface cracks around the Kertik Hill and Ilıncak village. **b, e** Close-up field views illustrating surface rupture/cracks along the Kertik Hill

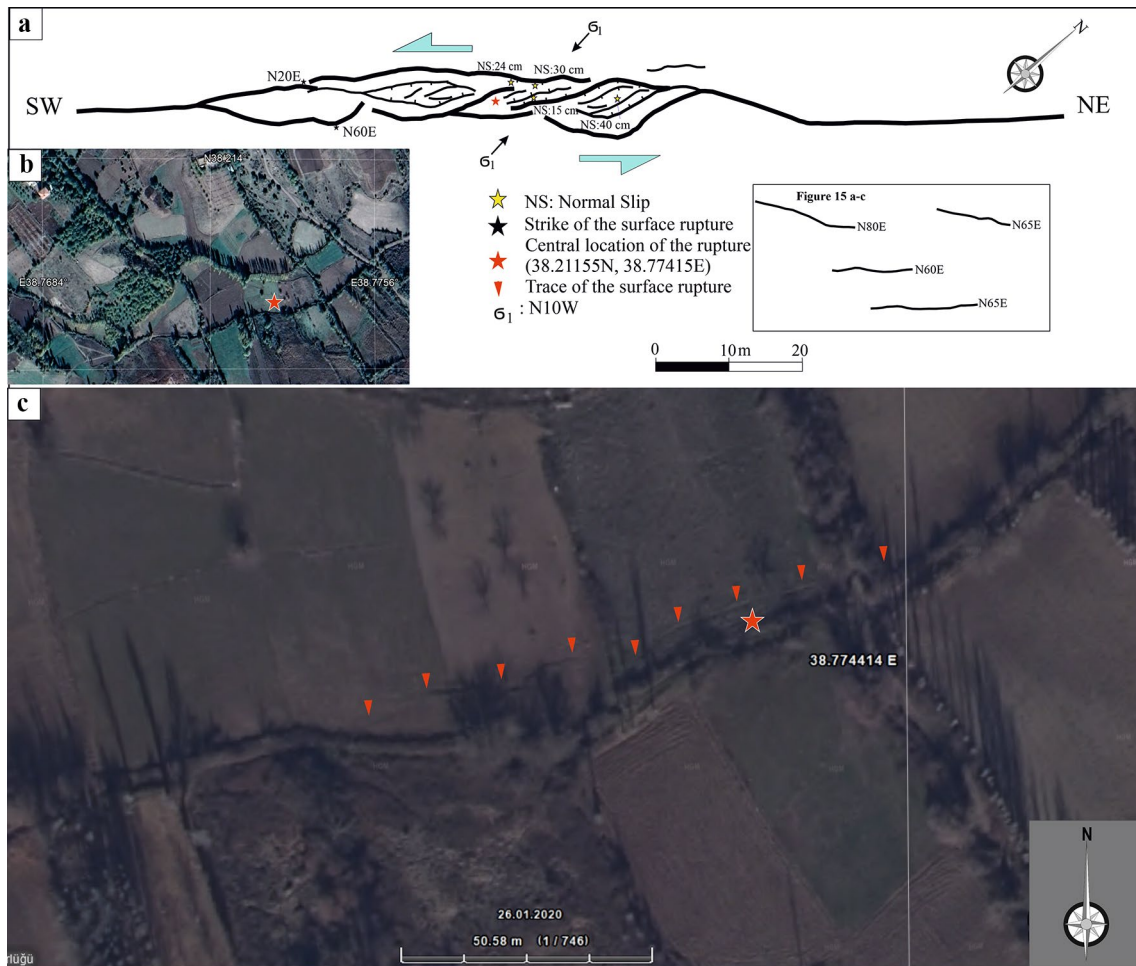
Surface deformation features are mapped in the south-east of Ormaniçi district in a N50°–60° E-trending zone of up to 500 m in length and 30 m in width (Figs. 12, 13, 14 and 15). Here, there are intermittent distances between individual fractures. The fracture network (Fig. 12a) and normal

vertical displacements along individual fractures are consistent with a typical sinistral strike-slip deformation.

Fig. 12 Structural map of fractures and GoogleEarth image showing surface deformation developing in the form of a large deformation zone to the southwest of Ormaniçi village

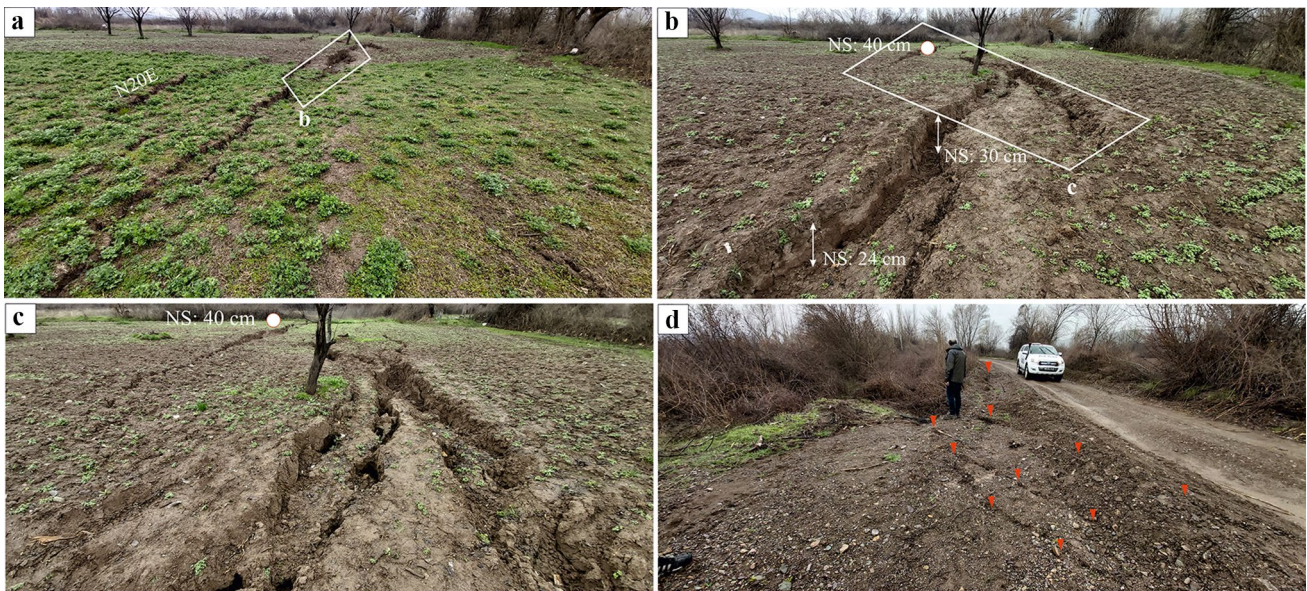
Fig. 13 Field views showing normal-slip motion along individual fractures in a deformation zone to 500 m southwest of Ormaniçi village. Vertical normal slip here reaches up to 40 cm. Views are from southwest to northeast

Although no significant strike-slip displacement was observed along the surface fractures, vertical offsets up to 40 cm were measured, especially in the southwest of Ormaniçi village. The absence of a regular surface fractures as a result of the 6.8 magnitude earthquake can be explained in different ways: (1) left-lateral strike-slip displacement was not able to reach the surface; (2) left-lateral torque movement of the fault around a vertical axis during the earthquake, (3) restraining bend nature of the Pütürge Segment, or (4) the presence of Pütürge metamorphics along the fault strike. It is also important to note that

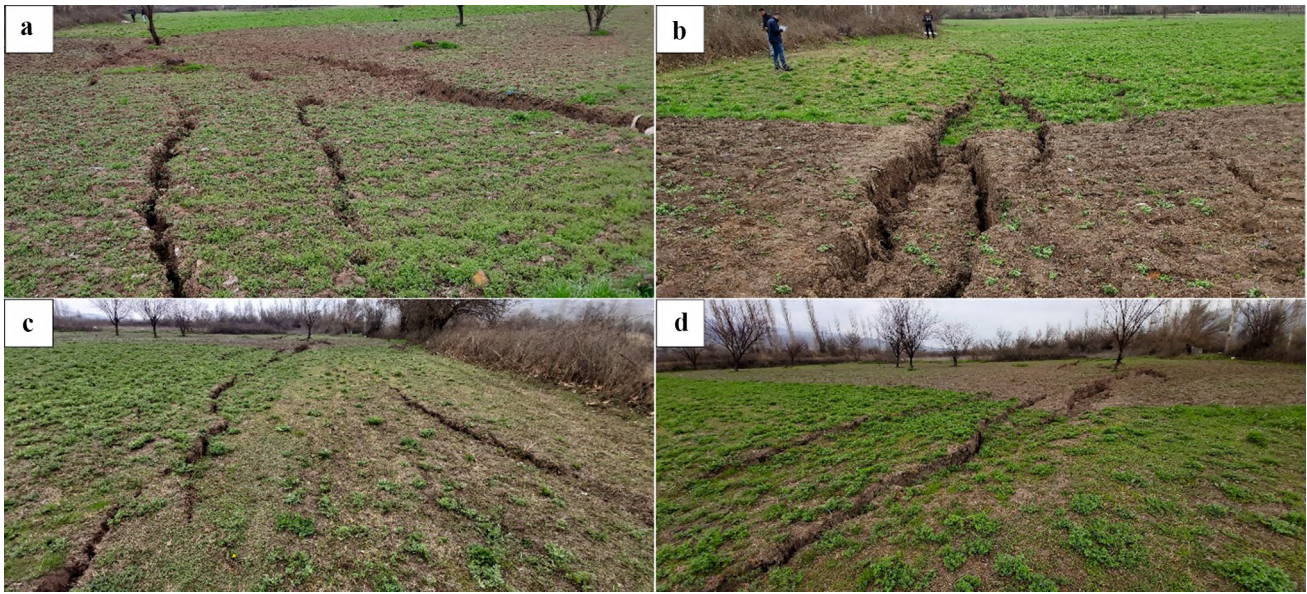
Fig. 14 Different views from surface deformation features observed in the southwest of Ormaniçi village; views are from northeast to southwest

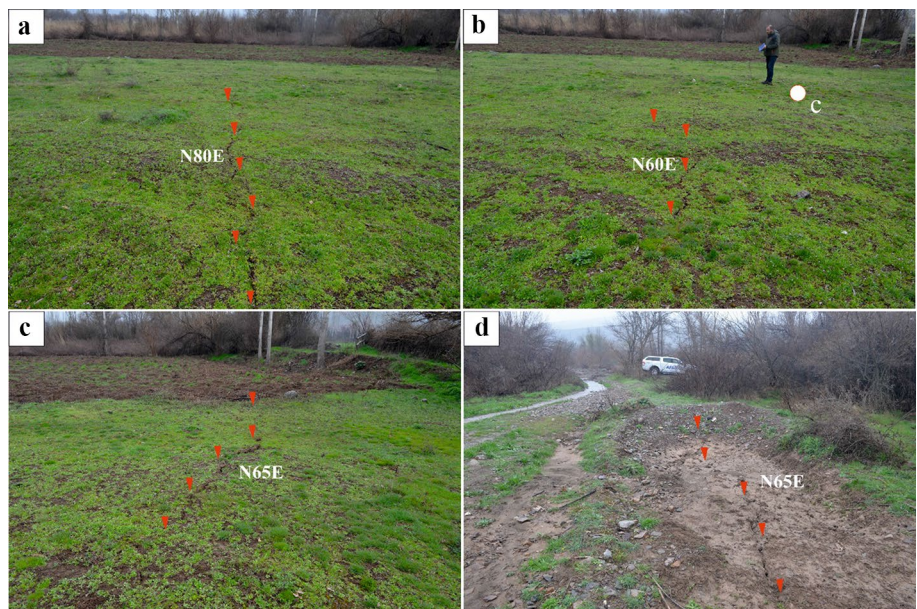
Fig. 15 Different views from surface deformation features observed in the southwest of Ormaniçi village

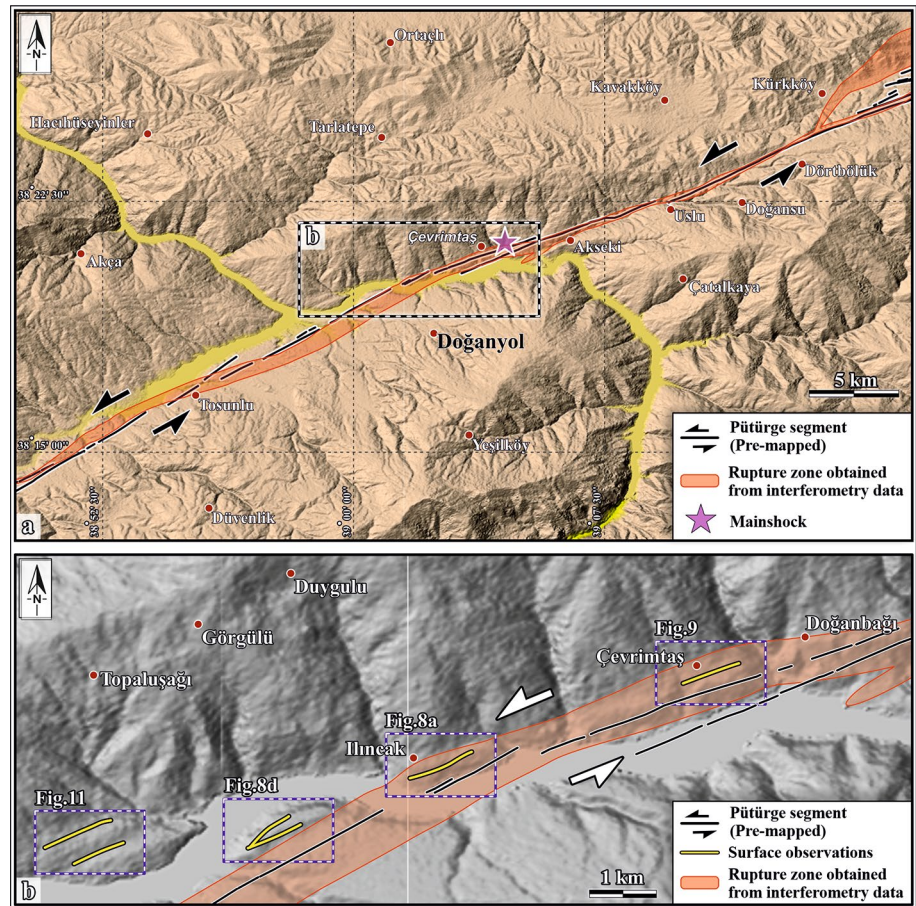
Fig. 18 **a** DEM map showing the relationship between the surface rupture obtained with interferometric data and the previously mapped Pütürge segment. **b** Surface deformations obtained by field observations and interferometric rupture zone

earthquake. The deformation zone width obtained from interferometry is, however, approximately 1 km (Fig. 18). The observed and mapped seismic geomorphological deformation and related features in the area between Gezin (Elâzığ) and Ormaniçi (Pütürge) villages are classified into two classes as seismotectonic and seismo-gravitational features. Surface rupture and cracks, uplifted and subsiding topography and elongated pressure ridges are common seismotectonic surface features while mass movements, lateral spreading and liquefaction are reported as seismo-gravitational surface features.

along most part of the Pütürge segment, surface deformation features are observed in areas where talus, colluvial or alluvial fan sediments are exposed. Unconsolidated and/or poorly consolidated nature of these sediments may also be counted as one of the main reason for not observing horizontal displacements on the surface. The fracture passes through the metamorphic rocks of the Pütürge Massif in the region. The earthquake increased the stress level on the southwestern end of the Pütürge segment and the adjacent Palu segment to the northeast. It has been observed that previously mapped Pütürge segment and field observations show a deformation pattern consistent with interferometry data (Fig. 18b).
