On the Reasons for the Premature Failure of Safety Valve Springs in the Equipment of Primary Oil Refining

Abstract—The reasons for the premature failure of a spring (made of 50KhFA steel) used in the safety valve of the column head part are analyzed. The failure of the spring occurred after 7 years of operation at a temperature below 90°C in a working environment of light oil products (sulfurous gasoline). Visual and measurement control, general chemical analysis of the composition of the steel, energy-dispersive analysis of the metal in local areas, measurements of hardness and microhardness, microstructural analysis of the metal, macro- and electron fractography, phase chemical and X-ray structural analyses, and recovering heat treatment are used for the studies. The characteristic external signs, typical microdamages, and mechanisms of sulfide (hydrogen) corrosion cracking of high-strength 50KhFA steel with the most dangerous accompanying process, hydrogenation, are revealed. The analysis of the chemical composition and hardness of the metal meets the requirements of the standards for this steel. The microstructure of the metal under study is tempered martensite with the presen

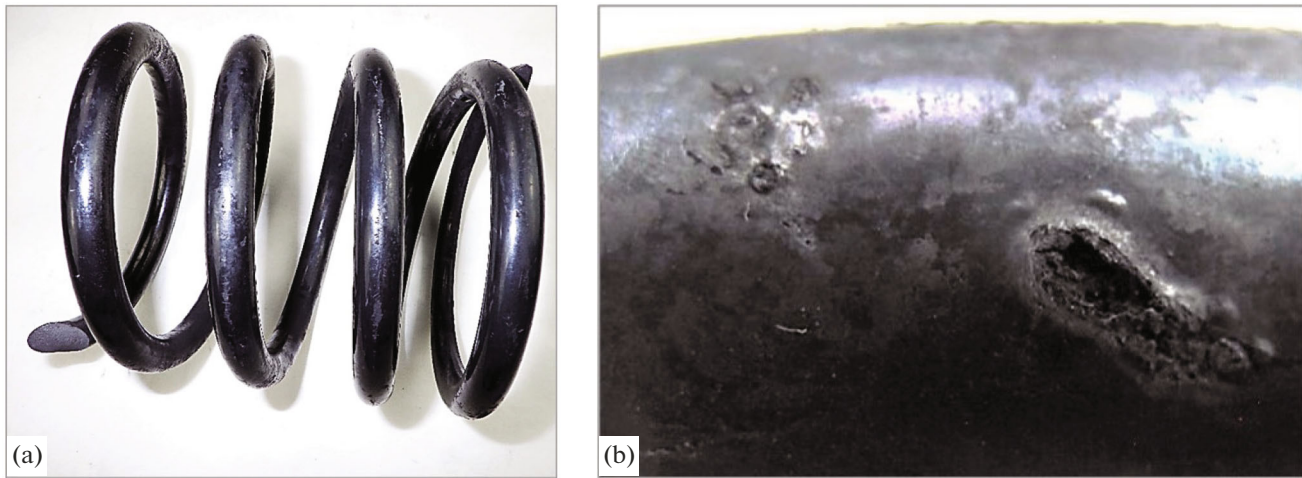
Fig. 1. Fragments of the spring after failure: (a) general view and (b) defects on the turns.

The appearance of a fragment of the spring with the surface of a fracture is presented in Fig. 1a. The visual and measurement control showed the correspondence of the number of turns, external diameter of the spring, diameter of the rod, and other dimensions to the initial parameters of the spring according to the manufacturer's specification. There was a protective paint-and-varnish coating with exfoliation, blistering, and peeling on the surface of the spring; lateral wear, corrosion deposits, and corrosion spots were seen. Cracks and voids were located in the areas of corrosion spots and blisters (Fig. 1b). The defects detected upon external examination of the springs are considered unacceptable in accordance with i. 6.7.3 of IPKM-2005 Instruction.

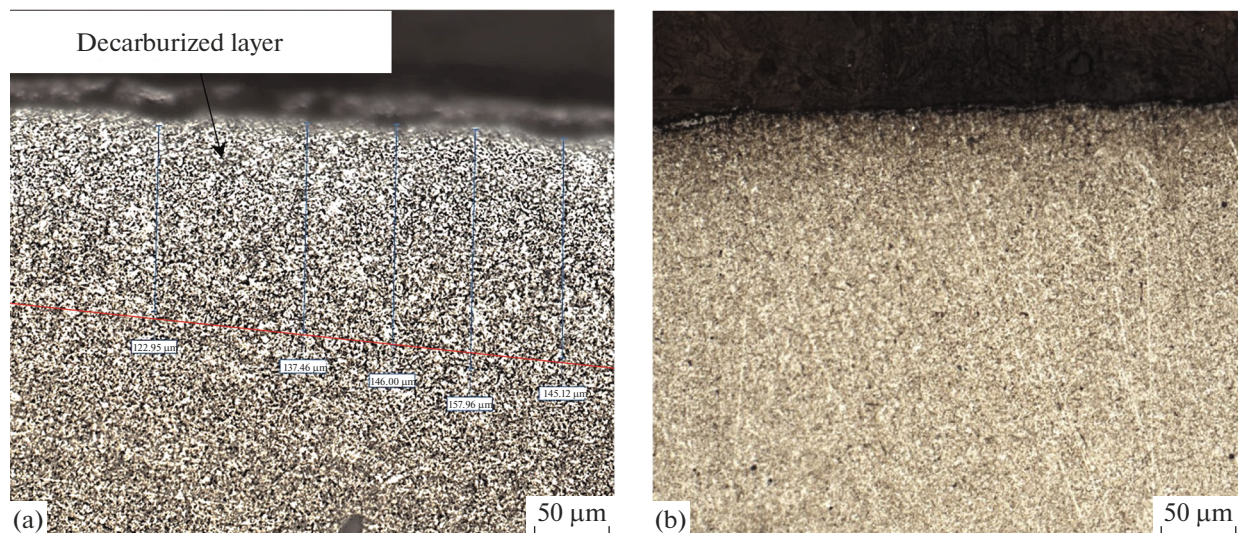
A zone of decarburization was observed on the surface of the spring turns (along the entire perimeter of circumference) (Fig. 2a). The decarburized layer had a depth of 0.114 to 0.158 mm (the error of measure-

ment of $\pm 1 \mu\text{m}$). According to GOST 14959-2016, the presence of a decarburized layer is not allowed for hot-rolled rods with a special surface finish, while for other types of rolled products, the depth of the decarburized layer should not exceed a value of $0.015d$, where d is the nominal diameter of the rod (in this case, 14 mm), i.e., 0.21 mm. The decarburized layer could have formed during process of operations upon the fabrication of the spring. No decarburized layer was detected on the surface of the heat-treated section (Fig. 2b) as a result of diffusion redistribution of carbon over the cross section.

Fig. 2. Surface of the metal section (a) before and (b) after heat treatment, $\times 200$.

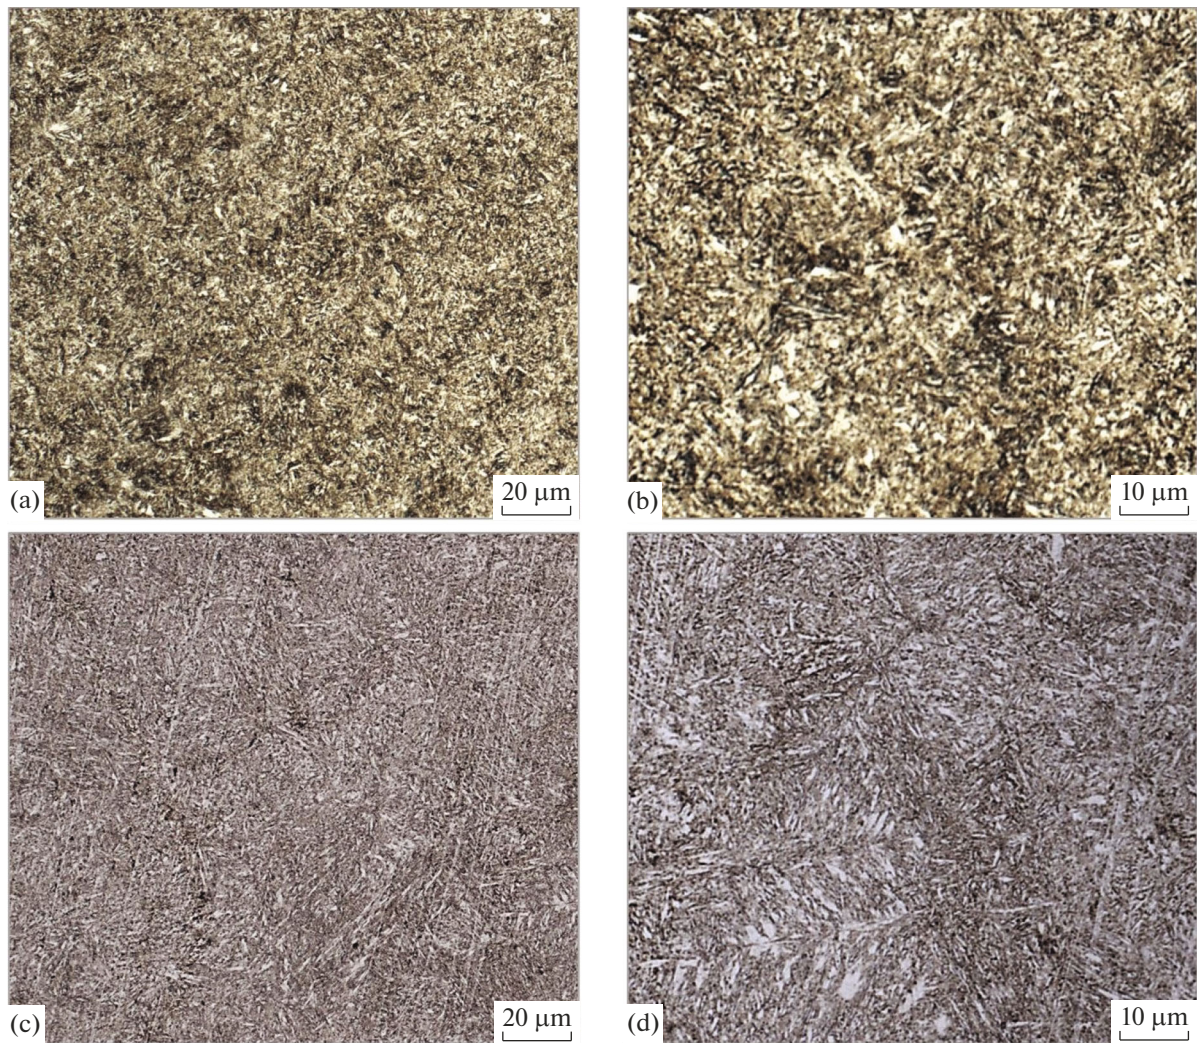
The microstructure of the metal after operation and recovering heat treatment (Figs. 3, 4) is tempered

martensite. The observed shape of carbides in the form of plates that are characteristic of spring steel after quenching and medium-temperature tempering as opposed to coagulated carbides after high-temperature tempering indicates high elastic properties of the spring.

Fig. 3. Initial microstructure of the microsection of the steel (a, b) before and (c, d) after heat treatment: (a, c) $\times 500$ and (b, d) $\times 1000$.

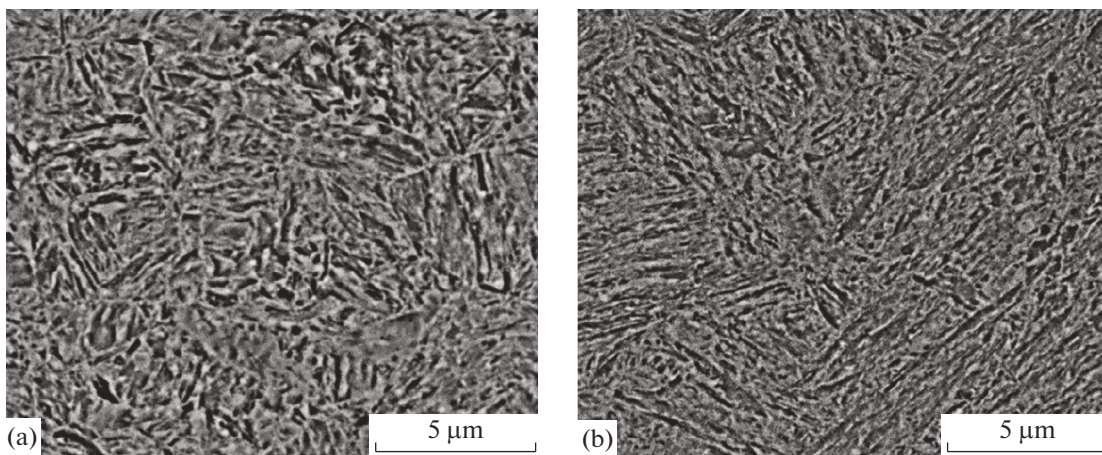
Fig. 4. Morphology of the carbide phase in the steel, $\times 10000$ (SEM image): (a) after operation and (b) after recovering heat treatment (operation + quenching + tempering).

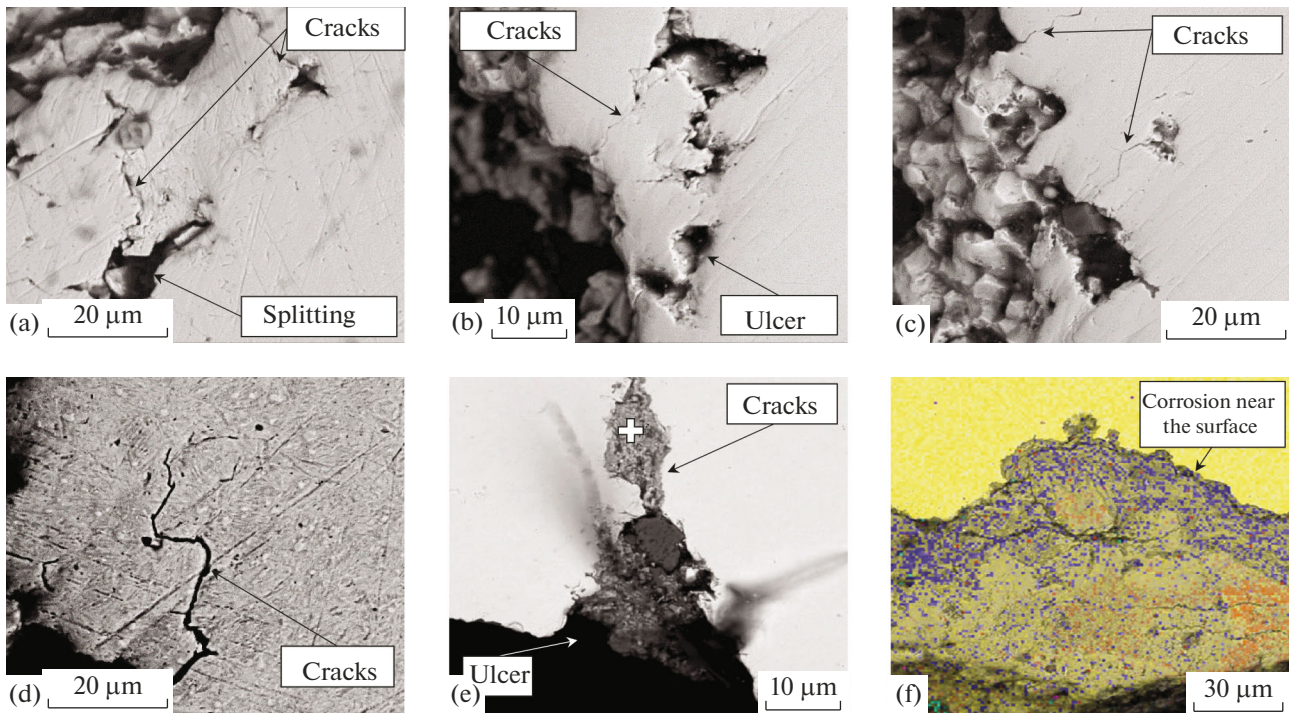
The study of the microstructure near the fracture nucleus has shown the presence of multiple surface defects in the form of pitting corrosion, cracks, splitting over the nonmetallic inclusions, and corrosion products penetrating into the deep layers of the metal (Fig. 5, Table 5). Microcracks originated from corrosion ulcers in the sites of damage of the protective coating and predominantly propagated along the grain boundaries to form closed contours and cavities filled with corrosion products, from which new microcracks developed. The analysis of the chemical elements in the microcracks and cavities indicates a significant concentration of sulfur and oxygen, which points to the occurrence of hydrogen sulfide corrosion.

Figure 5 shows the damage over the elements of the structure and morphology of the cracks on the sections after etching with a 4% solution of HNO_3 . The cracks propagate not only along the boundaries of the primary austenite grains, where the largest precipitates of carbides are located, but also along the interphase boundaries of the oriented plates of carbides. There

Element	Fig. 5e		Fig. 5f	
	at %	wt %	at %	wt %
Fe	38.15	61.34	60.44	76.66
O	37.42	17.24	34.01	17.66
S	18.90	17.45	4.22	4.39
C	2.79	0.96	0.53	0.21
Si	1.28	1.03	—	—
Cr	0.84	1.26	—	—
Ca	0.62	0.71	0.35	0.32

Fig. 5. Defects of the metal of the spring at the fracture nucleus: (a–c) pitting corrosion, microcracks, and cavities (prior to etching); (d) cracks along the grain boundaries of primary austenite (after etching); (e, f) composition of corrosion products in the cracks.

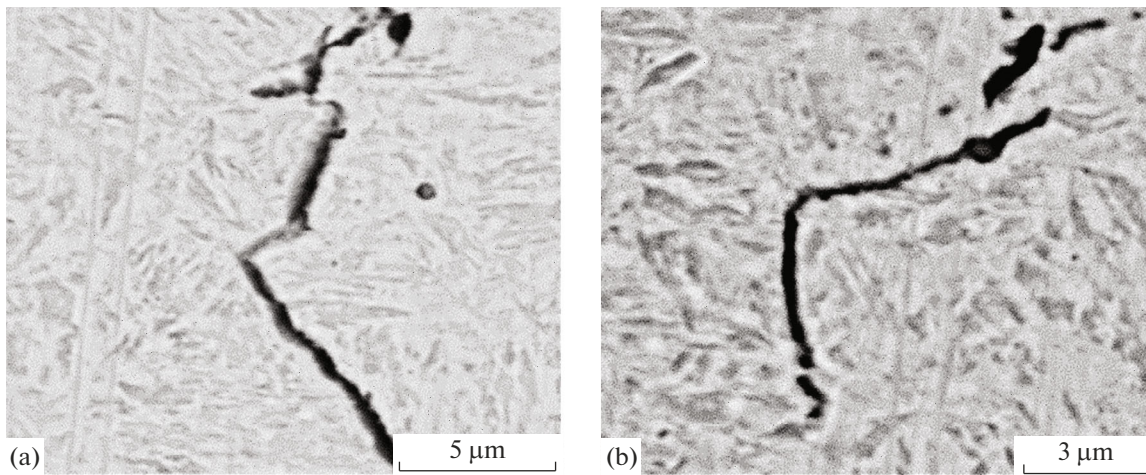
are also pores in the solid solution matrix (Fig. 6). The tiniest micropores with a size of up to $0.5 \mu\text{m}$ in martensite (Fig. 6b) have also been detected on the sections cut out far from the surface of the spring, which may be associated with the presence of hydrogen in steel which is formed in the case of occurrence of low-temperature hydrogen sulfide corrosion.

Fig. 6. Appearance of the cracks after etching: (a) $\times 15000$ and (b) $\times 20000$.

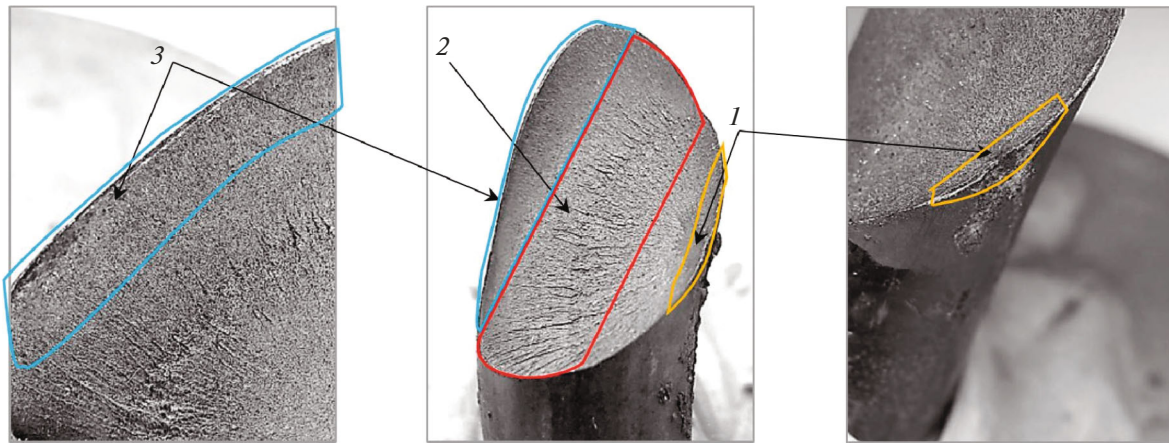
It has been found by the fractographic study that the fracture is matt, dark gray. The fracture surface is oriented at an angle of 45° to the axis of the rod and is perpendicular to the direction of action of the maximum stretching stresses upon twisting; there is a concavity in the central part which is characteristic for quasi-brittle materials [15]. The macrogeometry of the fracture indicated the formation of fracture in the process of operating loads. In terms of the macrostructure, the fracture of the spring was characterized by the following successive zones: 1—fracture nucleus zone with a smooth relief, 2—scarring zone that corresponds to the development of a crack, and 3—fast fracture zone with less rough areas (Fig. 7). A loss of the protective coating and ulcerous damage of the surface were observed near the nucleus determined by the convergence of the scars and located on the outer surface of the spring between the small and large radii of the turn (see Fig. 7). The small size of the nucleus zone

and a low number of circular lines corresponding to the front of crack propagation indicated high stresses.

Fig. 7. General view of the fracture of the spring: (1) fracture nucleus, (2) crack propagation zone, and (3) fast fracture zone.

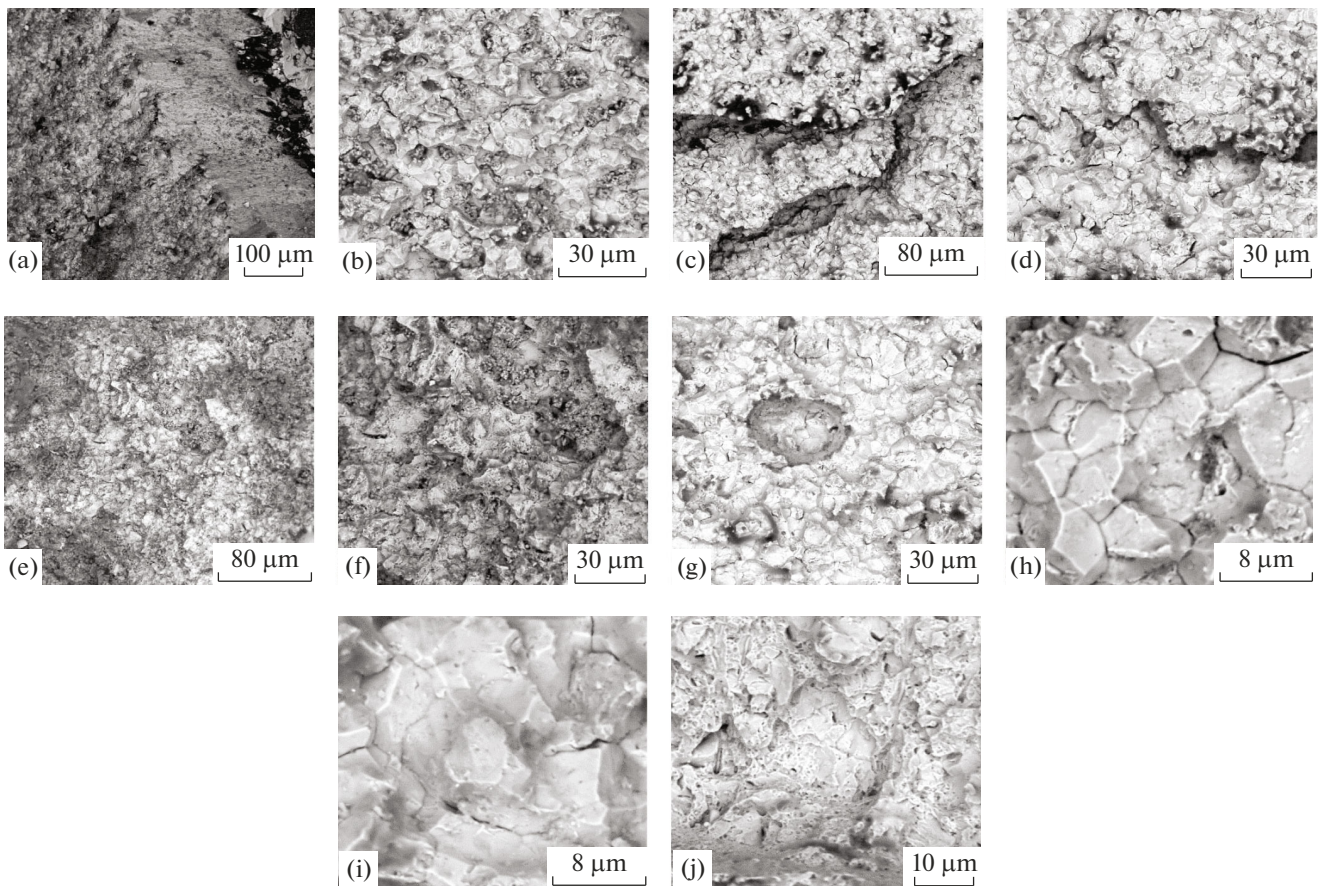
According to the electron fractographic studies, corrosion products are present in the fracture nucleus that coincides with the site of damage of the coating, while individual areas with fatigue striations are present in the decarburized surface layer; there are also opened bubble cavities, bubbles with cracks (Figs. 8a, 8g), nonmetallic inclusions, and intergrain facets and

cracks characteristic of hydrogen sulfide corrosion cracking (Figs. 8b, 8h). In the failure development zone (Figs. 8c, 8d, 8i), cleavage and quasi-cleavage facets, splitting along nonmetallic inclusions, and pores typical of decelerated failure under the action of hydrogen can be seen [4, 12, 14–16]. The fracture surface in the scarring zone is formed by intercrystalline failure facets with alternation of a quasi-cleavage and individual areas of pit relief. The fast fracture is also char-

Fig. 8. Electron fractograms of the fracture surface of the spring: (a, b) fracture nucleus; (c, d) fracture development, scarring zone; (e, f) fast fracture; (g) bubbles; (h, i) intergrain facets, cleavage facets, quasi-cleavage facets, splitting, multiple cracks, pores; and (j) splitting by sulfides, pits.

acterized by facets of intercrystallite and transcrystallite failure with areas of pit relief (Figs. 8e, 8f, 8j).

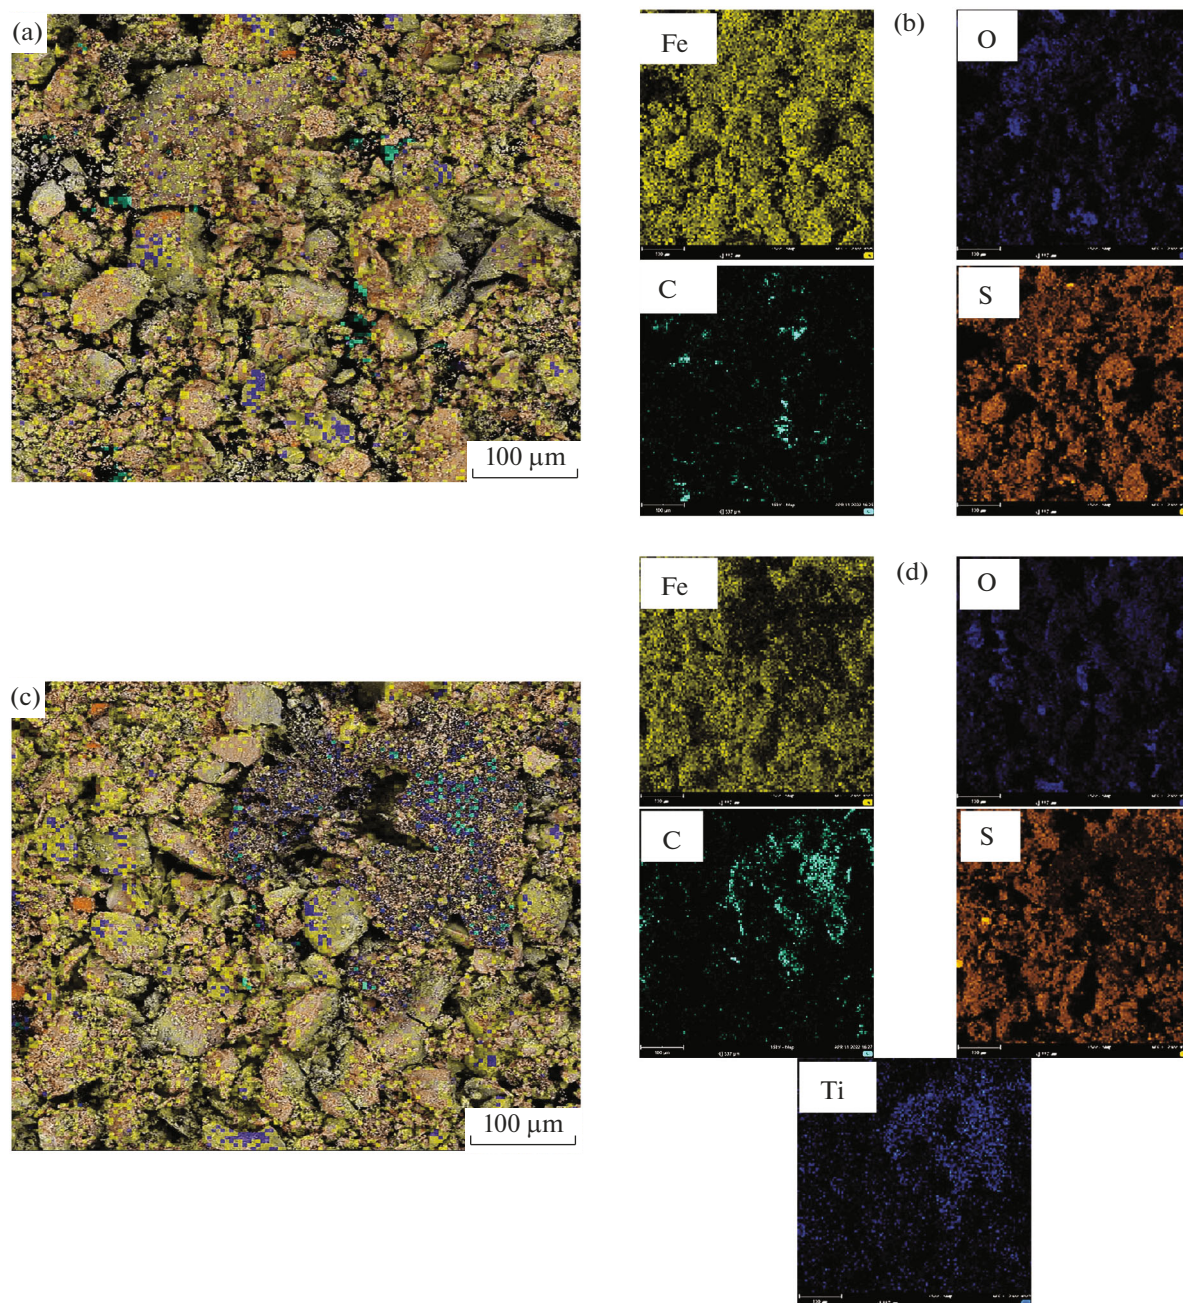
(Fig. 9). The presence of iron and oxygen in the deposits indicates that the corrosion products consist of iron oxides; the presence of sulfur suggests sulfur-containing compounds—iron sulfides formed by the

Fig. 9. (a, c) Results of the analysis of the deposits on the metal surface and (b, d) data of energy-dispersive analysis.

action of the hydrogen sulfide present in the environment. Titanium found in a small amount could be present in the composition of the pigment of the protective paint-and-varnish coating.
