APPLIED PROBLEMS
OF STRENGTH AND PLASTICITY

Corrosion-Mechanical Failure of the Fittings of Pipeline Systems in Deposits with a High CO₂ Content

Abstract—The results of field (bypass) tests of fittings made of 13KhFA steel in oilfield media with a high content of CO₂, H₂S, and Cl[−] are presented. The corrosion resistance of the branches made of 13KhFA steel is shown to be two to three times higher than that of traditionally used 09G2S steel. Intense development of bacterial corrosion in steeply curved bends is detected.

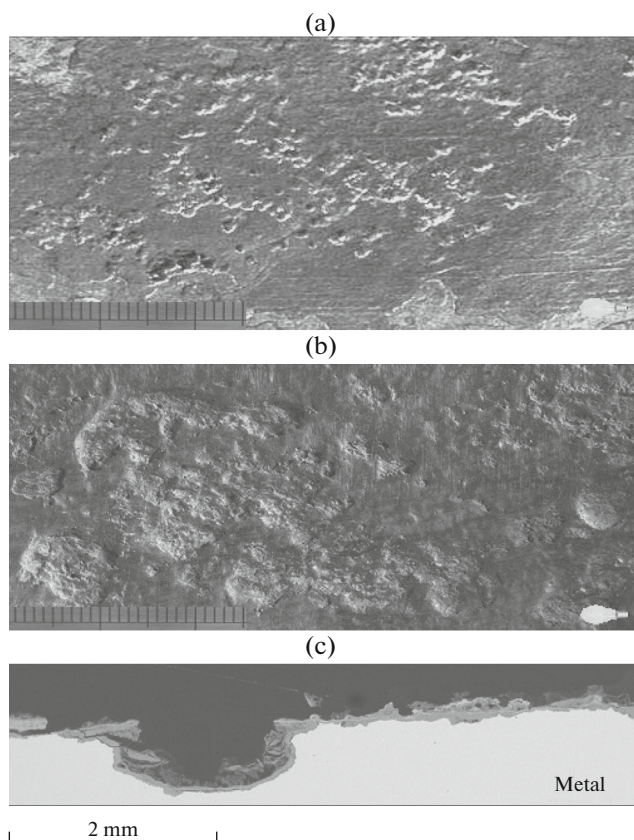
Fig. 3. Corrosion damage to the inner surface of the steeply curved section in the 13KhFA steel branch after PFT for (a) 19 and (b) 42 months. (c) Cross section of the branch wall in a pitting damage zone.

The type of failure and the determined rates of general and local corrosion of the branches made of 13KhFA steel during the test period indicate that local (pitting) form of corrosion-mechanical failure is the main type of corrosion (Fig. 3). Its rate is halved with an increase in the test time from 19 to 42 months at a slight change in the general corrosion rate (Table 3), which is thought to be caused by an increase the pro-

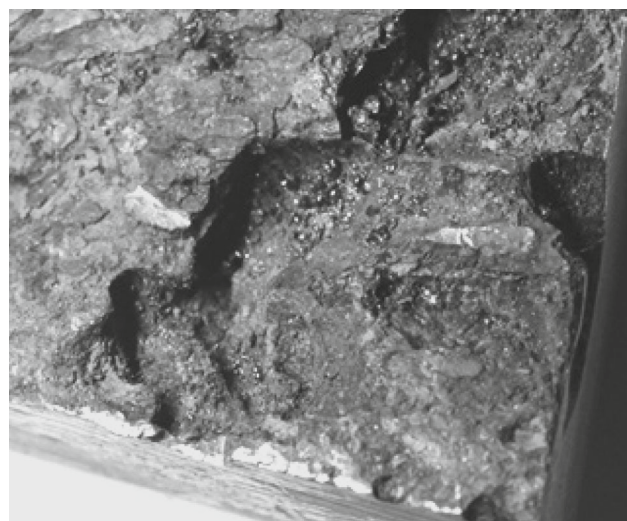
Fig. 4. Surface of the steeply curved part in the 09G2S steel branch after operation.

tective action of the corrosion products in time (they clog deeper pitting channels). It should be noted that the corrosion rate of branches made of 13KhFA steel is 2–3 times lower than that of the branches made of 09G2S steel operating in the same deposit. The branches made of 09G2S steel are characterized by intense local groove-type corrosion with numerous pits extending into the wall depth (Fig. 4).

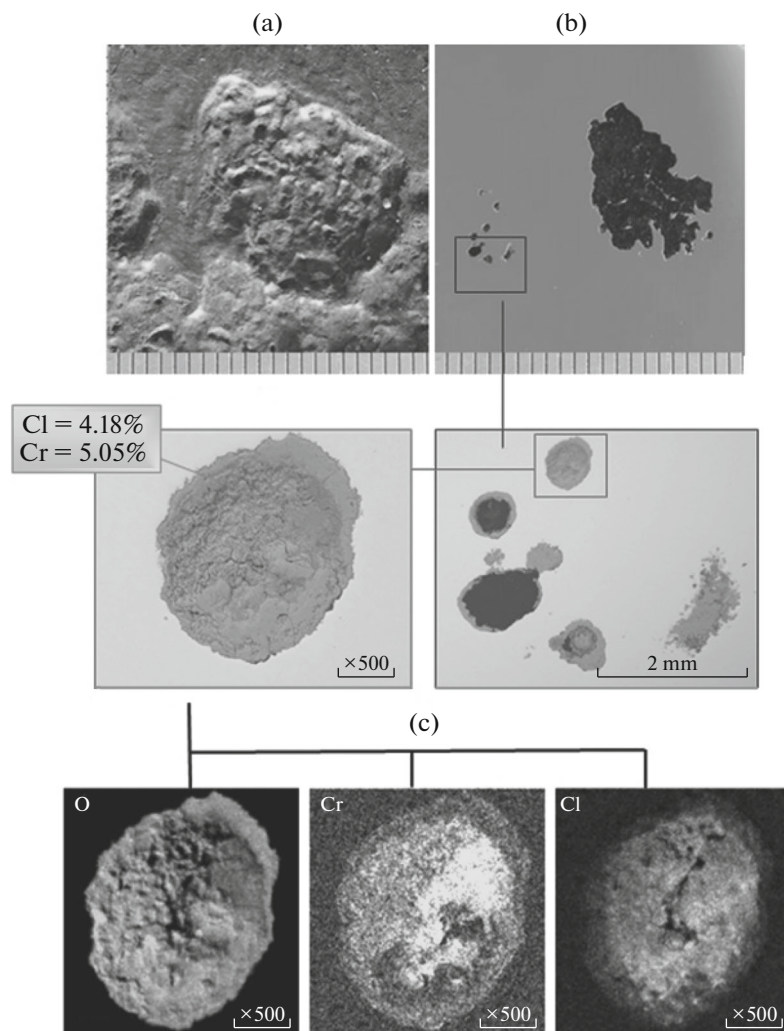
Figures 5–9 illustrate the character of corrosion damage and the composition and morphology of the corrosion products in the 13KhFA steel branches. During layer-by-layer grinding of the surface layer, we found that corrosion damage spreads in the form of pitting channels with numerous branches in the form of smaller channels (Fig. 5). Such a “worm-type” type of damage is characteristic of carbon dioxide media containing chlorine ions [9].

The corrosion products mainly consist of iron carbonates (FeCO_3), contain iron sulfides (FeS), have a high (as compared to steel) content of alloying elements (Cr, Mo, Si, etc.), and have a carbide phase inherited from corrosive steel. Chlorine concentrates at the interface between the corrosion products and the metal (see Fig. 5–8). The predominant mechanism of failure is carbon dioxide corrosion accelerated by chlorine ions.

Fig. 5. Pitting corrosion damage of the steel 13KhFA branch: (a) branch surface, (b) corrosion damage at a depth of 1.5 mm, (c) fragments of corrosion damage, and (d) chemical composition of the corrosion products.

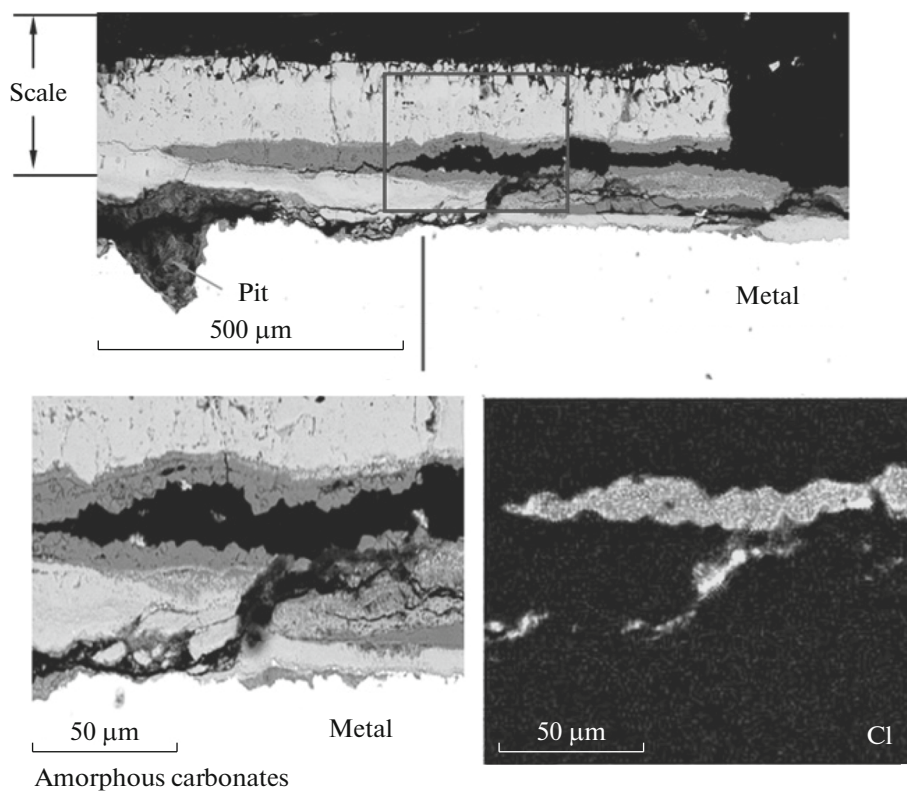
Fig. 6. Cross section of the 13KhFA branch wall after PFT for 19 months.

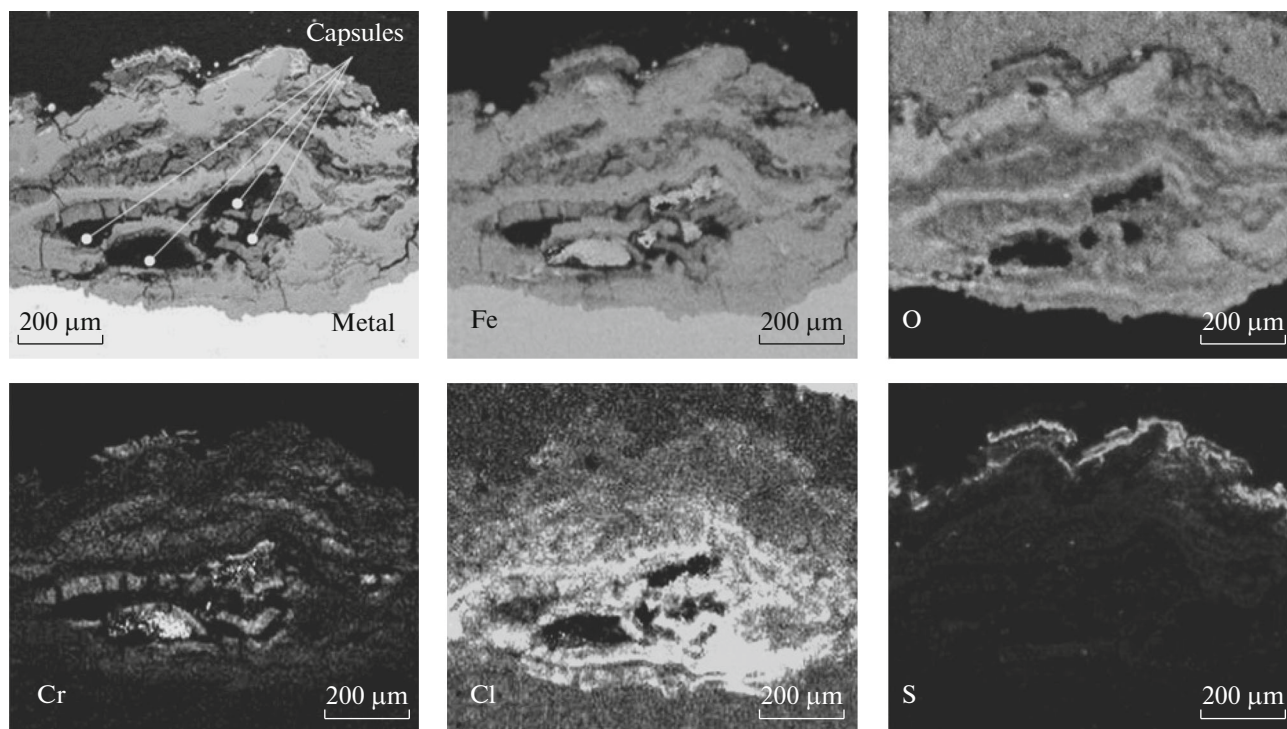
Fig. 7. Composition of the corrosion products in the 13KhFA branch after PFT for 19 months.

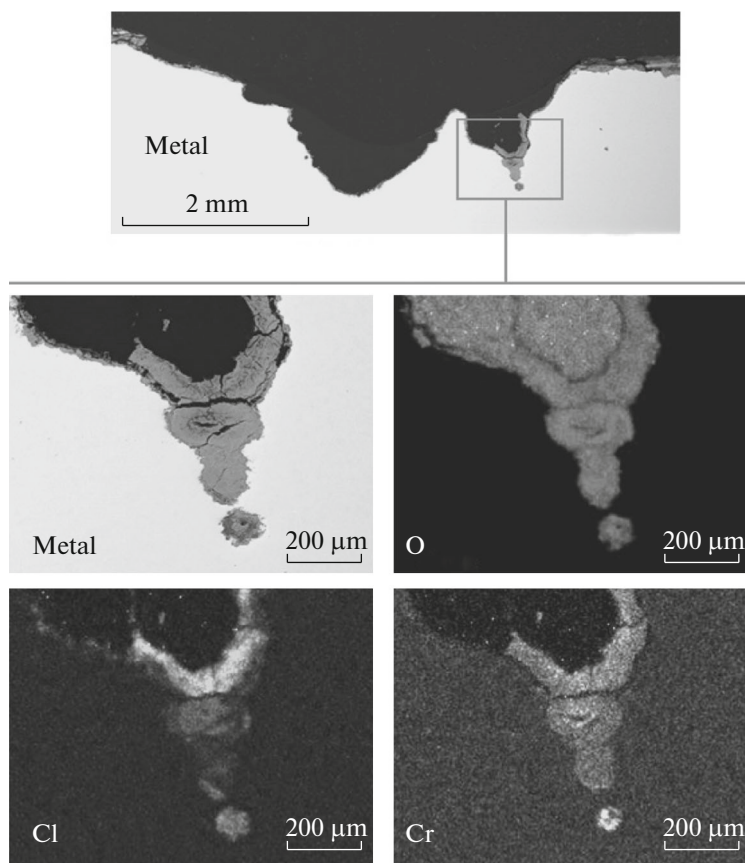
Fig. 8. Composition of the corrosion products in the 13KhFA branch after PFT for 42 months.
