# Correlation between the cracking pattern of historical structure and soil properties: the case of the church in Kozuchów

Krzysztof Raszczuk<sup>1</sup> and Anna Karolak<sup>1\*</sup>

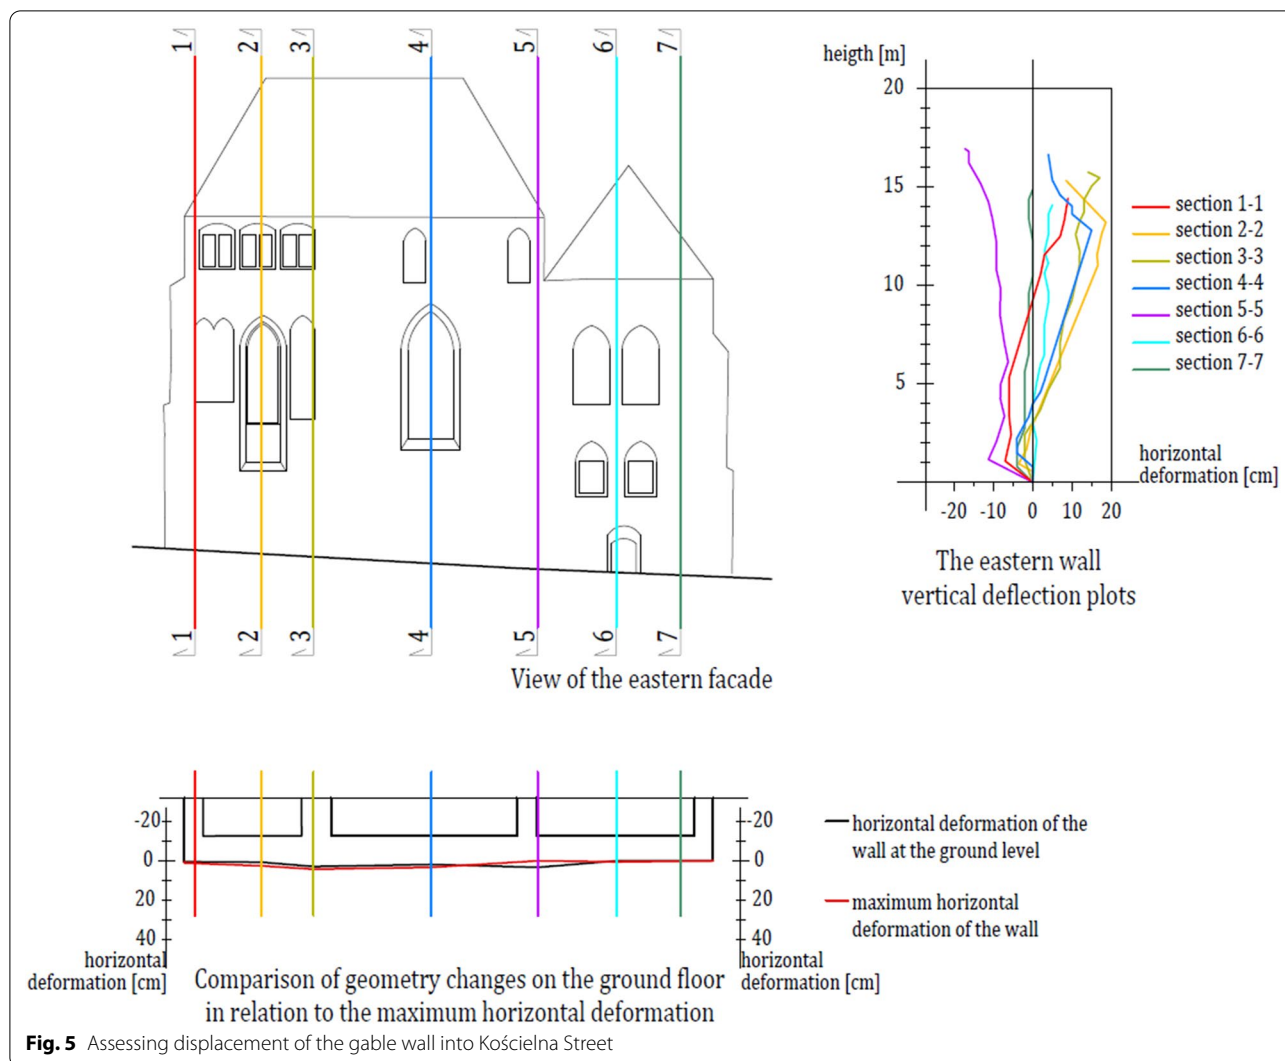
**Fig. 5** Assessing displacement of the gable wall into Kościelna Street

separate from cracking of the vaults resulting from the gable wall displacement in external direction. The cracking pattern points to global deformation of the gable wall, which leans out into Kościelna Street. The horizontal displacement of the gable wall has been confirmed through tacheometric testing (Fig. 5).

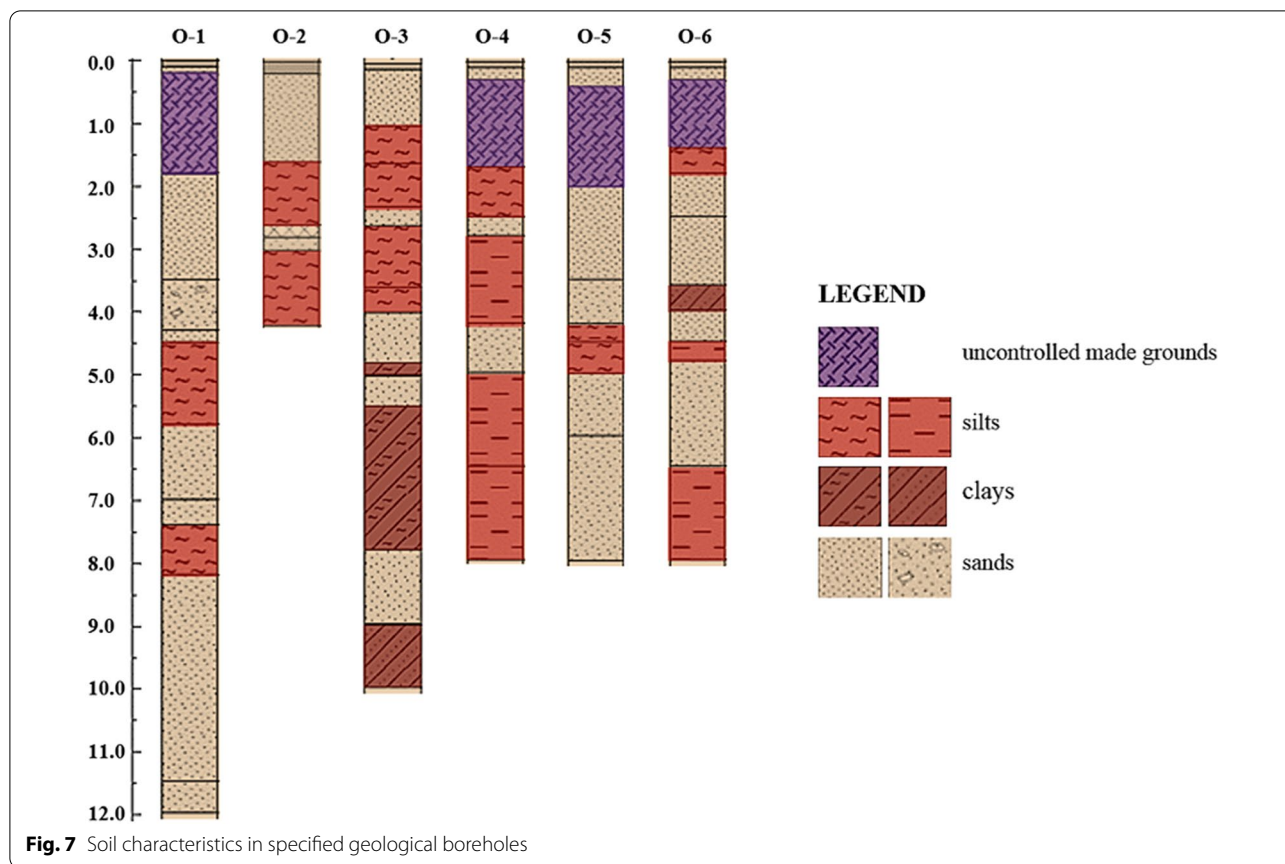
research also accurately determined the morphology and hydrography of the ground substrate. The depth of the ground water table was determined to be located 4.50–5.80 m below ground level and 7.80 m below ground level (in the O-3 geological borehole). Ground-water resources change under the influence of precipitation, evaporation and may be subject to seasonal fluctuations of ±1.0 m. The diversity of ground layers appearing in the geological borehole locations indicates

complex ground conditions underlying the foundations of the building (Fig. 7).

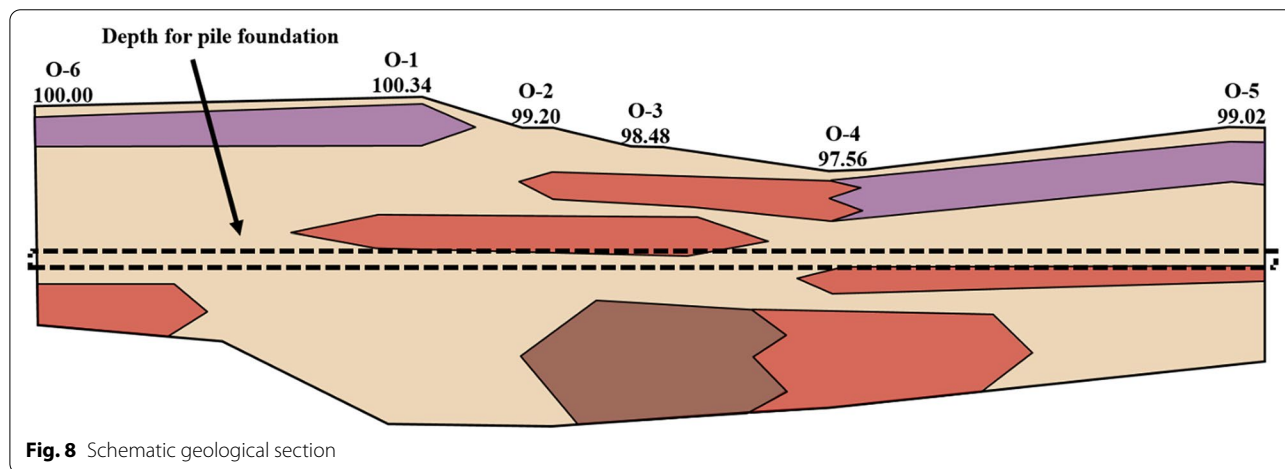
The analysis the influence of soil and water conditions on the building foundation is possible on the basis of geological cross-sections obtained for different directions in relation to the ground-level floor plan of the building (Fig. 8).

determined for the eastern wall area. The church structure was built on stone foundations placed at a depth of 0.60 to 0.70 m below ground level. The south-eastern chapel was built at a depth ranging from 2.10 to 1.40 m below ground level. The frost depth for the village of Kozuchów is 0.80 m, which means that part of the foundations on the eastern side do not meet minimum

requirements. Existing foundations are set partly in substrate subject to displacement (fine grained dust and phyllosilicate clays), and sensitive to freezing and ground water level changes. In the event of even slight water absorption, they can plasticize rapidly under even a small load and reduce their load-bearing capacity. The foundation wall of the church on the east side and the

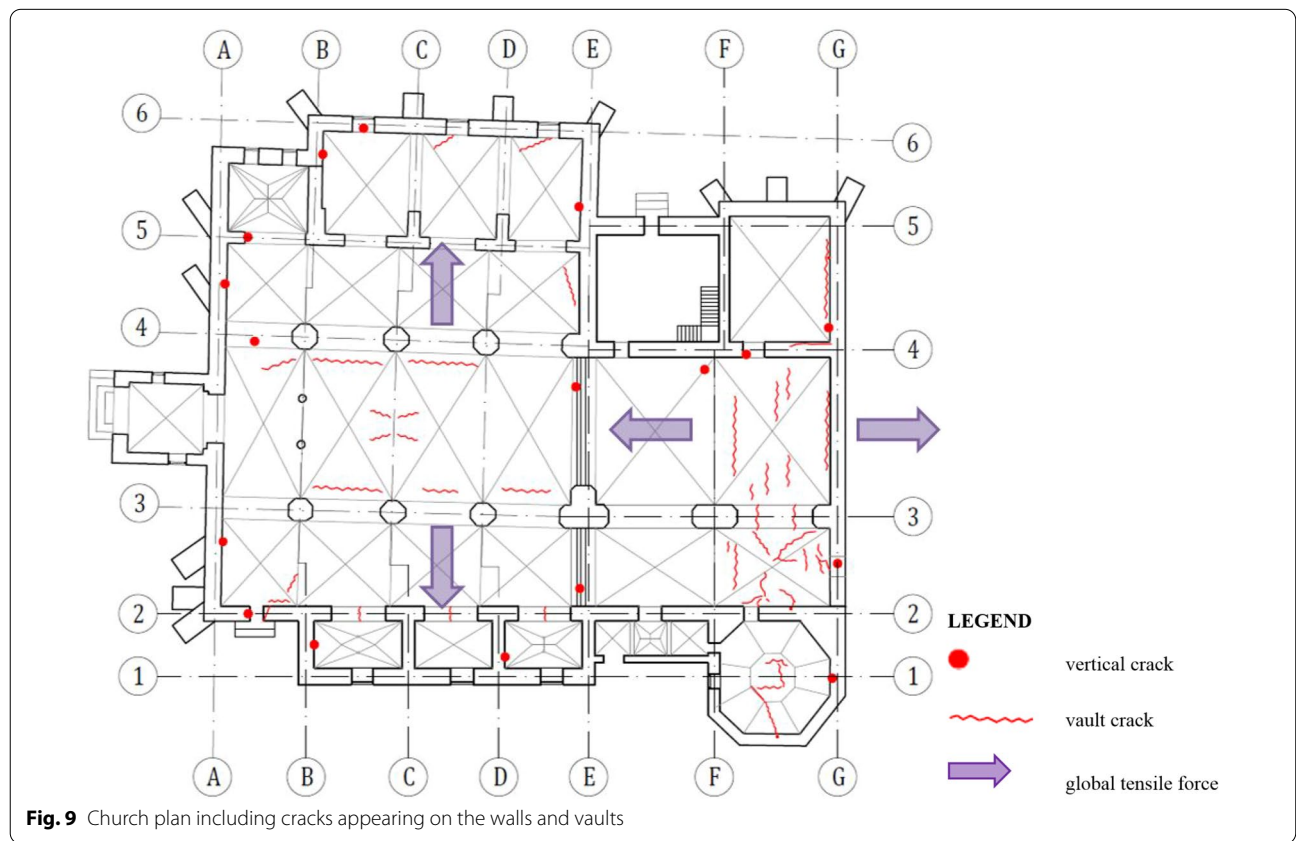
**Fig. 9** Church plan including cracks appearing on the walls and vaults

Observation of numerous cracks on the walls and vaults of the church prompted structural assessment of the building. The cracks were inventoried and presented on floorplans of the church. Cracking on the vault surfaces and vertical cracks in the walls were noted. Special attention was paid to the numerous longitudinal cracks in the eastern part of the heritage building (Fig. 9).

Cracking appeared on both walls and vaults mainly in the eastern part of the building, but also in the main nave. The most significant crack was identified in the inter-nave arch in axis 3, between axes F and G. In this case, the damage to the arch also manifested itself by shifting a wall fragment in a vertical direction. The crack size measured approx. 15–20 mm, posing a serious threat to structural safety. The direct cause of the crack and the formation of a hinge in the interval arch in axis 3 was the significant vertical load of the structure in the area of the roof truss above the arch. Measured from the church floor, the height of the nave at its highest point is 11.52 m. The vaults are supported by external walls (southern and eastern), by the rood arch in the E axis and by the pillar located at the intersection of axes 3 and F. Examples of the cracking are shown in the photographs in Fig. 10.

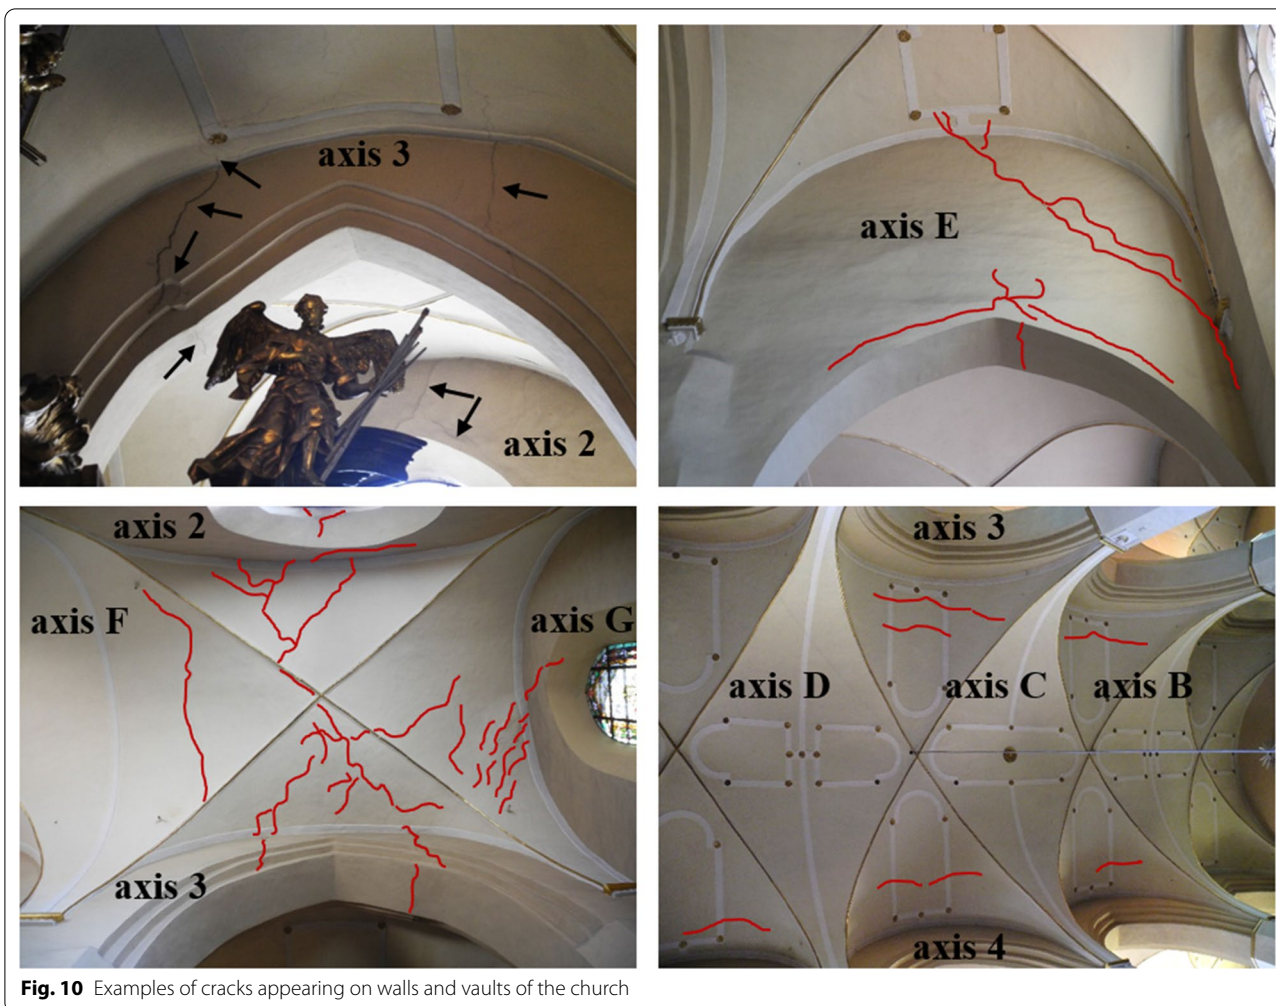
**Fig. 10** Examples of cracks appearing on walls and vaults of the church

It was determined that the observed damage (cracking) was caused by uneven horizontal and vertical movements of the foundations arising from variations in geological substrate. The cracking has been caused by: foundations that are too shallow, periodic fluctuations in water level in weak load-bearing soils and soil loosening due to excavation.

Cracking penetrating the entire thickness of the cross-section was observed in the area of the southern nave and the adjoining chapels. The cracking is concentrated especially in the area of the keystones of the window lintel arches in the upper part of the southern facade. Diagonal cracking was observed in the rood arch, which separates the southern nave from its extension towards the presbytery. Moreover, a deformation (twisting) of the rood arch from the vertical plane was observed. With a maximum height of 13.95 m, the main nave consists of 4 bays covered by cross vaults. Cracking was observed in line with the direction of compressive stress.

In the eastern part of the building, the cracking pattern of vaults indicates the occurrence of tensile stress along the external wall of the building. A typical vault cracking pattern resulting from exceeding tensile capacity in specific places in relation to the situation in the church in Koźuchów is presented in Fig. 11.

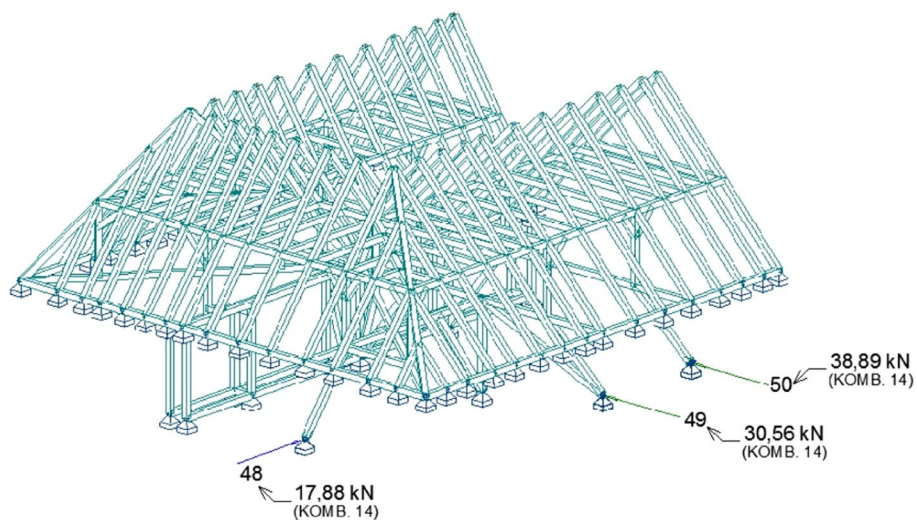
**Fig. 13** The values of reaction forces from the roof which act on the external walls

As a result of structural analysis, the values for reactions from the roof to the wall was determined (Fig. 13).

It was estimated that the internal stresses in the walls caused by horizontal forces from the roof are on the low level and do not have crucial meaning for the cracking appearance in the vaults, but there was a need to add tie rod to ensure the stability of high top walls.
