# Forensic investigation of flowslides triggered by the 2018 Sulawesi earthquake

Divyesh Rohit<sup>1\*</sup>

**Keywords:** Capping layer, Forensic investigation, Large-scale flowslides, Sulawesi earthquake, Water film

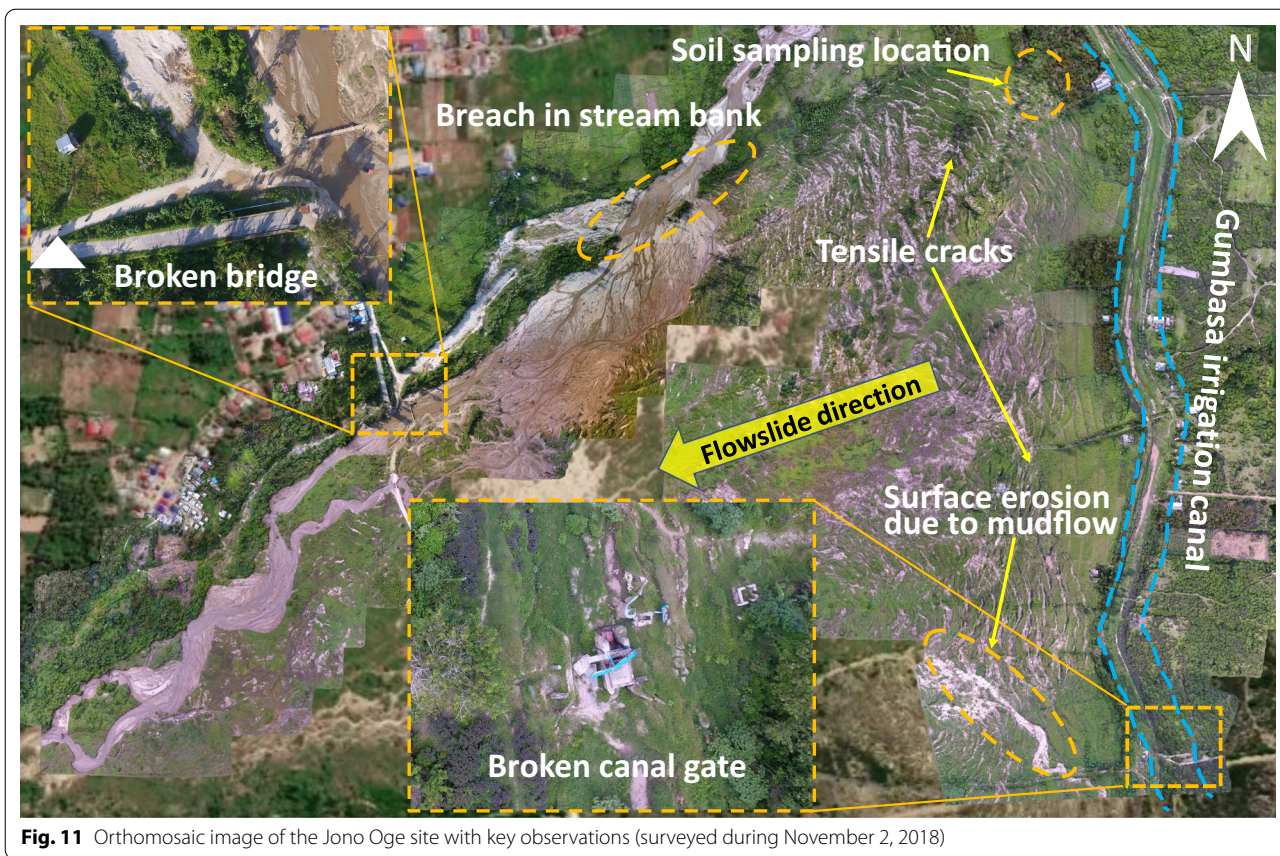
**Fig. 11** Orthomosaic image of the Jono Oge site with key observations (surveyed during November 2, 2018)

not cover the entire area of the site, it was helpful in identifying many important features of the flowslide as well as the destruction it caused. An orthomosaic image was created from the drone images collected during the aerial survey as shown in Fig. 11. The tensile cracks appear from the crest of the flowslide, which then decrease toward the center of the flowslide zone in the southwest

direction. It is important to note the rupture of the canal near the crest of the slide, which shows signs of soil erosion due to the flow of water from the canal during the earthquake. This rupture exacerbated the damage from the slide by creating a mudflow in a large portion of the site. In addition, the stream flowing along the right bank of the slide also appears to have ruptured, depositing a

lot of sediment debris outside its usual flow channel. This rupture is larger than the canal breach and appears to be the most obvious cause of the failure of the bridge connecting the site by scouring its abutment foundation. The extent of vertical ground displacement at the crown of the flowslide is shown in Fig. 12a, which also shows the vertical soil profile at this location. The location of this profile is marked in Fig. 11. Here, superimposed layers of gravelly sand (highly permeable) with sandy silt layers (low permeability) can be seen. The profile also shows the location of disturbed soil samples (J1–J3) collected from the soil wall. The soil gradation curves of the collected samples are shown in Fig. 12b, while Table 2 provides the information on the fines content in the samples. From the gradation curves, it could be clearly inferred that the soil is in the range of highly liquefiable to potentially liquefiable according to the classification of PHRI (1997). As shown in Table 2, samples J1 and J2 have higher fines content and therefore classified as sandy silt, while sample J3 has lower fines content with the presence of coarser soil particles with a higher weight fraction. The soil layers with higher fines content act as a capping layer that prevents the dissipation of the excess pore water pressure

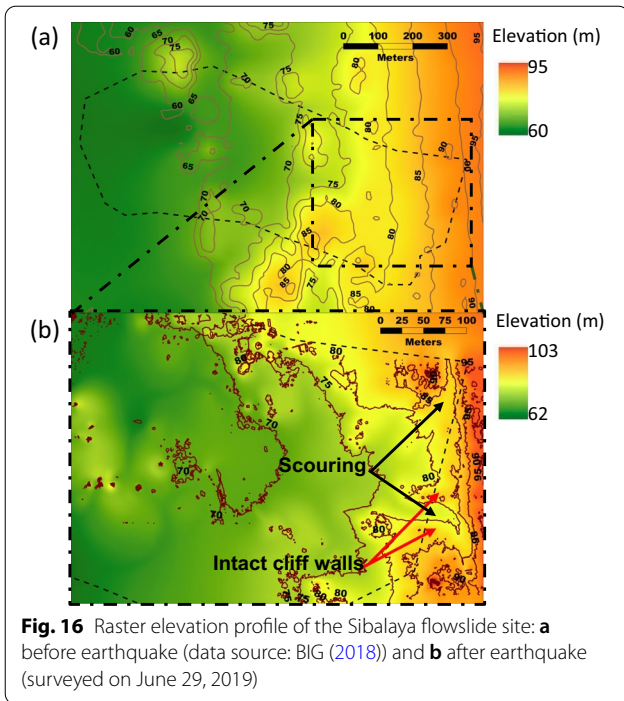
**Fig. 16** Raster elevation profile of the Sibalaya flowslide site: **a** before earthquake (data source: BIG (2018)) and **b** after earthquake (surveyed on June 29, 2019)

The change in the elevation profile of the Sibalaya site was evaluated by generating the raster images from the contour data of the pre- and post-earthquake conditions in a similar manner to Jono Oge. The raster image showing the elevation profile before the earthquake is shown in Fig. 16a (BIG 2018), while Fig. 16b shows the terrain after the earthquake. As can be seen in Fig. 16b, the scouring due to the canal rupture can be seen due to the low elevation of the site. While the elevation contours of the site were smoother before the earthquake, the post-earthquake contours show an uneven surface due to the undulation caused by the decrease in elevation and the uplift of the site caused by the flowslide. The intact rock walls behind Trenches 4 and 5 (Fig. 15) can also be seen from the elevation profile.

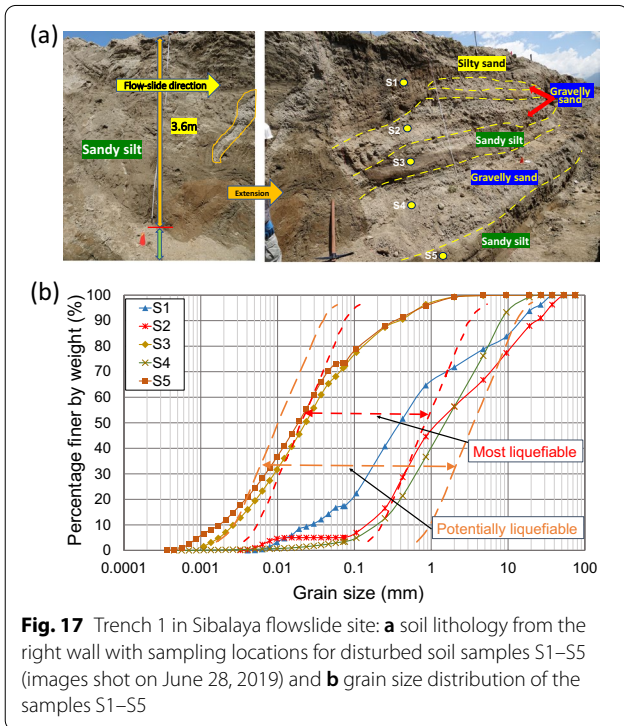
**Fig. 17** Trench 1 in Sibalaya flowslide site: **a** soil lithology from the right wall with sampling locations for disturbed soil samples S1–S5 (images shot on June 28, 2019) and **b** grain size distribution of the samples S1–S5

Trench 1 is excavated on the left side of the road running through the Sibalaya site (Fig. 15). An image of the soil lithology from the right wall of the trench is shown in Fig. 17a. The trench is excavated at an angle, with the deeper side facing the upstream direction of the flowslide, and the deepest part of the trench was more than 3.6 m high. The soil profile here appears highly stratified with layers of coarse (gravelly sand) and fine (sandy silt) soil. The right wall is divided into two images as shown in Fig. 17a. The left image, located in the deeper section of the trench, shows no such stratification, while the right image shows significant stratification. Also, it is important to note that the sand is ejected toward the surface, most likely after the flowslide has occurred and the overlying soil has been displaced. In addition, a converging soil boundary is observed with a gravelly sand layer pushing under the clayey sand layer. This could be due to forward thrusting by the slide, which may have caused

the clayey soil to attempt to bend the stratified soil layers seen in the right image. The left wall also has similar soil stratification, while the front wall appeared to consist mainly of a sandy layer. Figure 17a also shows the sampling locations of the disturbed soil samples (S1–S5). The grain size distribution curves of these samples are shown in Fig. 17b, and the fines content of the samples is given in Table 3. Here, samples S3 and S5, which look sticky from the surface, have higher fines content and are in the range of most liquefiable soil type, while sample S1 is partially in the range of most liquefiable to potentially

liquefiable, and samples S2 and S4 are in the category of potentially liquefiable soil type. The soil gradation is consistent with the visual observation in the field.

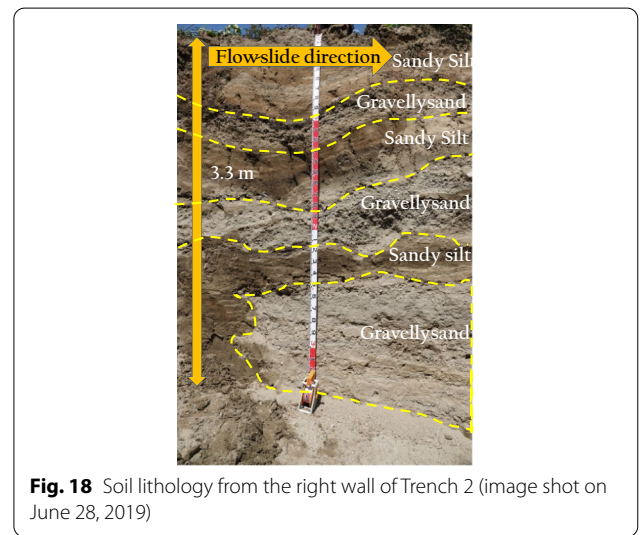
**Fig. 18** Soil lithology from the right wall of Trench 2 (image shot on June 28, 2019)

Trench 2 is located close to Trench 1 and has similar alignment. The soil profile of the left wall of the trench is shown in Fig. 18. This trench also has identical soil stratification as Trench 1, although the synclinal alignment of the shallower soil layers is unique, which is not observed in Trench 1. This feature may have resulted from the forward thrust of the soil blocks moving toward the downstream section during the flowslide and the resistance of the soil layers in the compression zone.

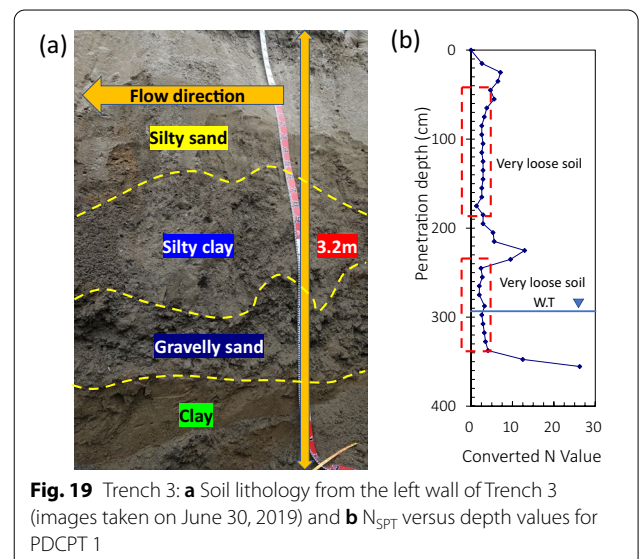
**Fig. 19** Trench 3: **a** Soil lithology from the left wall of Trench 3 (images taken on June 30, 2019) and **b**  $N_{SPT}$  versus depth values for PDCPT 1

Trench 3 is located in the central section of the flowslide with the deeper side toward the upstream of the flowslide. Figure 19a shows the soil profile of the left wall of Trench 3, with a much thicker overlying sandy silt layer. The uppermost layer consists primarily of soil transported from the upstream areas of the flowslide, with some remnants of plant roots and plastic bags also trapped in the soil. The surface of the soil layers in this profile is very soft and moist. This is confirmed by the PDCPT 1 conducted adjacent to this trench and shown in Fig. 19b. The PDCPT 1 values were in the range of 5 for sandy silt, silty clay, and clay layers; these soil layers could be classified as very loose soil (USACE 1994). Moreover, these  $N$  values

are consistent with the critical  $N_{cr}$  values for soils classified as potentially liquefiable at this depth range (Koi-zumi 1966). In addition, the  $N$  value increased up to 15 for the gravelly sand layer, which then decreases again for the clay layer and then increases at greater depths below the clay layer, confirming a hard stratum at the bottom.
