SHORT REPORT

Reassessment of the development and hazard of the Rampac Grande landslide, Cordillera Negra, Peru

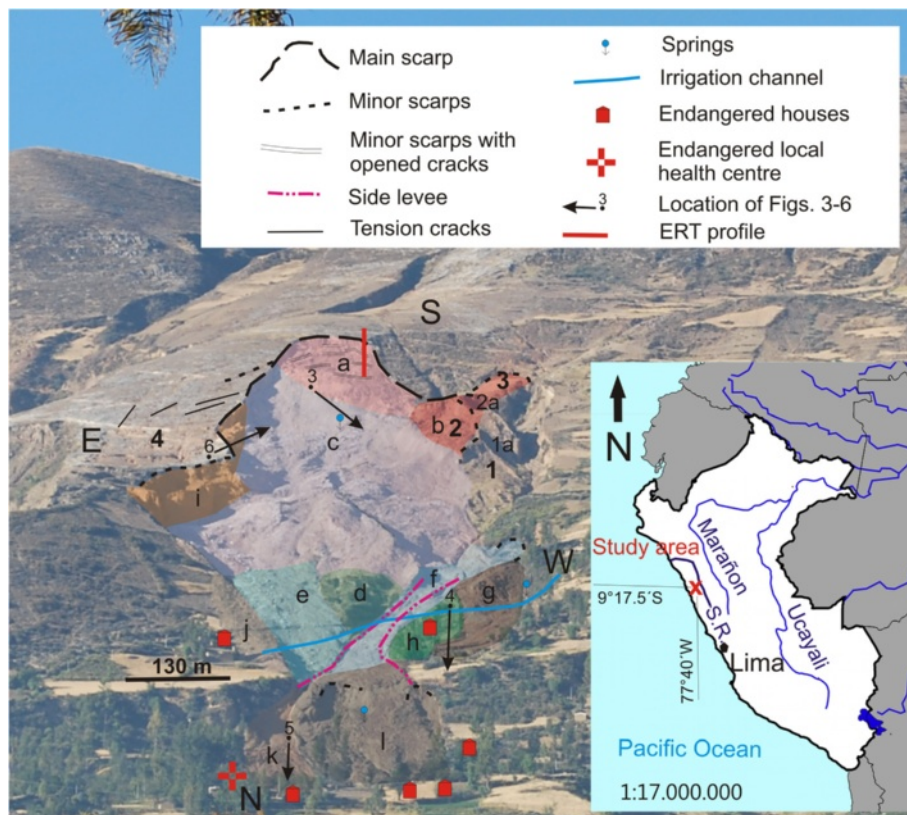
Fig. 1 An oblique photo of the complex landslide (after Klimeš and Vilímek, 2011). Different parts are categorized according to their prevailing character: a) scarp; b) hanging blocks in an unstable position; c) zone of depletion; d) stable part probably without any movement; e) and f) transport area; g) accumulation zone; h) stable part probably without any movement; i) detached rock block; j), k) and l) accumulation zones. Unstable blocks (1, 2, 3 and 4); partial landslides 1a, 2a

Some areas of the Rampac Grande landslide were reactivated but the activity could not be compared with the 2009 event. We identified remobilization of the landslide material in the scarp area—‘a’ (Fig. 1) which was considered as being highly unstable by Klimeš and Vilímek (2011). In addition to Mejía and Meza (2012), local people confirmed the sliding of this material, which probably occurred during the 2013/14 rainy season. The reactivation also involved the head scarp, which retreated by at least

The main reactivation in Rampac Grande happened during the 19th of April 2012 (Mejía and Meza, 2012) and is probably based on the intensive, short term precipitation which activated only the near surface layers in zone ‘c’ (Fig. 1). Remobilisation of accumulation produced two smaller debris flows which we identified in the eastern as well as western part of the landslide area—‘k’ and ‘g’ (Fig. 1).

Removal of the landslide material which occurs mainly by water erosion results in steepening of the slopes within the scarp and upper transportation area of the landslide and also creates longer slopes below landslide parts that were described as unstable in 2009 (numbers 1, 2, 3 and 4 in Fig. 1). We consider this process to be especially dangerous in the case of three individual landslides (numbers 1, 2, 3 and 4 in Fig. 1) as landslides 1 and 2 are exposed to continuous and quite intensive unloading at their toes. They have clear scarps with evidence of vertical movements of 5 m (landslide 1) and 7 m (landslide 2), which occurred during 2009. There are also two temporarily stable landslides (1a, 2a on Fig. 1) just next to them. Along with the toe unloading, we assume that weathering of the loosened landslide material mainly along the shear planes further diminishes their stability. Considering these recent processes and the long history of landsliding in this area, we consider it highly probable that landslide 1 or 2 (Fig. 1) will undergo major movement in the next 50 years.

Mapping of tension cracks (4 on Fig. 1) suggests a deep discontinuity crossing the narrow ridge to the east of the Rampac Grande landslide. Possible future propagation of these cracks may result in mobilization of approximately 25,000 m³ of the estimated volume of the rocks causing a smaller scale disaster than the landslide in 2009. Recent knowledge does not allow us to estimate the hazard degree of such a scenario. Nevertheless, the 2009 landslide proves it is feasible; therefore, we recommend establishing a long term project of monitoring of this part of the landslide, whose main requirement is a positive approach of the local community and their active involvement in the monitoring.

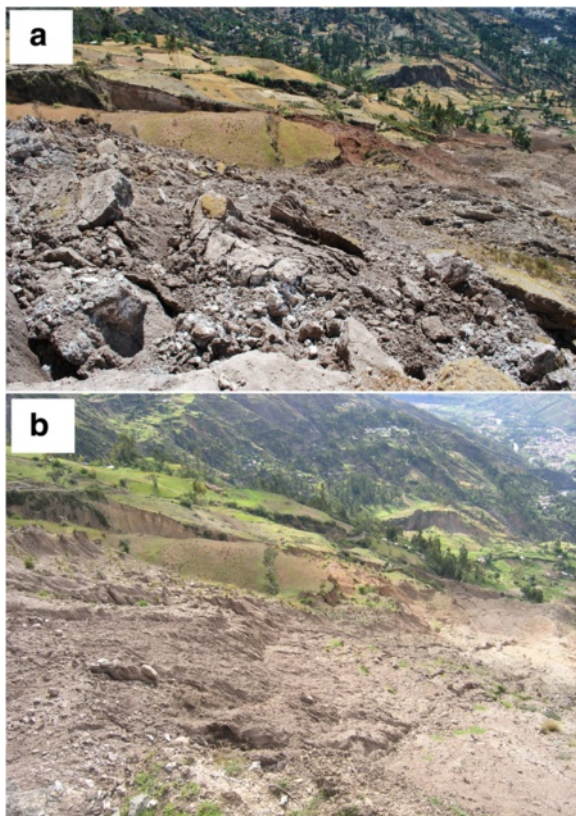
Fig. 2 a from 2009, b from 2014. Some material in the source area has been washed out down the slope since 2009

A comparison of historical photographs (from 2009) revealed a large remobilization of the landslide material

to the left of the transportation zone (Fig. 2a,b). Processes responsible for this remobilization are mainly water erosion starting as sheet erosion and propagating to rill and gully forming erosion. The most prominent gully formed along the east side of the landslide (‘e’, ‘k’ in Fig. 1) reaching a depth of up to 6 m in the accumulation area. This gully re-established the main drainage which existed before the landslide formation (Klímeš and Vilímek 2011) and now drains the whole landslide body. A similar process is responsible for considerable removal of the material from the western part of the landslide (‘b’ in Fig. 1) and in the place where the irrigation channel crosses the landslide. A freshly looking debris flow (200 m long) with a source area outside the landslide probably appeared during the 2013/14 rainy season. It deposited a thin layer (0.4 m) of material reaching the main landslide accumulation area (‘l’ in Fig. 1).

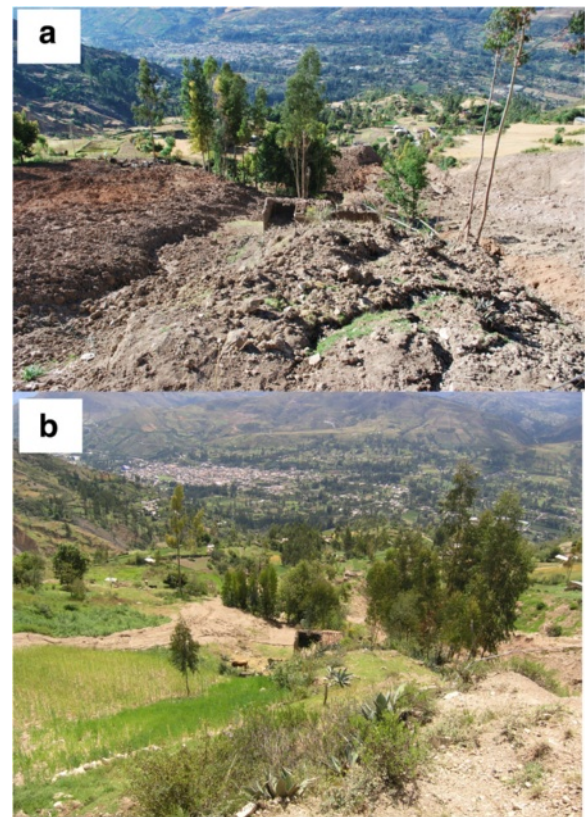
Fig. 3 a from 2009, b from 2014. A new flow accumulation was placed on the body of the complex landslide from 2009 – this time it arrived from a ravine located in the close vicinity of the complex landslide

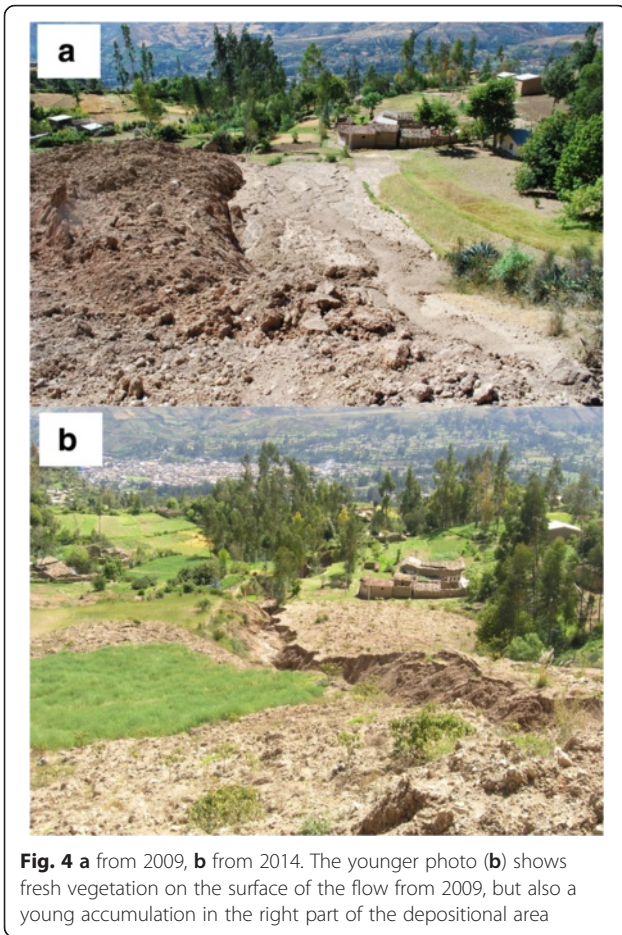
Fig. 4 **a** from 2009, **b** from 2014. The younger photo (**b**) shows fresh vegetation on the surface of the flow from 2009, but also a young accumulation in the right part of the depositional area

Along the incision of the ‘traditional’ stream, an accumulation of new material was deposited in the accumulation part of the landslide (Fig. 4a,b). We assume it was deposited by reactivation in 2012. The major process involved the removal of material from the landslide area is water erosion—flows with high sediment loads.

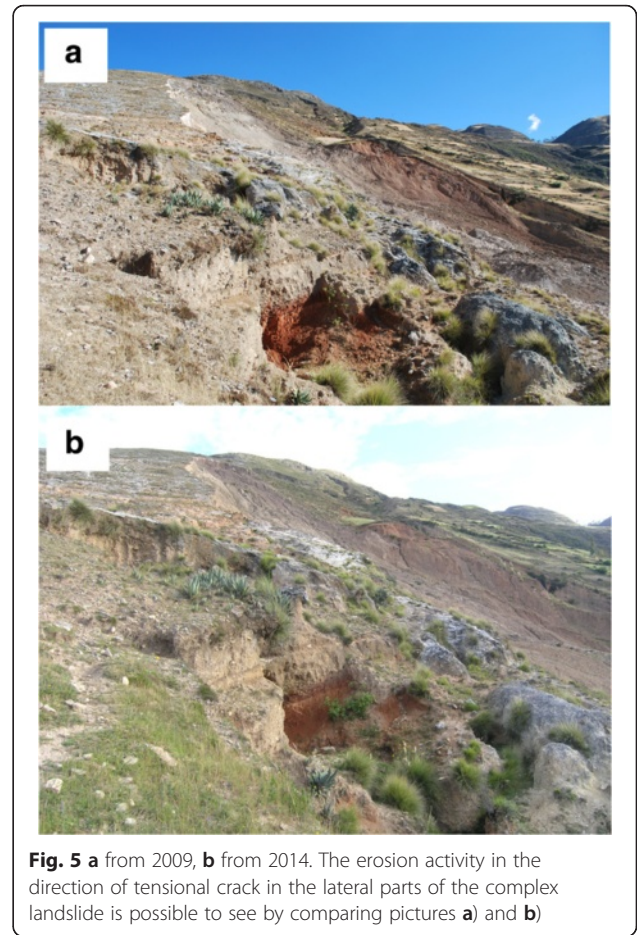
Fig. 5 **a** from 2009, **b** from 2014. The erosion activity in the direction of tensional crack in the lateral parts of the complex landslide is possible to see by comparing pictures **a**) and **b**)

The main changes in the landscape evolution of the landslide area are connected with fluvial erosion. The un-vegetated surface began to be modulated by rill erosion and the former water drainage created just after the landslide event is specified by deep-ward erosion (up to 5 m). The identification of types and intensity of fluvial erosion is important because it works as a destabilising process for possible future mass movements. Many open cracks were identified on the eastern margin of the complex landslide but not in the uppermost part. Future propagation of cracks will destabilise the side areas (Fig. 5).

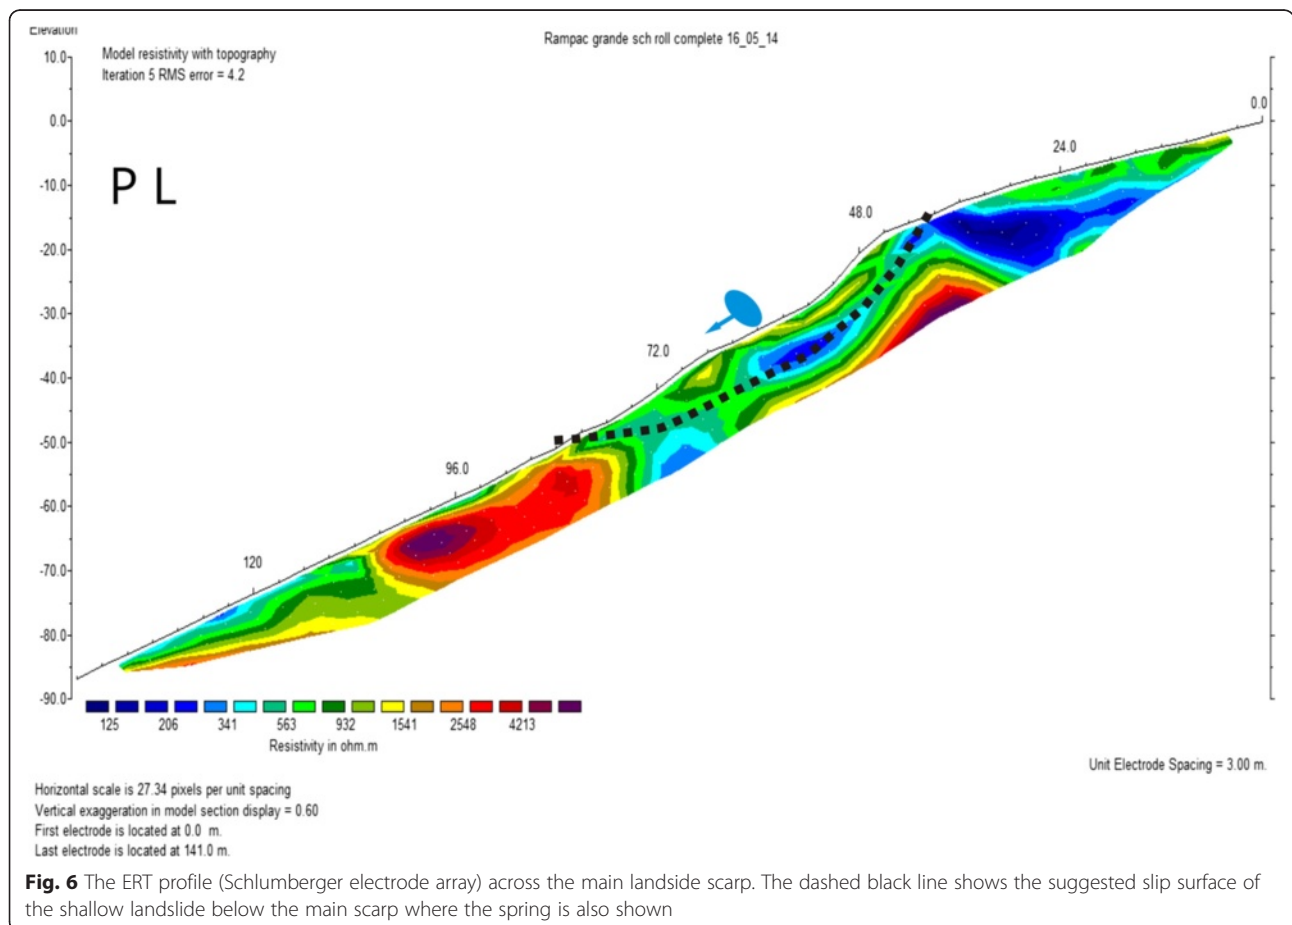
Geophysical research across the main landslide scarp revealed the highly variable properties of the slide mass with regions of higher resistivity probably formed by more compact rocks and low resistivity patches which could be related to a spring observed some 10 m to the east of the profile. Sharp transition of resistivity values from high to low across short depth along with modelled geometry of this boundary suggest presence of water saturated material which may. It may represent possible future sliding plane of a shallow (approximately 6 m deep) landslide (Fig. 6). Due to the limited depth penetration, the main sliding plane could not be identified.

Fig. 6 The ERT profile (Schlumberger electrode array) across the main landslide scarp. The dashed black line shows the suggested slip surface of the shallow landslide below the main scarp where the spring is also shown
