# Engineering geological characteristics and failure mechanics of Jure rock avalanche, Nepal

**Study area** The present work is aimed at assessing the failure mechanism of the disastrous 2014 Jure rock avalanche along Araniko Highway, Northern Nepal. The event had blocked the Sunkoshi River and blocked an economically significant route to China.

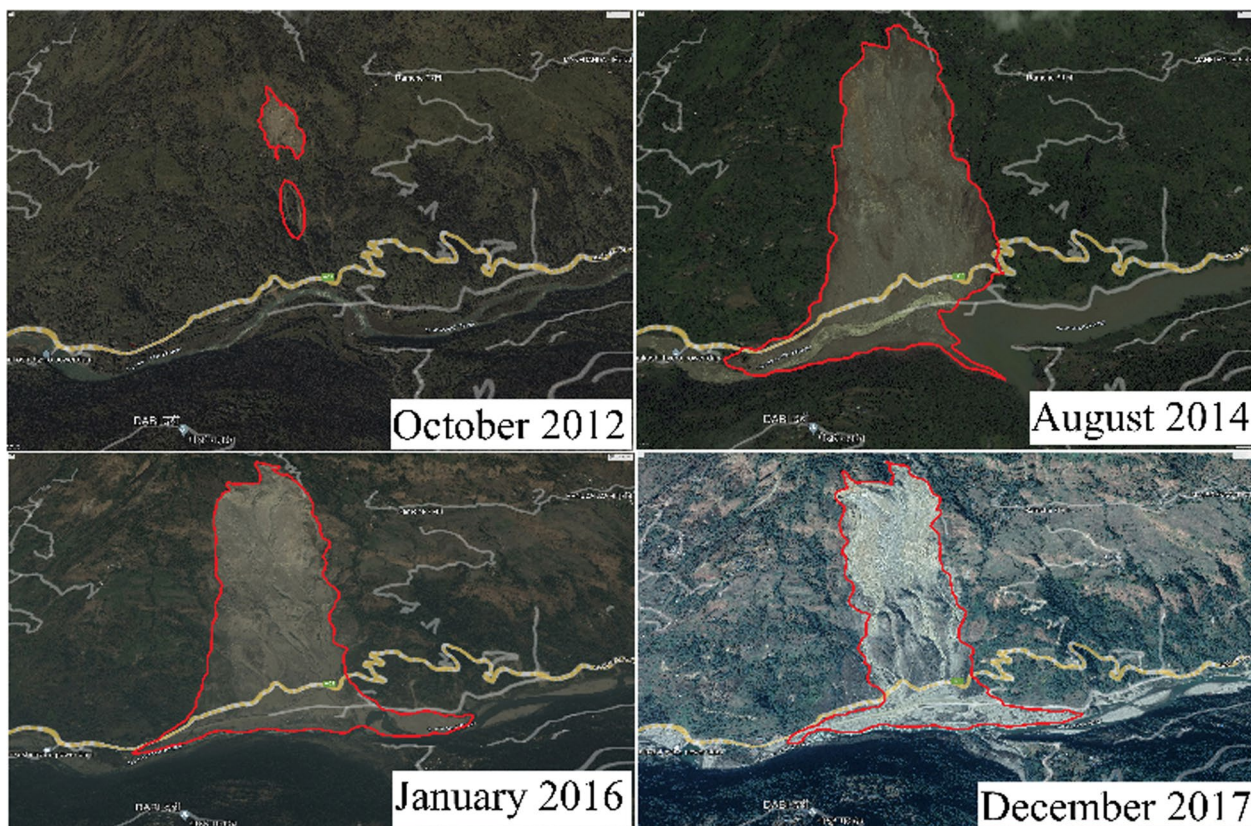
The mapping of fractures in the Jure landslide zone started in 1958 during the construction of Araniko highway. In 1967, 1971, and 1975 landslides were repeatedly observed just below the crown. In 1983, a landslide occurred on the crown, however the toe remained safe. After 1989, landslides activated and regenerated below crown to mid part. The GoogleEarth images since 2012 indicate an increasing rock fall and scarp development

activity of the landslide. There was a smaller slide in 2013 at the upper cliff. The slide reactivated suddenly on 2 August 2014 causing a huge collapse. Figure 3 shows the pre and post landslide features of the Jure landslide.

**Fig. 3** Google earth images of 2012, 2014, 2016, and 2017 of the study area

The satellite images since 2012 indicate an increasing rock fall and scarp development activity at the incident site (Fig. 3). However, it was difficult to assume the occurrence of such a catastrophic mishap. The records show that no seismic events were recorded prior to the failure, however, rainfall of more than 70 mm/day was recorded two days before the mishap. The natives have

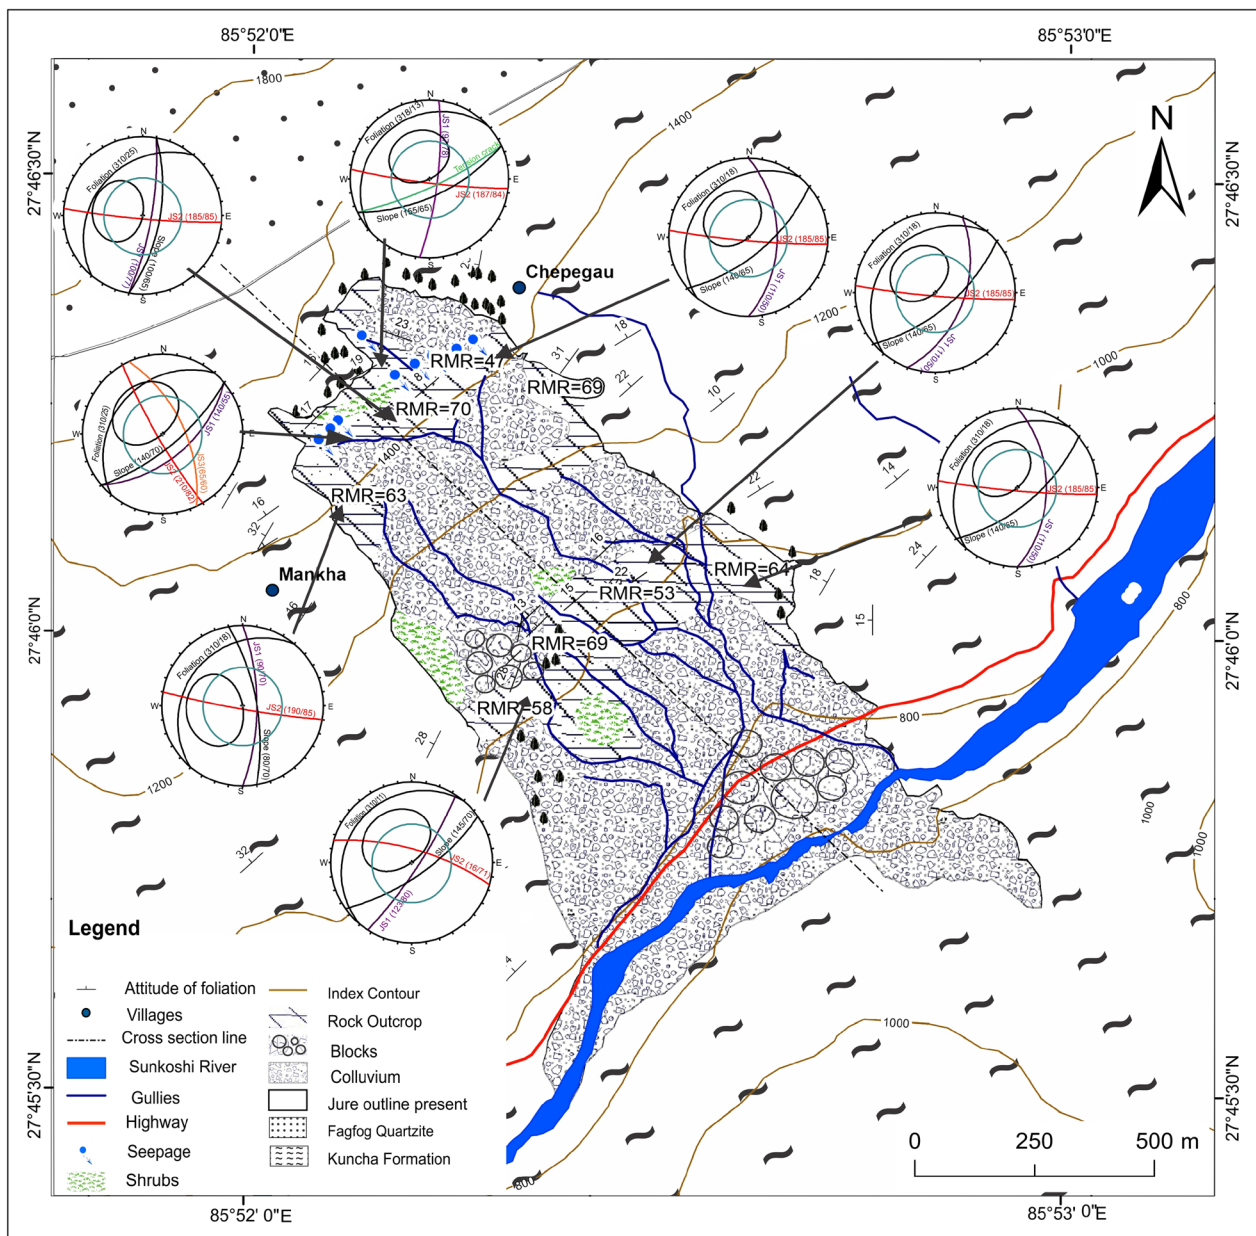
The engineering geological mapping was done to assess different parts of the landslide (Fig. 4). Numerous quartz veins are visible, and most are aligned parallel to the foliation. The foliation of the rocks gently dips about  $10^{\circ}$ – $25^{\circ}$  toward NW. The other two major joints are almost vertical, joint dipping  $70^{\circ}$ – $80^{\circ}$  towards East ( $J_{S1}$ ), from which most of the water is flowing down and joint dipping  $80^{\circ}$ – $85^{\circ}$  towards southwest ( $J_{S2}$ ). The kinematic analysis shows that failure in the lower cliff is unlikely. On the upper cliff, some wedges are formed on the left flank of landslide, implying possible wedge failure and on other parts wedges formed by intersection of joint planes  $J_{S1}$  and  $J_{S2}$  were observed which were stable without any external forces. The Jure landslide is a form of mass wasting that includes a wide range of ground movements such as rock falls, deep failure of slopes, and shallow debris flows. Although, the action of gravity is the primary driving force for a landslide to occur, there are other contributing factors affecting the original slope stability. In this landslide,

**Fig. 4** Engineering Geological map of study area

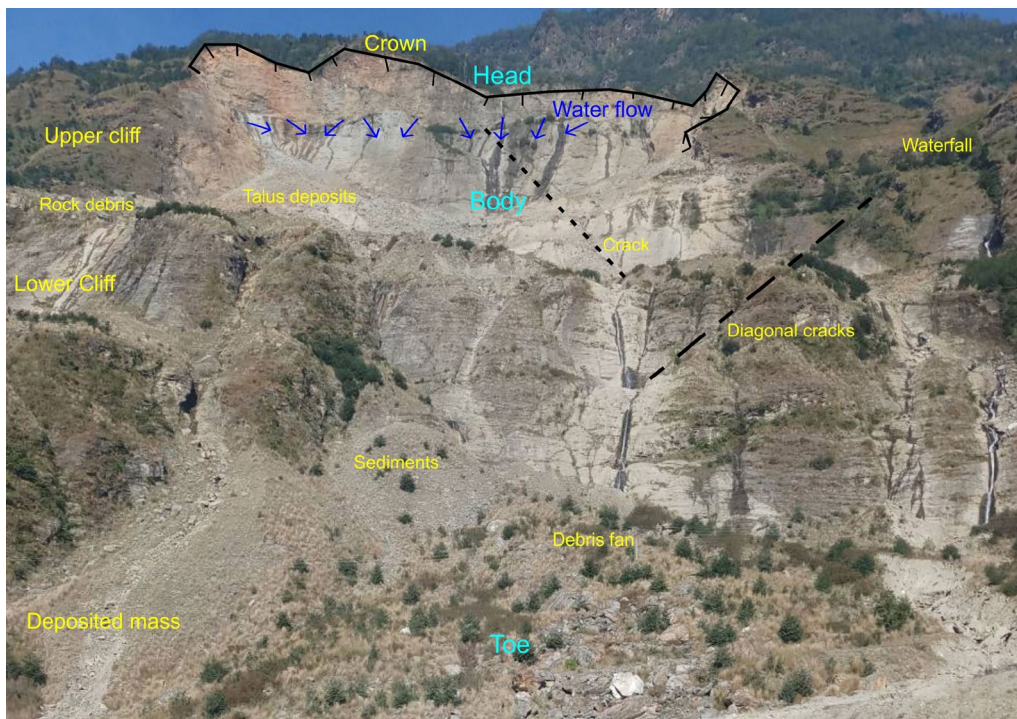
**Fig. 5** Jure rock avalanche showing different parts (view to N)

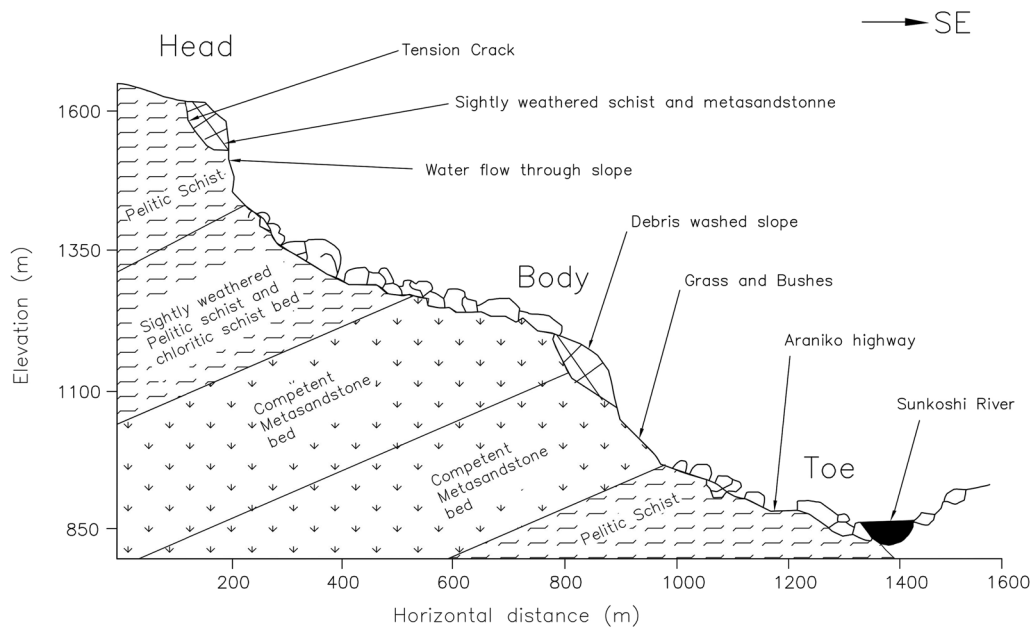
**Fig. 6** Cross section of Jure landslide showing various landslide parts

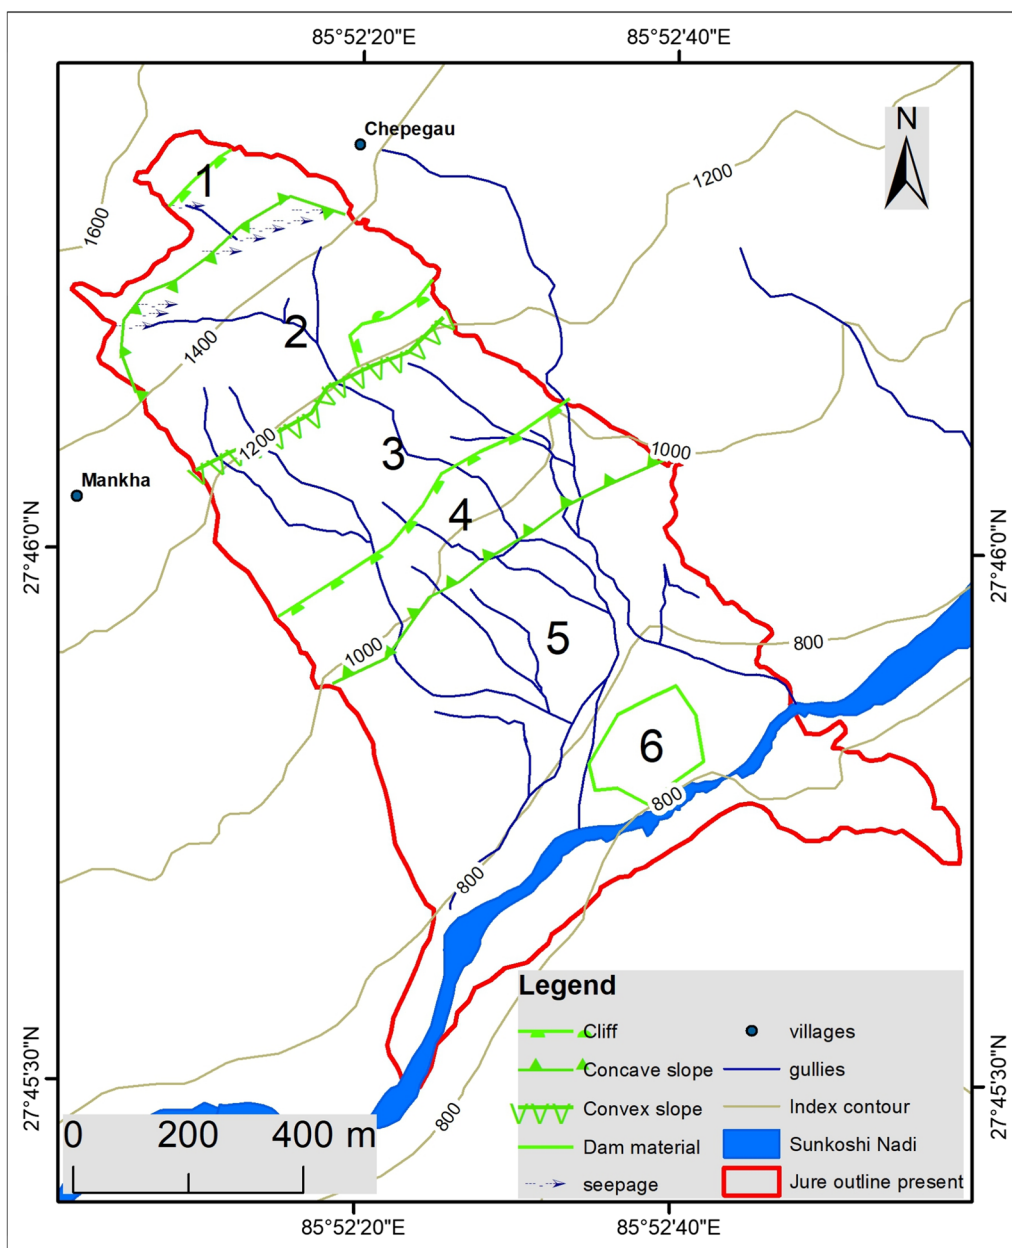
The crown is full of cracks, from where the spring water is discharging (zone 1). At this section, the slope is found to be 70°-80° with concavity throughout the slip surface. The slippage initiated from upper cliff (zone 2). At this section, the slope is found to be 65°-70° with concavity throughout the slip surface. This segment consists of highly weathered rocks. The exposed scar looks brownish in colour. Zone 3 comprises huge boulders and rock

fragments covering the flat land between the Lower and Upper cliff. This section of landslide consists of an abundance of debris material. The slope ranges from 30°-45°. The spring source flowing downwards from top of the

slope follows this section along the surface. Zone 4 of the landslide is the remains of the previous slope signifying the low potentiality of failure and the slope of this section is 55°-65°. This section primarily consists of highly

**Fig. 7** Geomorphological map of Jure landslide showing various failure zones

fractured rocks at the surface. The spring source that has been disappeared in, again appears at this section forming the distinct gullies. Zone 5 can be described as toe or debris fan deposit area of the landslide comprising colluvium. Zone 6 is the accumulation zone of failed mass that consists of large boulders dispersed in different sections throughout the landslide areas at toe.

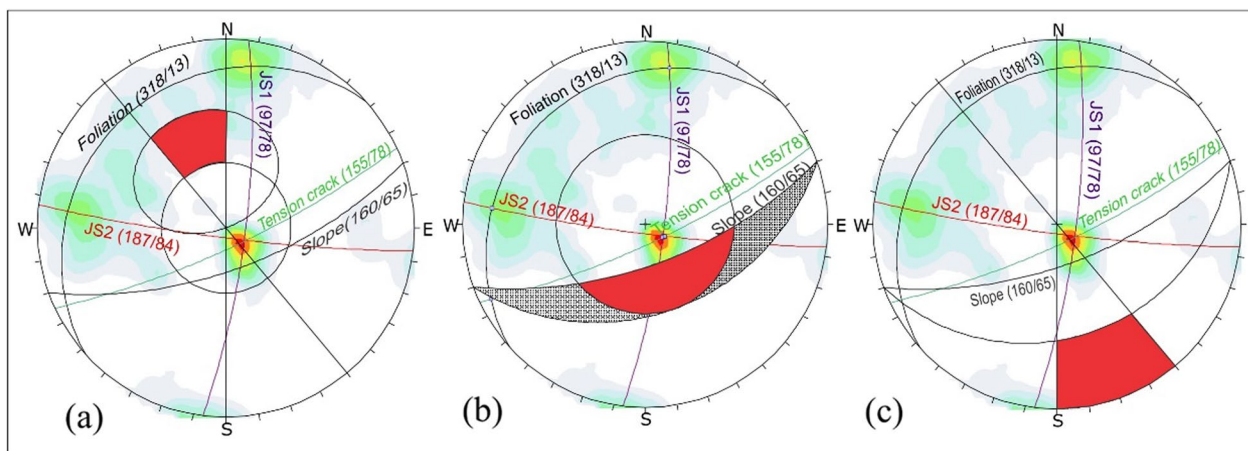
Most tension cracks parallel to slope had slightly greater inclination than the slope, denoting minimal chances (~6%) of plane failure (Fig. 8). Moreover, no wedge instability can be located considering mean orientation of major discontinuities from the upper cliff. However, two very gentle wedges formed by the intersection of foliation with  $J_{S2}$  and  $J_{S1}$  at the western and northern parts of the stereoplot (Fig. 8). Another three very steep (nearly vertical) wedges formed by  $J_{S1}$  and  $J_{S2}$ , tension crack and  $J_{S1}$ , and tension crack and  $J_{S2}$  are not daylighted. Additionally, there are no such discontinuities which may be responsible for the toppling failure (Fig. 8). This indicates none of the simple failure modes appear to be feasible. So, the water flowing from the tension crack may have ultimately appended the water pressure along joints, eventually lifting or pushing the wedges. This gives rise to the possibility of generation of newer fracture planes enabling sliding of the slope mass.

**Fig. 8** Kinematics analysis for failures, **a** planar failure, **b** wedge failure, **c** toppling failure

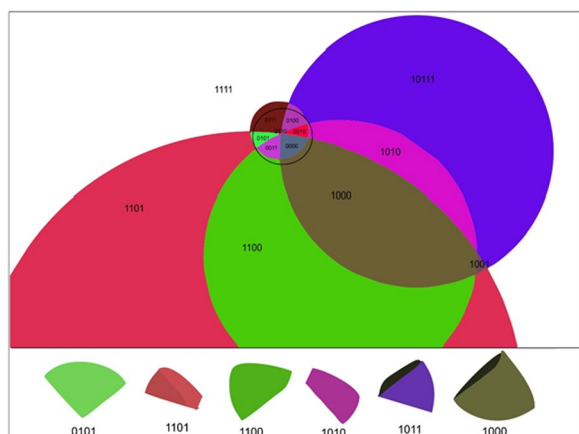
**Fig. 10** Joint pyramids and critical block shapes analysed from block theory analysis

and sized key blocks types, 6 were finite and removable (i.e., Joint Planes: 1000, 1100, 1010, 0101, 1101, and 1011) with FoS less than 1. A slight movement in these blocks by any external pressure and loading can cause these blocks to move. Consequently, the overlying blocks become free to move causing the failure to progressively become larger in a chainlike series.

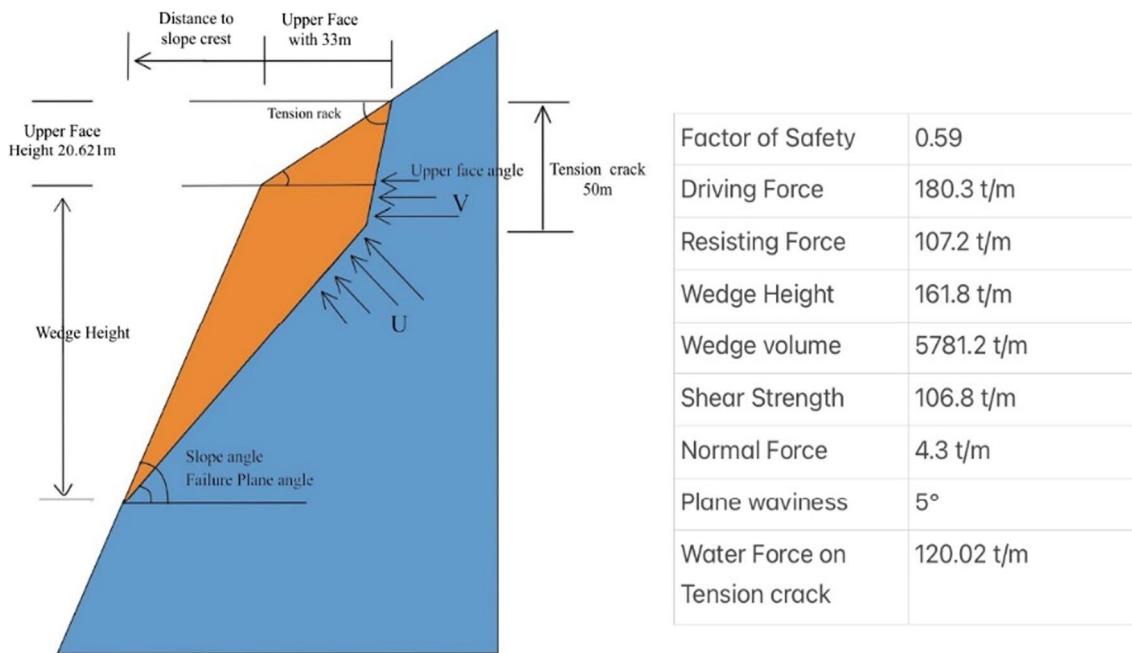
on trace observed at the avalanche. The height of water in the tension crack was gradually raised by hit and trial of 500 different combinations in order to cause failure on the sliding planes. Simultaneously, their corresponding factor of safety was determined. Afterwards, computer simulations for plane failure analysis were performed using the most critical conditions from parameters, as obtained in back analysis (Fig. 11). The calculation shows the slope was marginally stable in absence of any external forces. The dip of the sliding plane, upslope dip amount, and face dip amount were 48°, 32°, and 65° respectively as input parameters in back analysis of the Jure slope. Additionally, critical tension crack depth, position for tension crack, critical slide plane inclination was fed as 41.86 m, 33.60 m, and 51.50°, respectively. The factor of safety of the slope without water and with water in tension crack is calculated to be 1.7 and 0.59, respectively.

The spring water infiltrates through the tension cracks and  $J_{S1}$  leading to the alteration and degradation of rock mass. The process also increases the pore water pressure in the tension crack at the slope’s toe. The water pressure in these cracks allowed the block movement by the forces developed on the joint surfaces resulting in tilting of the blocks from the toe and ultimately slope failure. The sensitivity analysis indicates the variation in FoS with change in slope parameters such as slope angle, height, or water percent filled in tension cracks (Fig. 12). The back-analysis using hit and trial approach gave a perfect match with the result obtained from computation in RocPlane software (RocScience Inc.). Furthermore, the sensitivity analysis also fits the real ground condition (Fig. 12).

**Fig. 11** Planar wedge stability analysis of Jure slide

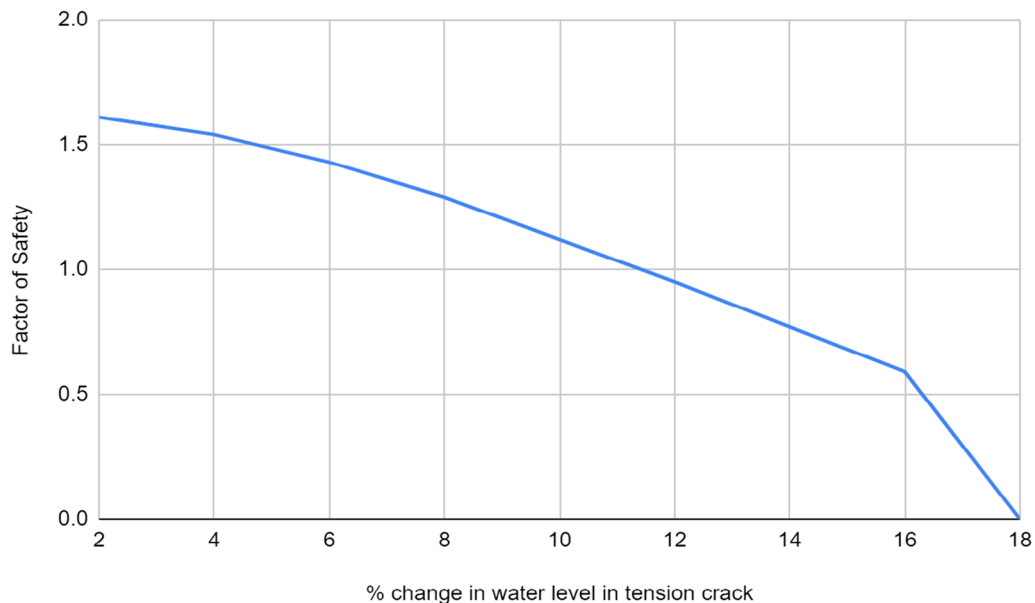
**Fig. 12** Sensitivity analysis for various slope parameters for planar failure

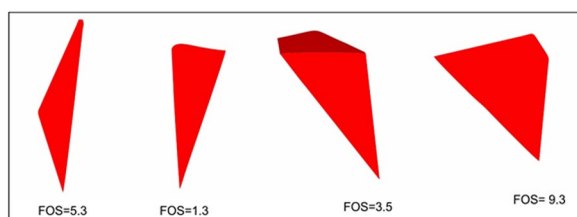
varies throughout the slope, various other valid directions of hillslopes are tested to obtain wedge blocks of different shape and size. All the possible combinations of two discontinuities and the slope surface that form a valid wedge were analysed (Fig. 13). The wedges are found to have a maximum weight of 155 tons, and with addition of water force in the most critical wedge formed by  $J_1$  and  $J_2$ ,

**Fig. 13** Various shaped and sized blocks formed by wedges in Jure

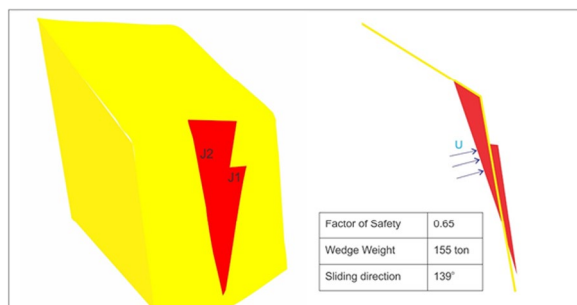
**Fig. 14** Wedge stability analysis for most critical wedges

the FoS is found to be 0.65 (Fig. 14). The water infiltrating through the joint intersection increases the water pressure in the walls of the joint that pushes the wedge. The development of pore water pressure at the base of the wedge caused the toe of the block to tilt and decrease in plunge which subsequently failed by sliding along the line of intersection, trending 139°.

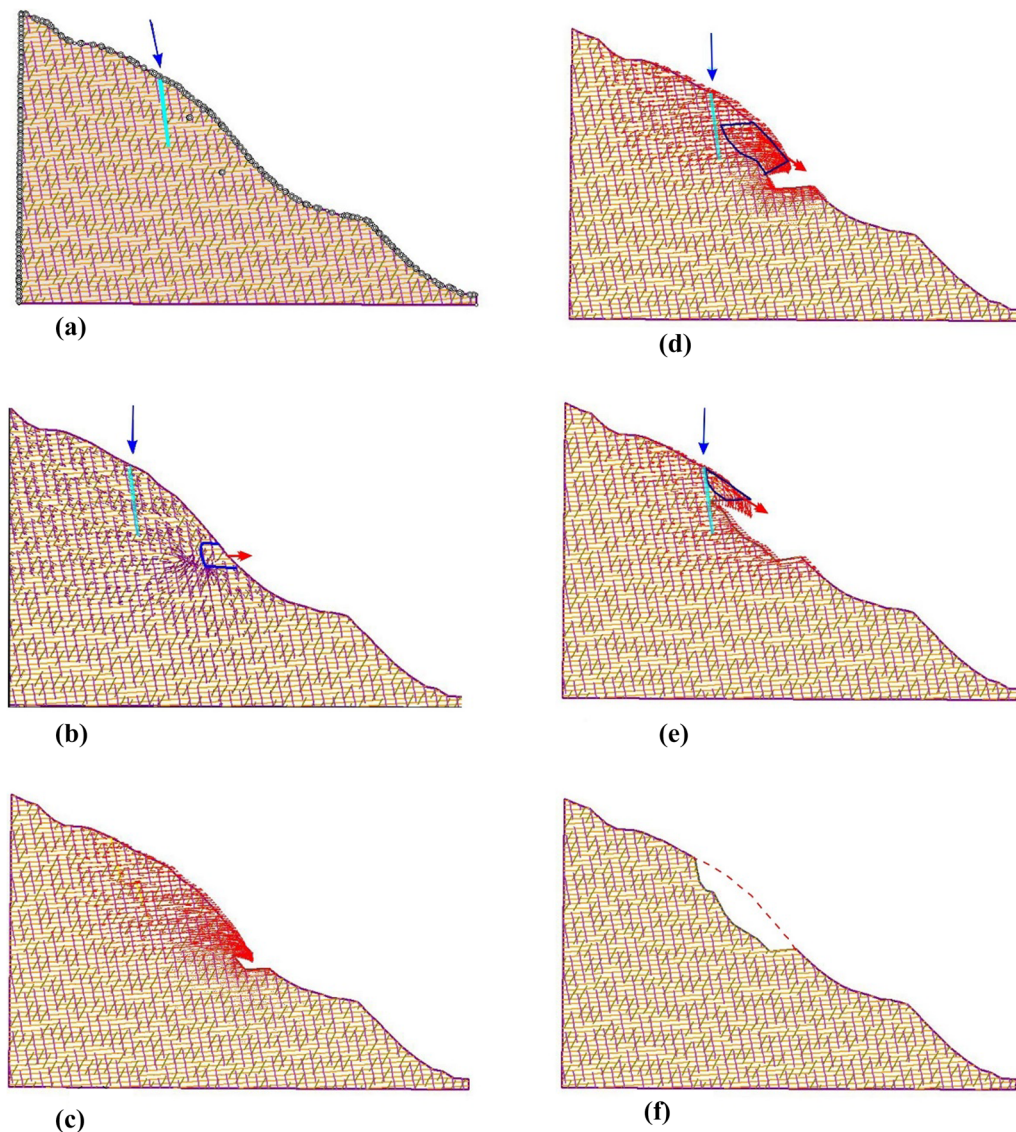
The interpretation of the evolution of the 2014 Jure rock avalanche can be seen in Fig. 15. The surface water infiltrates through tension cracks and joint networks over a period of time causing widening of joint apertures owing to freeze–thaw action and ultimately weakening the rock mass through physical disintegration process. The heavy rainfall (70 mm/day), prior to the event, influenced the pore water pressure in impervious and porous pelitic schist rockmass obstructing the flow by infilling materials in tension crack and some of the discontinuities. The impervious boundary allowed high water pressure to be concentrated on the walls of tension cracks and the toe of the blocks at the base of the upper cliff (Fig. 15a). And, this increase in pore water pressure along the structural discontinuities had significantly lowered the shear strength attributes along joints' surfaces and eventual decrease in factor of safety (FoS) value. Also, the hydrostatic pressure developed in the rockmass owing to heavy rainfall exceeded the static friction threshold of rock blocks and wedges. And, as the concentration is reached maximum around key blocks, the blocks in front are pushed forward. The tilting and pushing of key blocks by water pressure from the joint networks and base of blocks caused the blocks of schist (the key-block) to bulge out which ultimately was thrown outward along the gentle foliation plane (Fig. 15b). With the support removed below, the above hanging rocks became unstable as discussed above in the key-block theory section. And, around 80 m high rock cliff collapsed from the upper cliff on removal of key block support from below (Fig. 15c–f) and the debris moved downhill triggering the mass movement by washout of bedrock in the lower cliff. At this stage, the debris lost its momentum reaching the narrow valley floor where it buried the Araniko Highway, as well as some houses. Finally, the debris and blocks from the avalanche dammed the Sunkoshi River forming a landslide dam. Furthermore, the material forming the crown of avalanche became unstable, when the rock mass constituting the upper cliff was moved downhill. The movement propagates towards the crown after the main failure event happened (Fig. 15d). It can be observed that streams flowing downward above the crown and landslide mass has infiltrated through open joints. There is

**Fig. 15** Evolution and failure mechanism of Jure rock avalanche

still a large crack present in the upper cliff from where the spring water is coming out. The tilting of trees in different directions can be observed above the crown. The reactivation of slope during rainfall and in dry season occurs by smaller failures on crown area.
