Numerical Modelling and Structural Health Monitoring for Built Heritage Management: The Case of the Church of Santa Croce in Ravenna

Francesca Ferretti^(III), Chiara Monteferrante, and Claudio Mazzotti

DICAM Department, University of Bologna, Viale Risorgimento 2, 40136 Bologna, Italy francesca.ferretti10@unibo.it

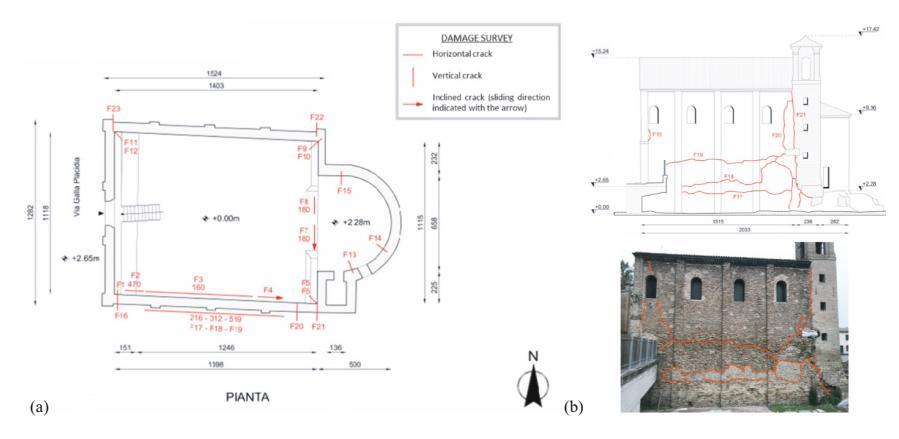
Regarding the state of damage of the Church, the survey of the crack pattern was carried out (Fig. 3). Major cracks were located in correspondence with the connections

between orthogonal walls, on the southern wall and in correspondence with the apsis, both at the roof level and at the base. Moreover, a severe problem highlighted during the on-site inspections was the detection of the groundwater level higher than the floor level of the Church, leading to problems related to capillary rising damp and, more in general, to the presence of water on the site.

Fig. 3. Damage survey: (a) plan view, (b) southern wall.

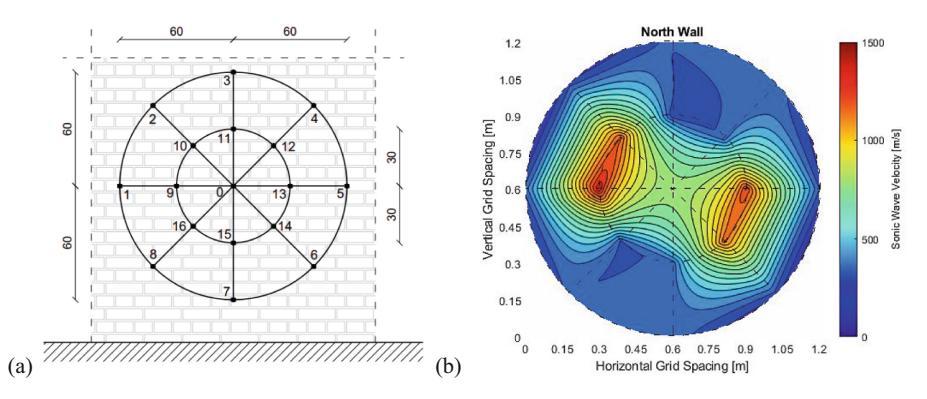
time the sonic waves take to travel, and the distance within the probes, it was possible to evaluate the wave velocity, that can be directly related to the material quality. The results of an indirect sonic test are presented in Fig. 5b, where the velocity contour plot was obtained by interpolating the results obtained at the different testing points. In Fig. 6, the comparison between the sonic wave velocities obtained for all the tests is presented. It is possible to observe that lower values of the wave velocities were obtained for the indirect sonic tests and this can be explained by the irregularities detectable on the wall surfaces, mainly due to damages and degradation of the mortar joints.

Fig. 5. Sonic tests: (a) location of testing points, (b) representative map of wave velocities for the indirect sonic test Sc_{-i3} .

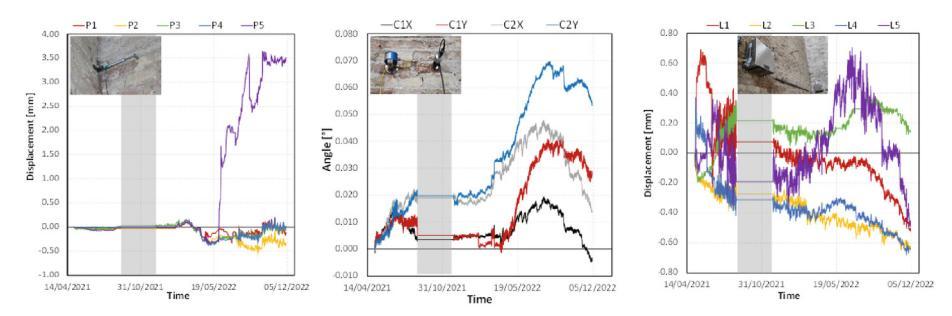
The structural monitoring began at the end of April 2021 and is currently in operation. The data registered by potentiometers, clinometers and level meters from April 2021 to December 2022 are presented in Fig. 8. In general, it can be observed that the only crack for which a consistent opening is registered is the crack in correspondence with the potentiometer P5, positioned at the base of the apsis, where the access to the crypt is located. Angle variations registered by the clinometers are comparable for the two longitudinal walls. Concerning vertical displacements, even if a global trend cannot be identified, consistently with the fact that the external walls of the church are not

Fig. 8. Real-time monitoring data from April 2021 until December 2022 (grey area: no data due to flooding of the Church).

adequately connected in correspondence with the corners, it is possible to notice that, at the end of 2022, a negative increment of the displacements is registered by all the level meters. The grey area indicated in the graphs of Fig. 8 represents a period of time in which the monitoring activities stopped due to the fact that the Church was flooded as a result of severe thunderstorms and of the malfunctioning of the drainage system.

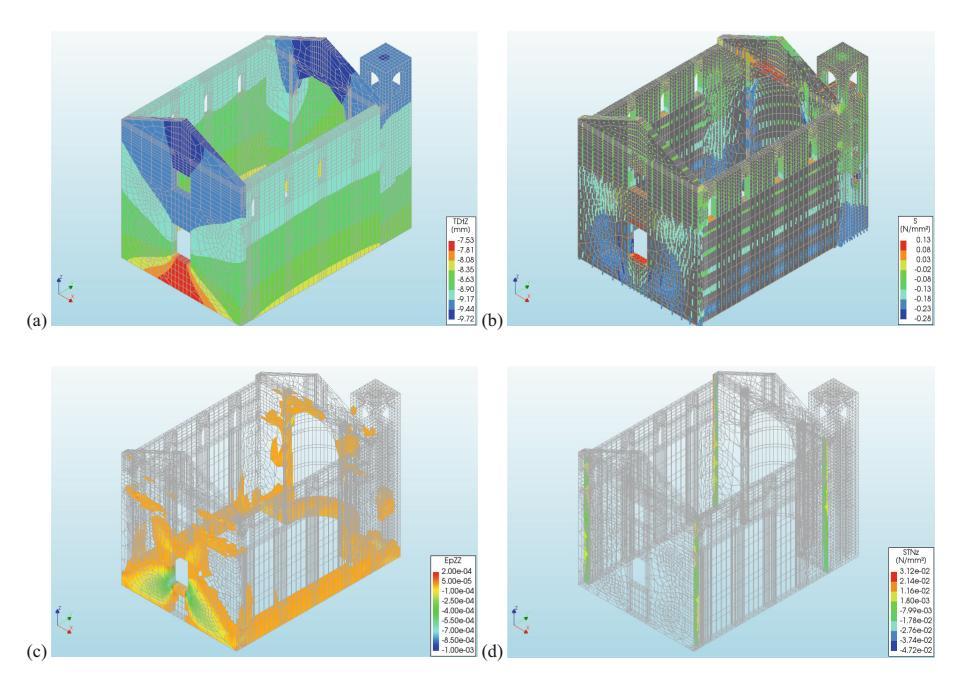
Fig. 11. Results of the nonlinear analyses: (a) vertical displacements, (b) in-plane principal stress components, (c) vertical plastic strains, (d) interface normal tractions.

It can be noticed that the most stressed masonry portions are located below the opening on the main façade, in correspondence with the apsis and, in general, in the lower portions of the masonry walls. Plastic strains can also be observed at the connection between the bell tower and the southern wall and between the bell tower and the apsis. Even if the presented results cannot precisely describe the crack pattern, it is worth mentioning that these locations are the ones in which most of the pre-existing damage was concentrated (Fig. 12). Due to the presence of the Galla Placidia street, it was not possible to investigate cracks in the masonry portion below the opening of the main façade. Along the interface elements at the corners, it can be observed that positive normal relative displacements are detected in many points, thus indicating the opening of cracks in those positions.

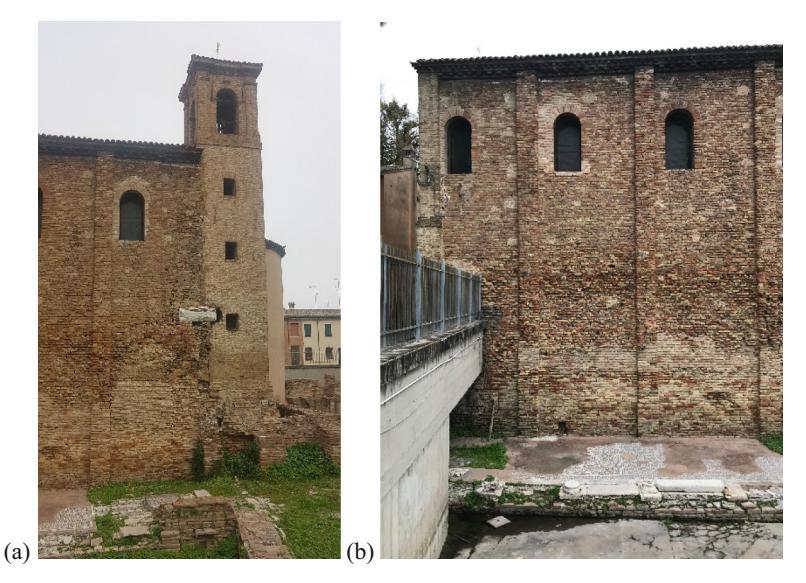
Fig. 12. Real damage pattern: (a) connection between the bell tower and the southern wall, (b) connection between the street and the southern wall.
