Experimental Modelling for the Effect of Rainfall and Earthquake on Slope Stability of Engineered Fill

Binod Tiwari, Santiago Caballero, and Wissam Zalzali

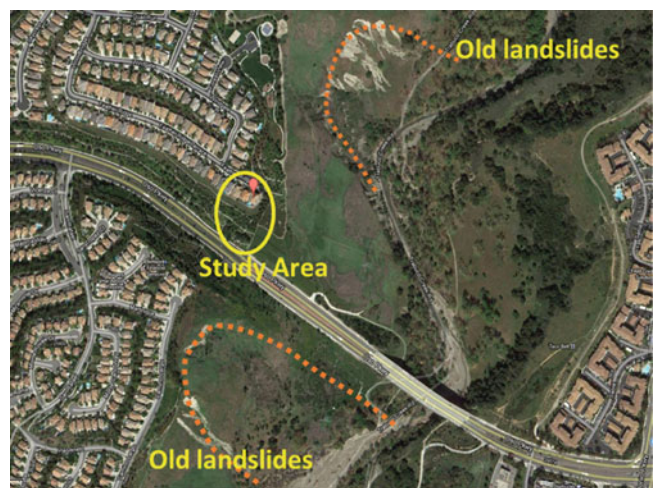
Presented in Fig. 1 is the google earth image of the study area. As can be observed in Fig. 1, the property is located at the corner of the filling and both east and south sides of the building have slopes. During the field investigation, the authors noticed that the area, especially at both banks of the river, had several existing landslides. Two of those landslides are presented in Fig. 2. The meandering pattern of the river shows possible landslide events in the past on the opposite bank of the river as well.

Fig. 2 Google earth image of the study area—two existing landslides are clearly visible in the area

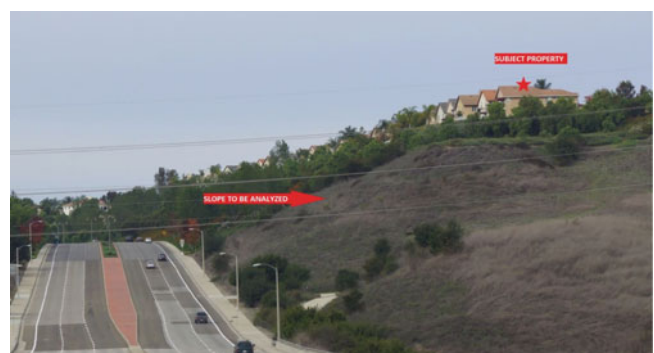
Close view of the south side of the slope, which will be considered during this study is presented in Fig. 3. The area is currently covered with grass. A good drainage network has been constructed in the area. The authors didn't detect any cracks in those drains during the field investigation. However, as presented in Figs. 4, 5, 6, and 7, cracks were identified on stuccos, swimming pools, drive ways, and the compound walls.

Fig. 3 Close view of the south side of the slope

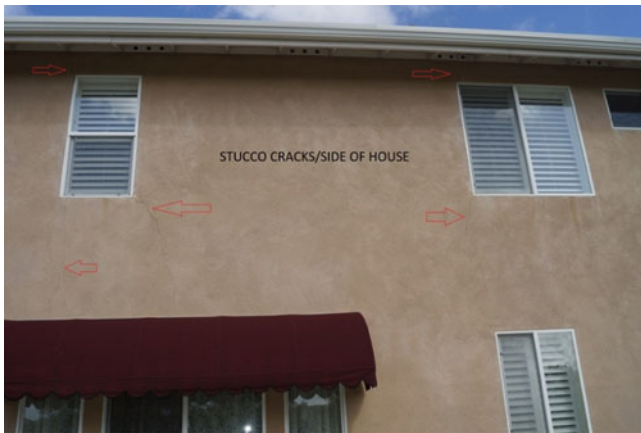
Fig. 4 Cracks on the stucco of the building

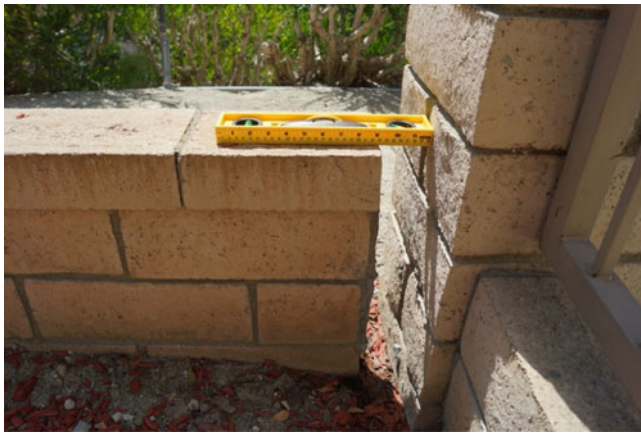
Fig. 5 Separation of compound wall from the main building—identified during the field visit

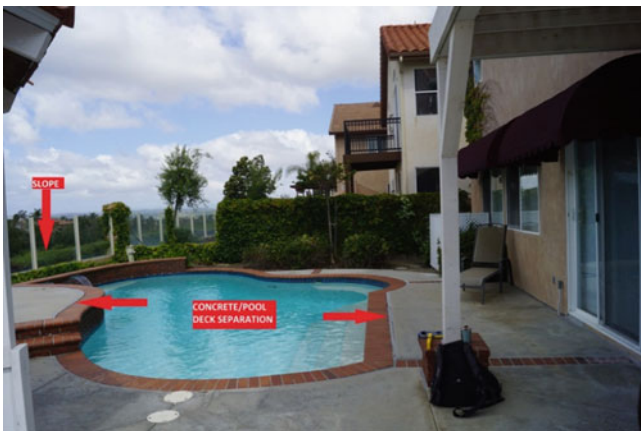
Fig. 6 Separation of pool walls from the floor slab—identified during the field visit

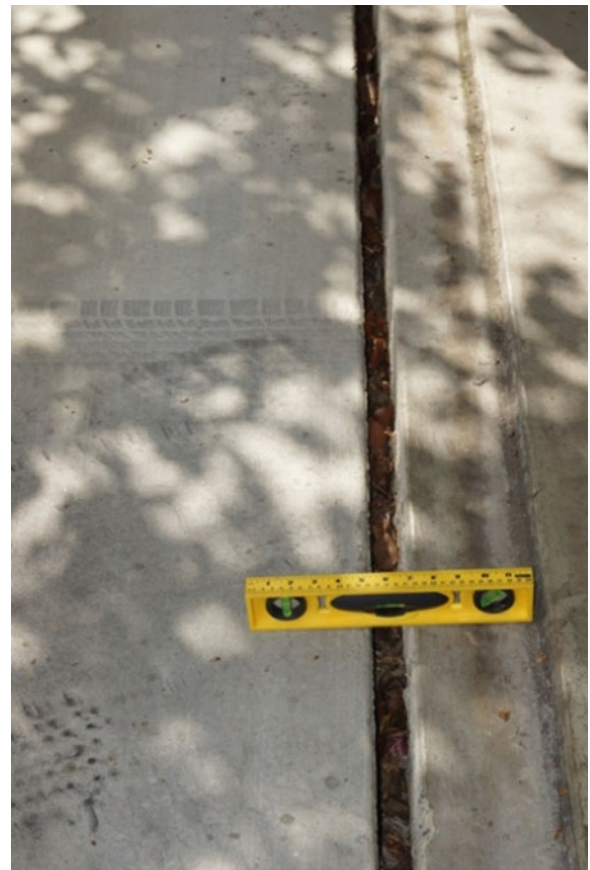
Fig. 7 Separation of garage slab from the driveway—identified during the field visit

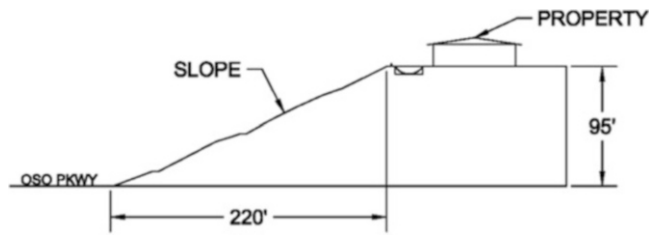
As presented in Fig. 13, the embankment slope was approximately 23.4° . This slope was utilized to prepare experimental model of the slope in the laboratory.

Fig. 13 Cross-section of the study slope
