The 2006 and 2009 Landslide and Flood Events in the Tartagal River Basin (Argentina)

José Daniel Brea, Pablo Spalletti, and Gabriel Amores

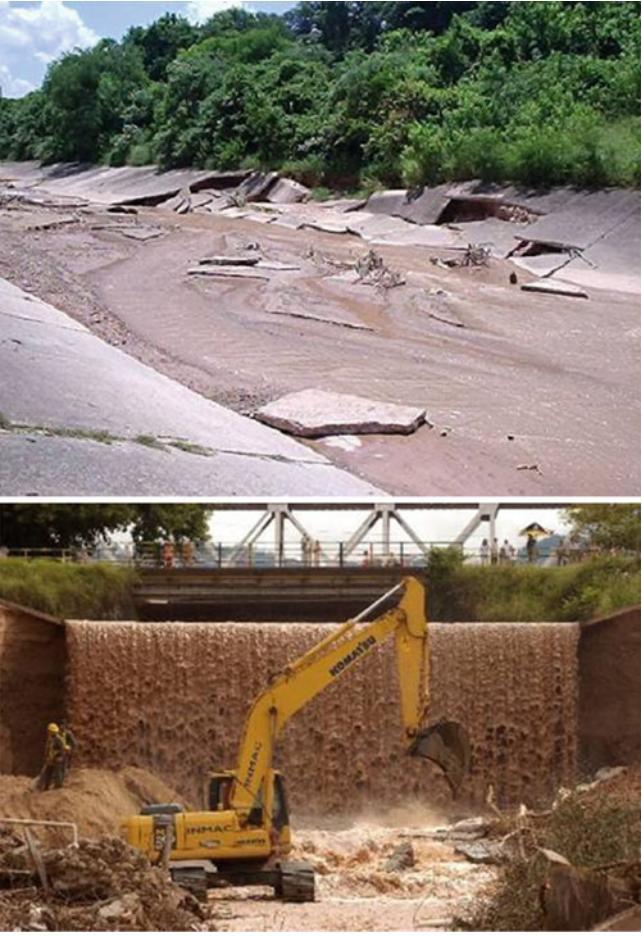
Product of intense rainfall occurred in the basin and in Tartagal City since late December 2005 to April 2006, significant discharges with high sediment transport in the Tartagal River were generated. Destruction of much of channel revetment, the collapse of the slopes of its margins and a retrograde erosion process at the main channel, resulted due to floods (Fig. 4).

Fig. 4 Processes observed in Tartagal River at Tartagal City, 2006

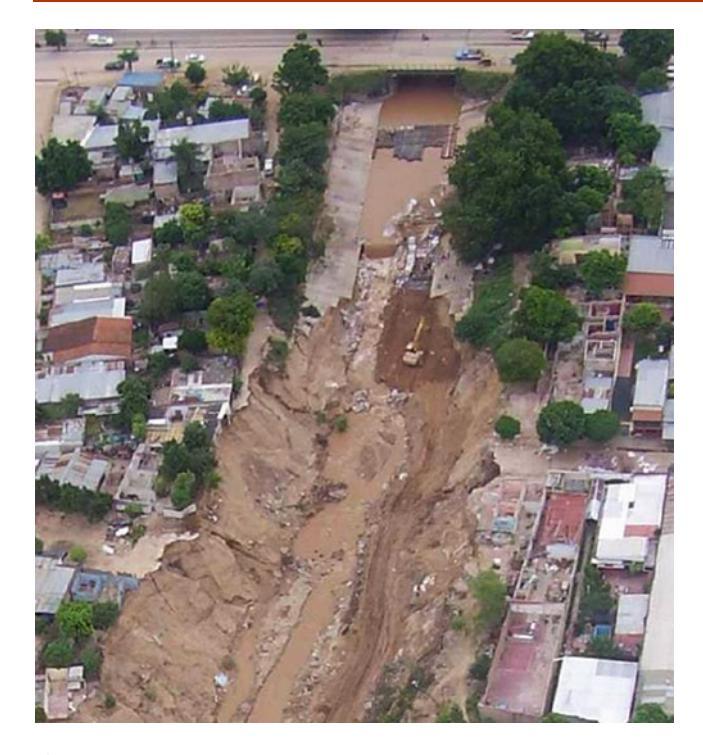
The building infrastructure of the city, as shown in Fig. 5, was severely affected by the fall of margin slopes due to retrograde erosion process at the channel.

Fig. 5 View of the Tartagal River after the event in 2006 and the affectation of the building infrastructure

The solution of the problem was a new river channel, with a segment of high slope, and reconstruction of the margins. The design flow rates were determined from the events recorded between December 2005 and March 2006, at pluviographs installed in the region, in the basin and surrounding areas, with few years of record (Table 1).

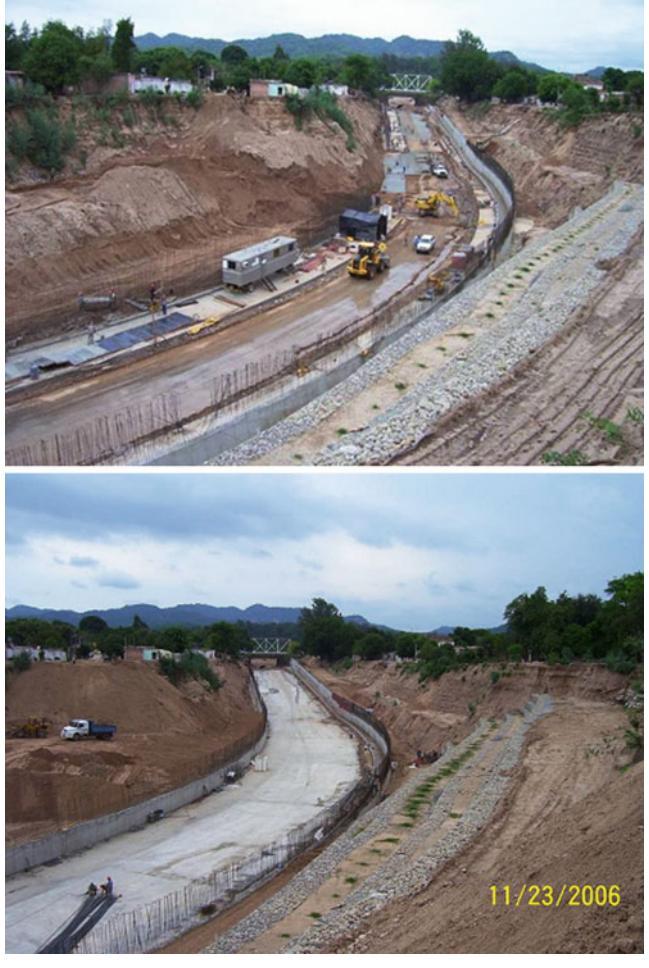
Fig. 7 Construction phase

Due to the emergency situation, the project and its execution began immediately after the flood period. The reconstruction of the channel was completed in June 2007. Figure 7 shows the new works during the construction phase and Fig. 8 illustrates a view of the completed channel.

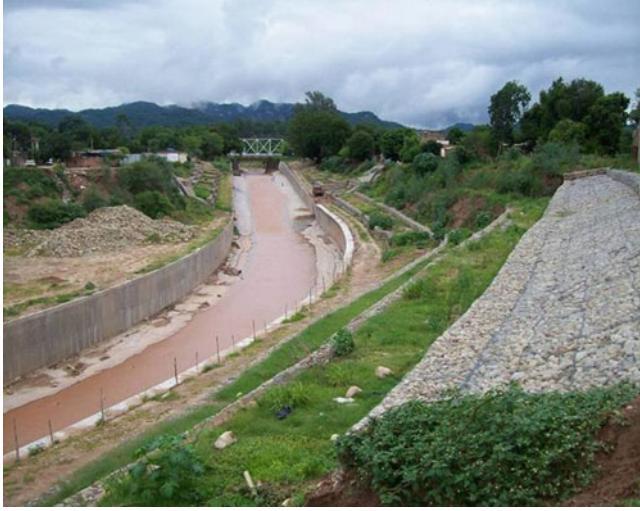
Fig. 8 Upstream view of Tartagal River channel in 2007. In the background the Packham Avenue bridge and the railway bridge can be seen

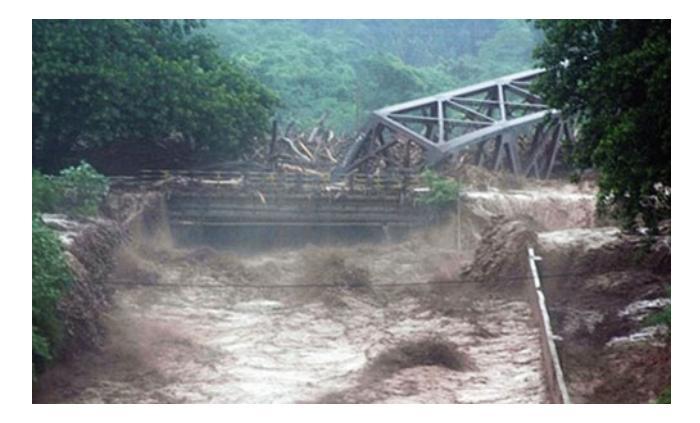
After the 2006 event, the following years were quiet until 2009. On Monday, February 9, 2009 in the morning, an avalanche of water, logs and sediment came down from the Tartagal River reaching the Packham Avenue Bridge. The contraction generated by the bridge caused the damming of the waters and the consequent accumulation of logs and branches carried by the flow of water and sediment, upstream of the road bridge.

Situation worsened when the action of mudflow and transported vegetation made the railway bridge located upstream to collapse, pivoting on the left abutment, and hitting the Packham Avenue urban road bridge (Fig. 9).

Fig. 9 Packham Avenue bridge during the flood

During the emergency and the following days, the broken railway bridge was removed, the board of the Packham Avenue bridge was also taken away, to increase discharge capacity at that control point, the traffic was restored with a Bailey bridge and the affected areas downstream from the bridge were repaired.

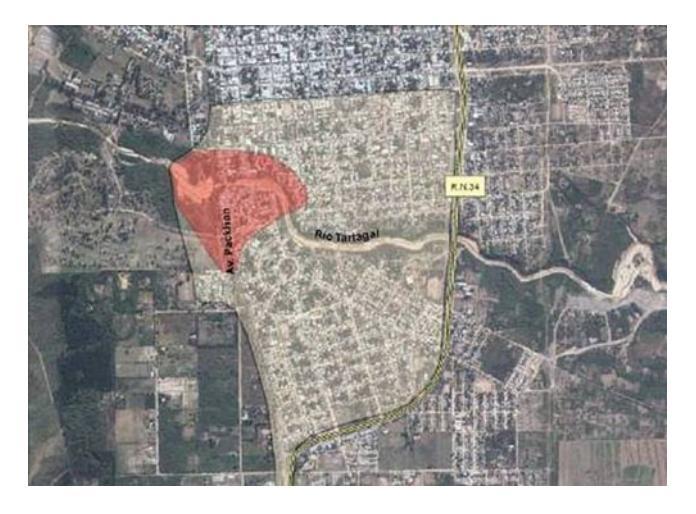
The events described led to the obstruction of the drainage section, causing a damming of logs and sediments, which impeded the free drainage of water, causing the overflow to both margins, going over the bridge embankment. This flow diverted to the sides of the river went into the houses adjacent to it, killing two people, and causing heavy damage and material loss (Fig. 10).

Fig. 10 The *red* polygon indicates the area most affected in the city, the *light yellow* area indicates how far the water and the solid material during flood went

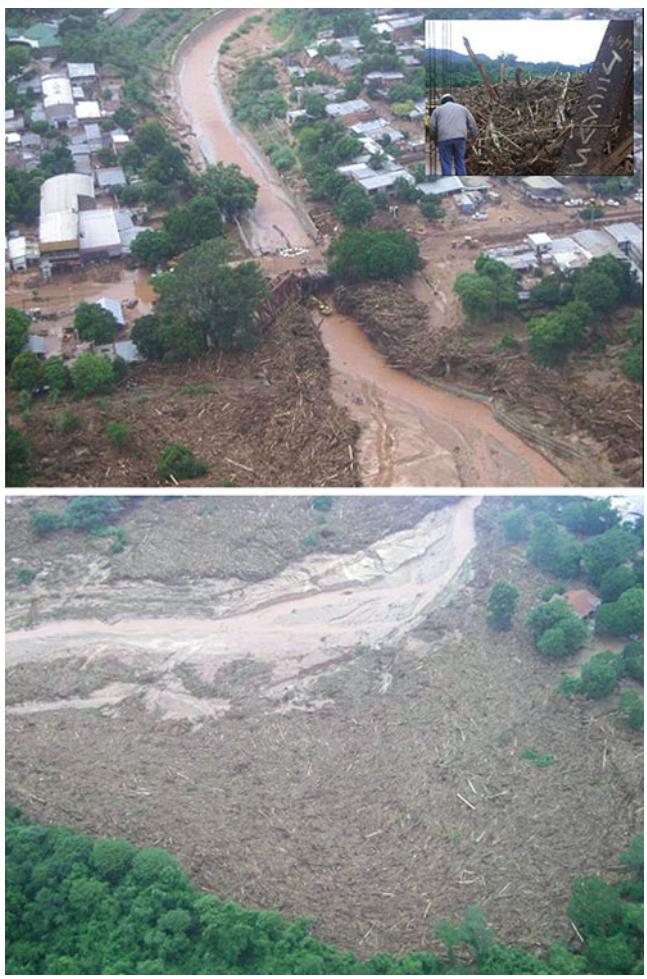
An important difference between the 2006 and the 2009 events, was the presence of large amounts of woody and debris material, absent in 2006. This is evident in the deposits remaining after the flood, recorded in Fig. 11.

Fig. 11 Log deposits upstream Packham Avenue bridge, after the 2009 flood

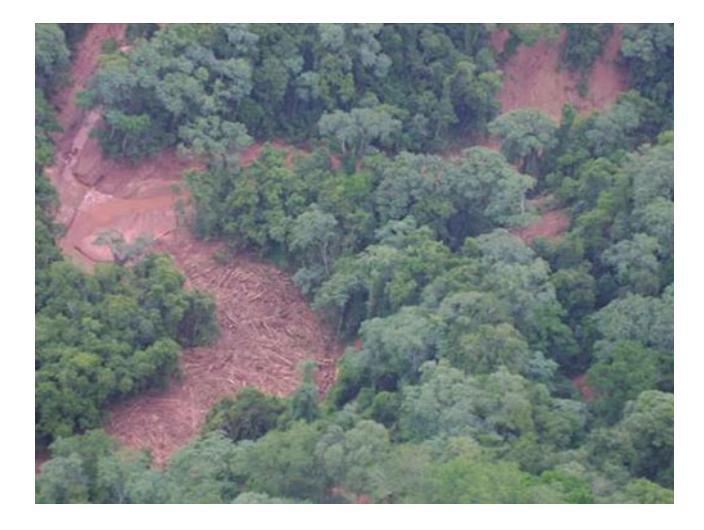
However, this situation would be endorsing the hypothesis of breaking natural stick dams in the basin. Flights over the watershed allowed finding visible evidence of the presence of natural stick and log levees, especially in tributaries to the river (Fig. 12).

The formation mechanism of these dams is, once a landslide is produced with fall trees and sediments, that it can block all or part of the section of a stream or river (Braudrick and Grant 2001). The strong contribution of logs into the system, makes the sticks accumulate, creating small reservoirs which also accumulate water (Gomi et al. 2001). When water pressure exceeds the strength of natural levee, it is broken, causing a flood peak, able to transport the removed material downstream, reinforced by the high slope of the channels in the basin.

Fig. 12 Log levees in the middle river basin observed during a flight 24 h after the event

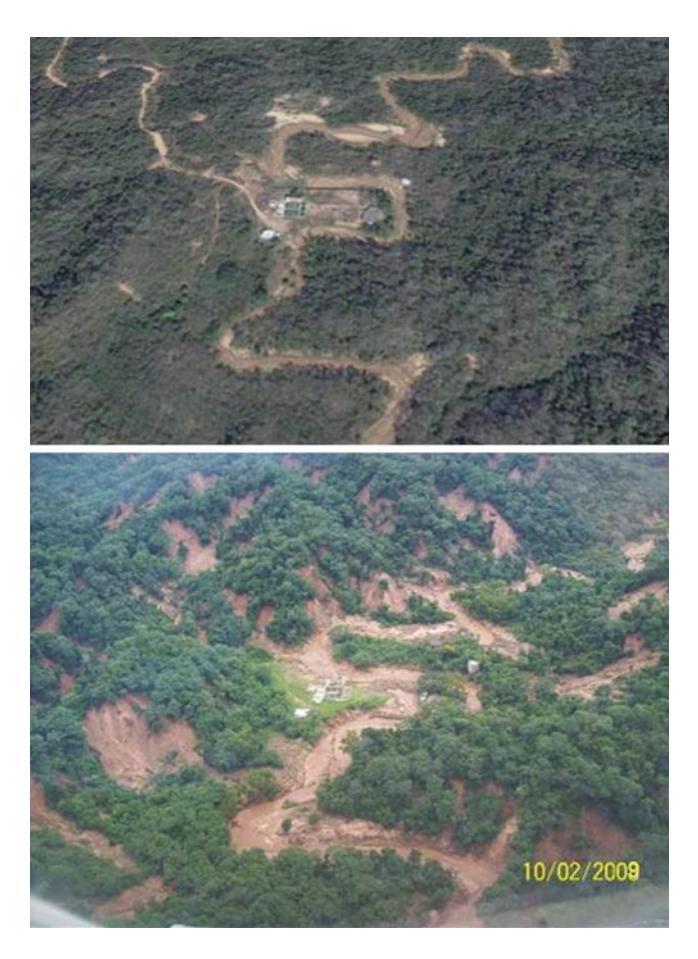
To identify the landslides occurring during heavy rains, considered the sources of woody debris and avalanche solid material, a comparison of an area inside the Tartagal middle river basin in 2006 and 2009 after the critical event is shown in Fig. 14. The large amount of mass removal in vegetated surfaces without clearing is evident.

Fig. 14 Comparison between 2006 and 2009 after landslides. The area is inside Tartagal middle river basin (Aguay Plant zone)

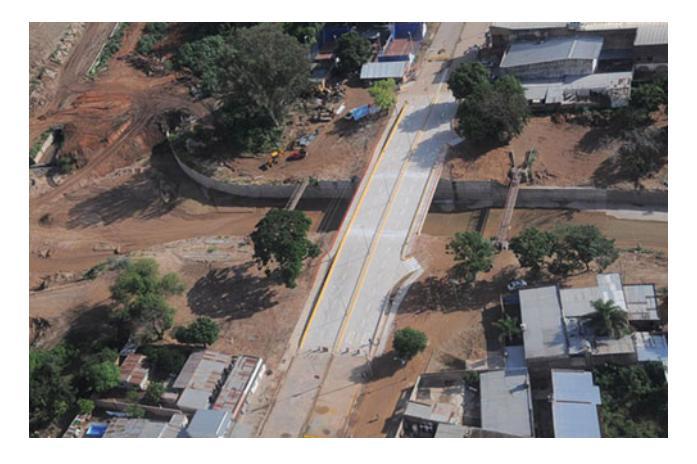
Fig. 15 New Packham Avenue bridge

In the medium term (first year), the Packham Avenue Bridge was rebuilt (Fig. 15), the plan and development of an early warning system began and a hydro-geological risk study and a planning and zoning project were scheduled. Protection concepts cannot be based on structural measures alone but should contain forest-technical measures.
