# **Blast Loading of Sandwich Structures and Composite Tubes**

#### H. Arora, P.A. Hooper, and J.P. Dear

Abstract This chapter reviews blast impact experimentation on glass fibre reinforced polymer (GFRP) and carbon-fibre reinforced polymer (CFRP) sandwich composite materials and laminate composite tubes. Explosive charges of 0.64-100 kg TNT equivalent were used during these air- and underwater-blast tests. The difference in response and damage inflicted from underwater- and air-blast loading was assessed from strain-field measurements and post-blast specimen analysis. Procedures for monitoring the structural response of such materials during blast events have been devised. High-speed photography was employed during the airblast loading of GFRP and CFRP sandwich panels, in conjunction with digital image correlation (DIC), to monitor the deformation of these structures under shock loading. Failure mechanisms have been revealed using DIC and confirmed in post-test sectioning. The improved performance of composite sandwich structures with CFRP skins compared to GFRP equivalent constructions is demonstrated for air-blast experiments. Strain gauges were used to monitor the structural

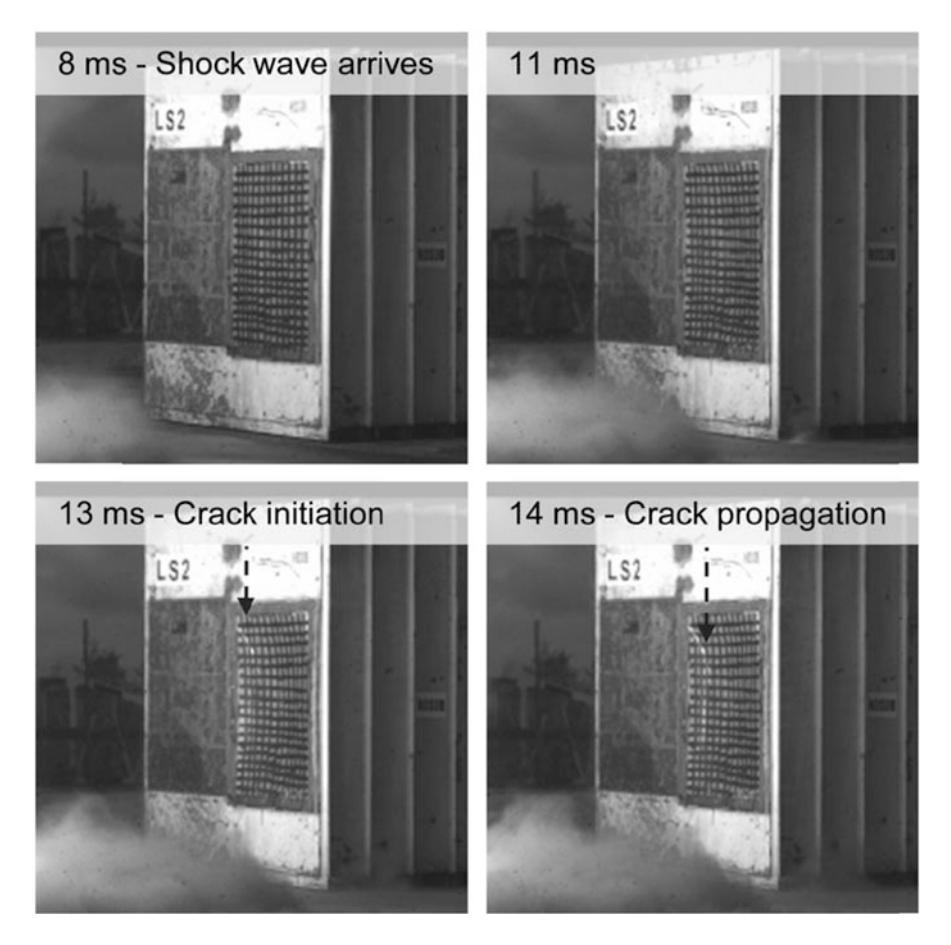
As the DIC analysis agreed with predictions for peak elastic displacements of the targets due to a 2 bar shock pressure, and both the DIC analysis and visual inspection showed no visible skin damage to panel G1, it was decided that another panel of the same construction as G1 be subject to a more substantial blast to induce significant skin and core damage. This highlighted clearly the failure diagnostic capabilities of the DIC technique in this context. Blast parameters for this final air blast involved a 30 kg charge positioned at a reduced stand-off of 8 m from G1. Figure 8 shows the progressive deformation and eventual skin damage inflicted on G1 by the 8 bar pressure shock wave. A skin crack is seen to originate from the top left hand edge of the panel and propagate down that side of the target.

Fig. 8 Images of the shock wave impinging on the test sample (8 ms) causing deformation and front-skin damage thereafter (sandwich panel G1 with core thickness 40 mm and charge of 30 kg charge at stand-off of 8 m)

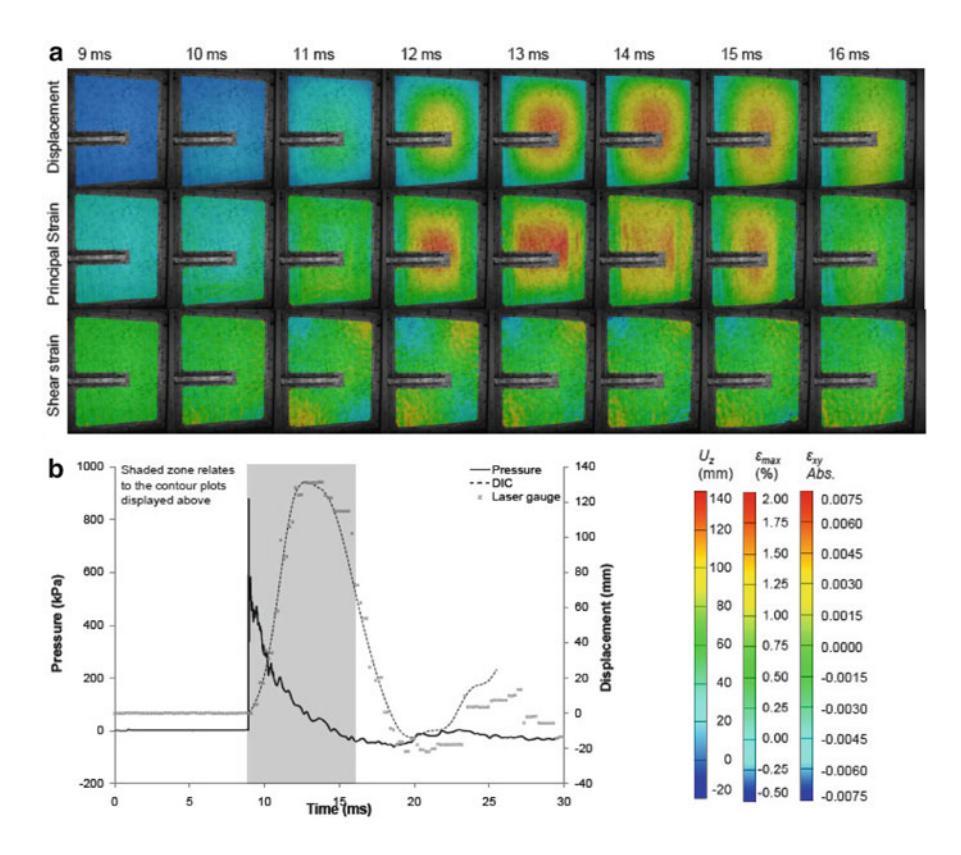
with at 30 kg charge at stand-off of 8 m. Comparing this plot of out-of-plane displacement to that shown earlier in Fig. 6, asides from the magnitude of peak out-of-plane displacement, immediately one can notice the difference in smoothness of the path taken during the first oscillation. Looking closely at the time period 12.5–13.5 ms, one can observe a flattening in the displacement curve near its maximum condition. This coincides with the time (13 ms) when the crack is observed to form in Fig. 8.

**Fig. 9** Blast summary for 30 kg C4 at 8 m stand-off from G1 including: (**a**) DIC analysis and (**b**) a plot of pressure–time and displacement-time using both DIC and laser gauge centre point measurements. The DIC analyses features contour plots of out-of-plane displacement, maximum principal strain and shear strain, corresponding to various stages in the graphical plot. The horizontal bar visible in the contour plots (from the *left hand edge* to the *centre*) is the region of the specimen obscured by the laser gauge

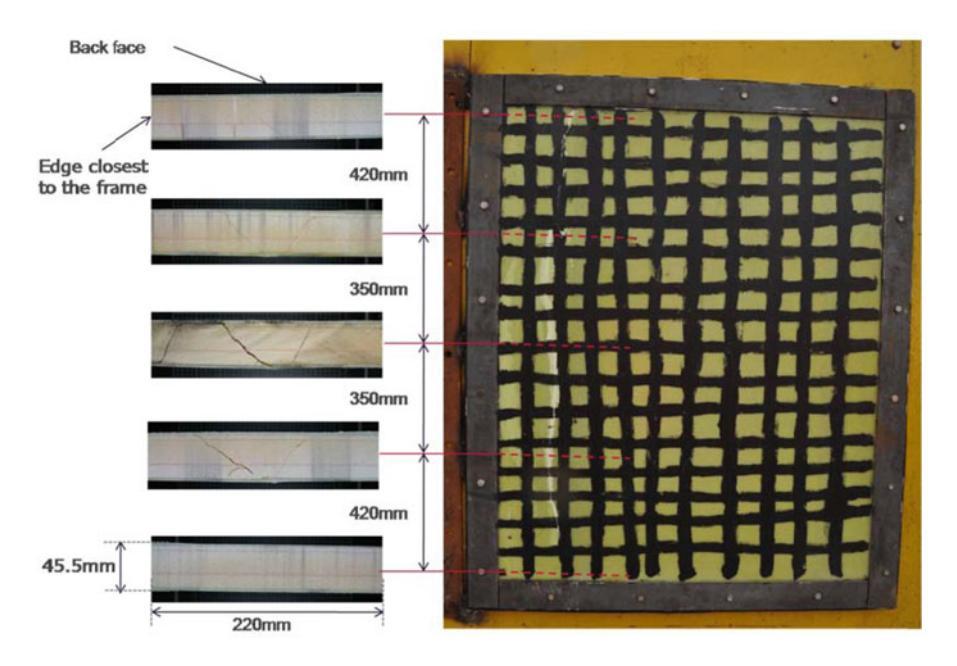
The peak out-of-plane displacement was 131 mm and strains peaked in the region of 3% prior to the crack developing. Upon post inspection, the front face sustained inter-laminar skin failure and front-ply fibre breakage whilst the core suffered a severe skin-to-skin crack (see Fig. 10). Towards the centre of the panel, the severity of the failure increased.

Fig. 10 Front face damage on G1: The whole panel with a clear crack down the *left-hand edge* of the panel (*right*), sectioned at regular intervals showing various failure mechanisms (*left*). This is for sandwich panel G1 – GFRP-skinned with core thickness 40 mm and charge of 30 kg charge at stand-off of 8 m

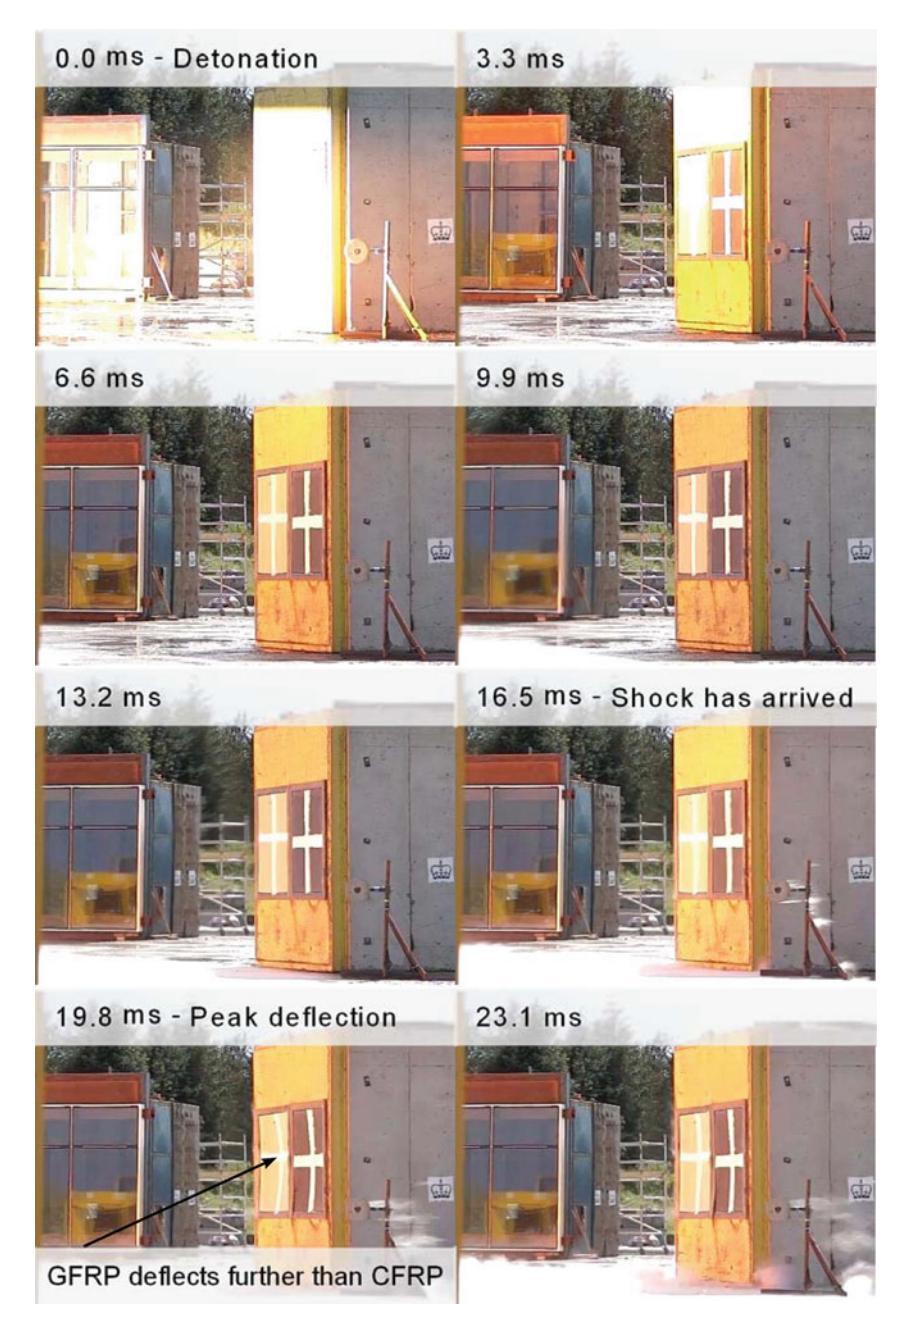
The 100 kg TNT at a 14 m stand-off blast was employed to give a severe comparison of CFRP-skinned composite sandwich panel (C1) with the GFRP-skinned composite sandwich panels (G3). The result for the experiment, forming the visible damage post-test, is presented below (for G3 and C1). Figure 11 shows the progressive deformation and eventual skin damage inflicted on the panel by the blast, where the peak overpressure was equal to 2.5 bar, corresponding to a 100 kg charge Nitromethane at 14 m stand-off. Unlike previous blast experiments, the overpressure or side-on pressure was measured rather than the reflected pressure. A skin crack is seen to originate from the top right hand edge of the panel at approximately 19 ms into the blast event and propagate down that side of the target.

**Fig. 11** Images of shock wave progression and front-face deformation of G3 and C1(GFRPskinned sandwich panel G3 with core thickness 25 mm and CFRP-skinned sandwich panel C1 with core thickness 25 mm separately subject to 100 kg TNT equivalent charge at stand-off of 14 m). Images are shown from the detonation (0 ms) through the shock wave arrival at target (15 ms) until targets begin their first rebound. Exact time at which these event occur are not shown in the images (due to availability), therefore timings of interest are highlighted around those exact times

Comparatively C1, in Fig. 11, is observed to deflect noticeably less than G3. The two panels are subject to the same blast (recorded peak pressure of 2.5 bar and duration ca. 12 ms). There are of course asymmetry effects with regard to the load distribution, however in this case the support structure is completely symmetrical and the charge was positioned central to the test structure, therefore any asymmetry of loading can be assumed to be consistent for both targets. A considerable skin crack is seen to form in G3, however C1 formed no global failure similar to G3. A fine crack was observed to form towards one of the panel edges and the core shear failure was still observed to a similar severity as for G3. Figure 13 shows a summary of the blast data recorded for this blast (100 kg Nitromethane at 14 m stand-off). The carbon-skinned sandwich panel (G3). The stiffer carbon skins minimise maximum deflection to 107 mm (compared to 135 mm for G3). The contour plots in Fig. 13 show a larger central region than G3. This is perhaps because more of the blast energy was distributed throughout the structure in C1, causing less severe but

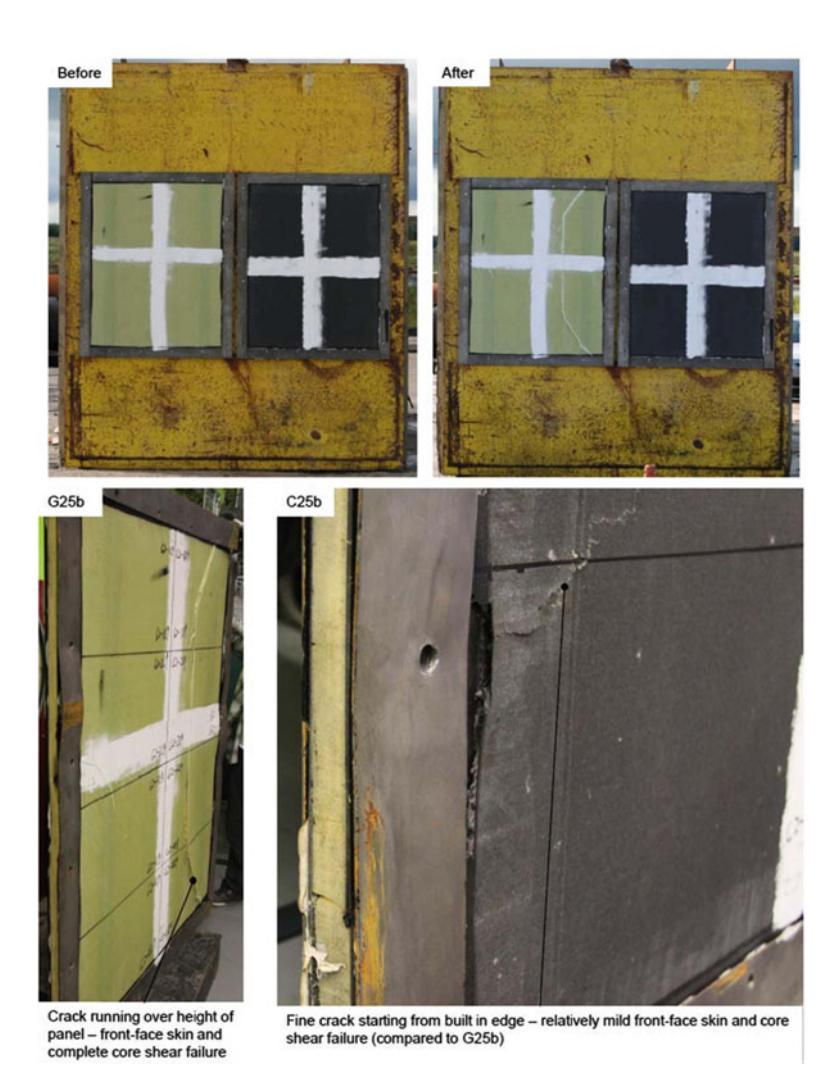
Upon post inspection, the front face sustained inter-laminar skin failure and severe front-ply fibre breakage whilst the core suffered cracking from skin to skin but the rear skin remained intact. Figure 14a shows an overview of the damage observed by the two panels. The front skins were more severely damaged in the GFRP-skinned composite sandwich panels (G3). This is when compared to the CFRP-skinned sandwich panels (C1). For both panels the rear skins of the composite sandwich panel showed no visible damage. This was consistent with

**Fig. 14** (a) Before and after images taken of the front face view of G3 and C1 after being subject to a charge of 100 kg TNT equivalent at stand-off of 14 m. (b) Images featuring the damage sustained by G3 and C1 after being blasted

previous air blast experiments in Series A. There was core damage present in G3 and C1 resulting from front skin failure and interlaminar failure between front skin and core. This damage initiated for G3 in transition regions from constraint to regions of deflection of the panel. This is where the stress state caused by the restraint and the impulsive loading, promotes failure initiation. The lack of sufficient distribution of energy lead to global propagation of the crack in the GFRP panels compared to the CFRP panels, which have small areas of skin cracking (which actually probably initiated from the stress concentration at the bolt hole, see Fig. 14b).

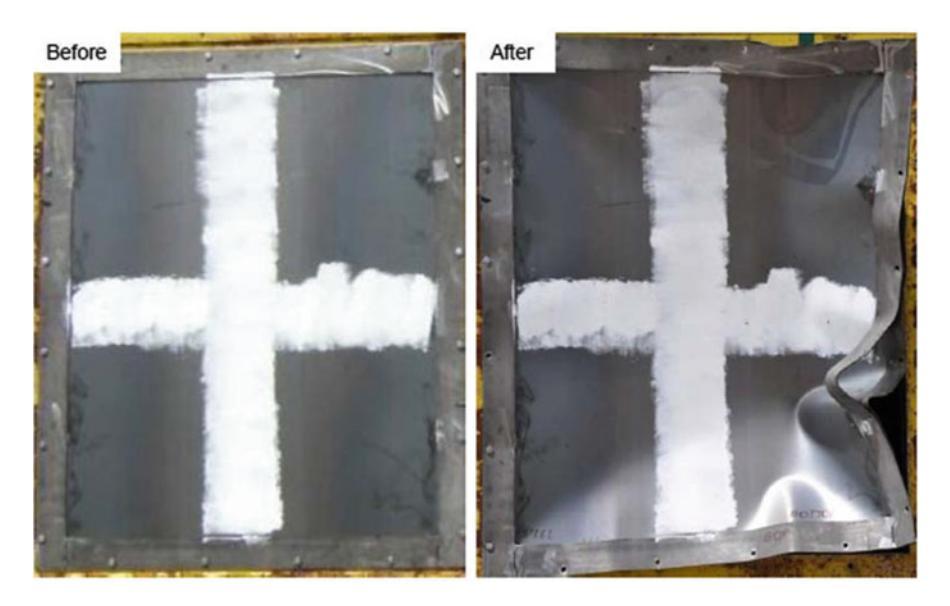
S1 had a peak deflection which was 270 mm, which is considerable more than GFRP and CFRP skinned sandwich panels. A deflection of approximately 120 mm was attained prior to bolt shear, which dissipated some energy and also relieved some of the blast pressure. Major principal strain peaks at approximately 1.1%. The damage sustained by S1 is featured in Fig. 17, showing the final deformed profile relative to its original at profile.

Fig. 17 Before and after images taken of the front face view of S1 after being subject to a charge of 100 kg TNT equivalent at stand-off of 14 m

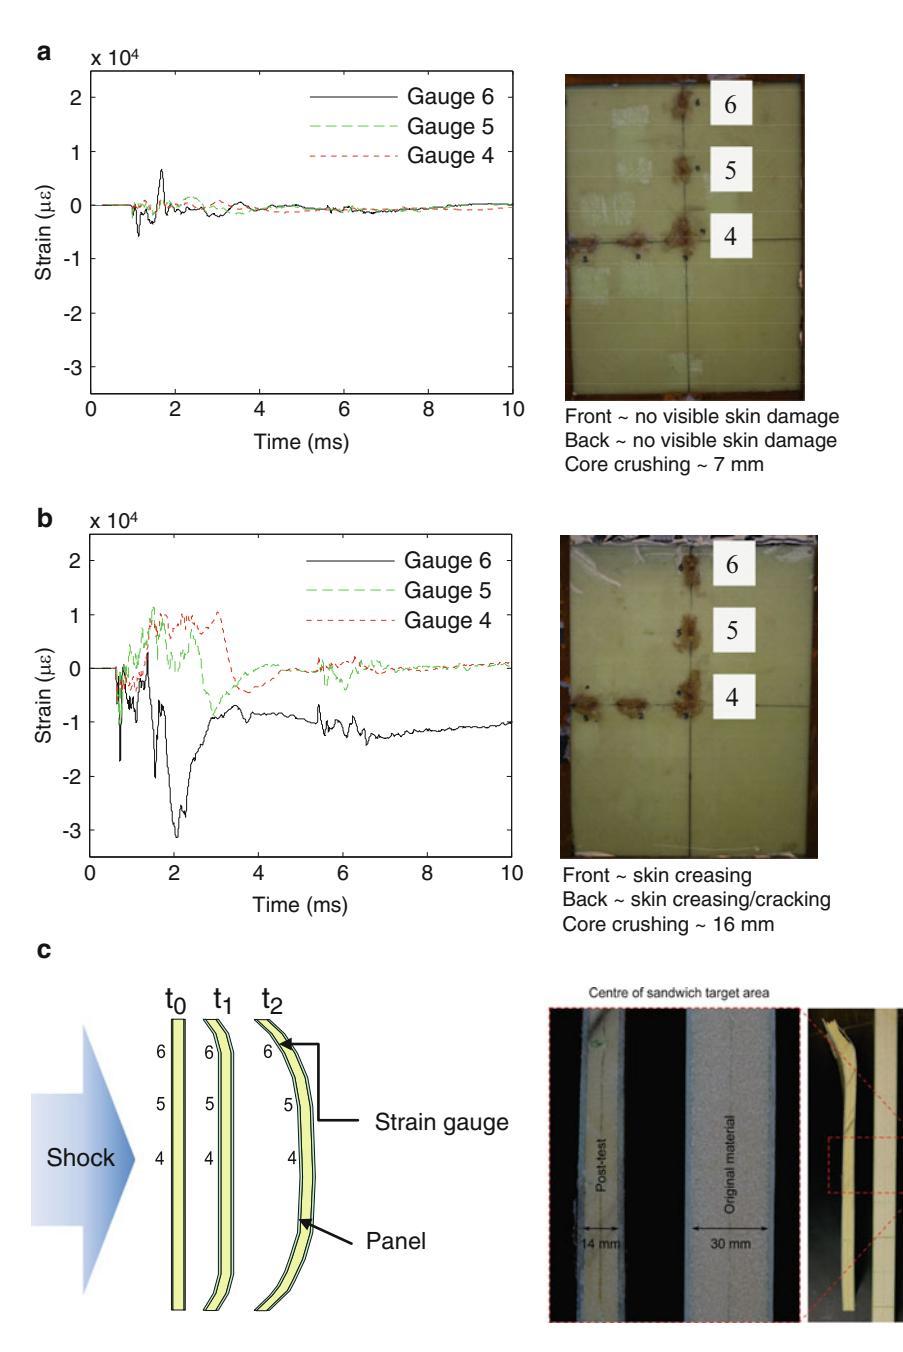
Blast pressures experienced by panels G4 (30 mm core) and G5 (15 mm core) peaked at a shock pressure of 430 bar (1 kg of C4; 6 m depth; stand-off 1 m; panel air-backed) and 300 bar (1 kg of C4; 6 m depth; stand-off 1.4 m; panel water-backed) respectively. The two pressure–time traces are shown in Fig. 19 for the two blast scenarios, illustrating the ferocity of the blast event, note that the strain gauge data will be restricted to the initial response also highlighted in Fig. 19. Figure 20 shows an example of all strain gauge data for G5. These pressures are very high shock pressures to subject the test panels to and it resulted in significant damage sustained by the targets. The air-backed G4 had its core crushed to half the original thickness (*16 mm* core thickness reduction) by the shock. There were initial surface strains in the region of 3% and once the panel membrane response began, surface strains of around 1% remained causing severe cracks to form within the skins along the panel edges. This is evident in Fig. 14.

two panel responses for G4 and G5 were compared in Fig. 21, the difference in strain magnitude is highlighted as well as the effect of the backing medium with the water-backed G5 (see Fig. 21a) experiencing lower surface strains compared to the air-backed G4 (see Fig. 21b). Moreover the characteristic response of a plate due to impulsive loads was captured by the strain gauge data for the air-backed G4 illustrated in Fig. 21c. The plate experienced an initial compression near the top edge of the panel whilst the central region remained in tension as evident in the strain gauge response shown in Fig. 21b.

Fig. 21 Comparison of underwater blast response of sandwich panels tested: The first 10 ms of strain gauge data is displayed for gauge positions 4–6 (numbered as shown in Fig. 3) for: (a) waterbacked sandwich panel G5 (core thickness 15 mm) with shock: 300 bar (1 kg of C4; 6 m depth; stand-off 1.4 m); (b) air-backed sandwich panel G4 (core thickness 30 mm) with shock: 430 bar (1 kg of C4; 6 m depth; stand-off 1.0 m); (c) diagrammatic representation and sectional views (before and after shock loading) of G4

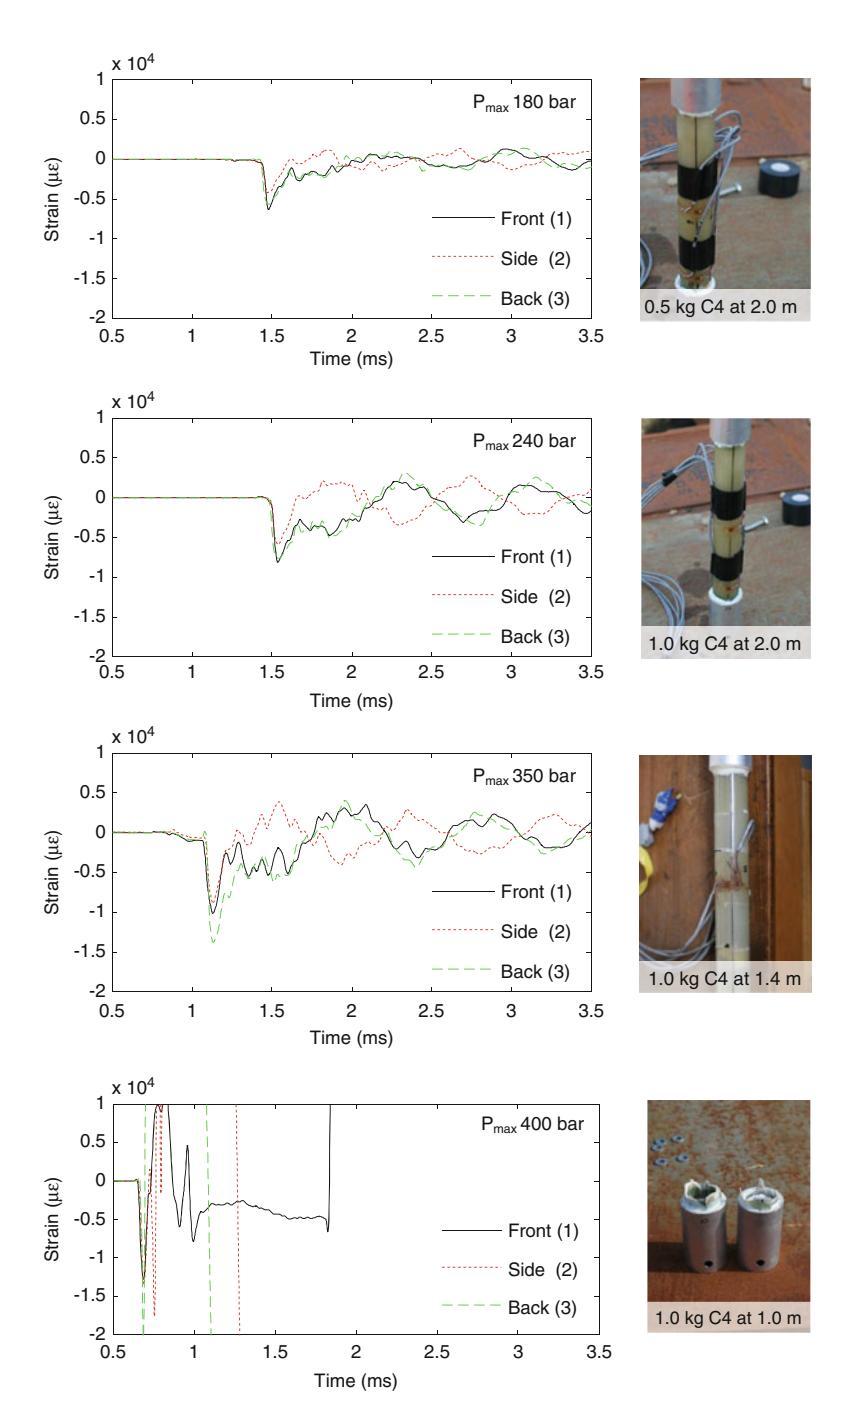
Figure 22 shows the combined pressure time traces for each underwater blast on composite tubular laminates of air-filled (AF) design. Peak pressures ranged from 180 to 400 bar for a range of blast parameters from 0.5 kg C4 explosive charge at a 2.0 m stand-off distance at a 6 m depth to a 1.0 kg charge at 1.0 m stand-off distance at the same depth. Figure 16 shows the combined results for the progressive loading of these tubular laminates. The 180 bar blast produced no visible skin damage to the targets with the surface strains sufficiently low to form an agreement with this observation. The 240 bar blast proved to be the threshold for damage evolution with surface strains reaching 1%. The tubes were then tested at a peak shock pressure of 350 bar and visible damage was inflicted on the targets with axial cracks forming along the front facing side of the sample as strains reached 1.5%. In the final test the tubes were taken beyond their limit, where complete shear failure was observed for a peak shock pressure of 400 bar. Similar signs of axial cracking were observed in this final sample (as for the blast of 350 bar) evident from the remains at the end-tabs featured in Fig. 23 prior to the entire gauge length shearing off at the supports.

Fig. 23 Shock loading of composite tubes with max shock pressure increasing from 180 to 400 bar

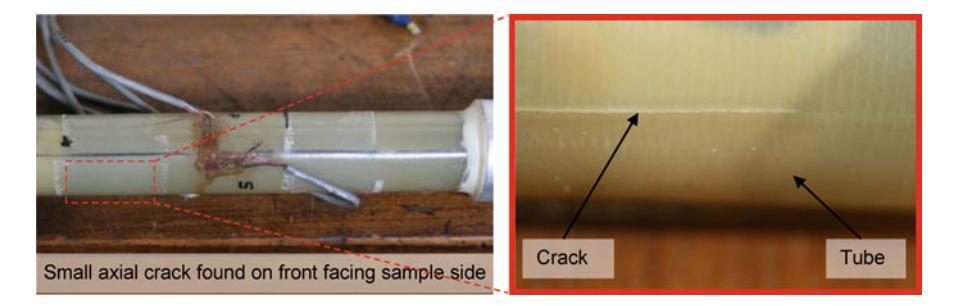
The tubes were both subject to a pressure of 350 bar (there were two independent recordings of pressure either side of the targets). The damage sustained by AF relative to WF was apparent with no visible damage observed for WF whereas AF shown in Fig. 25 shows axial cracking, most likely caused by shear failure during the circumferential crushing phase of the sample deformation causing cracks to initiate.

Fig. 25 Post-test images of the AF tube (peak shock pressure of 350 bar) featuring axial cracking near one end (*left*) and a zoomed in view of the crack formed during the blast (*right*)
