Influence of Low Permeability Capping Layers on Liquefaction Induced Failure in Stratified Ground

Divyesh Rohit, Siavash Manafi Khajeh Pasha, Hemanta Hazarika, Takaji Kokusho, and Sukiman Nurdin

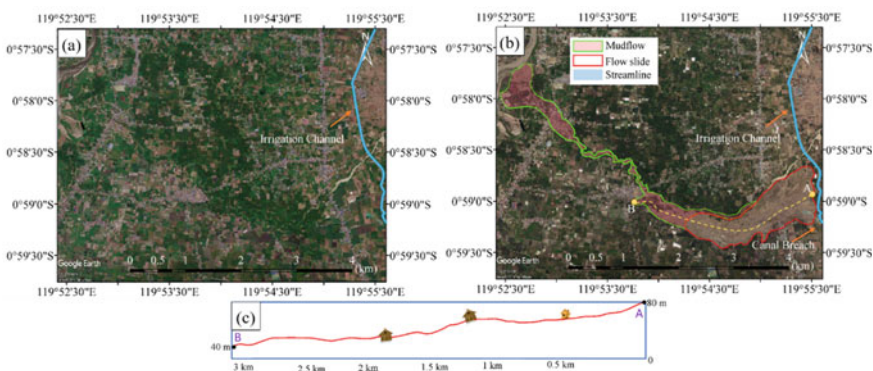
Our team from Kyushu University visited the flow liquefaction sites in Jono Oge, Sibalaya, and Balaroa in Palu aftermath of earthquake. The survey elements included site reconnaissance, disturbed soil sampling, portable dynamic cone penetration tests (PDCPT) and aerial survey with drone. Figure 3 here depicts the condition of the flow failure site at Jono Oge before (Fig. 3a) and after the seismic event (Fig. 3b). The site mainly composed of agricultural fields with a scant population and a very gentle sloping ground of less than 2% (Fig. 3c). It was also found that an irrigation channel which was passing from the eastern side of failure zone breached due to the liquefaction during the shockwave propagation as shown in Fig. 3b. Due to the presence of irrigation channel, the ground water level was very high (<5 m from ground surface) which is also considered to be a key factor contributing to flow failure. The breach of water channel discharged a large volume of water into the already failed zone causing a massive mudflow as shown in Fig. 3b.

Fig. 3 Lateral flow area in Jono Oge village due to Sulawesi Earthquake, **a** before flow failure, **b** after flow failure with mud flow and water channel and **c** slope profile of the flow area (modified from Google Earth)

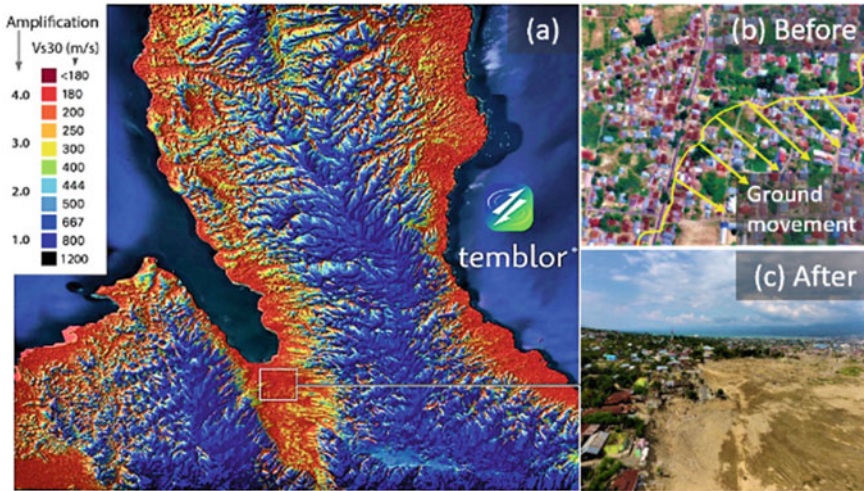
The maximum site amplification occurred in the Palu Valley, which has deposits with low shear wave velocity profile [10], as can be seen in Fig. 4a. It can be seen that the valley region along with the coast line has very low shear wave velocity while the mountainous region has high V_{s30} values. Figure 4b depicts the satellite image of liquefaction site at Balaroa before the event while Fig. 4c shows the condition of the site after liquefaction taken by a drone camera. It can be ascertained from Fig. 4b and c that a large-scale liquefaction occurred devastating and displacing all the housing structures in the area to hundreds of meters.

Fig. 4 Vs30 map of Palu region along with a site amplification forecast for an Mw 7.5 earthquake [10], **b** Google Earth image for site in Balaroa, Palu, prior to 2018, Sulawesi Earthquake and **c** Drone Image of Balaroa site after the event showing mass displacement of structures from original location

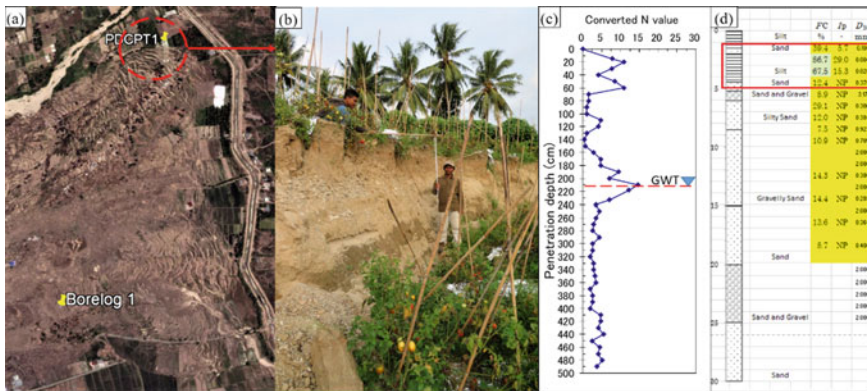
Further in Fig. 5a shows the location where the PDCPT and SPT tests were performed at the flow failure site in Jono Oge. Figure 5b shows the condition of soil profile at crown of failure, also depicting the difference in elevation of ground after liquefaction. Figure 5c represents the plot of N values versus depth obtained from

Fig. 5 **a** Location of PDCPT and SPT at Jono Oge, **b** Location of crown of the flow failure at Jono Oge site with high vertical settlement, **c** plot of N-value versus depth obtained by PDCPT1 test outside the failure zone and **d** Borelog1 profile of soil in failure zone

PDCPT test conducted outside the crown of failure zone. It can be seen from the plot that the subsoil condition is weak with a maximum *N*-value reaching upto 15 and dropping back to low numbers and presence of water table at a shallow depth of 2.15 m from the ground surface. Further Fig. 5d shows the subsoil condition at location of Borelog 1. It can be seen from the illustration that the silt layers are sandwiched in between sand layers at shallow depth with a higher fines content and some plasticity characteristics. These soft sandwiched silt layers are considered to

be a probable contributor to the large-scale flow failure by inhibiting the dissipation EPWP from below sand and gravel layers.

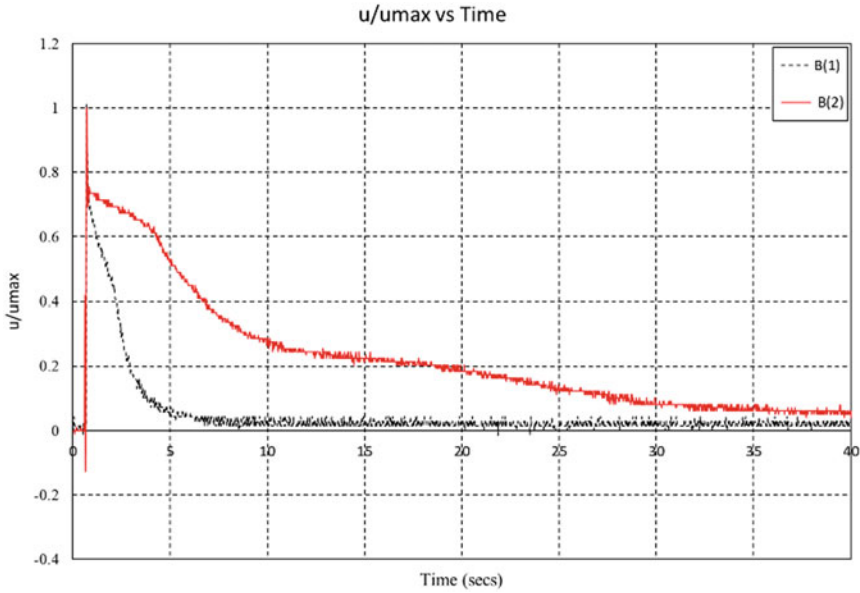
Further in Fig. 10, the plot for u/u_{max} versus time for transducer B is compared for both the cases (1 and 2). From the figure, it can be observed that ratio u/u_{max} for B (2) takes longer duration to dissipate after reaching peak and still has a higher

Fig. 10 Dissipation of excess pore water pressure versus time (s) at pore pressure transducer B for Cases 1 and 2

value while that for B (1) is dissipated. This implies the capping effect of clay seam which prevents the dissipation of excess pore water pressure in the sand layer below. In Fig. 11, the plots for u/u_{max} versus time for pore pressure transducers A and C are shown, where A is located above the clay seam and C is located at a distance of 15 cm from the bottom of the sand layer with D_r 70%. Here for both the transducers, the duration for dissipation of excess pore water pressure for sand with clay seam is higher than the condition without clay seam. This shows that the presence of a low permeability layer cannot only hinder the dissipation of pore water pressure in adjacent areas but also in regions at a higher distance from the layer vertically.

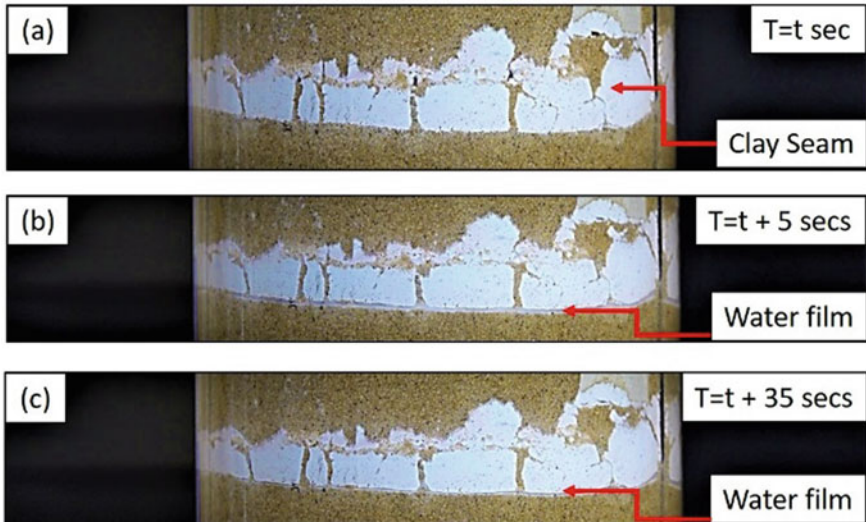
The pictorial evidence of the effect of clay seam in sand layer during liquefaction can be seen in Fig. 12. Here the development of water layer below the clay seam at different time frames is shown. Figure 12a is recorded at $T = t$ s when the hammer impact was made. Figure 12b depicts the maximum thickness of the water film at $t + 5$ s while Fig. 12c shows the decreased water film thickness at $t + 35$ s. This shows how the water film dissipates slowly, thereby influencing the dissipation of excess pore water pressure from the below sand layers by forming an impermeable capping layer. The water film thus created causes settlements in the clay seam after the overall dissipation of EPWP which can be seen in Fig. 13. Here in Fig. 13a, the base of clay seam can be seen at 39.8 cm which settles to 39.0 cm after the hammer blow due to the liquefaction as shown in Fig. 13b.

Fig. 12 Formation of water layer under the clay seam at different time durations: **a** Time (T) = t s, **b** $T = t + 5$ s and **c** $T = t + 35$ s

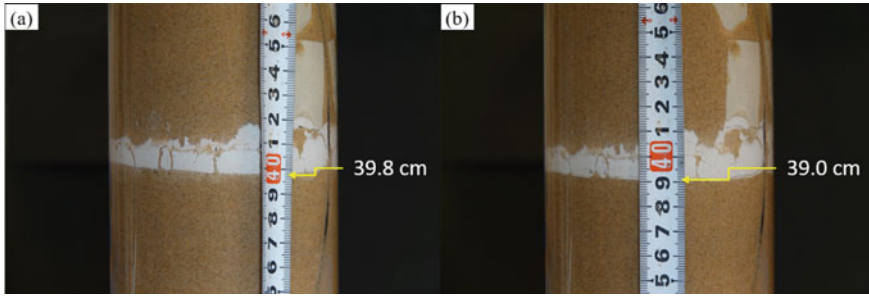
Fig. 13 Height of clay seam **a** before liquefaction and **b** after liquefaction
