**PACEMAKER MALFUNCTION DUE TO MICROCURRENT INJECTION FROM A BIOIMPEDANCE NONINVASIVE CARDIAC OUTPUT MONITOR**

*J. Antonio Aldrete, MD, MS, Carol Brown, RN, Judy Daily, RN, and Valerie Buerke, BA, MS*

J Clin Monit 1995;11:131-133

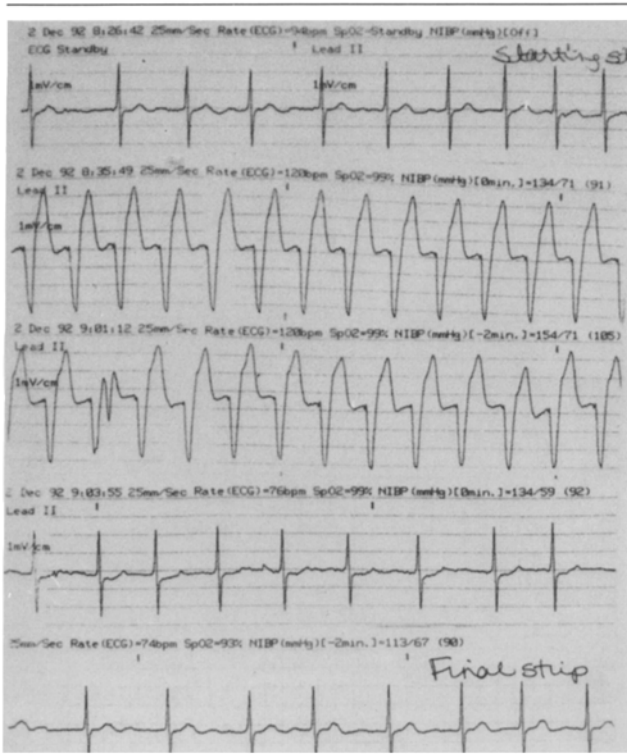
In the treatment room, a monitor (Critikon, Dinamap Plus, Vital Signs), was attached to the patient, obtaining a control electrocardiograph (ECG) tracing (Fig 1), blood pressure (BP) = 134/60, heart rate (HR) = 78, SpO<sub>2</sub> = 96%. As part of a study on the hemodynamic effects of cervical epidural blocks, pre-gelled electrodes of a NICOM (BoMed NCOM3-R7, Irvine, CA) were connected as follows: two on the neck along the carotid artery, two on the lateral aspect of the chest at the level of the xyphoid bilaterally, and one bipolar electrode on the anterior chest wall (Fig 2) to receive the outgoing signals. The NICOM was activated at 8:24. After the completion of the data entry process, it was noted in the ECG that the heart rate suddenly increased to 120 beats/min, with blood pressure = 134/71, SpO<sub>2</sub> = 96% at 8:29. Monitoring was continued throughout. The patient was treated with nasal oxygen 3 L/min. At 8:40, lidocaine 50 mg intravenously was given and repeated 2 min later. The heart rate remained unchanged, even after 15 mg of esmolol HCP was given, at divided dosages, within the next 10 min. At 8:45, the vital signs were: blood pressure = 143/73,

Fig 1. Patient's electrocardiograph tracing.

Two weeks later, as part of another study, the same NICOM was attached. The monitor obtained, as basic readings, blood pressure = 146/92, heart rate = 76 beats/min,  $SpO_2$  = 92%, and a control tracing of a bipolar ECG. After placement of the electrodes, when the NICOM was turned on, the patient again exhibited a heart rate of 120 beats/min, blood pressure of 138/82, and  $SpO_2$  94%. The ECG tracing was similar to that observed previously (consisting of pacemaker spikes). The onset of tachycardia coincided with the time when the NICOM was activated.

The predominance of spike action again suggested a pacemaker malfunction triggered by the NICOM. This time, the heart rate spontaneously returned to normal

Pacemaker manufacturers may wish to add NICOM-R7 to the list of potential hazards, while manufacturers of bioimpedance NICOMs need to list it as potentially dangerous to patients with cardiac pacemakers.

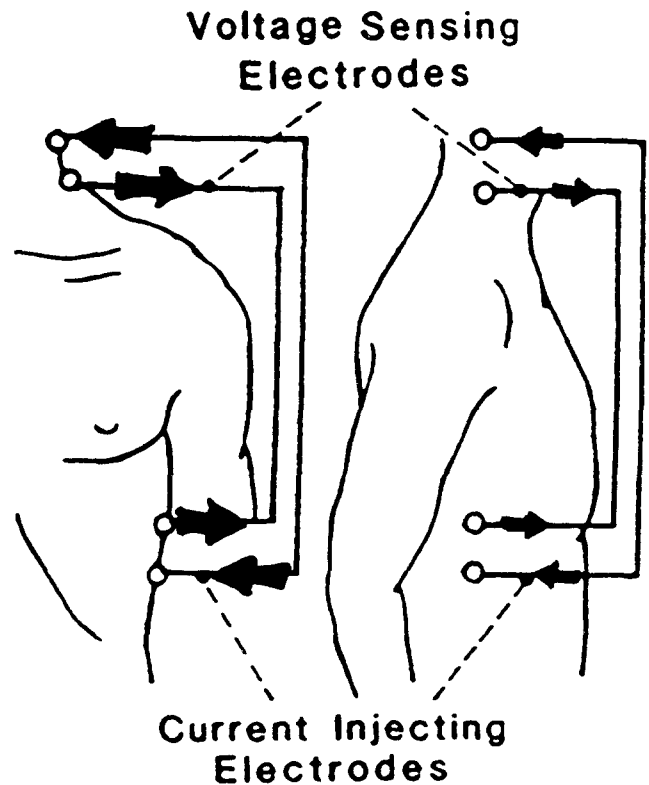
The measurement of cardiac output by thoracic bioimpedance is based on the principle that a pulsatile change in resistance is generated as a 2.5-mA current is injected through surface gel electrodes. These electrodes are placed on the neck and lateral aspect of the thoracic wall (see Fig 2). Supposedly, the outer pairs of electrodes inject a 70-R Hz, 2.5-mA current, which is then perceived by the inner pairs of electrodes [1]. The resistance to the injected high-frequency current is dependent upon the fluid characteristics of the thoracic volume. These changes are then timed to the ventricular electrical depolarization and mechanical systole, thus establishing a quantitative correlation of blood flow changes and ultimately stroke volume, from which cardiac output and ejection fraction can be derived [2,3].

Fig 2. Pre-gelled electrodes were connected to the patient as follows: two on the neck along the carotid artery; two on the lateral aspect of the chest at the level of the xyphoid bilaterally; and one bipolar electrode on the anterior chest wall.

mented previously [1,4]. The measurements are considered less accurate in severe dysrhythmias and tachycardia, in which pacemaker spikes result in incorrect determination of systolic time intervals, heart-rate determination, and, therefore, inaccurate cardiac output measurements [4,5]. Signal acquisition is impaired by electrode adherence defects and electrocautery [6]. The manufacturer's information included with the NICOM does not specifically warn about the possibility of its affecting pacemakers [2]. Although the alternate current delivered by bioimpedance monitors to measure thoracic resistance has been termed as "microcurrent," it appears that it is large enough to alter the performance of pacemakers. Though we failed to recognize the hazardous association of the two devices after the first incident, after the second occurrence we identified the link between them that prompted the report.
