RILEM TC 167-COM: 'Characterisation of old mortars with respect to their repair'

## Characterisation and damage analysis of old mortars

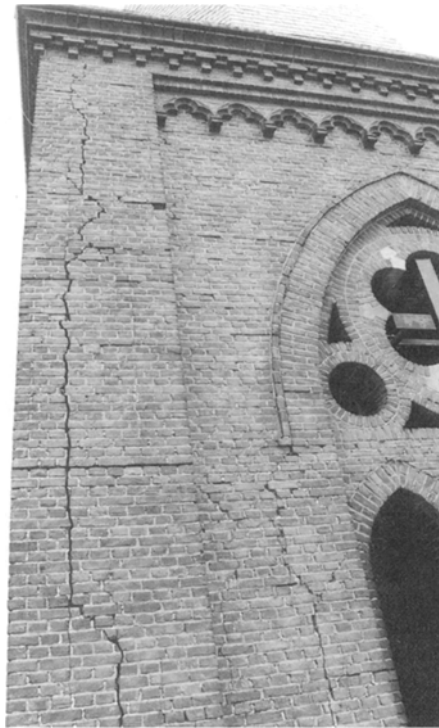
Fig. 1 - Wide (vertical and also horizontal) cracks, on the first sight looking like structural cracks, were found to be caused by swelling compounds in the inner part of the masonry.

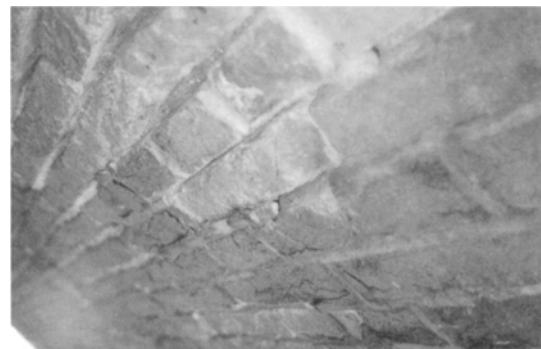
Fig. 2 - Damage in the passage (way) of a historical arch bridge: spalling of brick and pointing is pushed out.

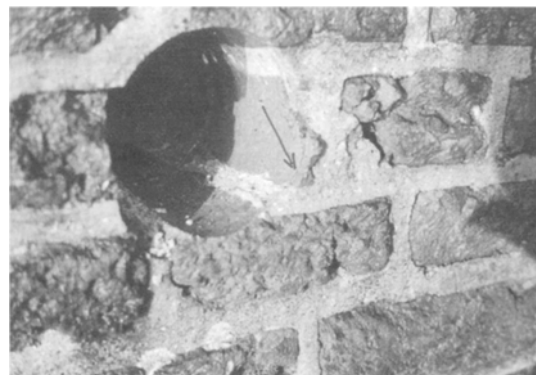
Fig. 3 - Start of damage visible in the hole left by the drilled core (see arrow for location): a layer of the brick begins to detach, the bedding mortar shows loss of cohesion.

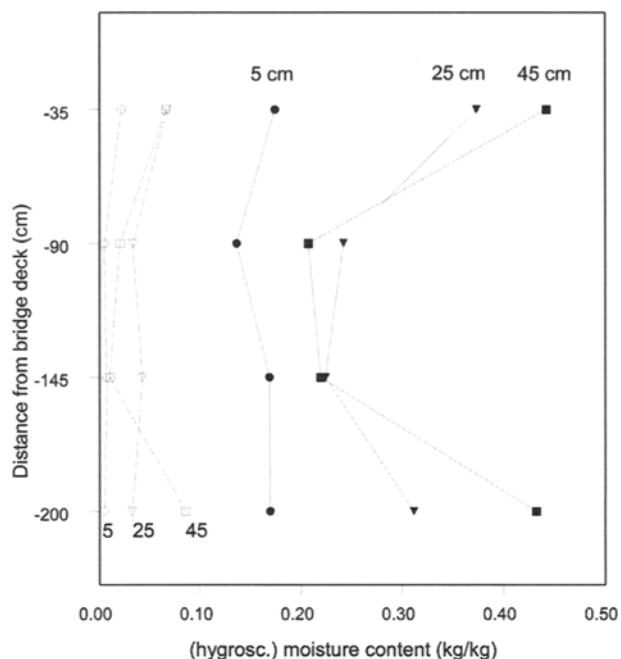
Fig. 4 - The moisture content (and distribution) in one of the bridge pillars as a function of the distance from the bridge deck and as a function of drilling depth (5, 25 and 45 cm). The continuous lines indicate the moisture profile. The dotted lines represent the hygroscopic moisture content at 93% RH and give an indication of the salt profile.

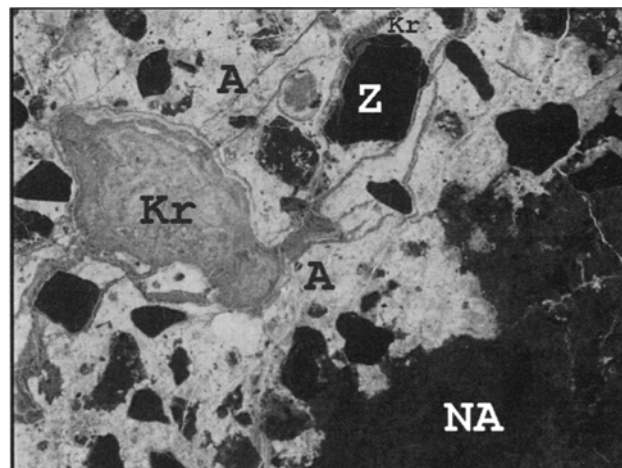
Fig. 5 - PFM picture (fluorescence) of decayed mortar. The dark not decayed zone has lower porosity. In the left part (light colour) the porosity is clearly higher; this is due to the dissolution of the binder; 'A' is used to indicate the decayed zone, 'NA' for the not decayed zone. The decay is shown by this phenomenon as well as by concentrations of structures in crystal form indicated by 'Kr'. Dimensions of the section shown are 2.7 x 1.8 mm (magnification: 50x). Location -/- 200 cm below bridge deck, depth 5 to 10 cm from the wall surface (see Fig. 4).
