A Fractographic Investigation of Thermal Embrittlement in Cast Duplex Stainless Steel

T. KOBAYASHI and D. A. SHOCKEY

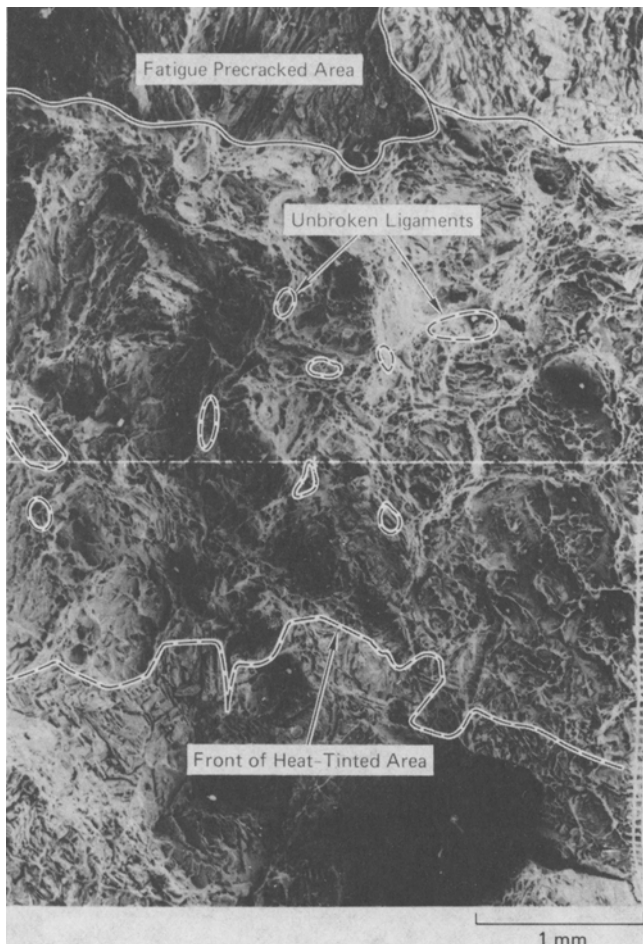
Detailed examination of the fracture surface revealed the existence of a significant number of non-heat-tinted islands (unbroken ligaments) in the heat-tinted region. We also observed that the fatigue precrack and heat-tint fronts were irregular. Furthermore, the amount of stable crack extension varied from approximately 3 mm in the center region to about 0.1 mm near the outer edges. Figure 2 shows the highlighted locations of the fatigue precrack front, unbroken ligaments, and the front of the heat-tinted area.

Fig. 2—Scanning electron micrograph of the fracture surface of cast and aged duplex stainless steel.

Figure 4(l) corresponds to the state at which the fracture test was interrupted. The locations of the predicted main crack front and unbroken ligaments agree well with those shown in Figure 2.

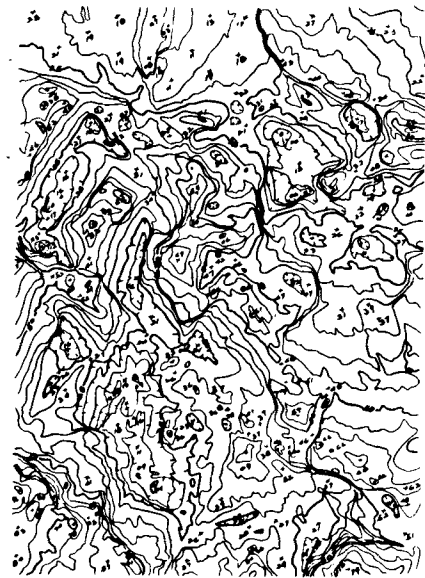
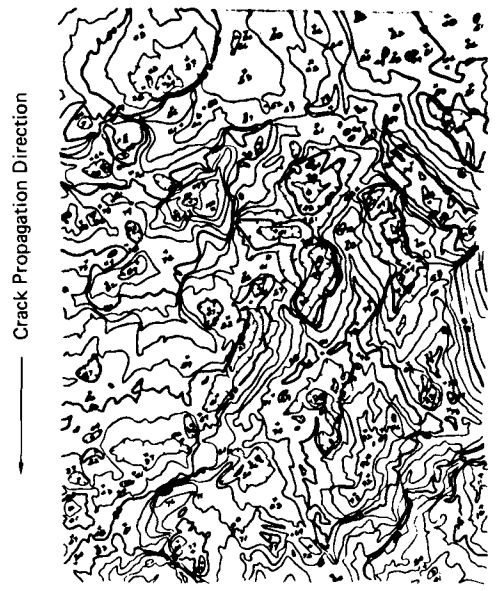
Fig. 3—Topographic maps of conjugate fracture surface areas in the specimen center.

the specimen. The crack propagation direction is from top to bottom. The fracture surface elevation shown in the topographic maps was measured from an arbitrary reference plane.

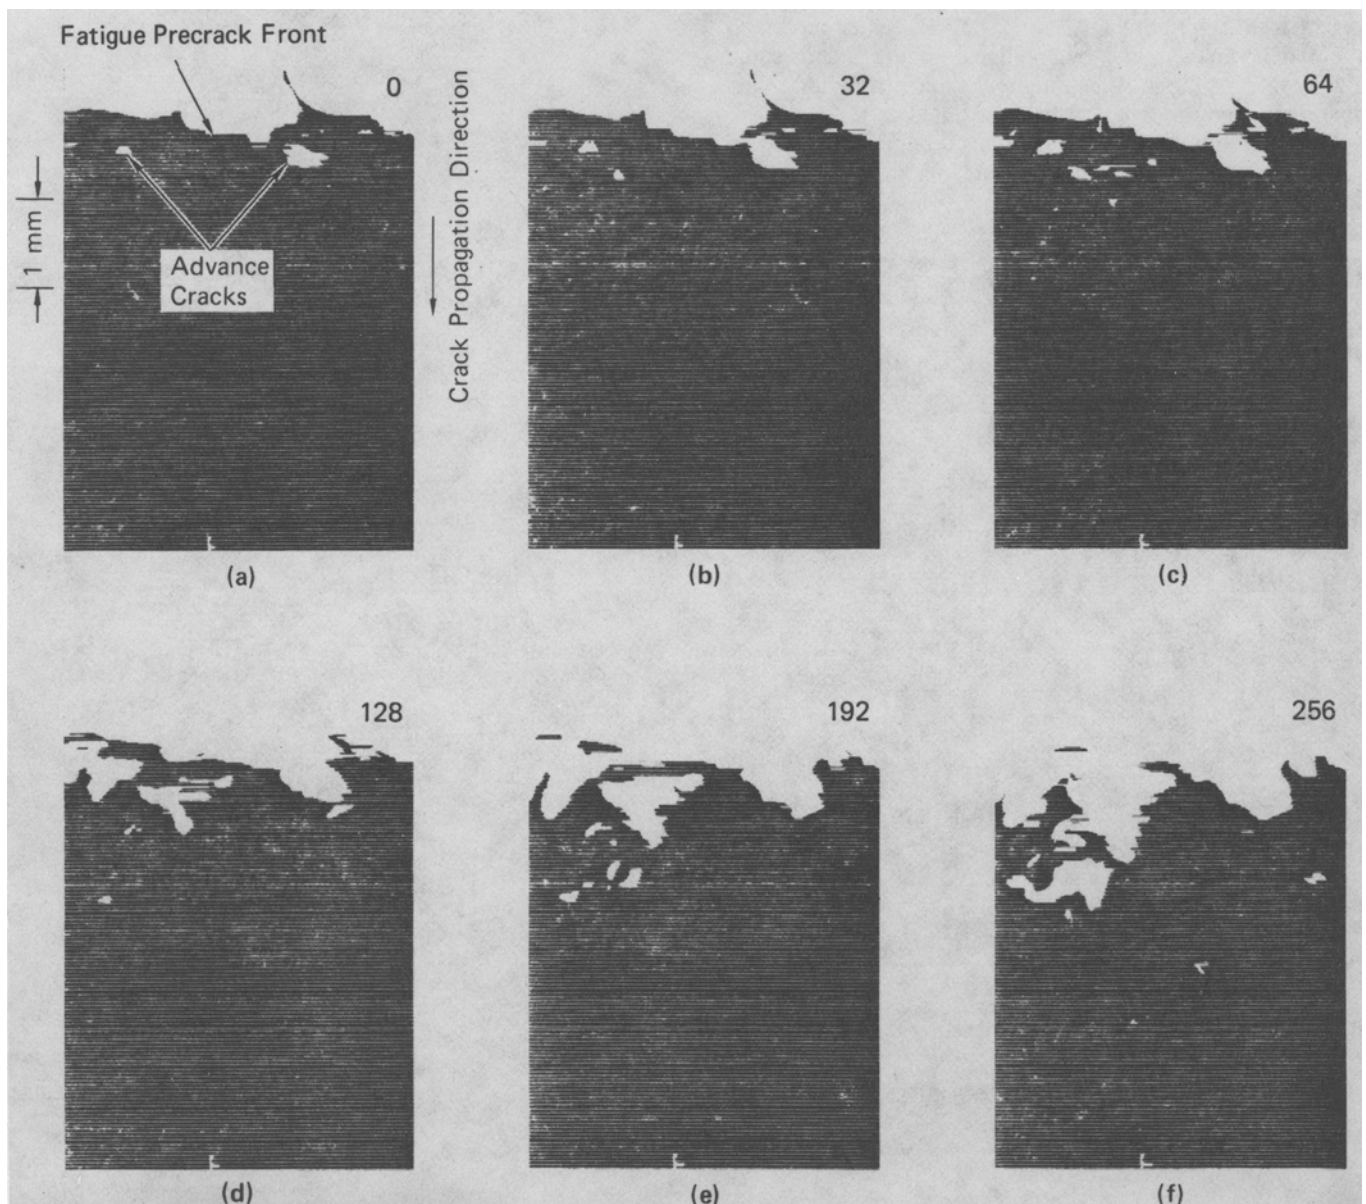
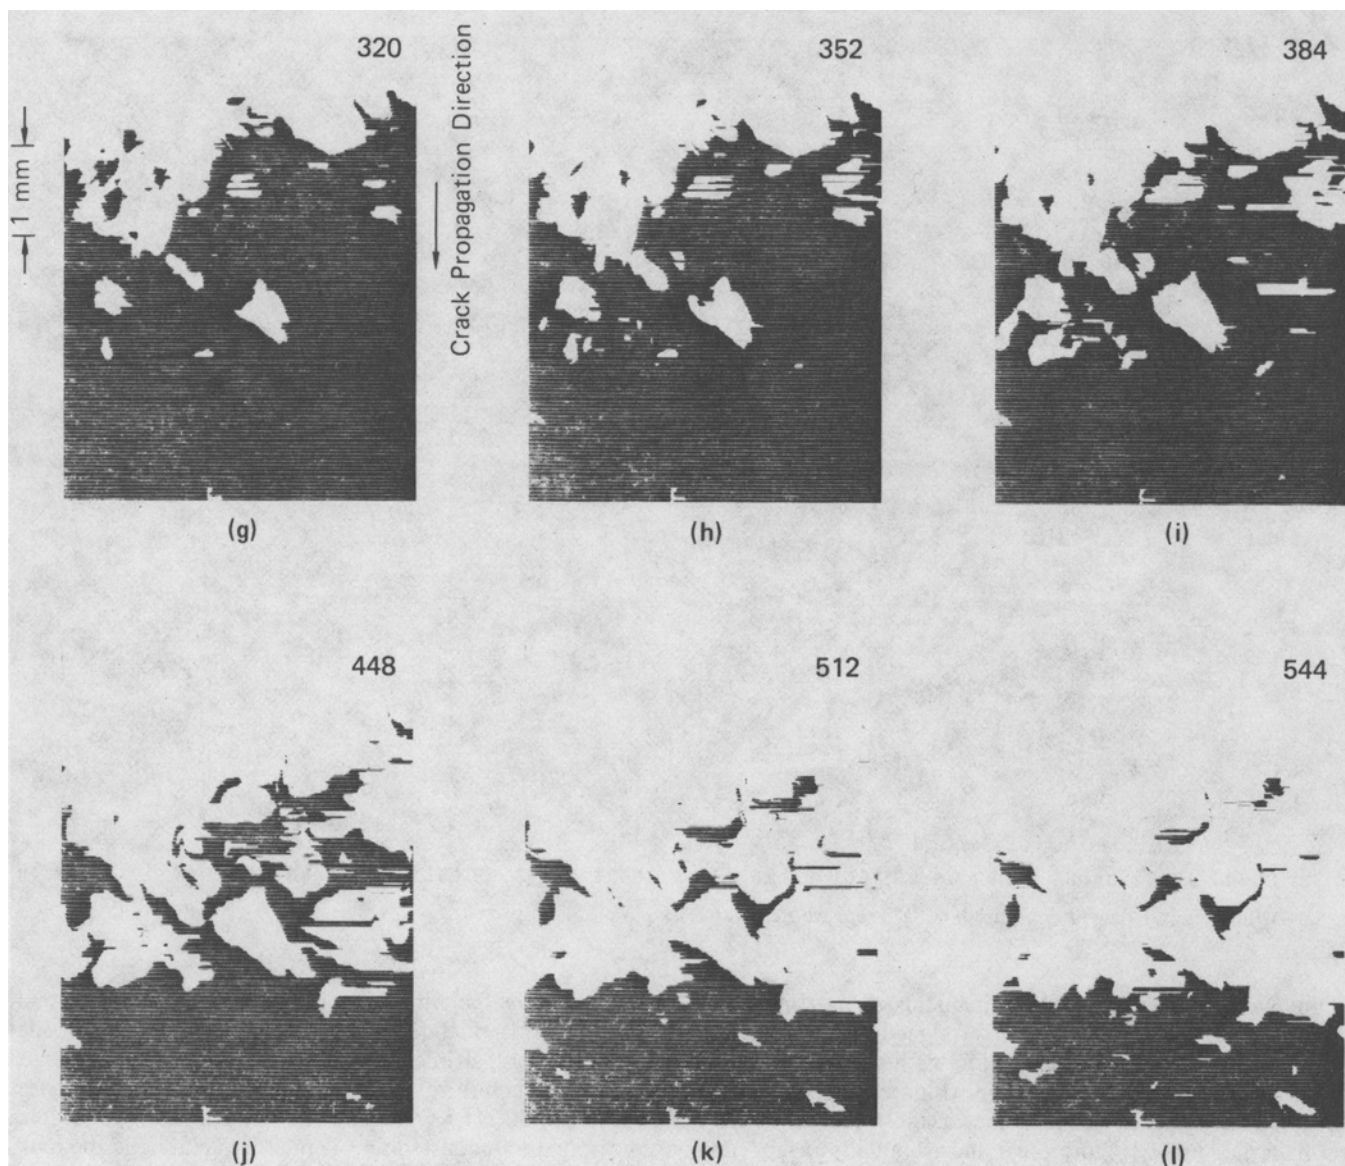
Figure 4(a) illustrates the specimen state at the onset of monotonic loading. The fatigue precrack front indicated by the computational conjugate contour matching agrees well with the actual fatigue precrack front observed in Figure 2.

Fig. 4—Fractured-area projection plots showing sequence of fracturing

Figure 4(a) also shows microcracks ahead of the fatigue precrack front, possibly formed during fatigue cycles. Distinct features associated with crack extension are revealed in Figure 4. As the separation between the conjugate maps increased (this is equivalent to increased load on the specimen or increased deformation of the specimen), the existing microcracks increased in size and coalesced with the main crack front [Figure 4(b)]. Also, new microcracks were formed, grew, and merged with each other to form larger microcracks before coalescing with the main crack front [Figures 4(c) through 4(f)].

It is important to note that, during the sequence between Figures 4(c) through 4(f), although the maps were separated with $64\text{-}\mu\text{m}$ increments, the main crack front did not advance appreciably; however, an examination of Figures 4(g) through 4(i) reveals rapid acceleration in microcrack formation and growth and in the main crack front movement despite a reduced separation increment of $32\text{ }\mu\text{m}$. We interpret this accelerated failure activity as the onset of crack growth, which begins in Figure 4(g).

Figures 4(b) through 4(j) clearly demonstrate that the mechanism of crack extension in this material can be described as nucleation, growth, and coalescence of microcracks with the main crack front. This mechanism produces an irregular crack front and results in the formation of unbroken ligaments, as shown in Figures 4(j) through 4(l).

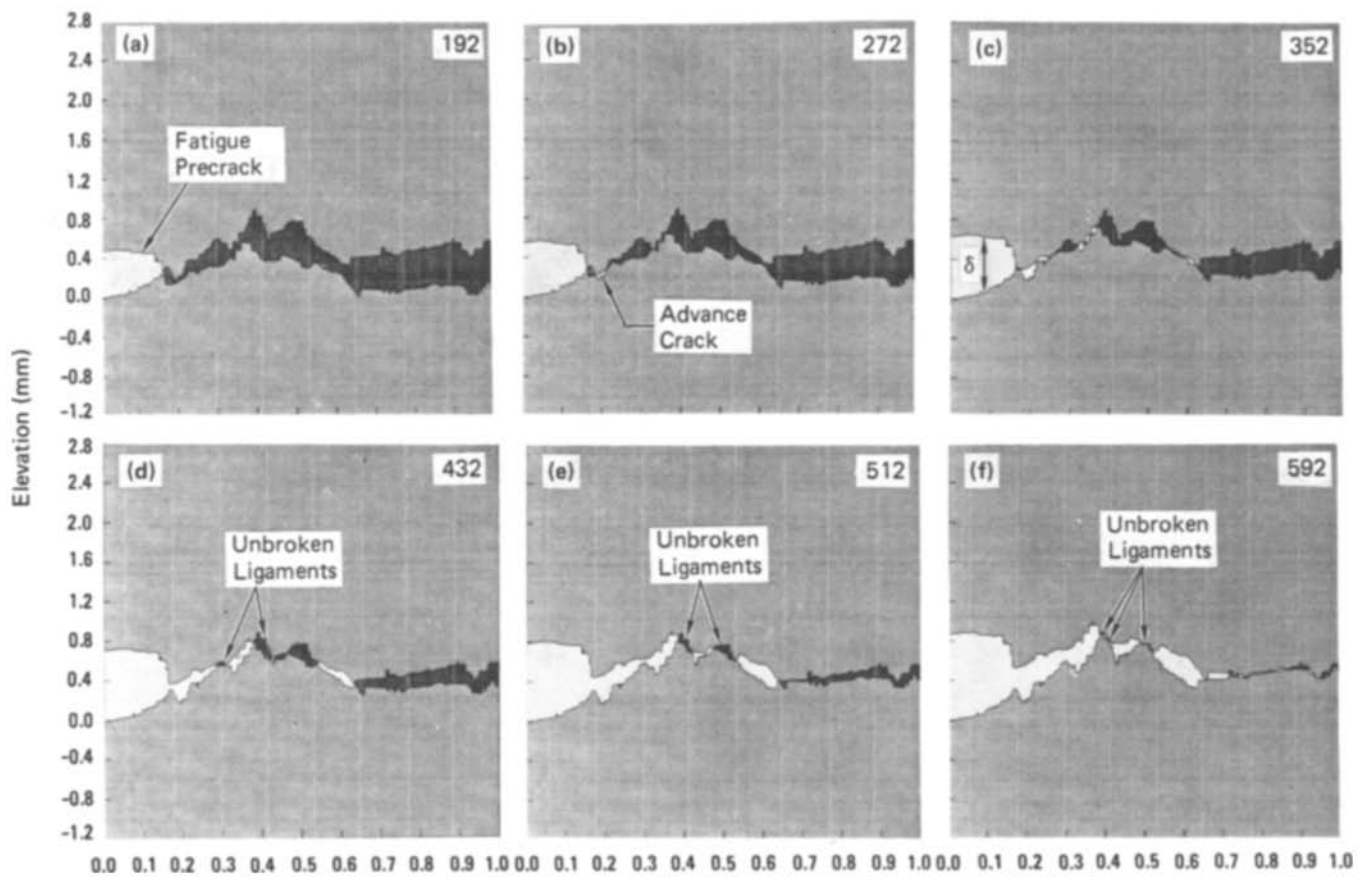
Fig. 5—Cross-sectional view of crack tip showing successive stages of crack propagation.

joining with the advance cracks. Ligaments of material connecting the fracture surfaces are produced as the microcracks ahead of the main crack tip join with one another and isolate islands of unbroken material [Figure 5(d)]. On further loading (additional displacement), these islands of intact material shrink [Figure 5(e)] and eventually disappear [Figure 5(f)] as the microcracks continue to grow and sever the ligaments.

The crack tip opening displacement (CTOD) observed at the tip of the fatigue precrack in Figure 5(c)—that is, at the onset of crack extension—is 0.65 mm. We used this value to compute crack initiation toughness, J_{Ic} , by taking the flow stress σ_0 to be 442 MPa (see Table I) and multiplying σ_0 and the CTOD. The resulting value, $J_{Ic} = 287 \text{ KJ/m}^2$, agrees well with the J_{Ic} value of 284 KJ/m^2 obtained using a conventional fracture test procedure.⁹

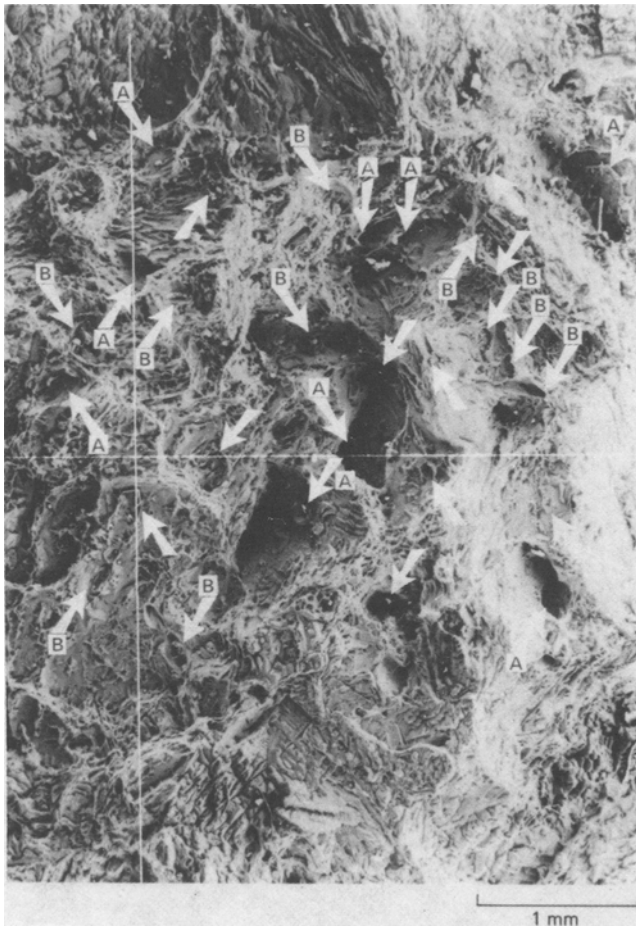
The sites of microcrack initiation indicated by the fractured-area projection plots in Figure 4 were compared with the fracture surface photograph in an attempt to identify the microstructural features responsible for microcrack initiation. The results are shown in Figure 6. The arrows labeled A point to several large, slanted planes on the topographs; the arrows labeled B point to layered or laminate structure. Unlabeled arrows indicate initiation sites at which distinguishing features could not be observed.

Comparison of the microstructure shown in Figure 7 with the fracture surface features shown in Figure 6 reveals that fine steps and scratchlike features represent deformed γ -phases; that the large, slanted planes marked by the arrows labeled A are related to the δ -grain boundaries; and that the fracture initiation sites labeled B may be associated with crack initiation between the γ -phase platelets.

Fig. 6—Microcrack initiation sites on the fracture surface as indicated by FRASTA.

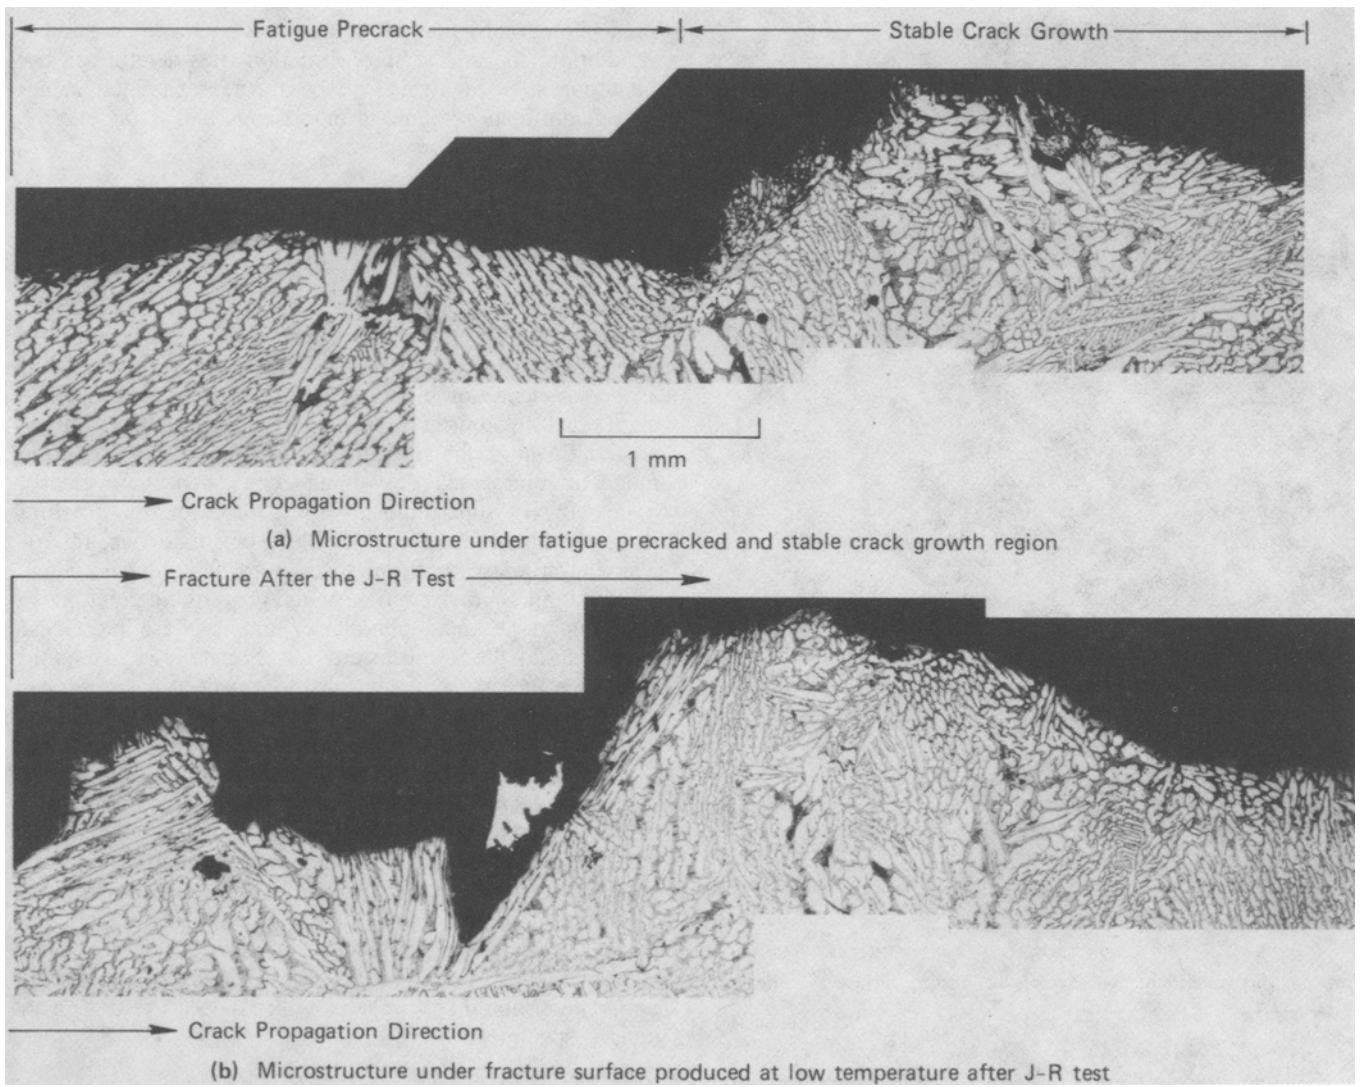
To establish relationships between microstructure and fracture surface features, the specimen was sectioned along the white vertical line shown in Figure 6. Figure 7 shows the microstructure revealed by an electrolytic (5 VDC for 5 seconds) 40 pct KOH etch. The white areas in the figure correspond to an austenitic (γ) structure and the dark areas to a ferritic (α) structure. Furthermore, we observed that this material exhibits a macrostructure and that the macrograin (δ -grain) boundaries influence the crack path significantly. For example, at the leading edge of the stable crack growth region in Figure 7(a), the crack path was parallel to the macrograin boundary. In the region fractured at low temperature after the test, shown in Figure 7(b), the crack also ran along some sections of the macrograin boundaries.

Fig. 7—Microstructural detail beneath the fracture surface in duplex stainless steel.

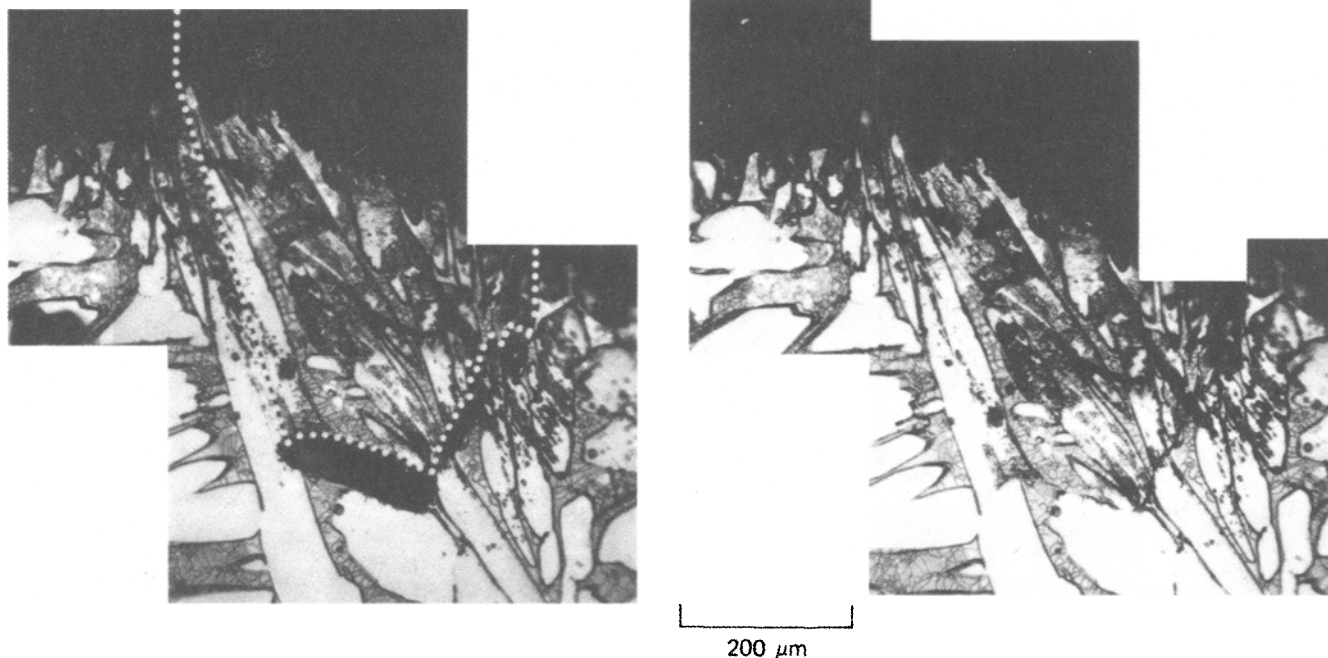
Other interesting features observed in the stable crack growth region are the small cracks formed under the fracture surface and the deformation of the material around them. Figure 8(a) shows a magnified view of one such crack and the area surrounding it. It is apparent that the crack occurred at the interface between the α and γ phases. The crack was arrested on the left side by the long γ phase;

on the right side, however, the crack changed direction and appeared to connect to the main fracture surface. Large plastic deformation in the gamma phase is indicated by the pits produced during etching.

(a) Crack under fracture surface (Dark area- α phase; Light area- γ phase)

Fig. 8—Microcrack formation at alpha-phase/gamma-phase interface illustrating the principle of FRASTA.
