TECHNICAL NOTE

Microseismic Monitoring of the Left Bank Slope at the Baihetan Hydropower Station, China

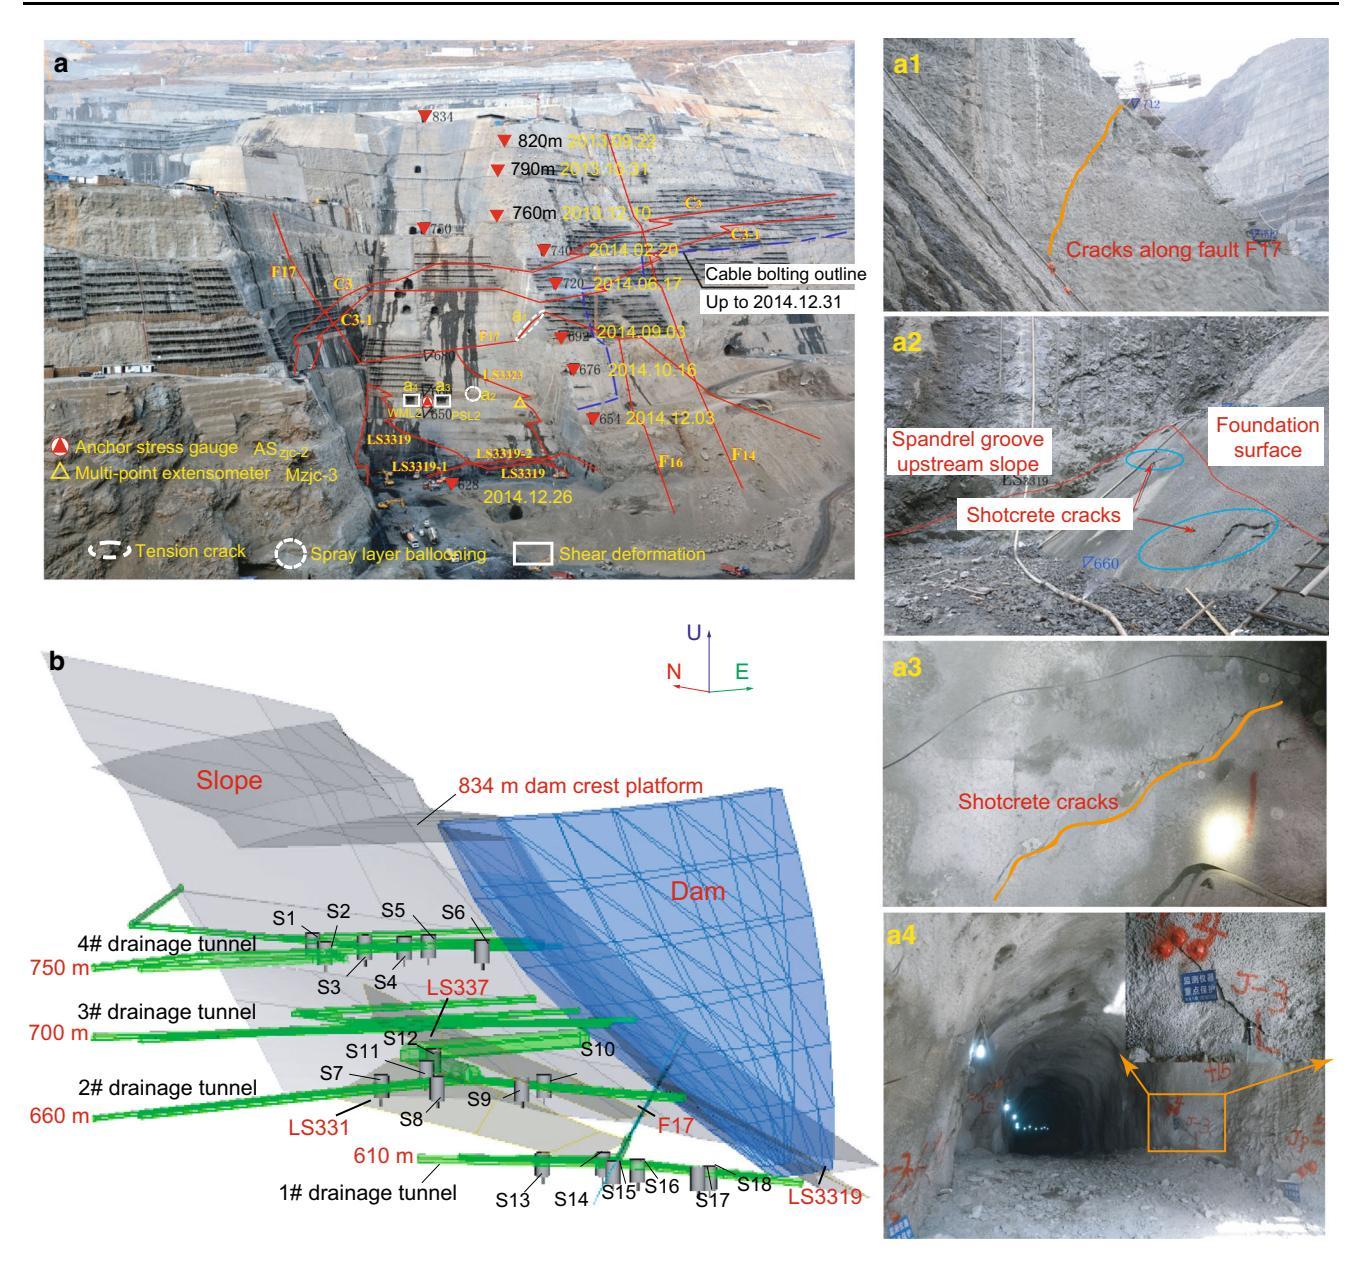
with a 60° slope. The left bank slope is a bedding slope with an attitude of N30–50°E and SE $\angle 15-25^{\circ}$. There are many interlayer staggered zones (i.e., C3 and C3-1, where the occurrence of C3 is N35–50°E and SE $\angle 15-20^{\circ}$) and faults with high deep angles in the NE direction (i.e., F17, F16 and F14). The interlayer staggered zones (i.e., LS412, LS415 and LS423) and faults (i.e., f108 and f110) along the NW direction develop at the elevations of 834-750 m. The interlayer staggered zone LS411 and the interlamination staggered zones C3-1 and C3 develop at the elevations of 750-700 m. Fault F17, along the NE direction and with a high deep angle and a width of 1.2-3.0 m, obliquely cuts the dam foundation at an elevation of 680 m. The intraformational faulted zones with columnar jointing (i.e., LS3319, LS3320 and LS3320-1) play a significant role in these regions. Figure 1a shows a sketch of the main geological structures at the left bank slope.

Some sprayed concrete spalling, occurring at the peripheries of the entrances to the drainage tunnel PSL2 and the curtain grouting tunnel WML2 at an elevation of 654 m, was first discovered on December 13, 2014, as illustrated in Fig. 1a. A mortar strip was applied to the cracks on December 18, 2014; however, new ruptures and malpositions occurred at the mortar strips on December 23, 2014. In addition, cracking occurred at the side slope of the downstream spandrel groove along fault F17 on December 25, 2014, with an approximately 1-cm expansion on the top and 0.3-cm expansion at the toe of the slope, 1 m away from the dam foundation surface, as shown in Fig. 1a. Some explanations can be provided based on the geological data: the failure phenomena are mainly attributed to the combined actions of the shear deformation of LS3319 and the expansion deformation of fault F17. The block composed of these two faults could become loose if the deformation continued to develop, which would be detrimental to the antisliding stability of the dam abutment. Thus, the excavation activity of the dam foundation slope was suspended on December 29, 2014. The support measures were requested to be completed before February, 2015.

Fig. 1 a Sketch of geological structures at the left bank slope and **b** spatial arrangement of the sensor array (the columns represent different tunnels such as transportation tunnels, drainage tunnels and grouting tunnels). Herein, a1-a4 are the different failure phenomena occurred at the rock slope. (*a1*) Cracks occurring along fault F17 at

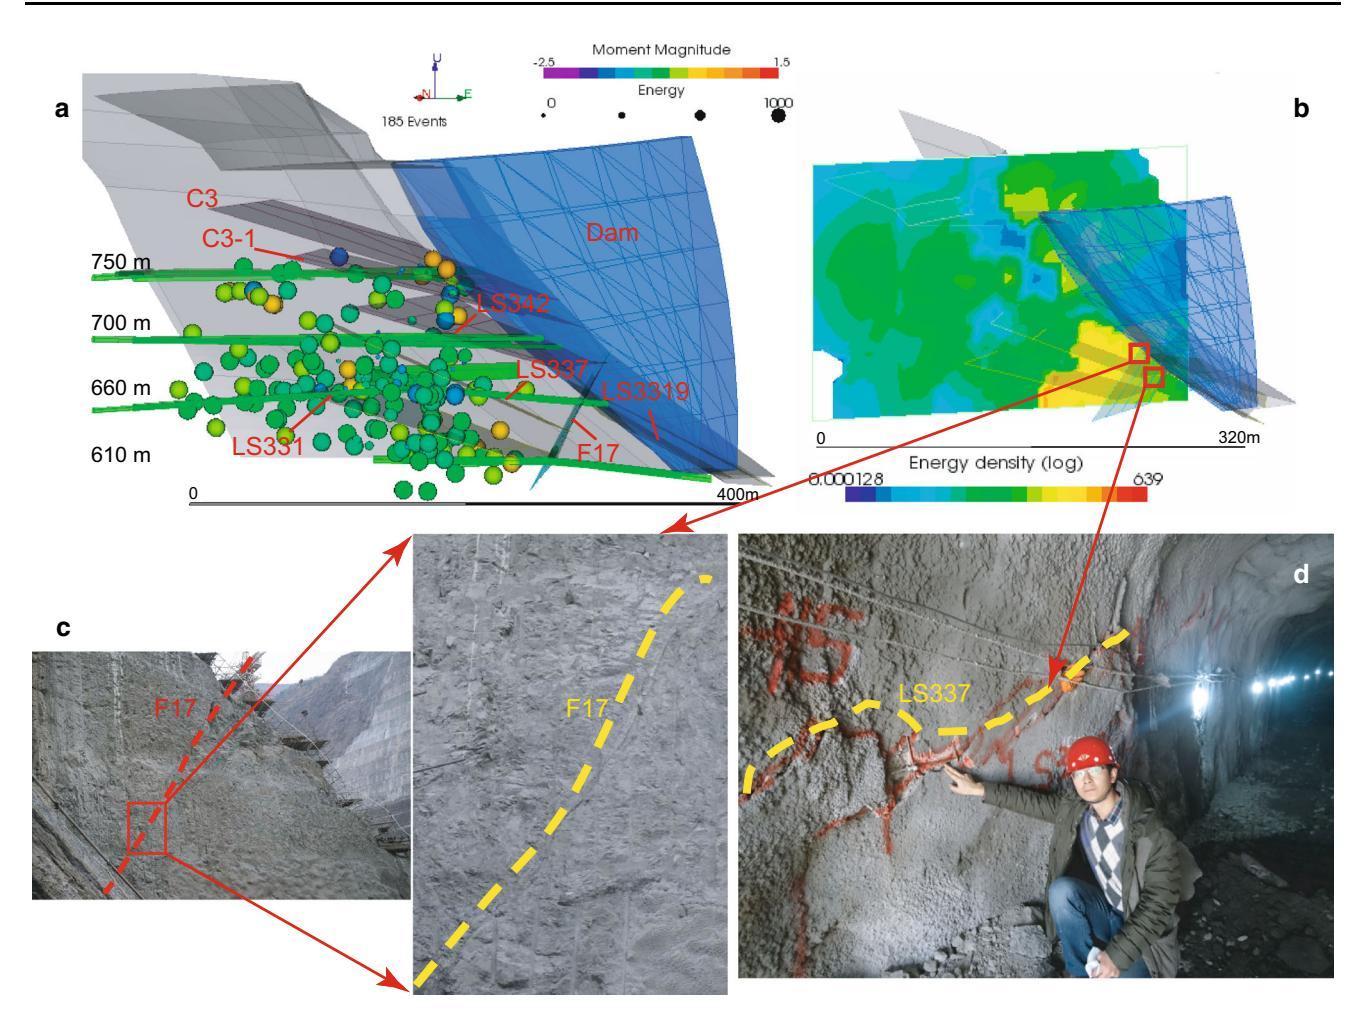
Moreover, to investigate the correlation between the MS activity and rock mass damage of the rock slope, field observations were frequently conducted. Some cracks were discovered in the past few months during continuous excavation of the rock slope, as shown in Fig. 1a. Figure 6 shows the comparison between the clustering of MS events and surface cracks in the rock slope. These cracks are mainly distributed around the spandrel groove slope of the arch dam, exactly above the excavation regions of the rock slope (Fig. 6d). With respect to the depths of MS events (Figs. 3, 4), the MS monitoring study conducted at the rock slope demonstrates that most of the MS events may be attributed to shear fractures between the different staggered zones (i.e., LS331, LS337 and C3-1) and tension cracking of faults (i.e., F17) induced by excavation unloading at the bottom of the dam foundation slope. Note that, right before the apparent field observation of surface cracks (see Sect. 2.2), the MS events had already accumulated significantly at different staggered zones (Figs. 3, 4); the occurring time of these surface cracks usually lags behind that of clustering MS events.

Fig. 6 Comparison between the clustering of MS events and surface cracks in the rock slope. **a** Spatial distribution of MS events, **b** energy density contour of MS events, **c** cracking occurring along fault F17

and \mathbf{d} sprayed concrete spalling occurred along LS337 in the curtain grouting tunnel WML2
