# Dynamic evolution mechanism and subsequent reactivated ancient landslide analyses of the "6.17" Danba sequential disasters

Nan Jiang<sup>1</sup> · Hai-bo Li<sup>2</sup> · Yu-xiang Hu<sup>1</sup> · Jie-yuan Zhang<sup>2</sup> · Wei Dai<sup>1</sup> · Cong-jiang Li<sup>2</sup> · Jia-wen Zhou<sup>1</sup>

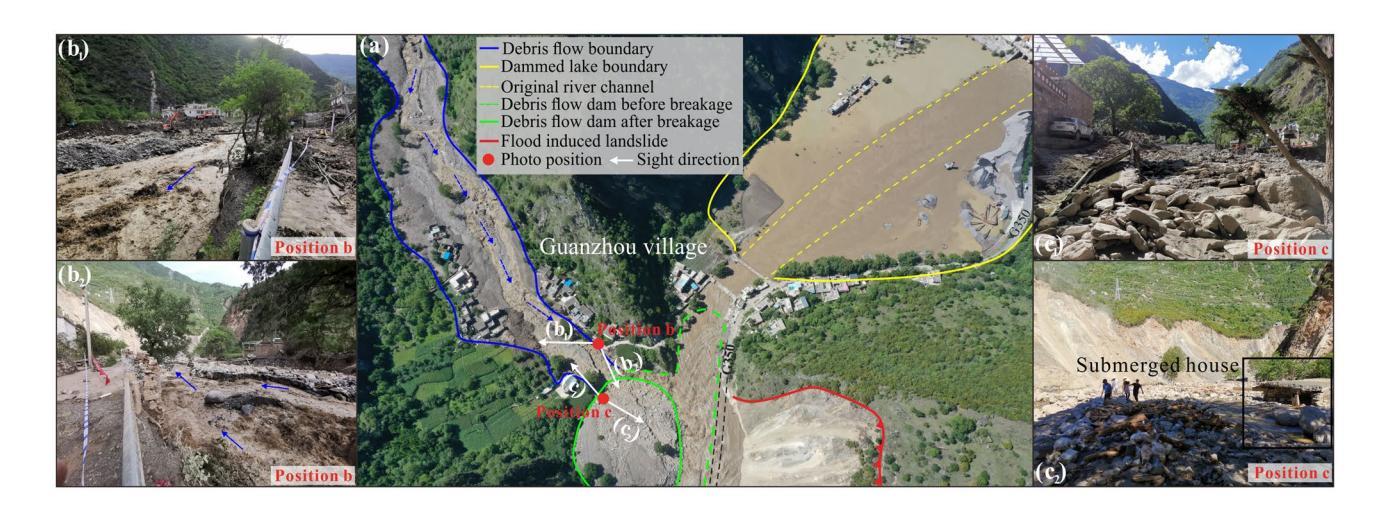
**Fig. 5** Onsite investigation of the Danba 6.17 sequential disaster event: (a) overview of the debris flow deposits, landslide and dammed lake;  $(\mathbf{b}_1)-(\mathbf{b}_2)$  file images taken in position b; and  $(\mathbf{c}_1)-(\mathbf{c}_2)$  file images taken in position c

The total amount of material from the debris flow was approximately 848,000 cubic meters according to the disaster survey by the Water Conservancy Bureau of Danba County (WCBDC). The debris flow contained a large number of large rocks and boulders, which led to great losses in Guanzhou village (Fig. 5). Almost all the houses on the right

bank of the Meilong gully were influenced by the debris flow, and casualties were reported (Fig.  $5b_1$  and  $b_2$ ). The bridges and part of the roads were completely destroyed, and some houses near the outlet were submerged by the debris flow deposits (Fig.  $5c_1$  and  $c_2$ ). According to the WCBDC, the water level reached the top of the debris flow dam at 4:00 p.m., which caused the overtopping of the debris flow dam. With the development of overtopping, the debris flow dam eventually failed, and the left bank slope was eroded by the dam break flood, resulting in the occurrence of landslides on the left bank and the destruction of national highway G350 (Fig. 6a). Large amounts of debris flow deposits and landslide masses were washed downstream, resulting in the uplift of the riverbed and the inundation of farmland, villages, and roads. In addition, the erosion of the left bank slope also led to the reactivation of an unstable slope: the Aniangzhai ancient landslide. These landslide deposits have existed for at least 100 years, according to a 72-year-old senior citizen in Guanzhou village. Within 1 month after the breakage of the debris flow dam, significant tensile cracks appeared along the back and lateral edges of the slope (Fig. 6b).

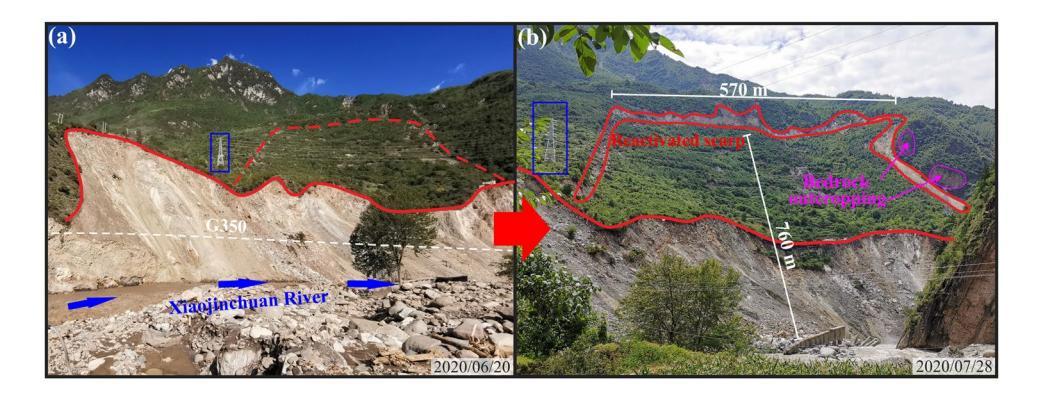
**Fig. 6** Reactivation of the ancient landslide: (**a**) two days after the breakage of the debris flow dam and (**b**) one month after the breakage of the debris flow dam

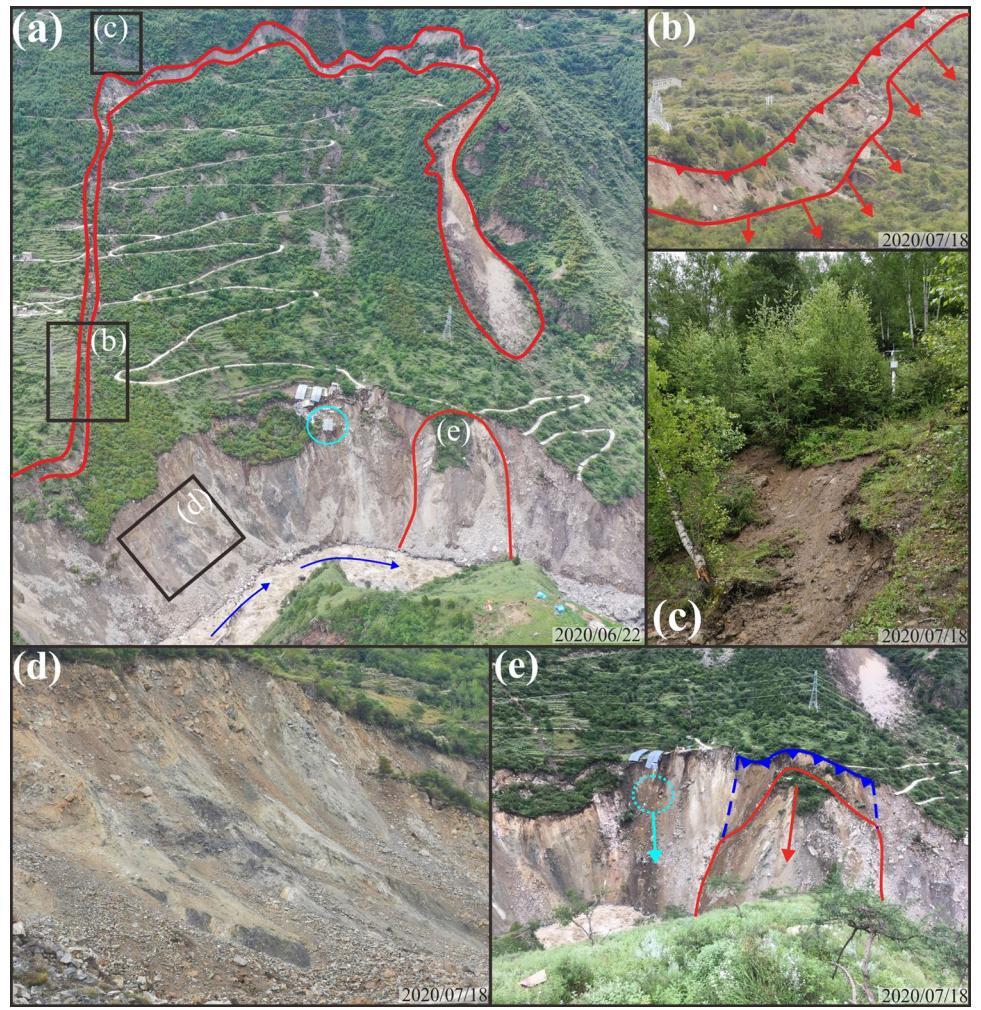
**Fig. 7** Onsite investigation of the reactivated ancient landslide: (**a**) overview of the reactivated ancient landslide after 5 days; (**b**) lateral scarp of the reactivated ancient landslide; (**c**) new scarps appearing above the reactivated ancient landslide after one month; (**d**) image of the flood-induced landslide scarp; and (**e**) collapse and large-scale deformation of the flood-induced landslide scarp

The earliest reactivation of the slope was concentrated in the river bend (Fig. 7a), and its main components were loose soils, gravels, and large stones with diameters of 0.5-2 m (Fig. 7d). With the deformation of the ancient landslide, the cracks along the back and lateral edge expanded over time (Fig. 7b), and new cracks in shallow layers began to appear on the top of the reactivated slope (Fig. 7c). Moreover, collapses, rockfalls, and subsidence occurred continuously on the flood-induced landslide scarp (Fig. 7e).

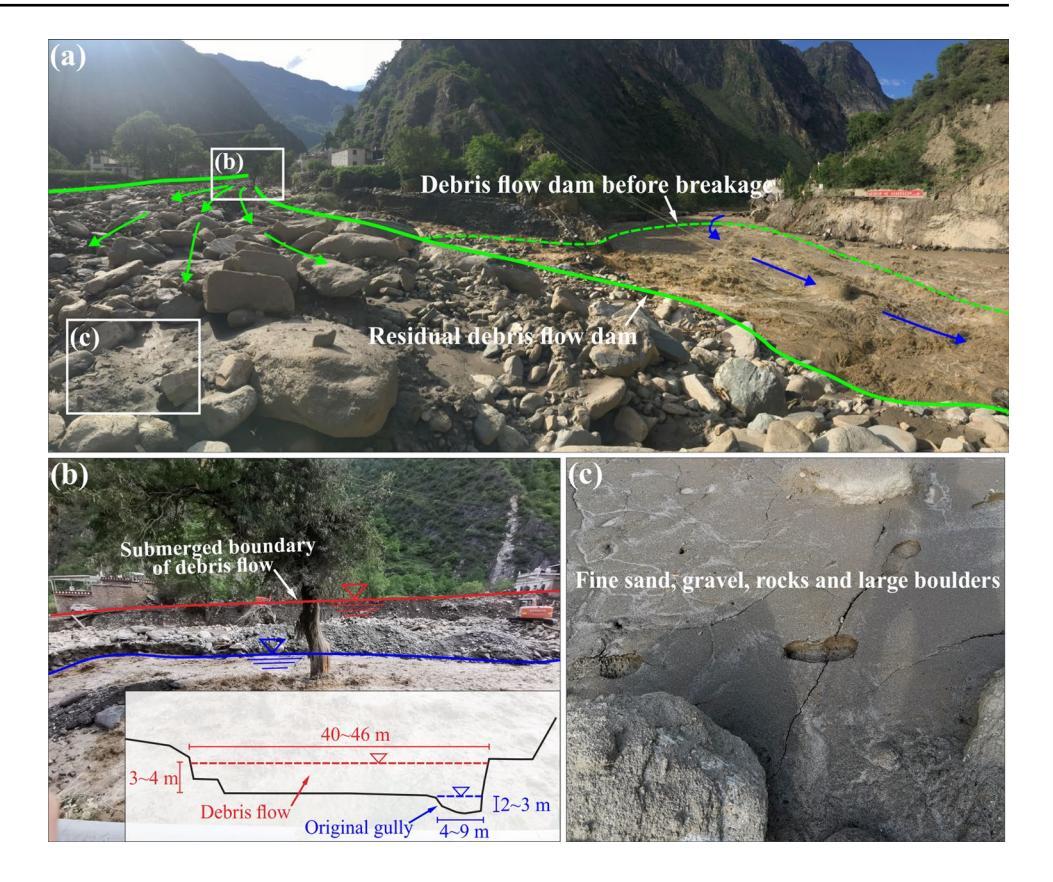
Fig. 10 Onsite investigation of the debris flow deposits:
(a) debris flow deposits;
(b) submerged area of the debris flow; and (c) major components of the debris flow deposit

According to the on-site investigation of the residual debris flow deposits (Fig. 10a), the main components of the debris flow are soils, fine sands, rocks, and boulders, and the particle size distribution ranges from less than 1 mm to more than 5 m (Fig. 10c). We counted the stones exposed on the debris flow deposits near Guanzhou village and found that almost all the rocks with a diameter of more than 0.5 m have experienced strong weathering and erosion, indicating that

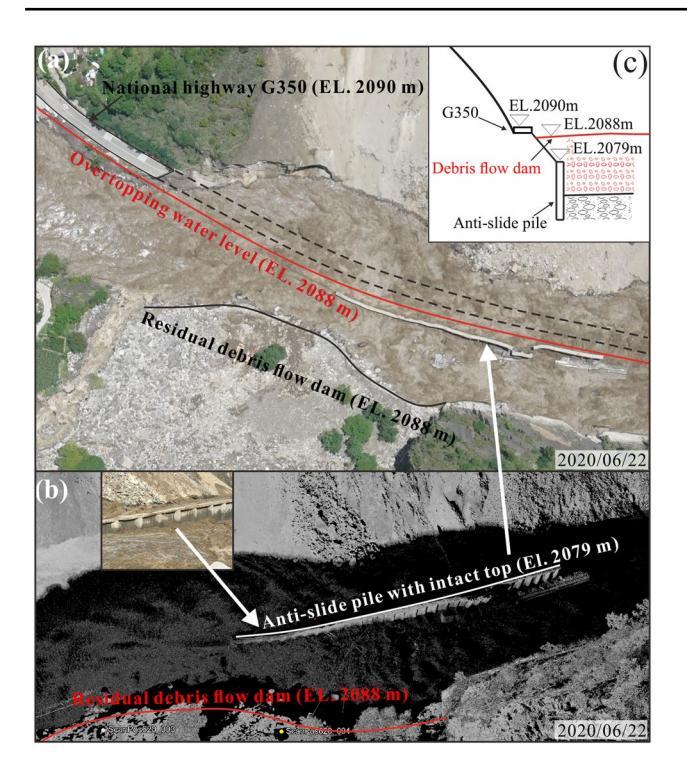
Fig. 11 On-site investigation and TLS data of the ground features: (a) overview of the investigated ground features; (b) TLS data for extracting the elevation of ground features; and (c) typical profile for the analysis of debris flow dams

Because of the existence of the ancient landslide, antislide piles were used as the foundation of national highway G350. Some of the anti-slide piles were destroyed in the flood-induced landslide, while others were preserved (Fig. 11a). As shown in Fig. 11b, most of the top beams of the preserved anti-slide piles were intact. According to the TLS data, we extracted the elevations of G350 (EL. 2090 m), the top of the anti-slide pile (EL. 2079 m), and the edge of the residual debris flow dam (EL. 2088 m) and then restored a typical section of the river channel before dam breakage (Fig. 11c).

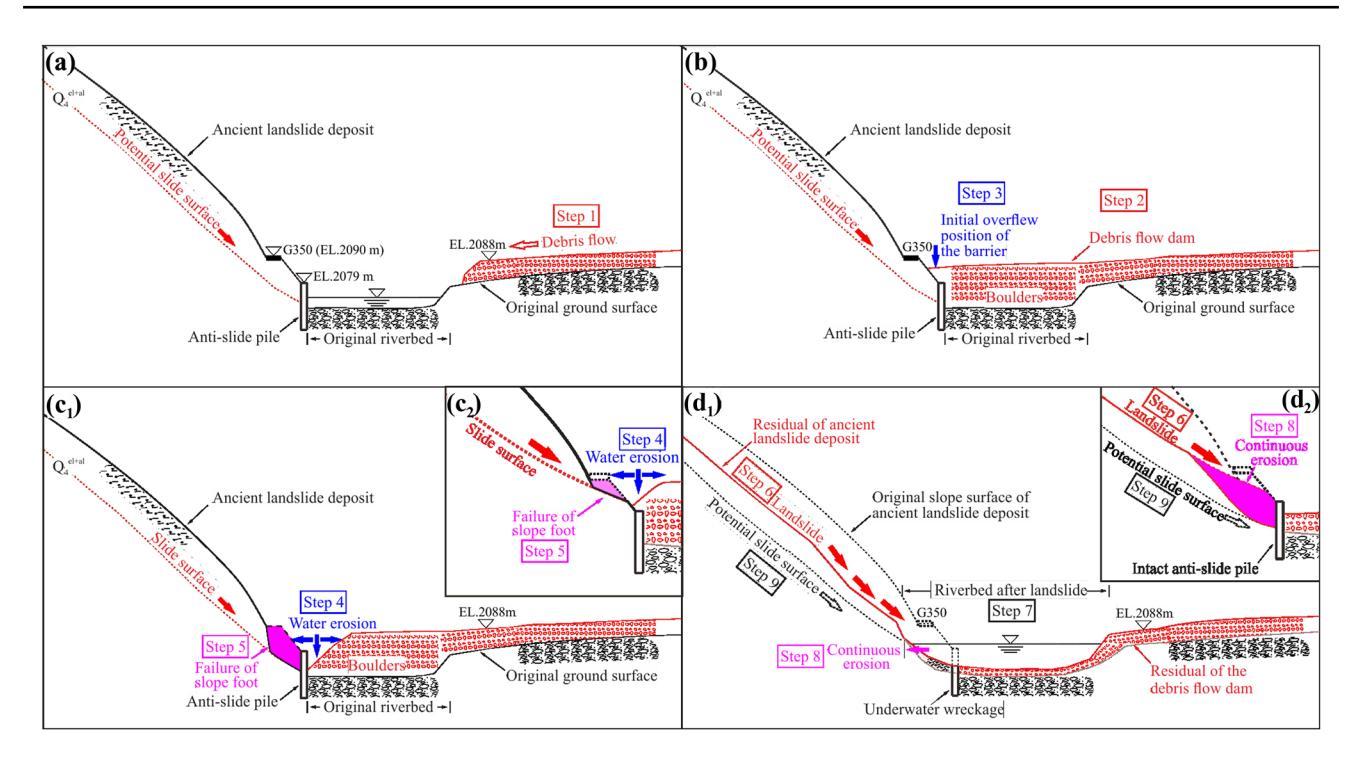
According to the elevation of these ground features, we speculate on the development of the breakage of the debris flow dam and the flood-induced landslide on the left bank. At first, the debris flow brought particles of various sizes into the main channel of the XJC and blocked the river channel (Fig. 12a). The anti-slide pile was completely buried by debris flow deposits (Fig. 12b). Generally, debris flow deposition is fan-shaped, and the height of the front edge is relatively low (Chen et al. 2013; Hu et al. 2019; Wang et al. 2017). Therefore, the initial overtopping might have occurred near the intersection of debris flow deposits and the left bank slope (Fig. 12b). As erosion developed at the slope toe, the bank slope gradually lost its stability. Two types of landslide surfaces might exist in this situation: (a) the sliding surface of the landslide is deep, and the anti-slide pile is damaged by the direct impact of the landslide (Fig.  $12c_1$  and  $d_1$ ); (b) the sliding surface was shallow, and the landslide occurred above the anti-slide pile, resulting in the anti-slide pile remaining intact (Fig.  $12c_2$  and  $d_2$ ). Then, because of the existence of the dammed lake and the increased upstream flow in the flood season, the water level at the breach was much higher than usual, which had a strong erosion effect on the left bank landslide residues, resulting in the continuous occurrence of landslides, collapses, subsidence, and rockfalls.

**Fig. 12** Formation and breakage of the debris flow dam: (a) typical profile of the original river channel; (b) river blockage by the debris flow dam;  $(c_1)$  and  $(c_2)$  overtopping of the debris flow dam and the

erosion process of the water; and  $(\boldsymbol{d}_1)$  and  $(\boldsymbol{d}_2)$  process of the flood-induced landslide

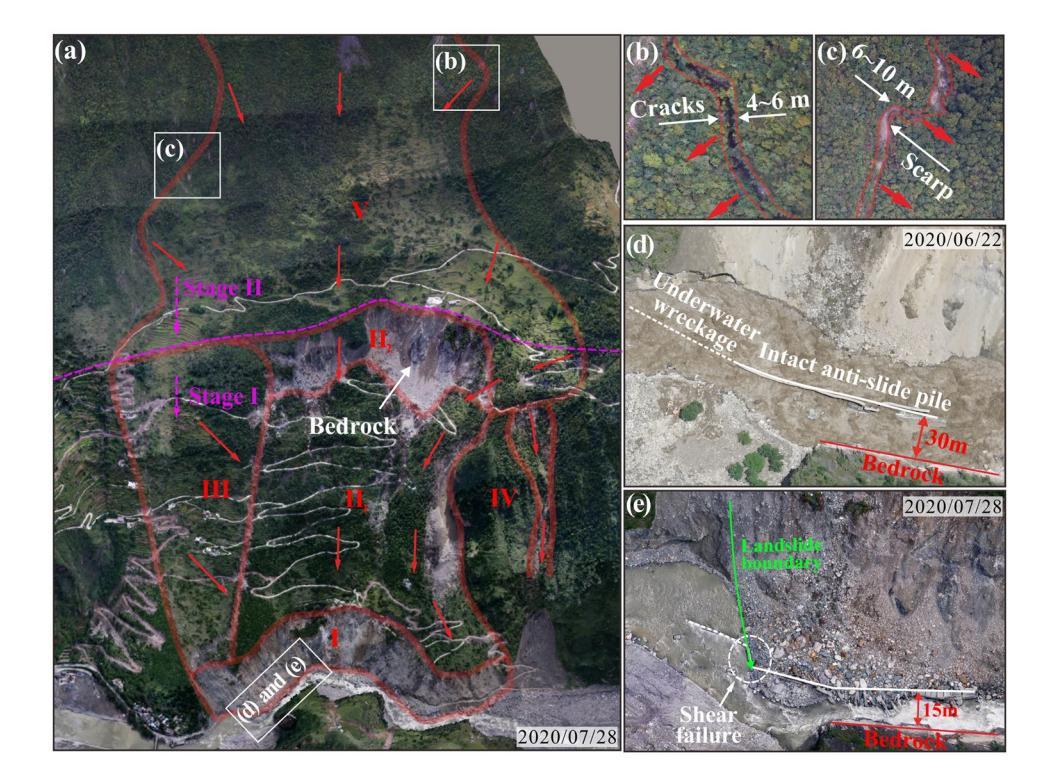
According to the monitoring results, the ancient landslide can be divided into two stages and five zones (Fig. 13a). The reactivation of the lower stage (Stage I) began with the dam break flood, which can be subdivided into four smaller zones (zones I, II, III, and IV) according to the accumulated deformation. Zone I is the scarp of the flood-induced landslide, with a length of approximately 650 m along the river and an average width of approximately 180 m along the slope. The height of this area is approximately 70 m, and the slope is approximately 40 degrees. Zone II is the area with the largest deformation during the landslide, which can be divided into two parts: Zone II<sub>1</sub> and Zone II<sub>2</sub>. Zone  $II_1$  is the main landslide mass and Zone  $II_2$  is the reactivated scarp of Zone II<sub>1</sub>, as well as the toe of Zone V (stage II). Zone III is the upstream triangular-shaped area whose deformation process is controlled by the instability of its toe and the lateral restraint in Zone II<sub>1</sub>. The length along the slope is approximately 700 m, and the top and bottom widths are approximately 300 m and 100 m, respectively. Zone IV is a downstream syncline bedrock on which two bedrock outcrops appeared. There is no significant displacement in this area. The reactivation of Zone V (stage II) is approximately 1 month later than that of stage I, with a small sliding distance and good integrity. There are obvious tension cracks on its trailing edge, ranging in width from 4 to 10 m (Fig. 13b and c). In addition, there was a significant horizontal displacement of the anti-slip pile on the riverbed, which moved approximately 15 m toward the opposite bank a few months after reactivation (Fig. 13d and e).

Fig. 13 Deformation of the reactivated ancient landslide after one month: (a) overview of the ancient landslide; (b), (c) cracks and scarps at the back edge of the ancient landslide; and (d), (e) horizontal displacement of the slope toe from 2020 Jun 22 to 2020 Jul 28

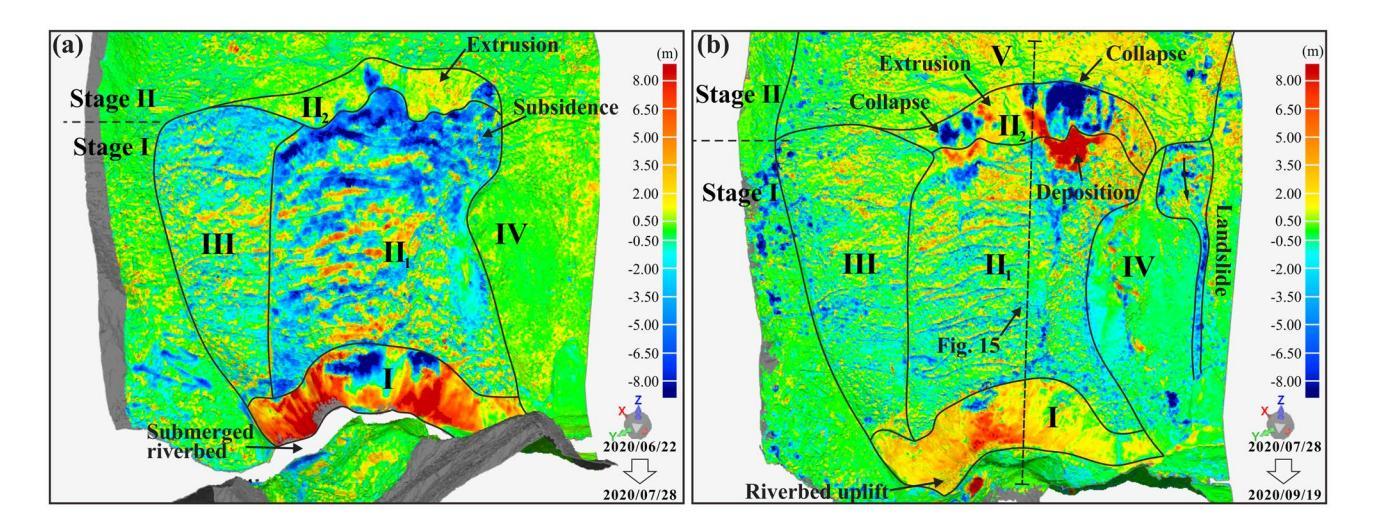
first month (Fig. 14a) and in the second to third months (Fig. 14b). As a result, the accumulated deformation and failure mode of the ancient landslide varied spatially and temporally. The most obvious phenomenon is that the overall

**Fig. 14** 3D deformation analysis based on point cloud data obtained from UAV photogrammetry: (**a**) 3D deformation from 2020 Jun 20 to 2020 Jul 28 and (**b**) 3D deformation from 2020 Jul 28 to 2020 Aug 19

deformation of the landslide gradually decreases, but the deformation area expands significantly. During the first month, the deformation area was mainly concentrated in stage I, and the maximum deformation appeared in Zone  $II_1$ . The slope mass in this area slid down along the slope, which led to the extrusion, collapse, and subsidence of the slope toe (Zone I). In the next 2 months, the deformation of stage I slowed down to a large extent, while stage II started

to show a significant displacement. Stage II gradually destabilized after losing the restraint from Zone II<sub>1</sub>, and its slope toe exhibited obvious outward extrusion and collapse.

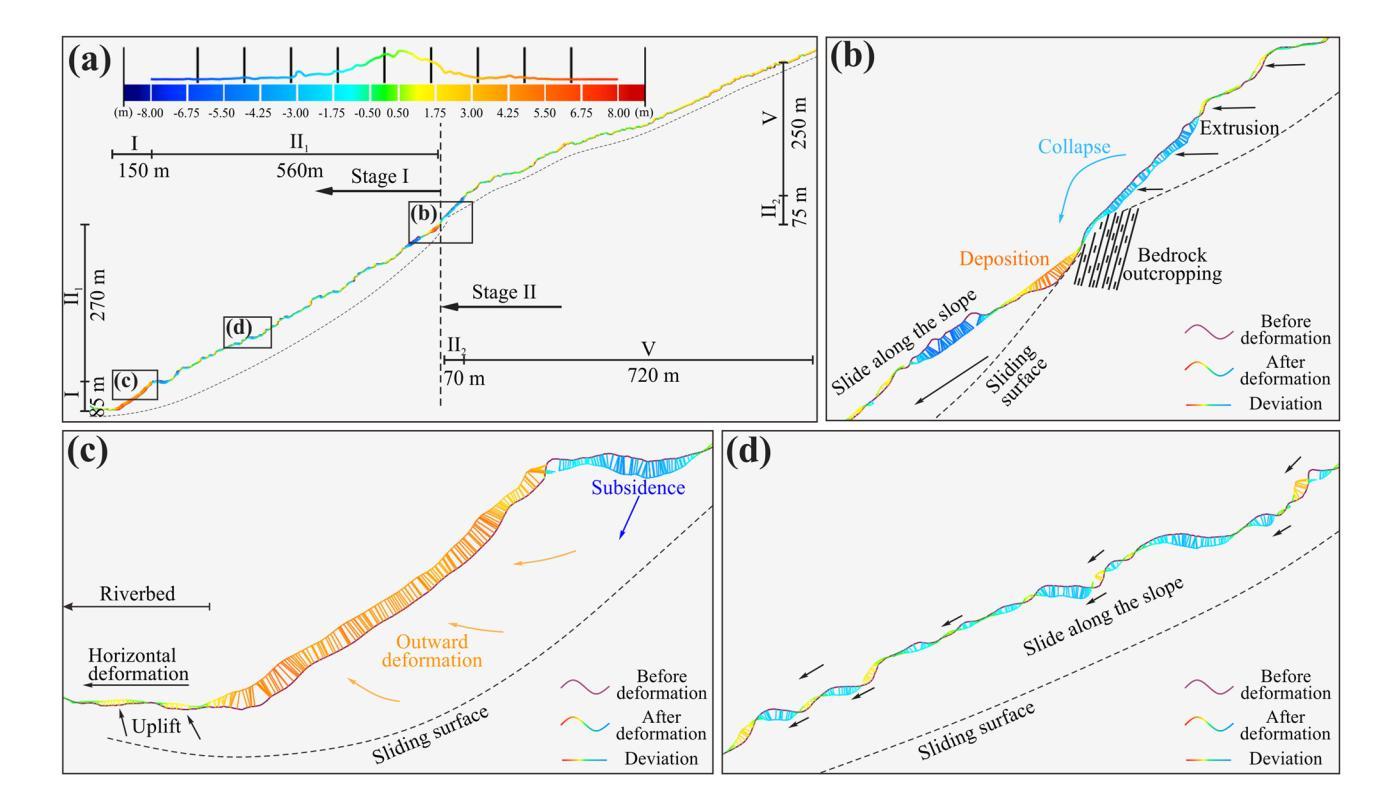
Figure 15a shows a typical profile of the 3D deformation map in Fig. 14b. The deformation mode of zone I can be deduced by Fig. 15c:

1. Subsidence on the back edge

Fig. 15 Typical profile of the 3D deformation map: (a) overall profile and (b)-(d) local deformation diagram in Zones  $II_2$ , I and  $II_1$

- 2. Outward extrusion and uplift on the front edge
- 3. Uplift and horizontal displacement of the riverbed

The most obvious difference between the deformation forms of Zones I and  $II_2$  is the rotation deformation at the front edge (Fig. 15c). Although the cause of the reactivation of both stages I and II was the instability of the front edge, the former underwent a rotational deformation in which the front edge lifted and the trailing edge subsided. As a result, the sliding surface of stage I should be located below the riverbed, which is the only way to cause the uplift and horizontal displacement of the riverbed.

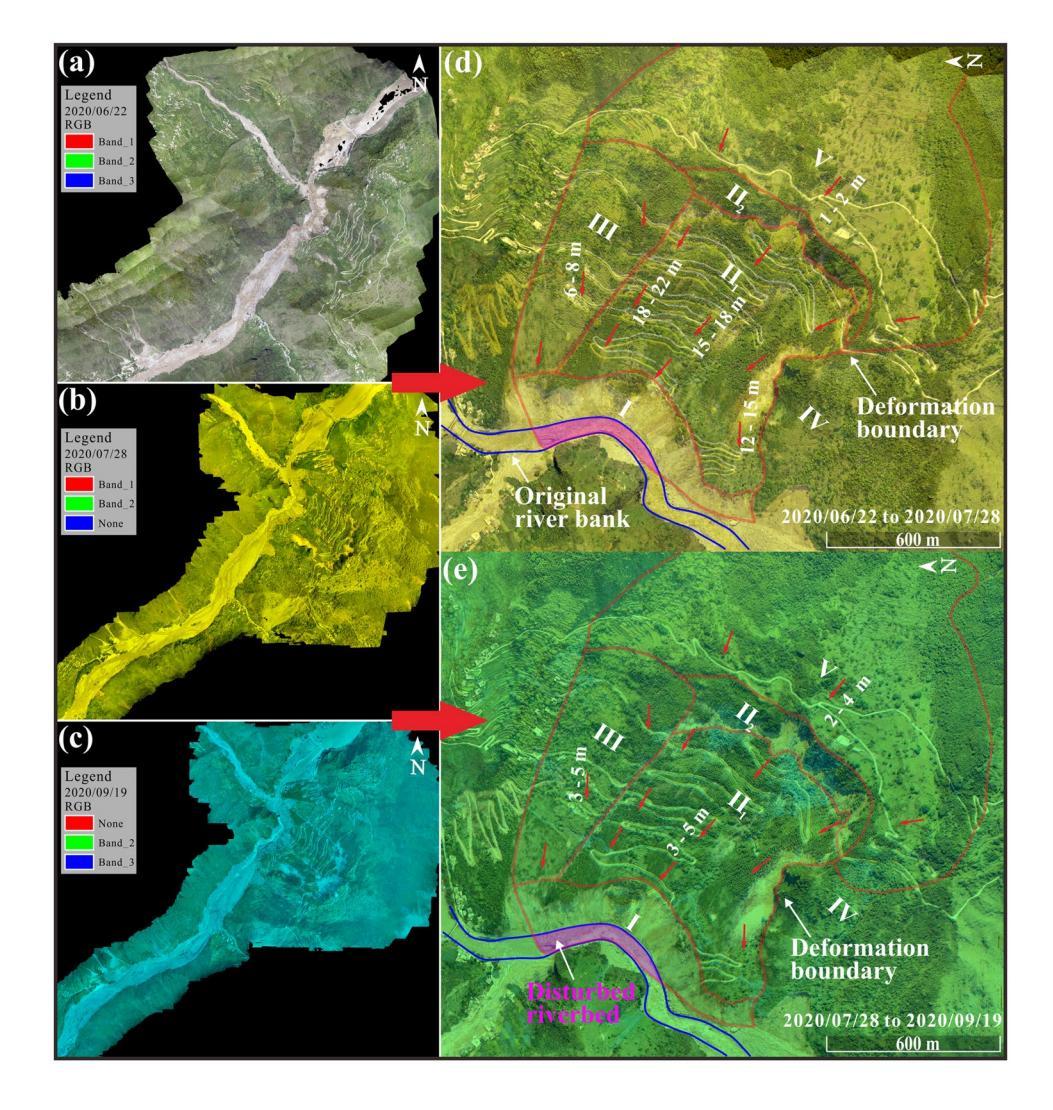
As a result, the use of the DOO allows a better visualization of the ancient landslide sliding down the slope. Since the maximum slope angle of the ancient landslide is less than  $45^{\circ}$  (approximately  $40^{\circ}$ ), there is a certain degree of synchronization between the horizontal displacement and the actual displacement, and the horizontal displacement can reflect the actual displacement to a certain extent. In addition, this method can overcome the data shortage caused by the lack of point cloud data. For example, due to the high

**Fig. 16** Horizontal displacement based on the differences in orthophotos (DOO): (**a**)-(**c**) UAV orthophotographs on 2020 Jun 20, 2020 Jul 28, and 2020 Aug 19 in different color bands and (**d**), (**e**) horizontal displacement of the ancient landslide water level in the first month, it is difficult to obtain the terrain of the riverbed (Fig. 14a), so it is difficult to analyze the evolution of the riverbed in the first month by means of 3D analysis. Instead, we determined the boundary of the landslide by means of the DOO and found that part of the riverbed deformed synchronously with the ancient landslide. Moreover, we quantitatively analyzed the horizontal displacement of the ancient landslide and found that the cumulative horizontal displacements in Zone II and Zone III were 12–22 m and 6–8 m, respectively, in the first month, and the maximum displacement occurred at the junction of Zone II and Zone III (approximately 18–22 m).

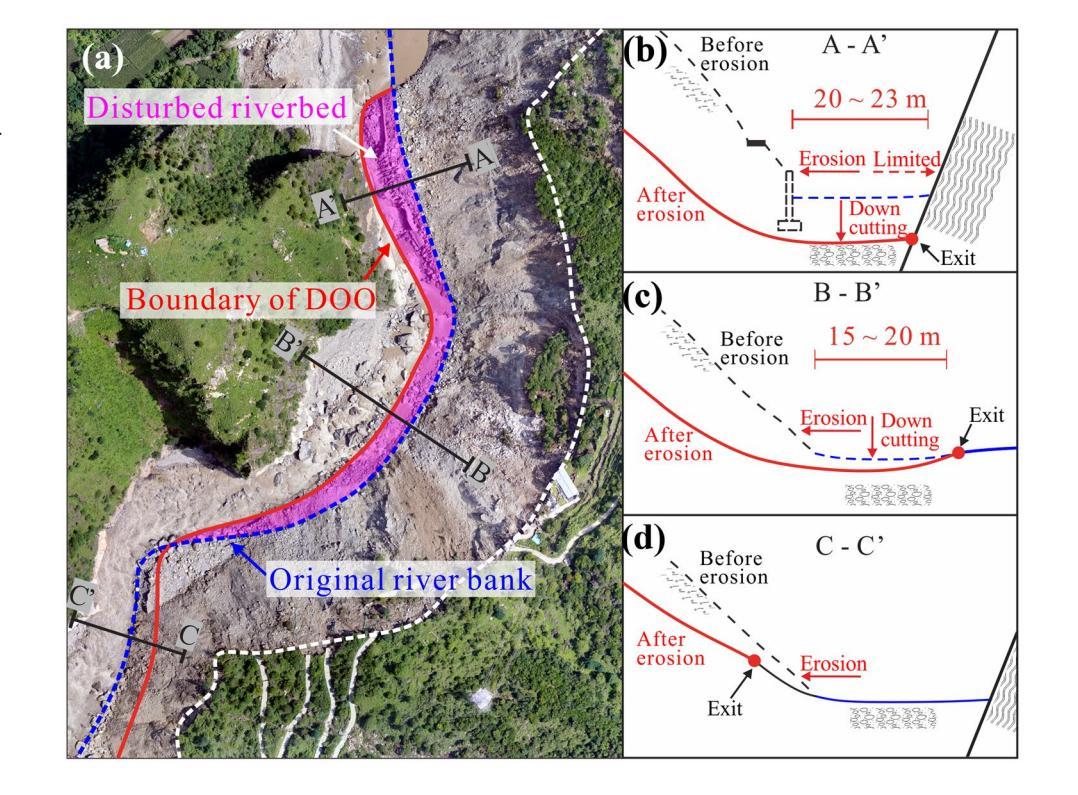
Based on the boundary of the DOO and the original riverbank, we determined the boundary of the disturbed riverbed and the exit of the sliding surface. Then, the horizontal displacement of the riverbed was determined by quantitatively calculating the horizontal displacement of the anti-slide piles and the large boulders in the riverbed (Fig. 17a). From these results, we drew three typical profiles of the disturbed riverbed (Fig. 17b-d). The maximum width of the disturbed riverbed appeared on the upstream side (profile A-A'), and the horizontal displacement of the riverbed was approximately 20-23 m, which was almost equal to the horizontal displacement of the ancient landslide above this area in Fig. 16d (18–22 m in the first month and 3–5 m in the next 2 months). Similarly, the horizontal displacement of profile B-B' was almost the same as that of the upper ancient landslide. It can be determined that this part of the disturbed riverbed deformed synchronously with the ancient landslide, indicating that the exit of the sliding surface of the ancient landslide had penetrated into the river channel. In contrast, the DOO boundary in profile C-C' was on the slope surface of Zone I, and the riverbed in this area was stable.

It can be inferred that the reactivation of the ancient landslide was related to both slope erosion and riverbed undercutting. The undercutting of the riverbed caused deep sliding of the ancient landslide, resulting in synchronous deformation of the riverbed and the ancient landslide, while slope erosion caused shallow sliding of the slope. The main reasons for the different deformation modes of the three profiles include the deposition range of the debris flow dam, the shape of the river channel, and the topographic constraints. Profile C–C' was located downstream of the ancient landslide, which was far from the debris flow dam, so the erosion effect of the dam break flood was the weakest. Compared with profile B-B', profile A-A'

Fig. 17 Analysis of the landslide boundary: (a) determination of the range of the disturbed riverbed based on the DOO; (b)–(d) typical profiles of the riverbed Fig. 18 Schematic diagram of the mechanism of continuous disasters: landslide-dammed lake disasters (blue lines), landslide-debris flow-dammed lake disasters (red lines) and the 6.17 Danba disasters (purple lines)

was closer to the debris flow dam. Moreover, the narrow channel and hard bedrock on the opposite bank limited the expansion of the spillway during the outburst flood, leading to increased vertical erosion and more severe disturbance of the riverbed. Therefore, the riverbed disturbance in profile A-A' was larger, which was reflected in the larger horizontal displacement in this section.
