Damage Characteristics of CFRP Laminates Subjected to Multiple Lightning Current Strike

Jinru Sun¹ · Xueling Yao¹

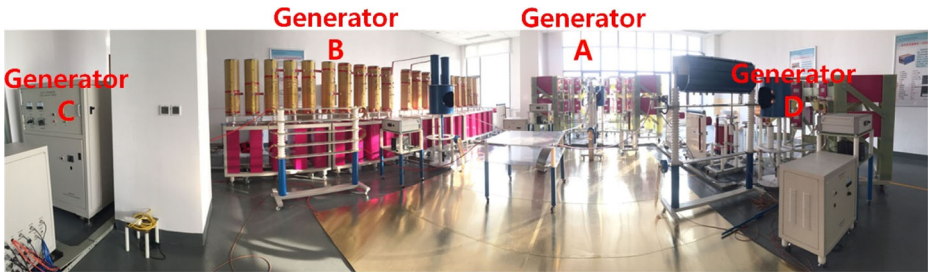
Fig. 3 Lightning direct effect test system

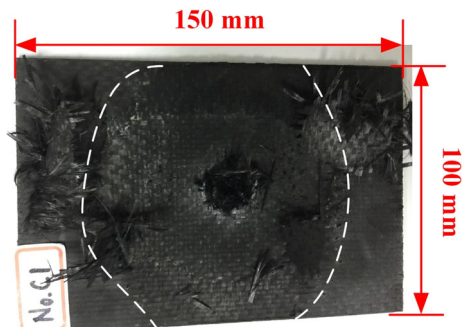
Fig. 4 Lightning damage of a CFRP laminate under the effect of lightning component A with an amplitude of 100 kA

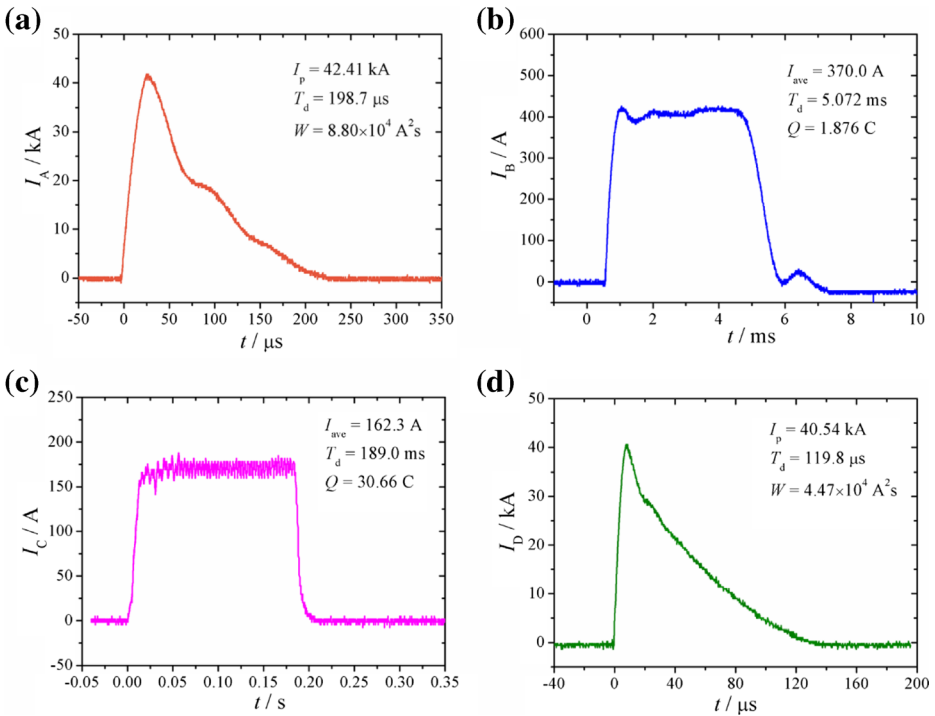
Fig. 5 The waveforms and parameters of the lightning current components: **a** lightning component A, **b** lightning component B, **c** lightning component C, and **d** lightning component D. I_p : amplitude; I_{ave} : average current; T_d : duration; W : electrical action integration; and Q : transfer charge

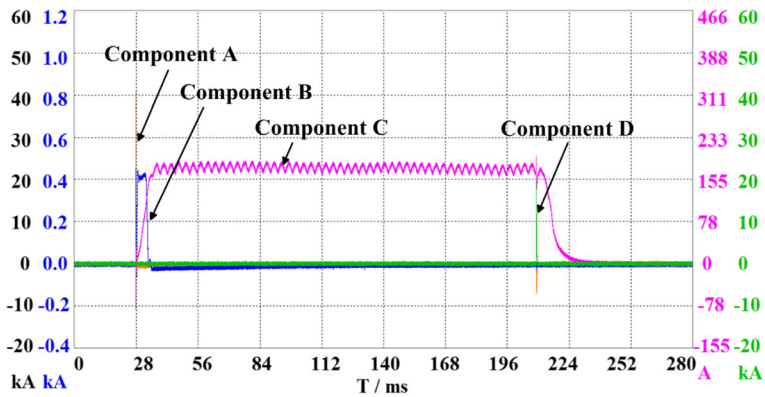
Fig. 6 Continuous test waveform for the “ABCD” test mode

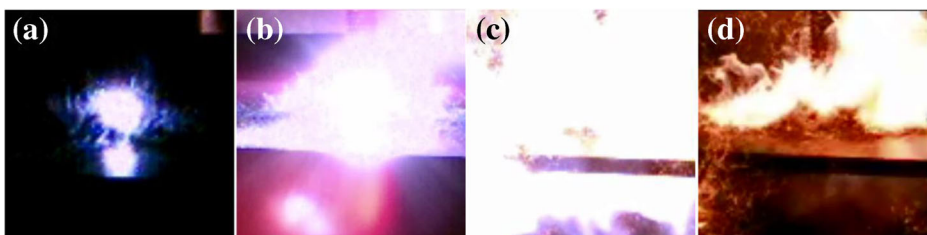
Fig. 7 The discharge process: **a** $t = 4.52 \mu\text{s}$; **b** $t = 9.04 \mu\text{s}$; **c** $t = 363.2 \mu\text{s}$; **d** $t = 726.4 \mu\text{s}$

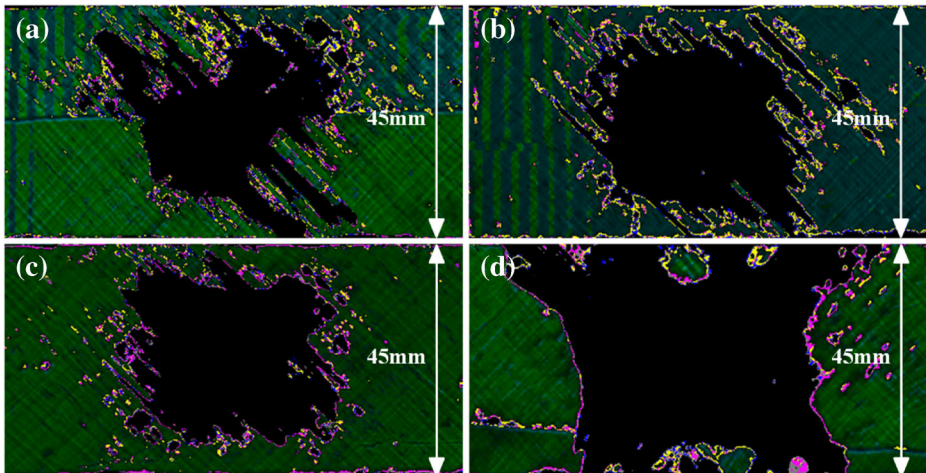
Fig. 12 Ultrasonic T-scan images of the lightning damage areas in CFRP samples: **a** S1, **b** S2, **c** S3, and **d** S5

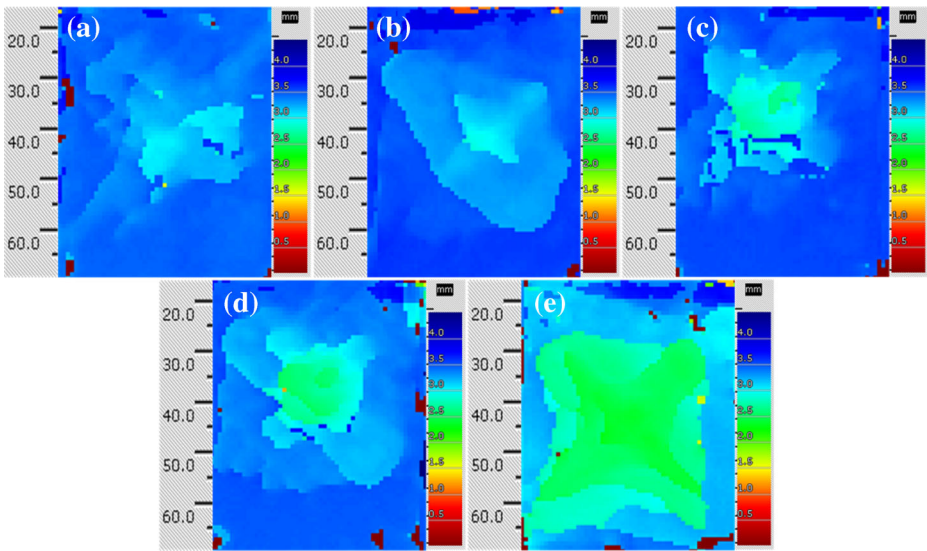
Fig. 13 Ultrasonic C-scan images of the lightning damage depth in the CFRP samples: **a** S1, **b** S2, **c** S3, **d** S4, and **e** S5 (The colors represent the thickness of the test CFRP laminate)

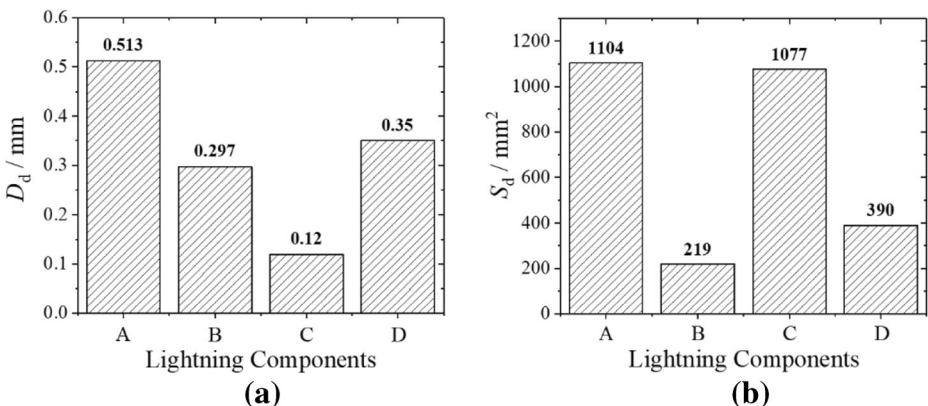
Fig. 14 The contributions of individual lightning current components to the **a** damage depth (D_d) and **b** damage area (S_d)

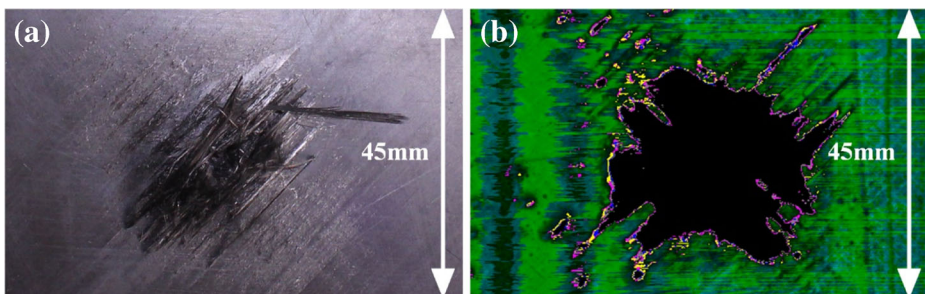
Fig. 15 The lightning damage of the CFRP laminate under lightning component D: **a** visual inspection, **b** ultrasonic scan
