## FAILURE OF MAGNESIUM SHEETS UNDER MONOTONIC LOADING: 3D EXAMINATION OF FRACTURE MODE AND MECHANISMS

**Abstract.** Damage evolution in a commercial magnesium sheet alloy (Mg-3Al-1Zn-0.3Mn) at room temperature is investigated. Kahn tear tests were performed to characterize the crack extension behaviour. Scanning electron microscopy of the fracture surfaces revealed flat inclined areas and the absence of cracked particles and dimples. Post-mortem synchrotron tomography of a stopped crack was used to further identify the predominant damage mechanism in the specimen's ligament. Nucleation of submicrometre-voids, a micro-void sheeting mechanism and the absence of classical void growth could be identified.

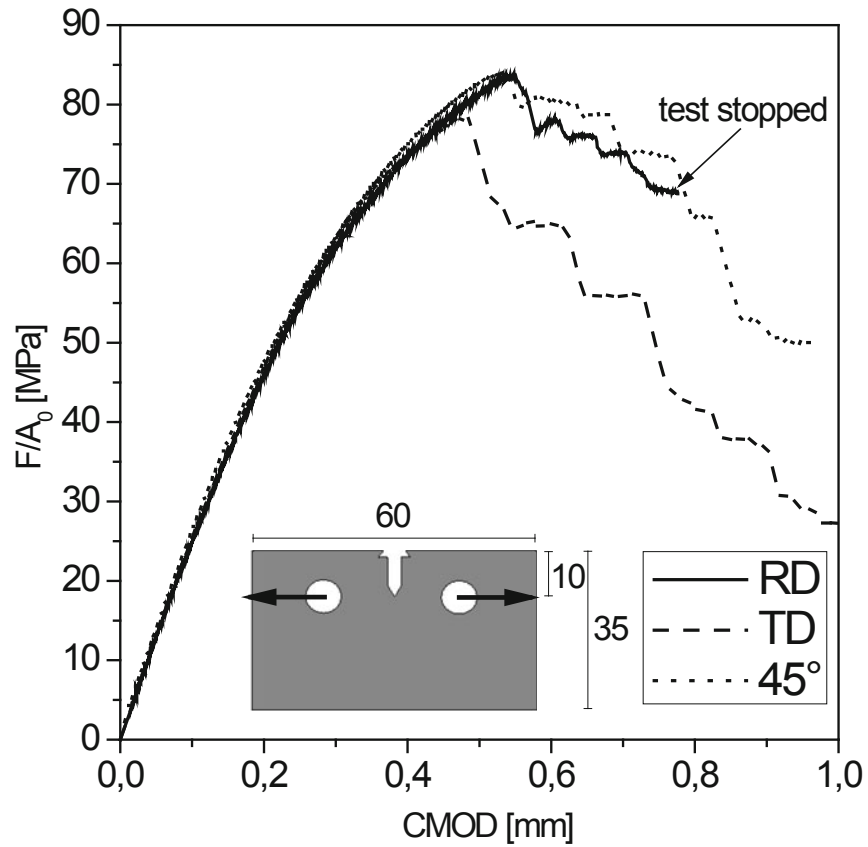
Figure 2: Normalised force-CMOD behaviour of the tested samples. Specimen loaded in RD-orientation was further investigated. Measures in mm.

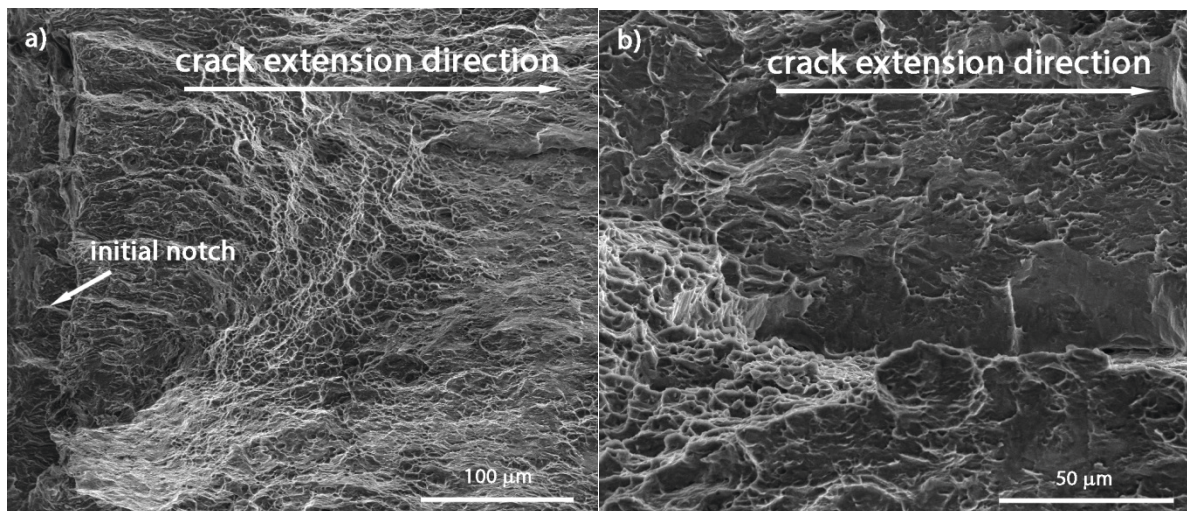
macroscopically rough fracture surface. Microscopically, two main features can be observed: A very small amount of ductile crack extension in a dimple-dominated triangle region ahead of the initial crack tip (Figure 3a), and the remaining large region showing flat surfaces (Figure 3b) of a size similar to the grain size. While the triangular section is oriented perpendicular to the main loading direction, the major part of the fracture surface is irregularly tilted by  $45^\circ$  against the sheet's normal direction. As dimples are hardly visible on that part of the fracture surface, it seems that failure is not based on void growth and coalescence here. Thus it is not a typical ductile failure mechanism. The fracture surface bears similar features like the one described recently (Liang et al. 2013), where “quasicleavage fracture characteristics” are reported for a extruded Mg-alloy of similar chemical composition.

Figure 3: SEM micrographs showing the fracture surface ahead of the initial notch tip with small dimples (a) and in the flat-to-slant transition region showing flat surfaces with micro-dimples (b).

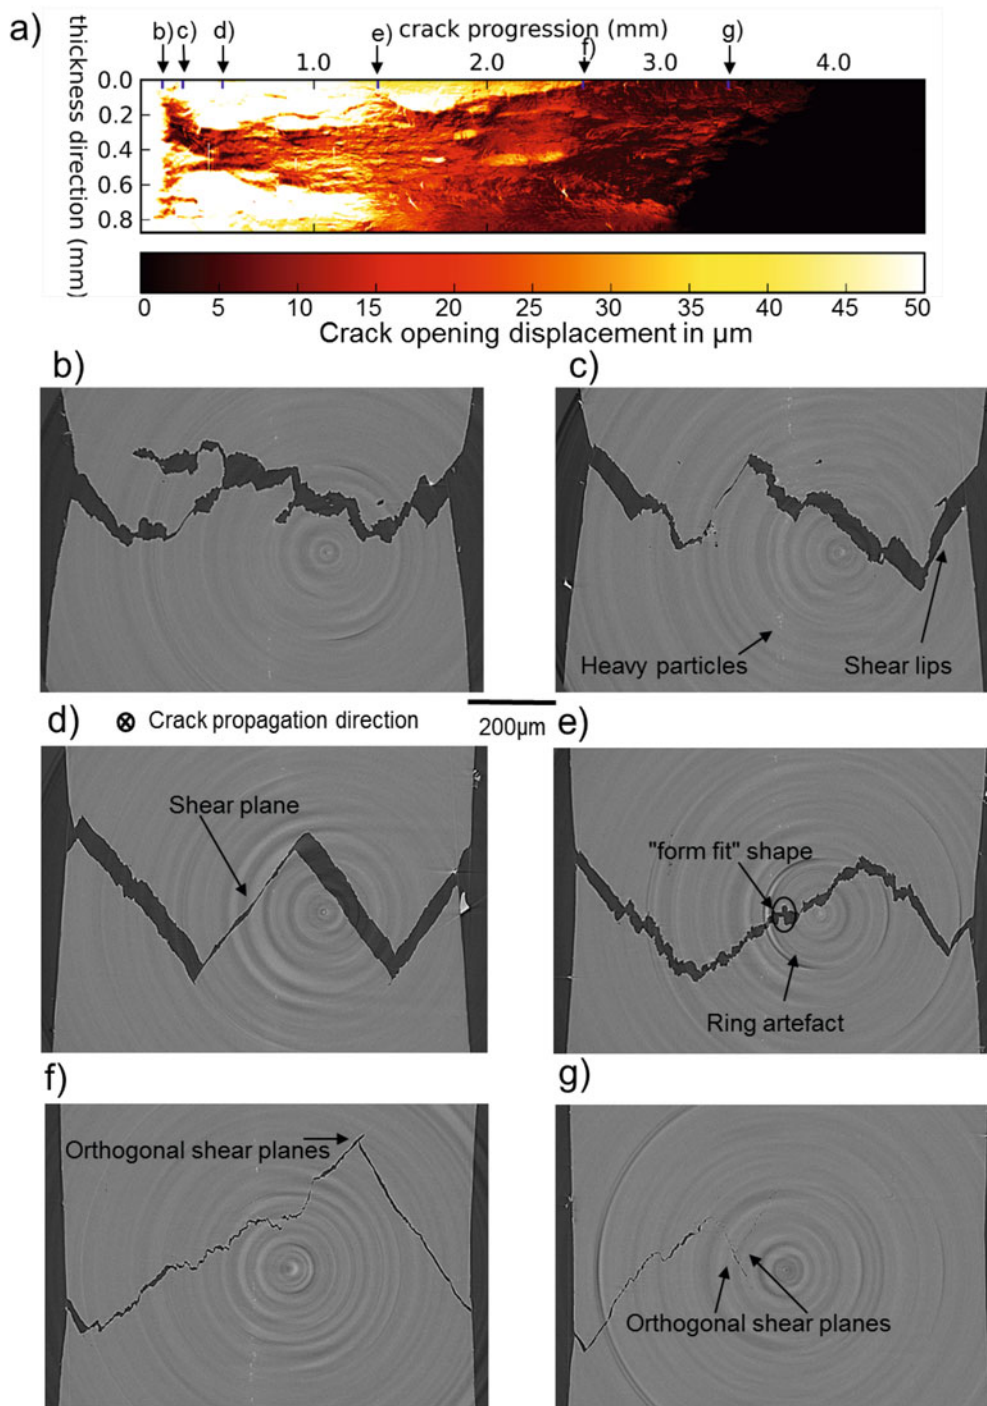
Figure 4 shows tomography data of the stopped crack in terms of local crack opening displacement (COD) (Figure 4a) and in terms of 2D sections normal to the crack propagation direction at different distances from the notch root (Figure 4b-g). Figure 4a gives an overview over the crack from the notch root to the crack tip. The locations where the 2D sections were taken are indicated. It can be seen that the crack tip is neither straight nor tunnelling but inclined with respect to the specimen surface. The bright regions in the local CTOD map represent the regions near the surface where shear lips separate from each other due to non-symmetric (mode III) opening of the crack. In the middle of the crack at 1 mm from the notch root some uneven local crack tip opening can be seen that is a hint for the surface roughness in this area.

Figure 4b shows a 2D section at the notch root. The curved sides of the specimen result from necking of the ligament. Some opened crack regions can be seen as well as narrow regions and crack bifurcation. However, in contrast to other engineering alloys such as aluminium alloys, no second phase particles are discernible in this AZ31 alloy that could act as void nucleation sites. Around the crack hardly any micrometric voids are visible. Figure 4c shows a region 0.1 mm away from the notch root. Again only very few voids can be seen around the crack (black spots). This is astonishing as the stress triaxiality is expected to be at a maximum in the crack initiation region and a high triaxiality is known to trigger void growth (Bron and Besson 2006). The opened regions of the crack seem to be less caused by void growth but by the crack surface opening, because the opposite surfaces would still fit together. Some white features can be seen at the mid-thickness: Heavy particles, which are however not cracked. Figure 4d is taken at  $\sim 0.4$  mm from the notch root. No voids are seen around the crack that has a zig-zag shape and a very smooth fracture surface. Again, the damage process does not seem to be consistent with a classical ductile damage process that includes pre-existing voids or void nucleation at brittle particles, their subsequent growth

and coalescence. Despite the expected high levels of stress triaxiality no micrometric voids are seen here either. The damage process consists of strain localisation in very narrow inclined bands followed by sudden failure at sub-micrometre scale. Figure 4e shows the crack at 1.5 mm from the notch root. Near the surface smooth areas corresponding to shear lips are present whereas the centre of the crack is rough. There still seems to be little void growth but the rough surface points to a different fracture mechanism compared to the shear lips. Possibly the increased level of stress triaxiality in the centre of the specimen favours a failure of grain boundaries but supplementary experimental assessments would be necessary to confirm this point. Figure 4f and g represent cross-sections at 2.5 mm and 3.5 mm from the notch root, respectively. Again the competition between smooth shear lip failure and rough surface failure can be inspected. In addition, the “overshoot” of two orthogonal damage planes can be seen in the two images. This seems to indicate that orthogonal strain bands are active during tearing that lead to cracking of the material. In Figure 4g (corresponds to the stopped crack tip) there are hardly any voids ahead of the crack visible. The crack extension mechanism seems to be governed by simultaneous nucleation and coalescence of sub-micrometre voids in the strain bands (see also fractography in Figure 3). Void growth cannot be observed.

Figure 4: Tomography data of the stopped crack in terms of local crack tip opening displacement (CTOD) (a) and in terms of 2D sections normal to the crack propagation direction at different distances from the notch root (b)-(g).
