Evaluating the Reliability of Glass-Braid-Reinforced Polymer Composite Coil Spring for Automotive Suspension Development Using Finite Element Method and Empirical Tests

Jaeki Kwon¹ · Jungil Jeon² · Jungkyu Shin²

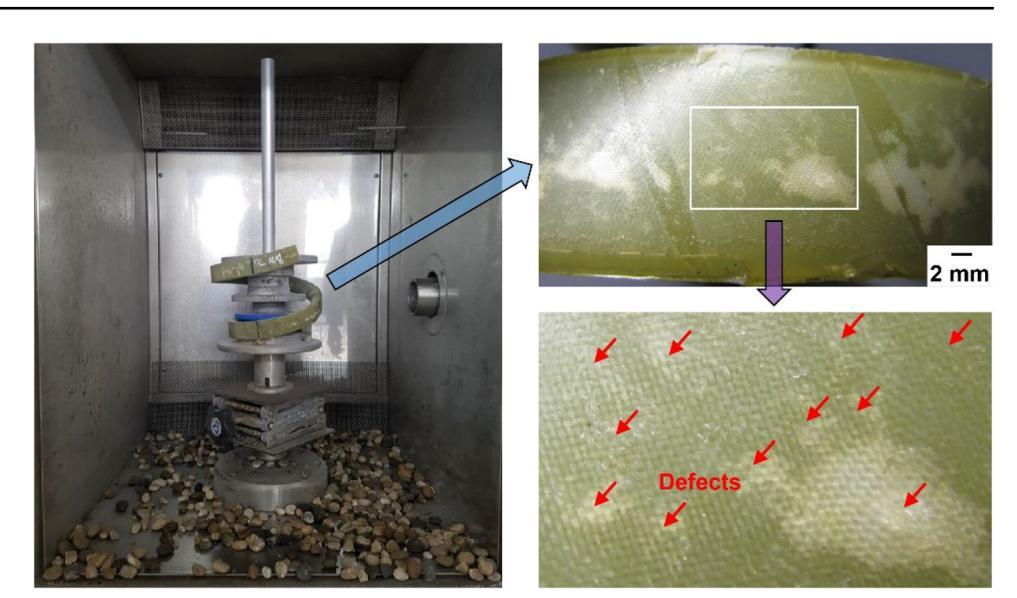
Figure 11 displays photographs of the damaged surface areas and the sample post-chipping test. When gravel was dialyzed, the material failed to absorb the impact energy, leading to surface flaws. Previous reports suggest that the structural properties of braid-reinforced composites rapidly deteriorate when damage occurs due to an object's impact [45, 46]. Nevertheless, the load–displacement curves obtained using the samples before and after the chipping test demonstrated the same trend (Fig. 10c).

Fig. 11 Photographs of damaged parts on the surface of the GBRP composite coil spring after chipping test

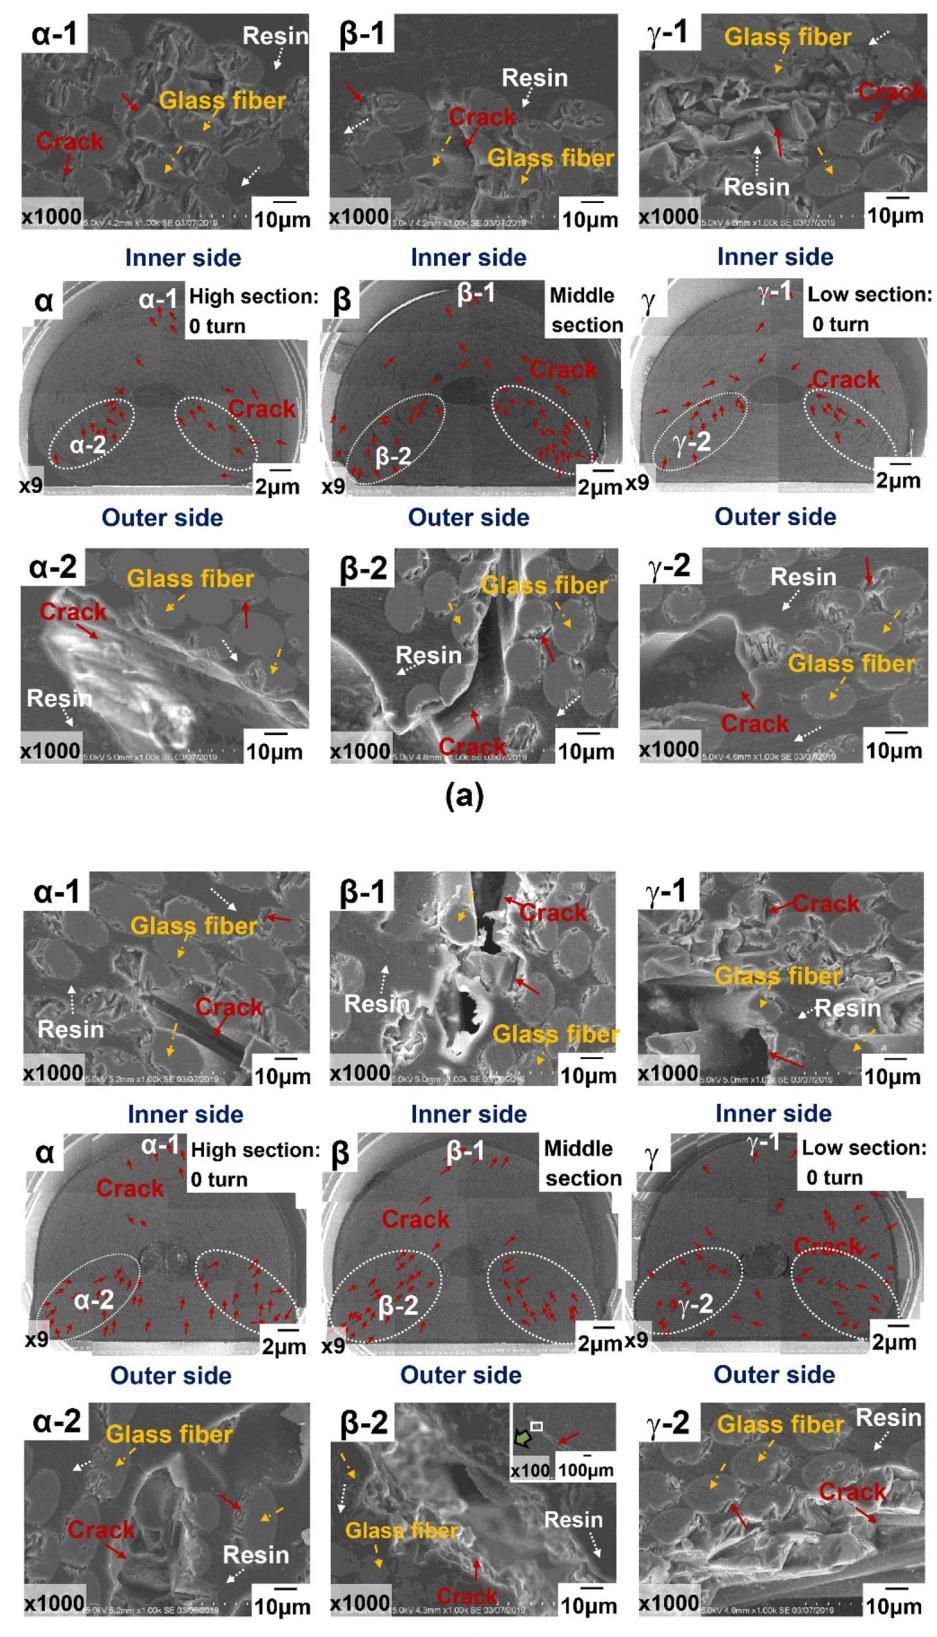
the durability and plastic deformation tests was evaluated using SEM. The results are shown in Fig. 12. Figure 12a shows low- and high-magnification SEM images of the cross-sectional samples taken from the half-coil, two-coil, and four-coil portions of the spring after the durability test. The arrows in images (α) to (γ) indicate areas where cracks were confirmed at low magnification. Examining the spring's interior, where the stress was concentrated during the test, revealed failure modes such as cracks at the interface between the fibers and resin, fiber failure, and matrix failure. The phenomenon of stress concentration inside the spring upon application of a compressive load was confirmed using FEM. However, SEM observation of the cross-sectional samples revealed that the cracks were more densely distributed from the core to the edge compared to the inner part of the spring. The corner corresponds to the spring's outer part, and during manufacturing, the preform is pressed; thus, the glass fibers are densely packed. Consequently, the resistance to crack initiation and propagation was reduced because the area occupied by the matrix was significantly smaller than that of the other areas.

Figure 12b shows SEM images of cross-sectional samples taken from the upper zero turn and the middle and lower zero turns of the spring after the plastic deformation test. The behavior of crack initiation and the distribution of cracks in the inner part exhibited similar trends to those observed in the samples after the durability test. However, the damage tended to be more widespread. Delamination occurs when the load on the composite plies surpasses the interlaminar fracture toughness of the composite, leading to layer separation, interlaminar cracks, and discontinuities in the material [47]. In areas of high deformation, failure modes such as delamination failure were also observed.

Glass fiber, a reinforcing material, has a coefficient of thermal expansion close to zero [48]. However, resins may undergo strength degradation even at 60 °C [49]. Furthermore, the temperature and deformation conditions applied during the plastic deformation test accelerated crack initiation and propagation in the GBRP composite. The change in free height observed before and after both the durability and plastic deformation tests aligned with the results of the damage analysis using SEM. This explains the significantly large change in free height after the plastic deformation test compared to that after the durability test. Assuming uniform geometry and effective dispersion of glass fibers within the epoxy matrix, the prevalent form of fatigue anticipated during the operational lifespan of braided glass/epoxy composites is likely to commence with crack initiation at the fiber-resin interface, subsequently leading to interlaminar delamination. This constitutes the primary failure mechanism in fiber-reinforced composites. Prior research has involved the fabrication of GBRP composite coil springs and bars, featuring varying fiber orientations, thicknesses, and weaving techniques. These specimens underwent damage analysis via static testing methodologies and SEM [27-30]. Although the extent of damage varied among the specimens, the modes of damage exhibited considerable consistency [27-30]. In this study, a similar pattern was noted during the assessment of damage for samples subjected to durability and plastic deformation tests.

Fig. 12 Photographs of crack initiation, propagation, and distribution observed in the cross-sectional specimens taken from the upper 0, middle, and lower 0 turns of the GBRP composite coil springs after the **a** durability and **b** plastic deformation tests

To enhance the crack resistance of the composite spring, it is recommended to design it with a round shape and large radius corners where the density of the glass fiber increases excessively. Since delamination failure can directly influence the reduction of strength and safety of the composite, it is suggested that the glass fiber layer be manufactured with less stacking than currently applied. This can improve the adhesion of the glass fiber by increasing the distribution area of the resin.

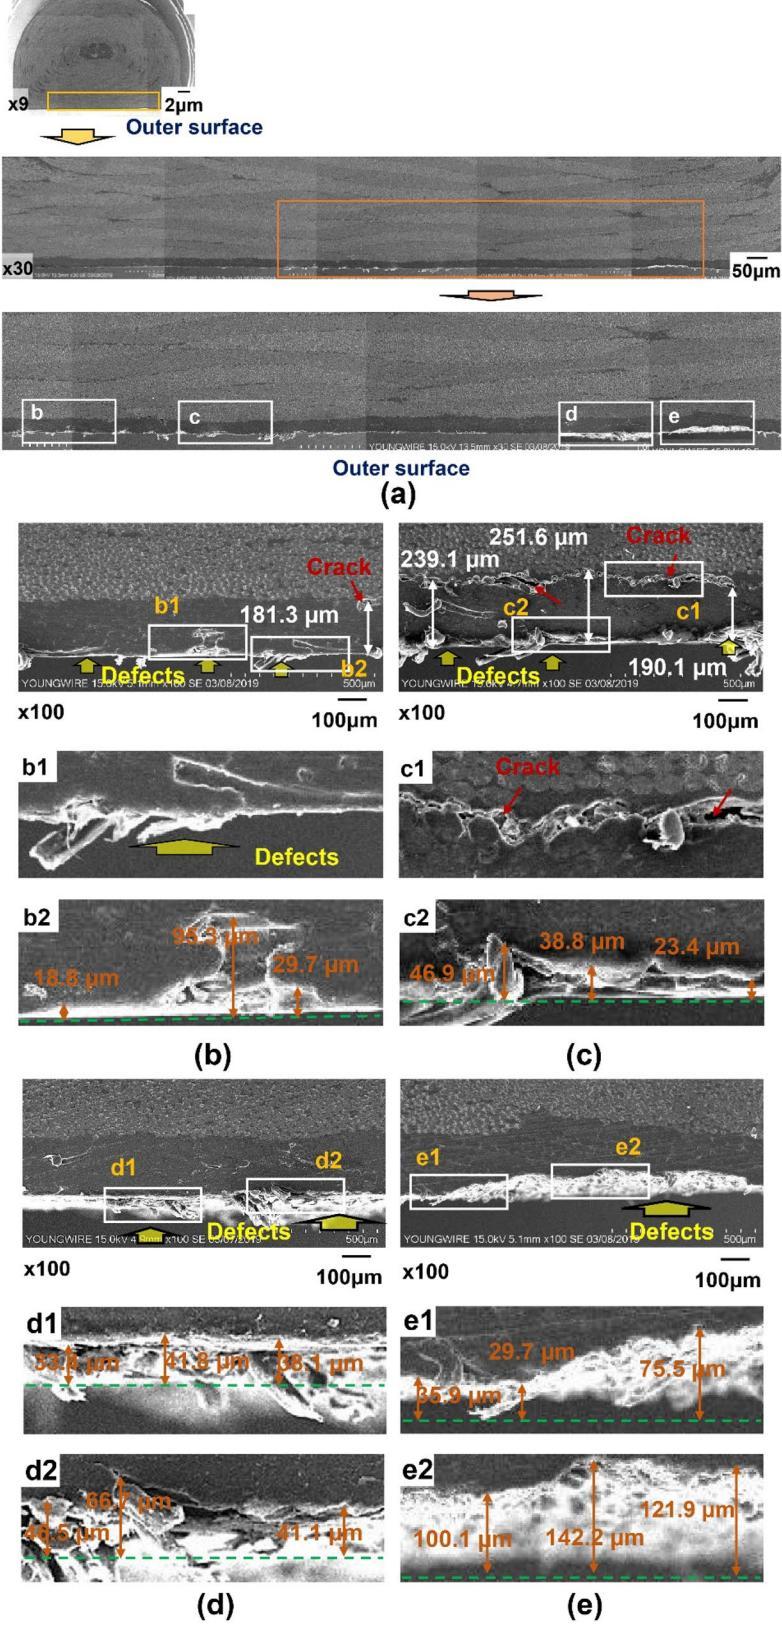
SEM was utilized to inspect the damaged portion of the cross-sectional sample after the chipping test. This was done to analyze the depth and failure pattern of the defects observed on the sample surface, and the results are depicted in Fig. 13. Damage was observed only on certain parts of the uppermost surface layer of the spring, where fiber breakage and resin peeling occurred. The damage extended to depths of approximately 18-142 µm, and the cracks that developed in the transverse direction were approximately 181-252 µm below the surface of the damaged part. Kang et al. studied the impact resistance of filament-winding composites and reported that the fibers tended to break even at a certain distance from the impact point [50]. When impact damage occurs, local vibrations and load reduction transpire [51], and these physical phenomena may affect the sample's surface and adjacent areas. Furthermore, matrix damage, which is the initial form of composite material damage comprised

of laminated structures, does not immediately lead to a final fracture. Instead, it reduces the structure's stiffness and causes separation between layers [52–54]. However, according to the load–displacement curve, the damage at a depth of approximately 250 μ m caused by the impact applied to the sample surface during the chipping test had a negligible effect on the static properties of the structure.

Fig. 13 Photographs of b-e damaged area and depth below **a** the outer surface of the GBRP composite cross-sectional specimen after the chipping test
