Mechanism of mine water inrush from overlying porous aquifer in Quaternary: a case study in Xinhe Coal Mine of Shandong Province, China

Huiyong Yin¹ · Han Zhao¹ · Daolei Xie¹ · Shizhen Sang¹ · Yongli Shi¹ · Maohu Tian²

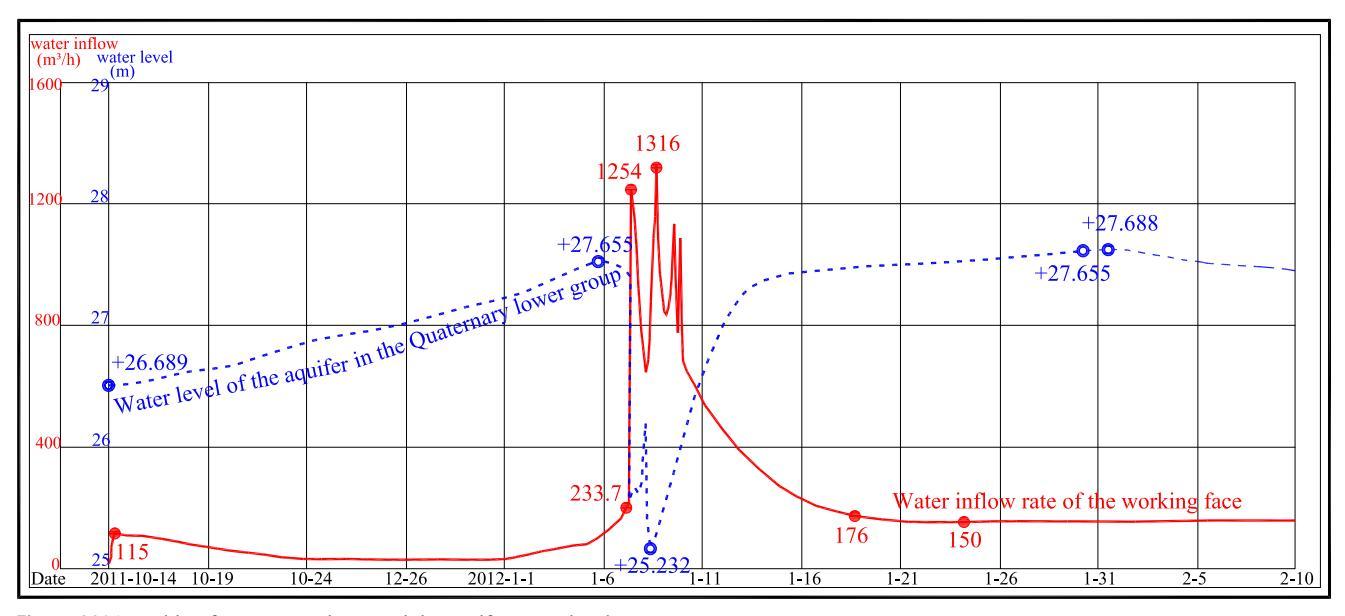
Fig. 4 3301 working face water volume and the aquifer water level curve

However, the water level of the lower group aquifer in the Quaternary deposits corresponded to the change of water inrush quantity, which indicates that the water inrush source is closely related to the calcareous layer and gravel layer at the lower group aquifer in the Quaternary deposits, as shown in Fig. 4.

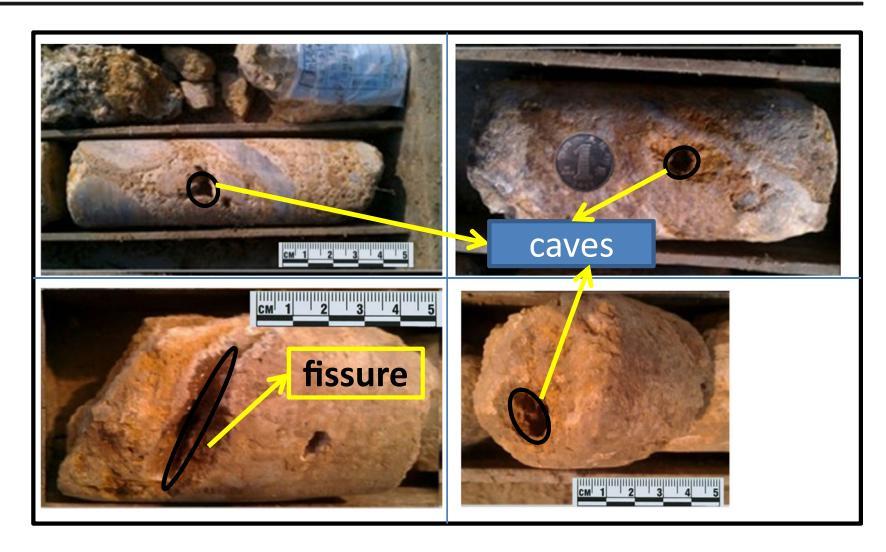
Based on the borehole data, the Quaternary formation is 240.3 m thick with 15.9 m conglomerate at the bottom. The core samples show cavities ranging from 10 to 40 mm in size and fracture length in 10 to 40 mm, as shown in Fig. 5.

Fig. 5 Distribution of caves and fissures of aquifers in the Quaternary

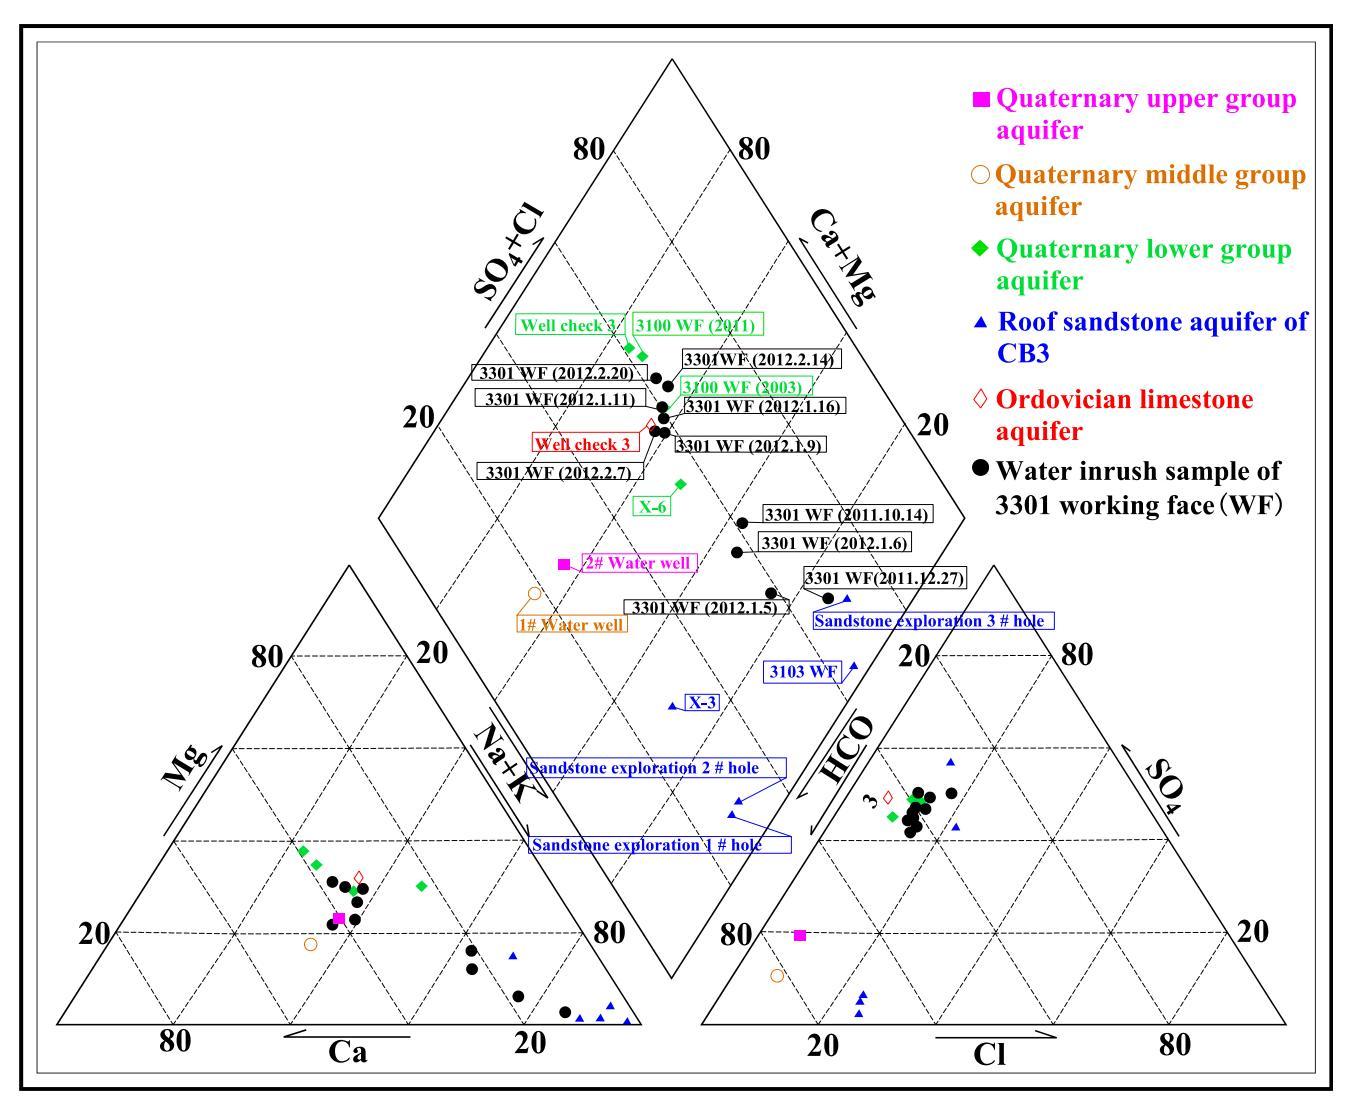
Fig. 6 Water chemistry Piper diagram

In addition to the water level data, the water quality test data provided another piece of evidence to identify the source of mine water inrush (Wu et al. 2017b; Xu et al. 2018). The mine water quality data suggests that the mine water inrush source was the sandstone aquifer on the CB3 roof before January 6, 2012. On January 7, after the sudden increase in water volume in the working face, the water quality was similar to the lower group calcareous layer of the Quaternary formation. As shown in the water chemistry Piper diagram of Fig. 6, the Ca²⁺ concentration is relatively high, while the previous water sample data shows that the Ca²⁺ concentration is relatively low. All the test data indicate that the source of mine water inrush originated from the lower group calcareous layer of the Quaternary formation.

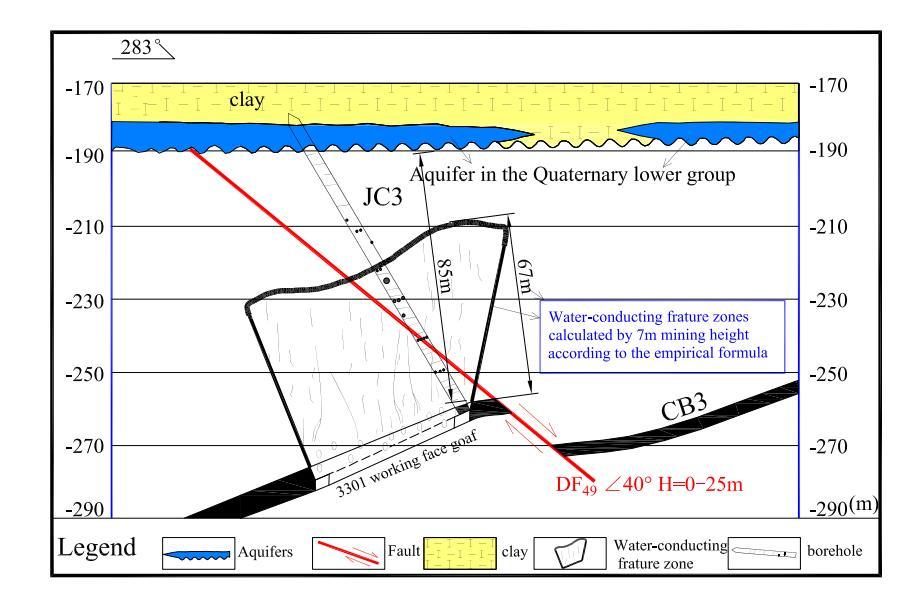
In the process of mining the low-angle fault footwall, the roof of the mined-out area subsided by gravity. Hindering the roof sinking is mainly the fault plane between the hanging wall and footwall cementation cohesion. Smaller angles indicate greater fault cohesion to withstand the gravity and the degree of fracture of the fault plane under certain conditions. And smaller angles are more susceptible to activation of the fault. In response to mining at the 3301 working face, the immediate overlying rock caved and fractures above the caving zone extended to the fault location, leading to fault stress state changes, The fault plane and the surrounding fissure expanded, and plastic damage occurred in the fault plane and the upper part of the contact with the Quaternary area, resulting in greatly enhanced permeability in the fault and plastic damage zone. The permeable zone could be an important pathway for the conductive Quaternary base aquifer. On the other hand, the bottom of the Quaternary formation is strong aquifer overlying the fault. Under the condition of waterrock interaction, the seepage is concentrated on the fault plane. When the top seepage area and fault plane and fracture are hydraulically connected, the Quaternary water could flow in the work space along the fault and water-conducting fracture zones, causing the water inrush accident (Fig. 7).

Fig. 7 Sketch of position between fault and water-conducting fracture zone

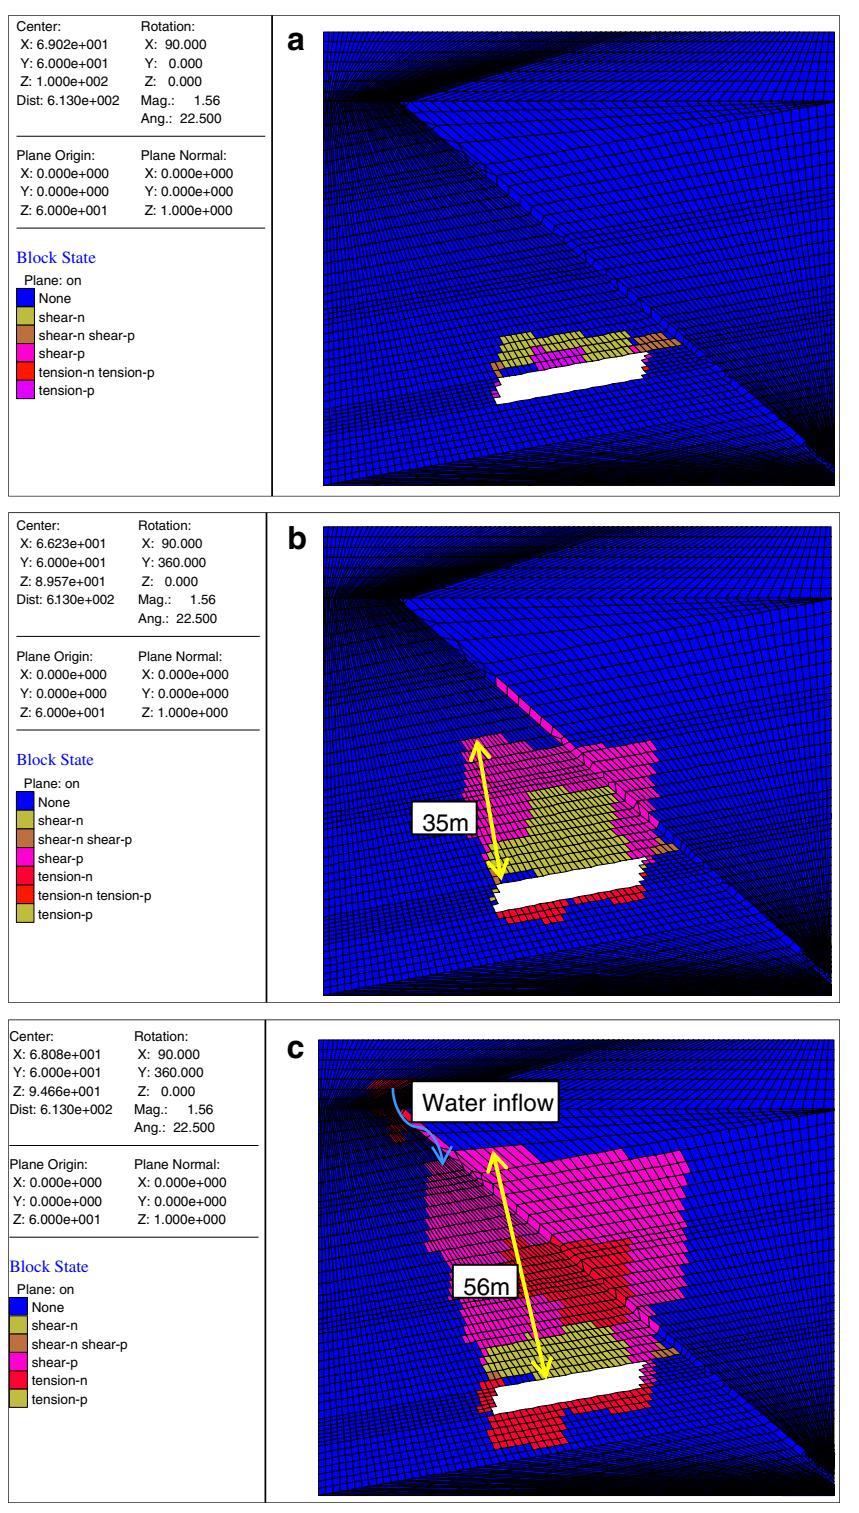
Fig. 8 Plastic failure zone diagram with mining 10 m (A), 20 m (B) and 35 m (C)

The plastic failure zone diagram with mining at 10 m (A), 20 m (B), and 35 m (C) are shown in Fig. 8. A stress arch appeared around the working face; there are stress concentration areas on both sides of the working face, and the stress of the fault increases especially where the fault roof is in contact with the Quaternary formation. Figure 8 (A) shows that the plastic failure occurs in the range of 3 to 7 m on top of the working face, and the failure zone is close to the fault, but the fault has not yet been plasticized; Fig. 8 (B) shows that the destruction of roof and floor intensifies and the scope of roof damage expands. The maximum height of the plastic failure zone appears on the fault plane. In particular, there is a separate plastic failure zone above the plastic failure zone on the roof, indicating that the fault has a partial activation phenomenon. The height of the

plastic damage zone increased to 56 m, as shown in Fig. 8 (C), and the area of the plastic fracture zone of the fault plane is expanded, and the plastic destruction zone appears in the upper part of the fault to the bottom of the Quaternary, which indicates that the upper part of the fault is activated and the local failure zone is connected with the lower aquifers in Quaternary; therefore, the water inrush pathway formed (Zhang et al. 2018b), and large amounts of mine water were released from the calcareous cementation aquifer in Quaternary. Therefore, the mine water inrush source and pathway in the accident were identified which contribute to make fine countermeasures such as grouting the water inrush pathway.
