Engineering geological characterization for evaluation of seepage and geomechanical properties of Chalchal Dam Site, Bale Zone, Southeastern Ethiopia

Tola Garo^{1,2} · Matebie Meten^{1,3}

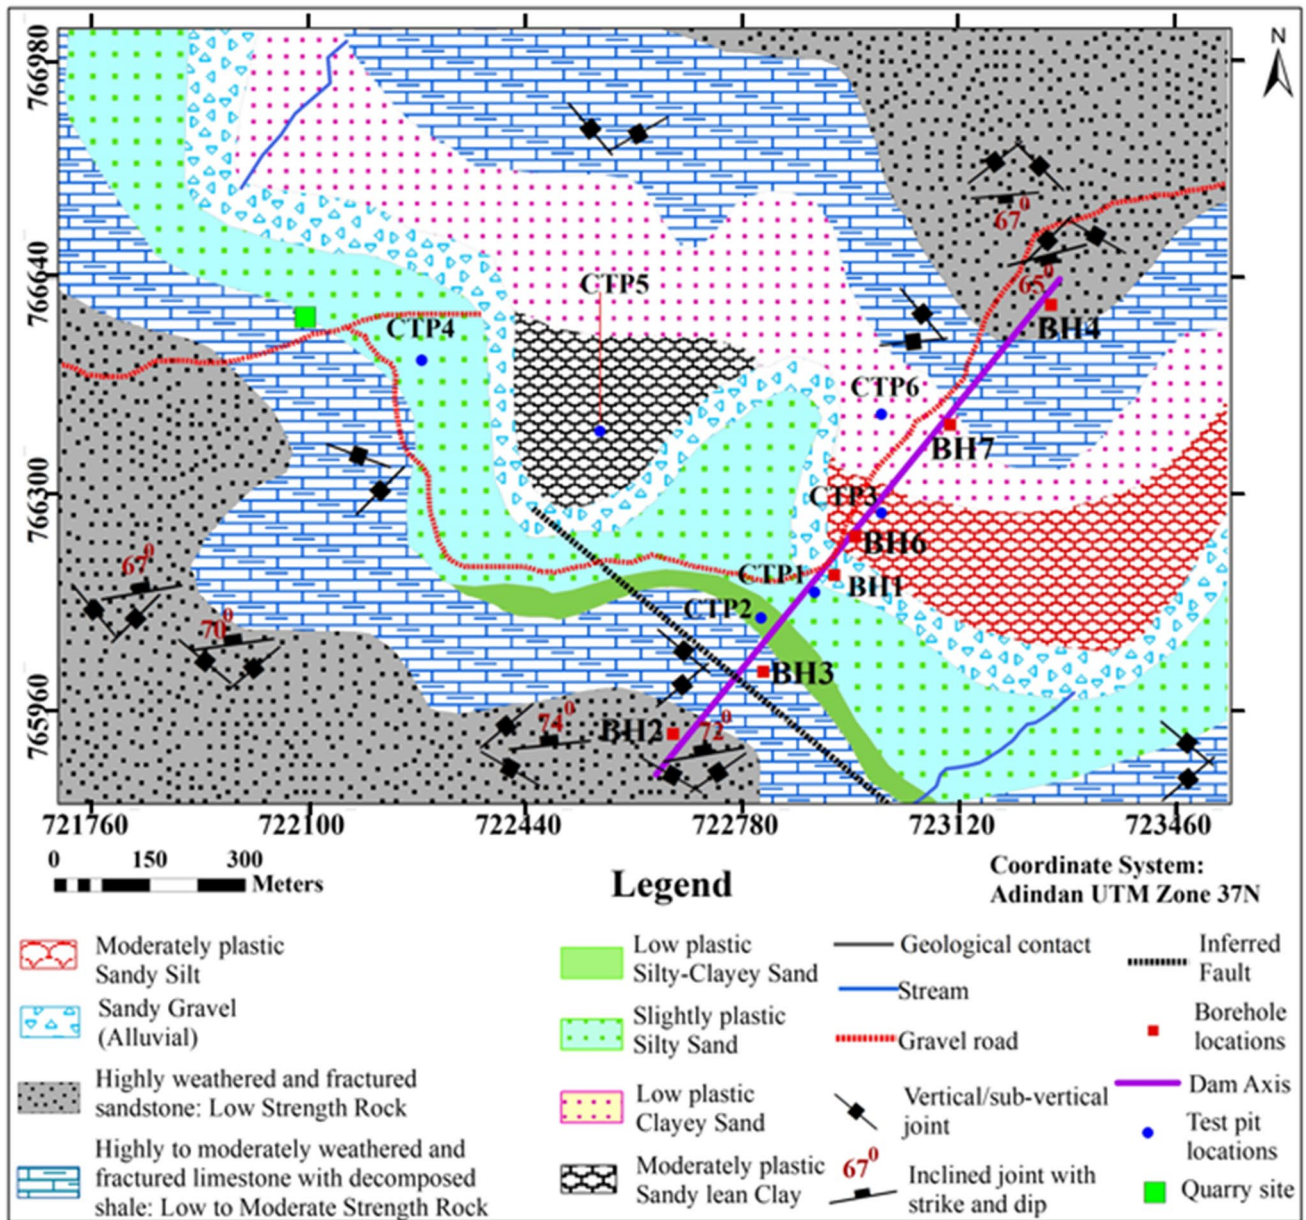
Fig. 2 Engineering geological map of the Chalchal dam site

The major rock units that are outcropped within the dam site are Mesozoic sedimentary rocks such as limestone-shale intercalation, sandstone, and Quaternary alluvial and colluvial deposits (Fig. 2). The limestone-shale intercalation is

horizontally bedded and mainly outcropped along the gently sloping part of the abutments of the dam's upstream and downstream sections. The limestone beds in this intercalation unit are highly to moderately weathered and fractured. The layer of shale within this intercalation is weak, fissile in places, and extremely weathered to totally decompose into a fine soil. Hence, it can introduce groutability problems owing to its decomposition. The sandstone unit overlies the intercalation and is exposed forming cliffs. It is weak, highly friable, and extremely weathered rock which can easily disintegrate into pieces by a single hammer blow. It is also highly fractured with closely to widely spaced, highly persistent, and open to partially filled vertical to steeply dipping systematic and non-systematic joints. Colluvial deposit is found overlying the limestone-shale intercalation in most localities while the alluvial deposits are limited to the center and banks of the river.

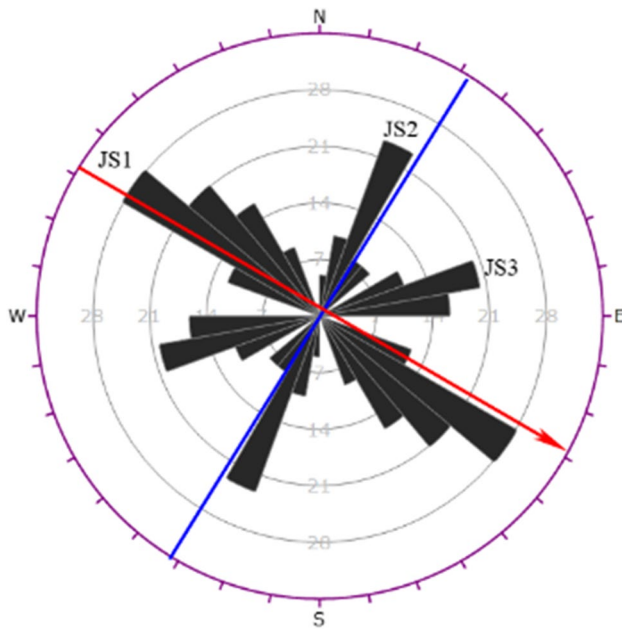
Fig. 3 Rosset diagram of discontinuity strikes plotted by dip.6.0 software (Blue and red lines represent the approximate alignment of the dam axis and river flow direction respectively)

NW–SE (JS1), NE–SW (JS2), and ENE–WSW (J3) were identified (Fig. 3). These joint sets are more or less oriented similar to the regional geological structures. In addition, the bedding plane, J4, is horizontal. As shown in Fig. 3, NW–SE trending JS1 and the river flow direction (which is indicated by the red arrow) are oriented nearly parallel to each other. In the dam site, joints that are parallel the river flow direction favor seepage (Maerz and Zhou 1999; Abay and Meisina 2015). Thus, JS1 has a favorable orientation for seepage in this dam site. In general, discontinuities of this dam site are closely to widely spaced and highly persistent in the exposed surfaces and beyond. The average spacing and aperture range from 0.241 to 0.462 m and from 0.0034 to 0.0132 m, respectively.

different degrees of weathering and fracturing. These rock units are cut by three dominant joint sets namely NW–SE (JS1), NE–SW (JS2), and ENE–WSW (J3) with the former one being parallel to the river flow direction thereby favoring a potential seepage.

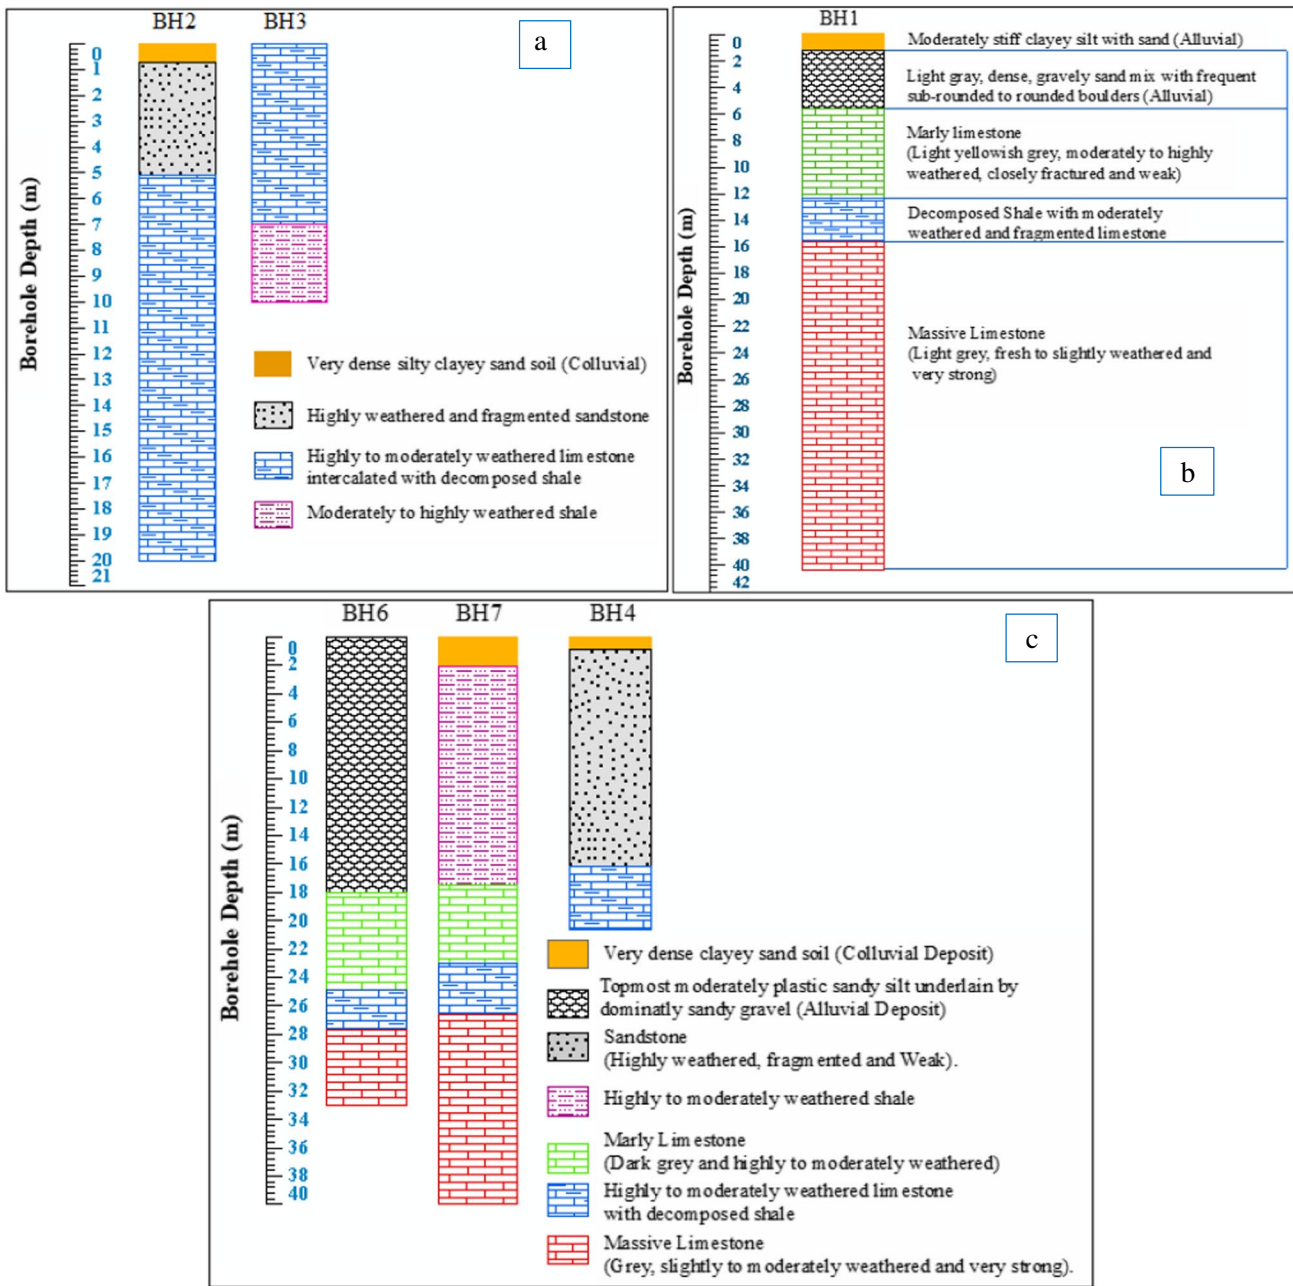
Proper logging of geological formation of the dam site shows a complex sedimentary succession. The studied core samples show variation in the nature of strata, degree of weathering and fracturing, and their overall geotechnical properties. The geology of left and right abutment of the dam is similar and underlain from top to bottom by colluvial deposit and variably fractured and weathered sandstone, limestone with decomposed shale, shale, marly limestone, limestone with decomposed shale, and massive limestone rock units (Figs. 4a, c; 5a; and 6). The geological sequence of the river center is similar to those of the left and right abutment of the dam except that there are alluvial deposits (sand-gravel

mixture and sandy silt) with the thickness of 18 m covering the center and left of bank of the river (Figs. 4b, 5b, and 6).

Fig. 4 Lithological log of the boreholes: **a** BH2 and BH3 at the right abutment, **b** BH1 at river center, and **c** BH4, BH6, and BH7 at the left abutment of the dam

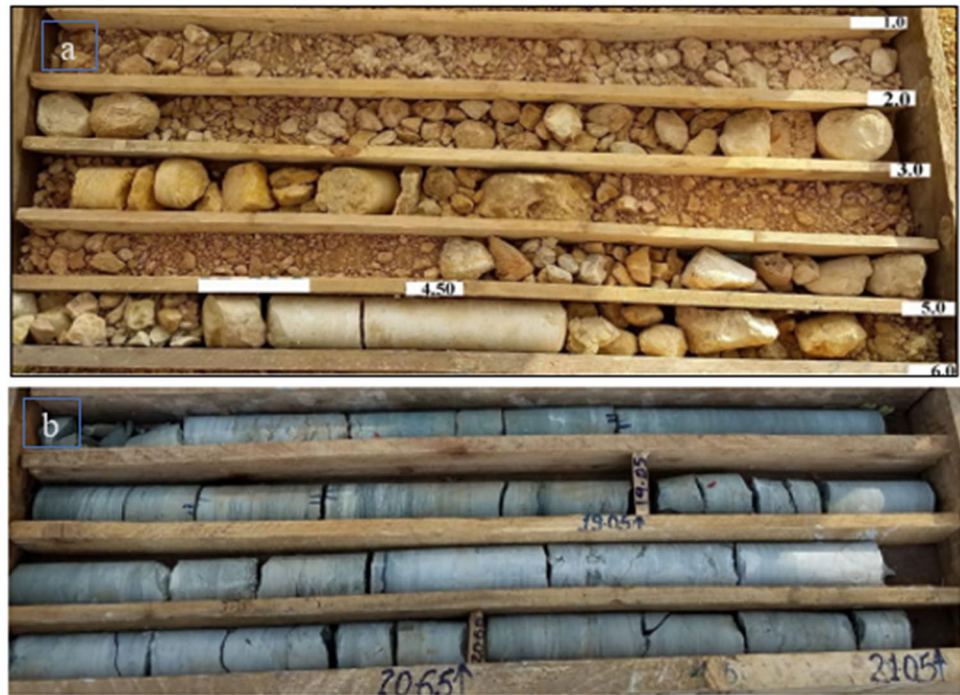
Fig. 5 Selected core samples from Chalchal dam site: **a** sandstone rock unit (BH4, depth interval: 1.00–6.00 m), **b** massive limestone rock unit (BH1, depth interval: 17.85–21.05 m)

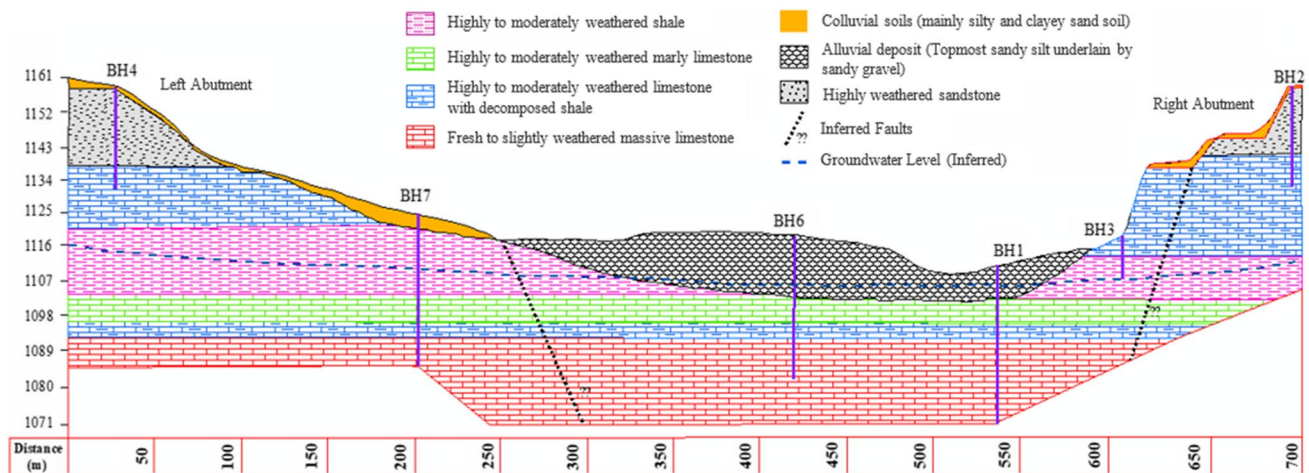
Fig. 6 Engineering geological cross-section from six boreholes along the dam axis (facing downstream)

- Colluvial deposit and 18-m-thick alluvial deposit should be removed from the dam axis before the construction of the dam.
- Curtain grouting to the depth of 20 m for the left abutment and 24 m for the river center is also recommended while a detailed water pressure test is suggested to decide the grouting depth for the right abutment of the dam.
- This study also recommends the application of slurry trench or concrete cutoff to replace curtain grout in the parts of the dam axis where shale unit introduces groutability problem due to its decomposition into a fine soil mass.

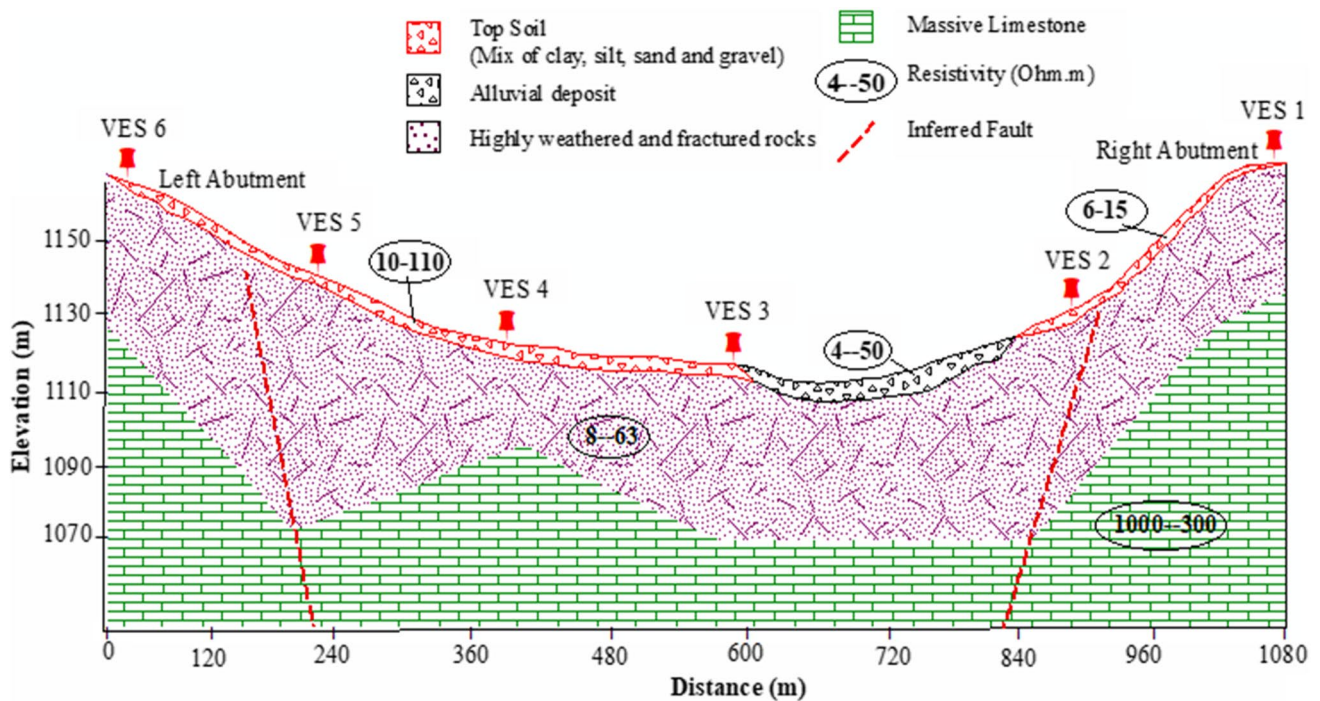
Interpretation of VES data through the construction of geo-electric section also confirmed the presence of a weak zone (fault) at the right abutment of the dam which was inferred during the field geological mapping. Besides, this geo-electric section also depicted the presence of another fault passing through the left abutment of the dam as well (Fig. 7). A fault within the dam site, among many factors, leads to water-tightness, differential settlement, and seismicity problems (Tosun 2011). Therefore, these faults need a very detailed investigation before the dam is constructed.

Fig. 7 Geo-electric section along the dam axis (modified after OWWDSE, 2018)

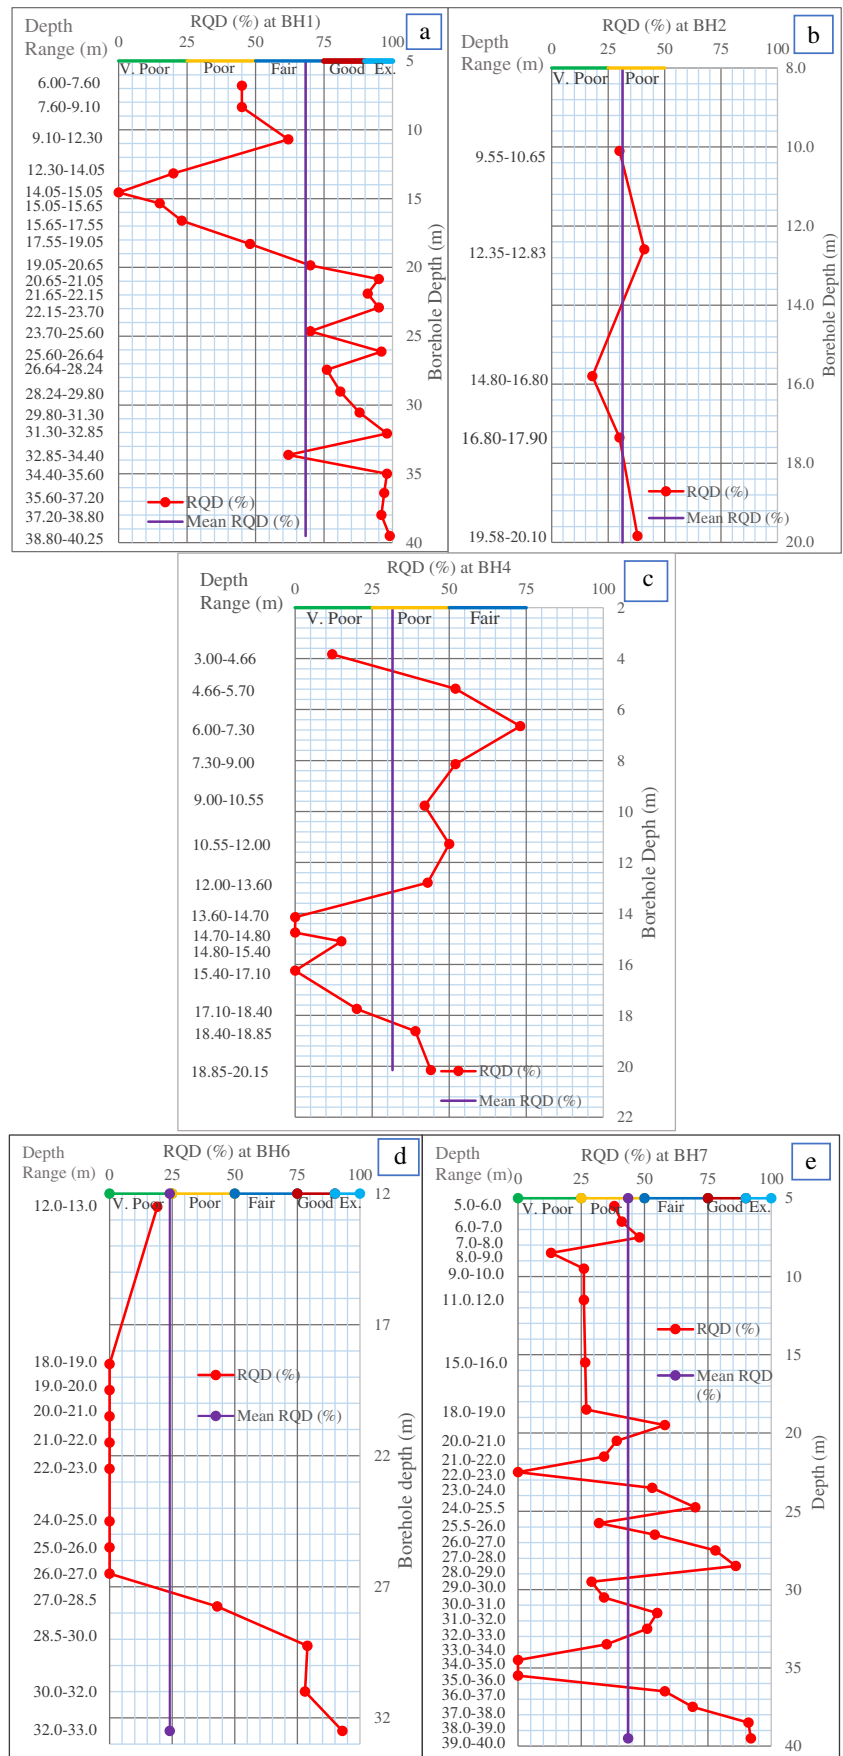
Figure 8 illustrates the plot of RQD with depth for 5 boreholes drilled at the river center, right and left abutments of

the dam. The analysis showed that RQD records were plotted for very poor to fair RQD classes up to the depth intervals of 19.05–20.65 m, 28.5–30.0 m, and 36.0–37.0 m below BH1, BH6, and BH7, respectively (Fig. 8a, d, e). Beyond these depth intervals, almost all RQD values fall in a good to excellent rock mass quality classes in these boreholes. From the geotechnical cross-section shown in Fig. 6, the depths of low RQD correspond to the elevation of 1090.5 m, 1088 m, and 1089 m below BH1, BH6, and BH7, respectively. On the contrary, majority of the calculated RQD records were

plotted in very poor to poor rock mass quality classes for the entire drilled depth for BH4 and BH2 (Fig. 8b, c).

Although depth ranges in the low RQD rocks have been differentiated, the plot of RQD values did not show any clear trend with depth (Fig. 8 a, c, d, and e). This is possibly attributed to changes in rock type and the degrees of fracturing with depth. In such conditions, it is difficult to rely on RQD values for deciding on the groutability of materials and selecting depth sections for permeability tests (Uromeihy and Farrokhi 2011; Berhane and Walraevens 2013). Therefore, for this dam, RQD should be integrated with other techniques such as water pressure for deciding the groutability

Fig. 8 RQD variation with depth **a** at river center, **b** at right abutment, and **c, d, e** at left abutment of the dam

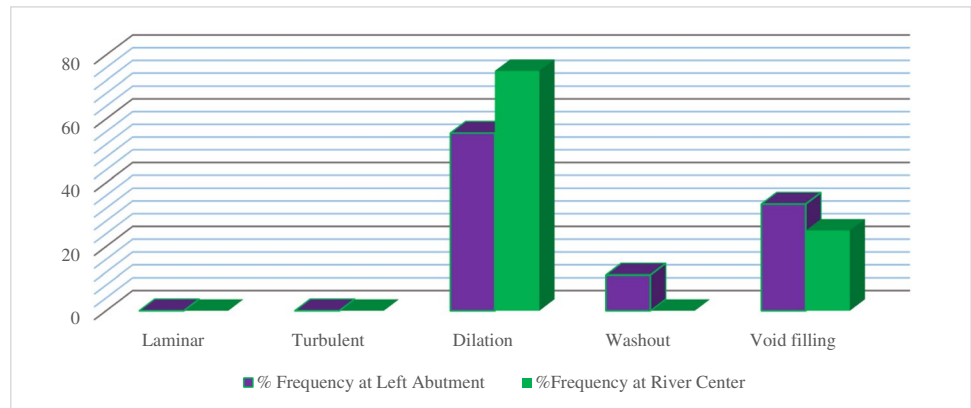
Fig. 9 Percentage distribution of water flow behaviors at the river center and left abutment

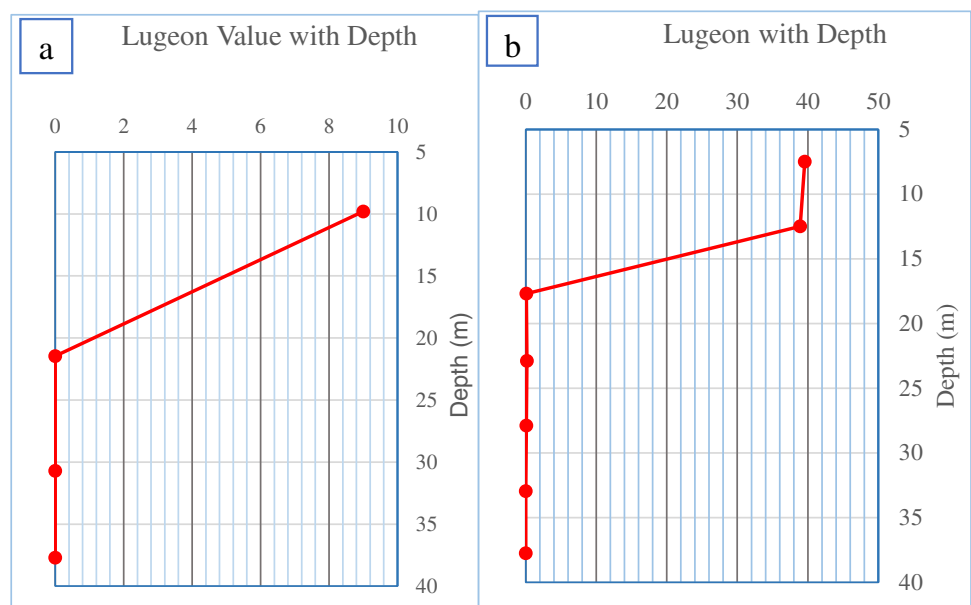
Correlation of Lugeon values with depth was made for the central foundation and left abutment of the dam. Accordingly, the Lugeon value tends to decrease with depth and approaches zero after a certain depth in both locations (Fig. 10). This decrease in Lugeon value may be attributed to an increase in the overburden effect with depth (Lee and Farmer 1993; Nappi et al. 2005). Besides, it may be related

Fig. 10 Variation of Lugeon values with depth for a BH1 and b BH7

to a decrease in the degree of weathering and fracturing with depth.
