Micro-environmental change as a trigger for granite decay in offshore Irish lighthouses: implications for the long-term preservation of operational historic buildings

P. A. Warke · B. J. Smith · E. Lehane

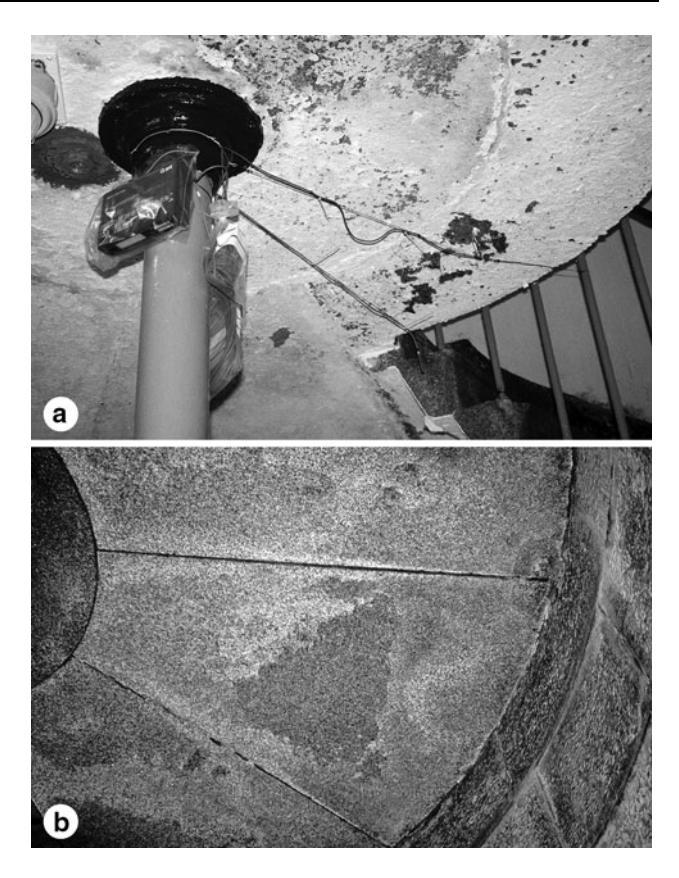
In both Eagle and Eeragh, deterioration of ceiling granite affects approximately the outer 10 mm of stone producing a friable grusified surface. Release of this material primarily through granular disintegration has produced obvious surface retreat, which is especially noticeable close to the lead infilled gaps between separate ceiling slabs (Fig. 5a) and as loose debris on the floor. Debris release comprises a mixture of silt to sand-sized material reflecting the disintegration of mica and feldspar and the release of individual quartz grains. Some material is also released as small scales cemented together by salt (Fig. 5b). These small scales are typically around 5 mm in depth and between 10 and 30 mm in diameter.

Fig. 3 a Ceiling granite in the ground floor level at Eagle Island showing widespread granular disintegration and surface disruption one of the automatic dataloggers, humidity and temperature probes are also shown in situ; b ceiling granite in the ground floor level at Eeragh showing evident surface disruption and loss of material primarily through granular disintegration

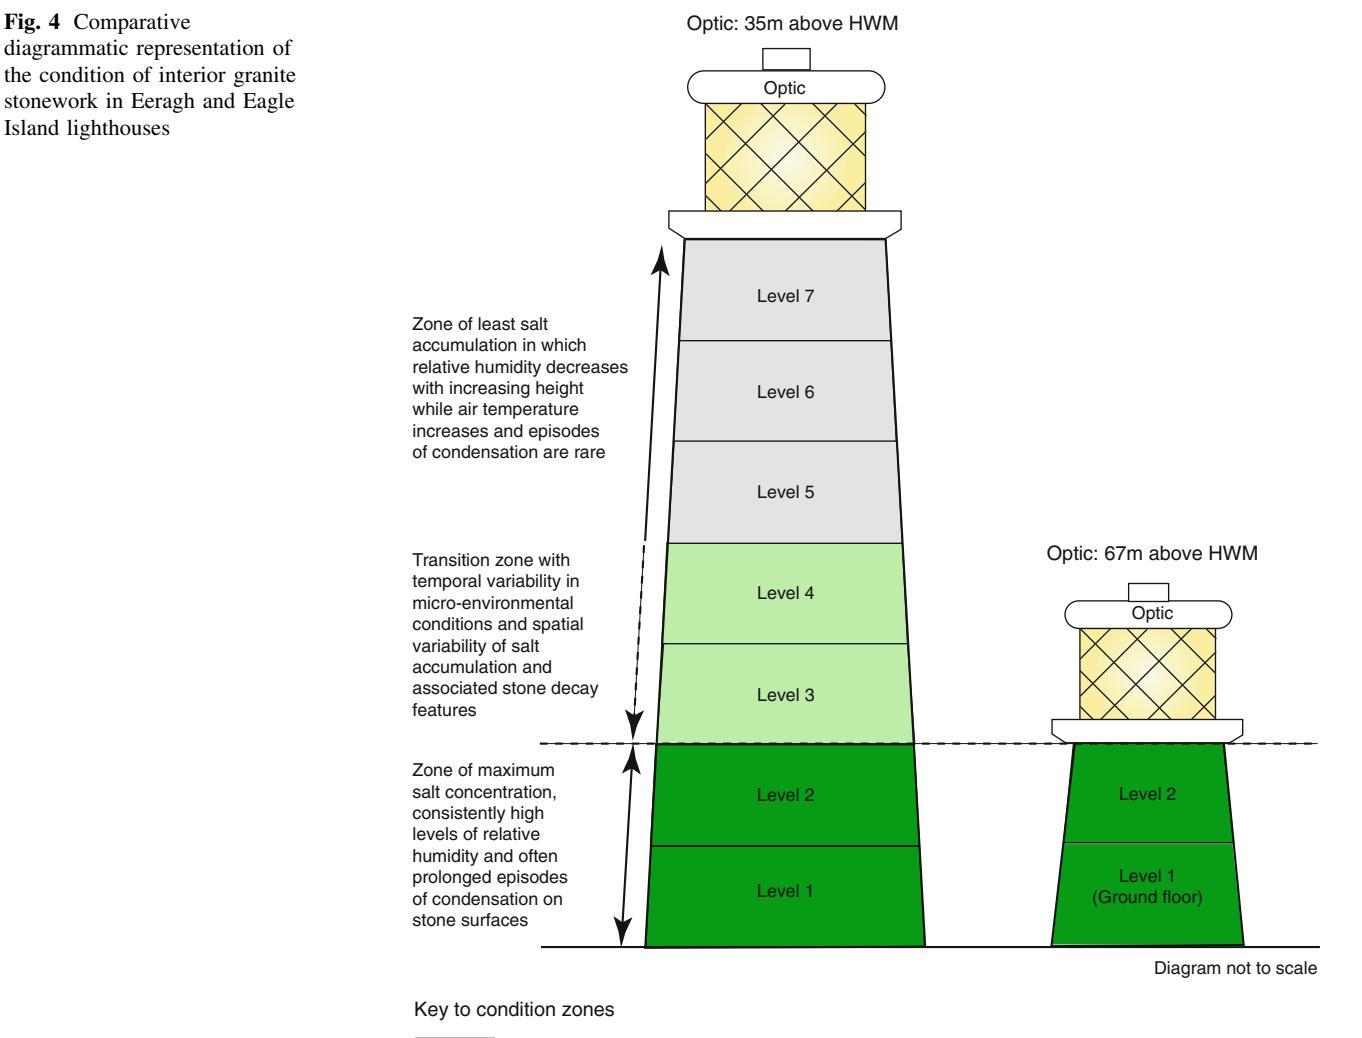
Granite ceilings show extensive evidence of surface breakdown with widespread loss of material through scaling and granular disintegration

Isolated, patchy deterioration of ceiling and floor granite with some loss of material through granular disintegration

Granite floors and ceilings are intact with no evidence of deterioration

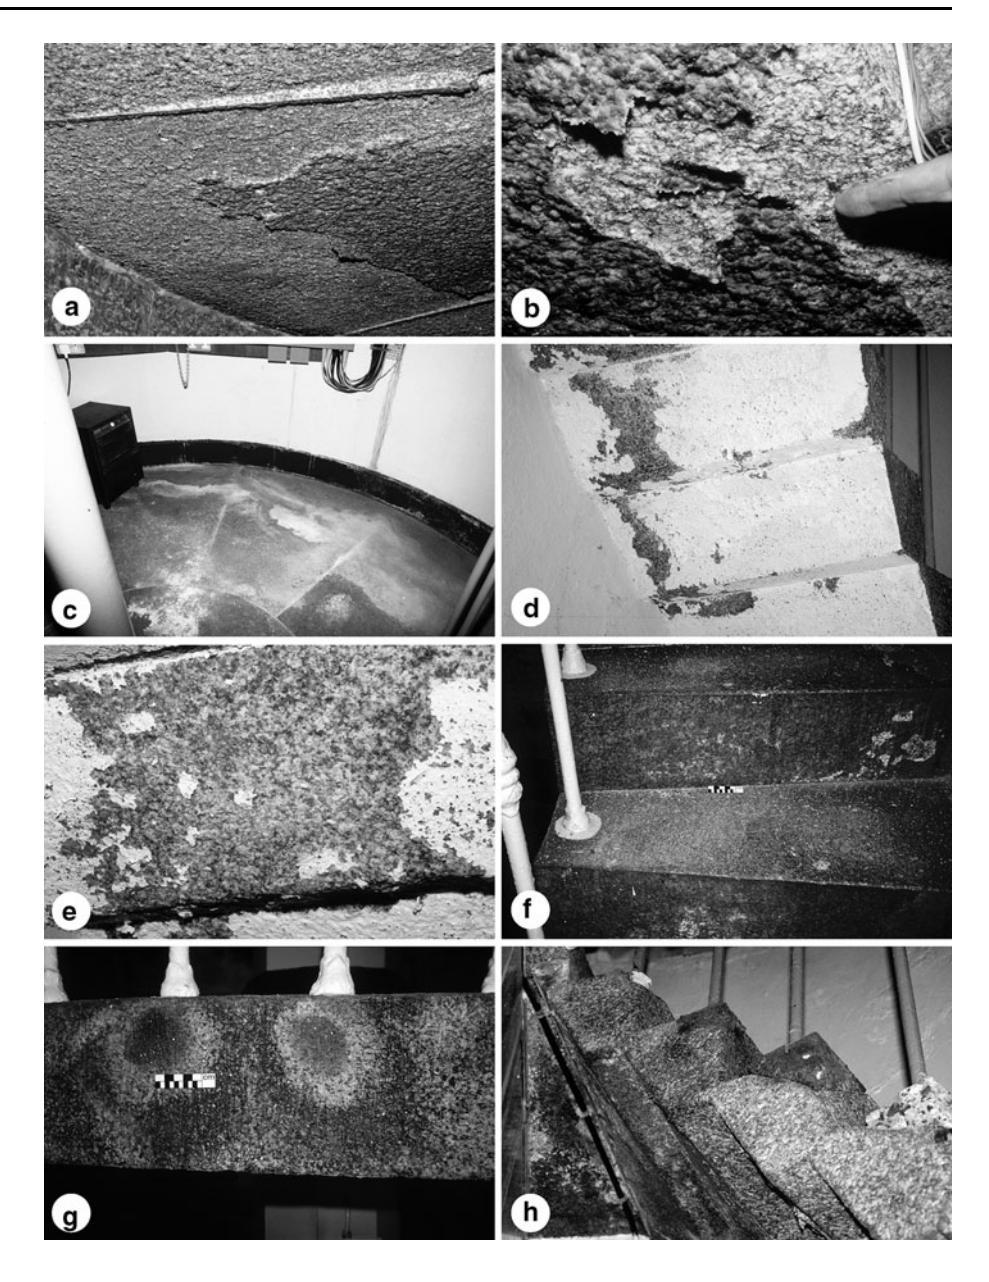
Understep areas also show significant evidence of granular disintegration in the lower tower levels (Fig. 5d, e). The upper surfaces of granite steps, especially the risers, show evidence of surface roughening and granular disintegration through the entire height of the towers again possibly resulting from contamination by salts transferred on the soles of shoes during ascent from lower tower levels

(Fig. 5f). All flights of steps show 'pop-out' features where corrosion and associated expansion of cast-iron handrail supports embedded in the granite have resulted in the dislodgement of corner sections (Fig. 5g, h). This form of damage tends to be most severe in the lower levels of both towers and is most often repaired with cement.

Fig. 5 a Details of the ceiling granite on the ground floor level at Eeragh showing the extent of material loss; b release of ceiling granite through scaling; c development of salt efflorescence on granite floor at Eagle Island associated with the patterns of airflow created by the free-standing dehumidifier; **d** condition of under-step area on the ground floor at Eagle Island showing evidence of surface disaggregation; e details of under-step area at Eagle Island; f surface of granite steps and risers; g circular patterns of iron staining of granite stonework are indicative of corrosion of ironwork embedded within the granite; **h** expansion of corroded ironwork often results in development of 'pop-out' features which in this instance have been repaired using cement

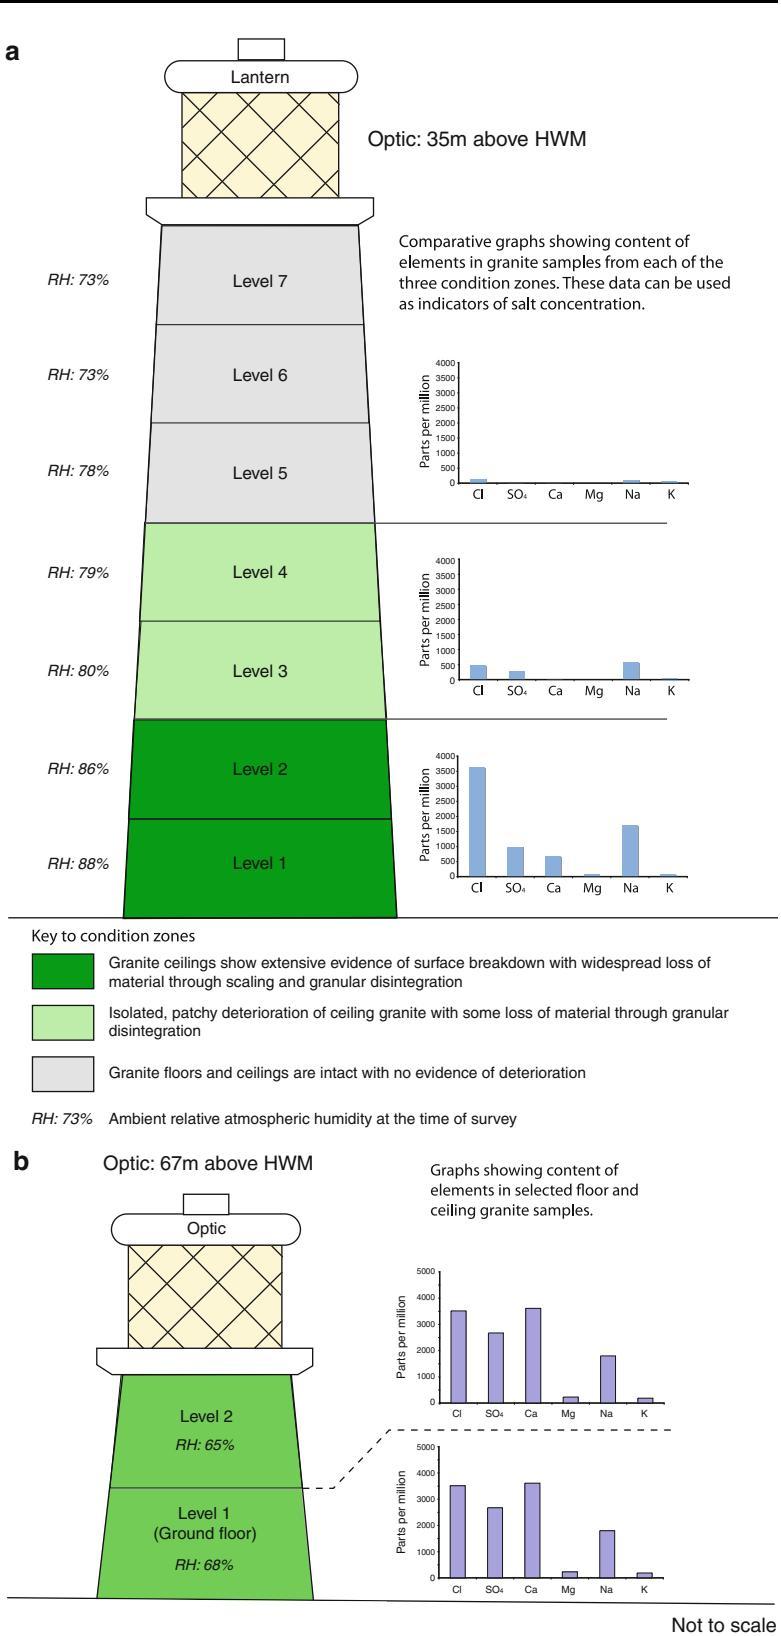
Fig. 6 a Summary condition diagram for Eeragh (North Aran) with examples of elemental analyses of weathered surface material. b Summary condition diagram for Eagle Island with examples of elemental analyses of weathered surface material

Granite ceilings show extensive evidence of surface breakdown with widespread loss of material through scaling and granular disintegration. Widespread salt efflorescence affects granite floors with associated surface roughening through granular disintegration. RH: 68% Ambient relative atmospheric humidity within the tower at the time of survey

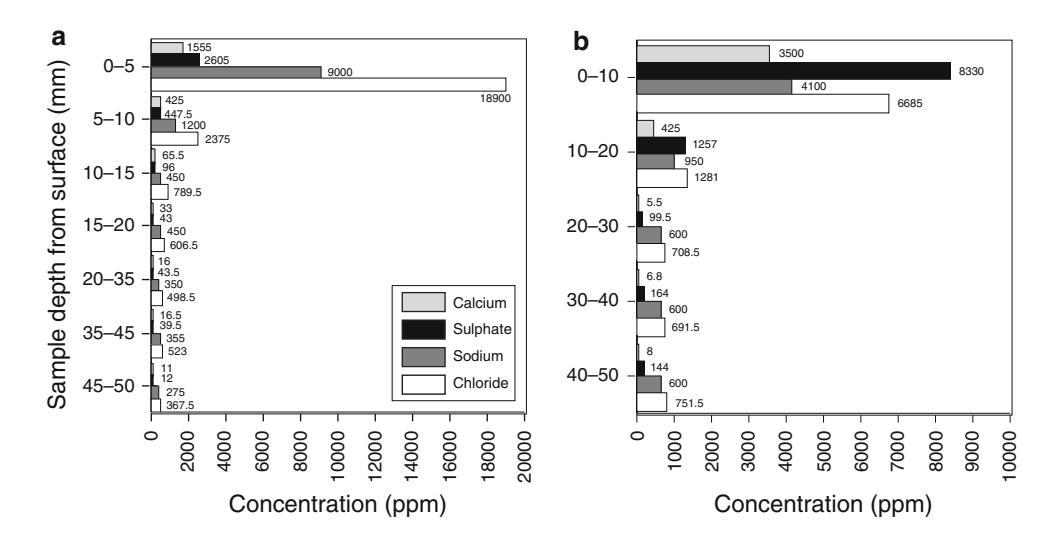
IC and AAS analysis of dry-drilled cores extracted from interior and exterior granite stonework demonstrate the relatively limited penetration of salts in substrate material with high concentrations of salts restricted to approximately the outer 10 mm of stone (Fig. 7). Data indicate that while concentrations of calcium and sulphate decrease quite markedly within the upper 10 mm of the cores, concentrations of sodium and chloride can remain comparatively high through the entire depth of the core. This may reflect the greater mobility of these elements in the presence of moisture. XRD analysis supported IC and AAS data with high concentrations of halite, particularly in surface samples where it is often associated with traces of gypsum.

Fig. 7 Elemental analysis from IC and AAS of interior granite cores from Eagle Island and Eeragh lighthouses. a Eagle Island interior granite core. b Eeragh interior granite core

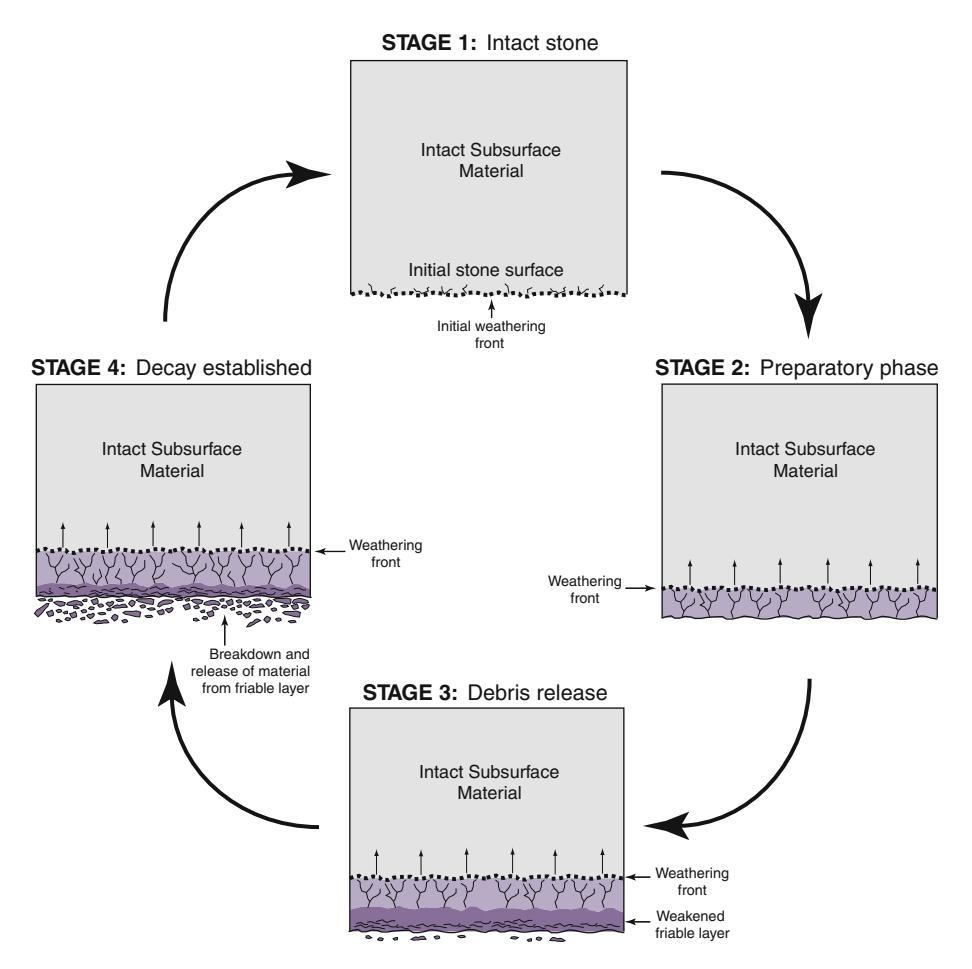
Fig. 12 Conceptual model showing the different stages of the granite decay sequence at Eeragh and Eagle Island lighthouses. *Stage 1* surface flaws and discontinuities facilitate some salt penetration under conditions of limited condensation but with reduced ventilation and more frequent episodes of surface condensation, salts start to accumulate. *Stage 2* micro-fracture networks initially developed at the stone surface begin to extend into subsurface material as a result of salt weathering and chemical alteration which break or weaken intergranular bonds and degrade the lattice structure of individual mineral grains. *Stage 3* positive feedback conditions prevail whereby

The primary management action in the case of both Eagle Island and Eeragh lighthouses was to improve airflow within the towers by trialling vents in external doors and windows on the ground level and by reopening ventilation slats in the optic level to encourage the throughflow of air. This work is ongoing. Unfortunately, it is not possible to return the interior granite stonework to its preautomation condition because of the structural and mineralogical changes that have already occurred and which have resulted in considerable salt loading of surface and subsurface granite, especially in the lower levels of the towers. The aim of management intervention is twofold:
