# Mortars and plasters - How to characterize mortar and plaster degradation

**Keywords** Degradation of mortars · Salt decay · Black crusts · Biodeterioration

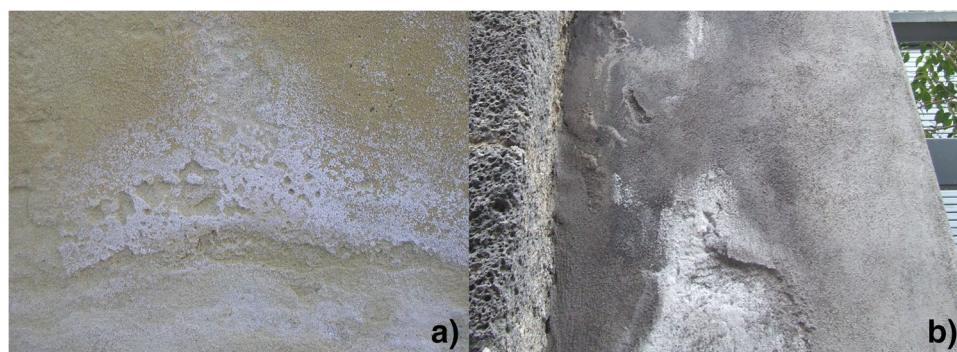
**Fig. 1** Examples of salt degradation: **a** efflorescence, **b** subflorescence

A high rate of water evaporation leads to a crystallization of the salts on the surface of the material, leading to the formation of efflorescence (Fig. 1a), which generally only has an aesthetic consequence. If the evaporation proceeds slowly, there is a high probability to have subflorescences (Fig. 1b), that is, the crystallization of the salts in depth; this is considered one of the most damaging mechanisms for mortars and plasters, where the volumetric salt expansion causes stresses (Theoulakis and Moropoulou 1997; Mosquera et al. 2002).

The main pathological form in mortars/plasters due to salts is the breaking and disintegration of the surface. In masonry structures, mortars and plasters are generally lime-based and play a fundamental role in the circulation of saline solutions throughout the wall. The porosity in these materials is generally high, up to about 25% (Papayianni and Stefanidou 2001) and with many interconnections, and therefore, there is a large fraction of open porosity; this means that there is a high evaporation rate and a low retention of water (Stefanidou and Papayianni 2006). These characteristics lead mortars and plasters to be considered as carriers of water inside the walls and, therefore, also salts, not only between the different wall materials, but also at different heights of the structure causing problems mainly aesthetic and often functional to structures. According to different theories, if the growing crystals exceed the pore size, significant pressures build up on the pore walls resulting in the structure breaking (Scherer 2004).

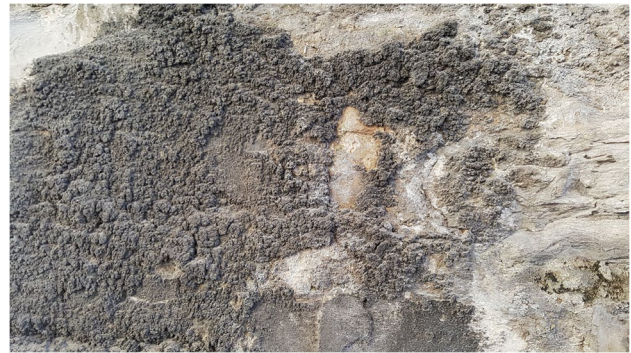
The other atmospheric components, such as metals and metal oxides, act as catalysts in the sulphating reaction (Barca et al. 2014). The formation of black crusts leads to a detachment of the degraded layer, because these newly formed materials have different properties with respect to the substrate in terms of texture and porosity, and then the adhesion between them is compromised, that is why black crusts are often observed together with detachments (Fig. 2).

**Fig. 2** Black crust on a plastered wall. Detachment phenomena are also visible

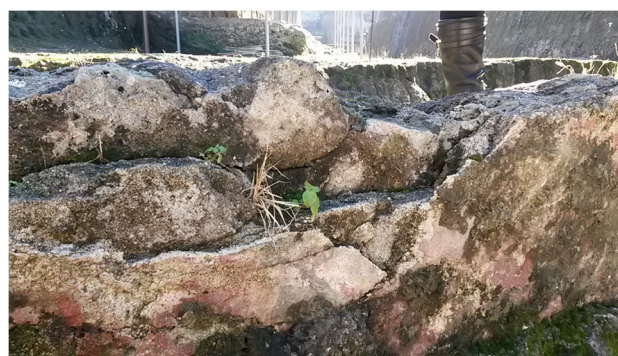
**Fig. 3** Plastered wall of an archaeological site affected by biological colonization

Furthermore, their ability to attack a wide range of polymeric substances, including those added to the stone for protective reasons, means that their presence must be considered during conservation treatments (Salvadori and Nugari 1988; Tiano et al. 2000) (Fig. 3).

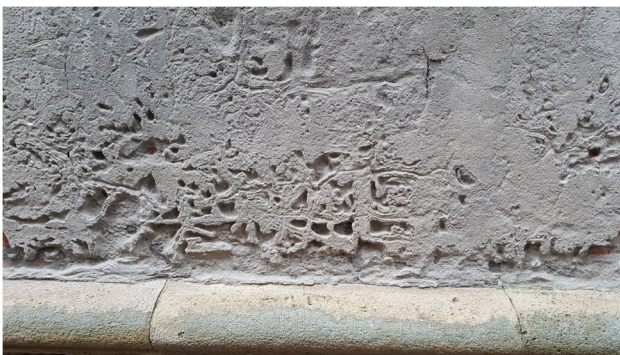
It is a unique form of deterioration present on aerial and hydraulic plasters on external walls. It is characterized by the development of concentric or sub-concentric grooves (Fig. 4). Currently it is not fully clear what are the factors that trigger on this degradation, although salts and biological growth seem to be involved. However, recently Actinobacteria has been isolated from plasters affected by this degradation, suggesting its active role in the process, together with hygroscopic soluble salts, leading to selective intergranular decohesion (Randazzo et al. 2015). On the contrary, mineralogical, petrographic and physical–chemical features seem to not have any effect on such deterioration development.

Fig. 4 A plaster affected by *Flos Tectorii*

It would appear also that the kinetics of the phenomenon might be related to the microclimate conditions, which favour recurrent high relative humidity. The proximity to the sea seems to be the major risk factor for the advance of this type of degradation, with faster kinetics under more aggressive environmental conditions.
