# Mortars and plasters—how to manage mortars and plasters conservation

## Abstract

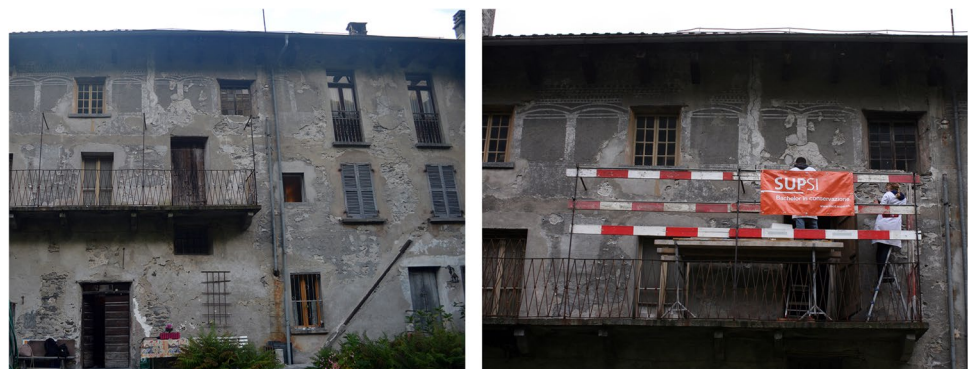
**Fig. 1** Casa Zuccarelli, Ticino (CH). Examples of a decorated facade. On the left the general view of the deteriorated plaster; on the right a detail of the graffito, representing a loggia of the same façade during the conservation works

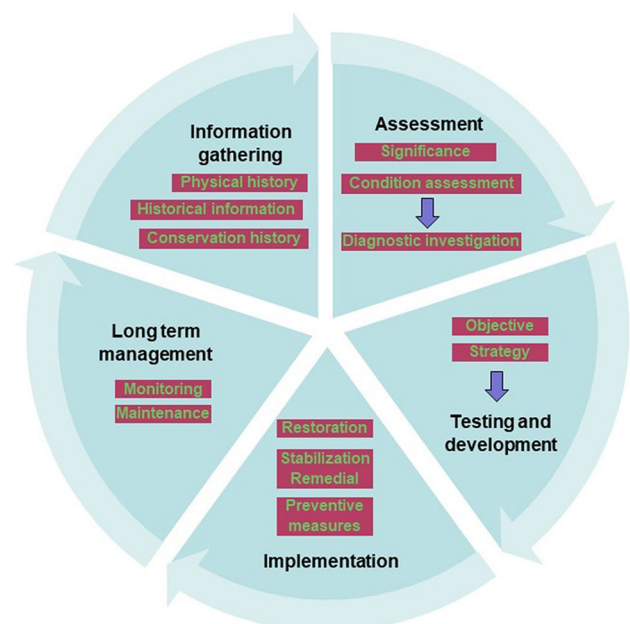
**Fig. 2** Summary scheme of the conservation process, modifying the one proposed by Piqué et al 2010

Following characterization of the material, the conservation process (assessment, in Fig. 2) tackles condition and environmental assessment. This moment is the fundamental prerequisite for understanding the causes and mechanisms of deterioration (Demas, 2002; La Russa and Ruffolo, 2021). It is important to distinguish damage from deterioration and to describe their distribution. There are European standards that specify the requirements for a condition survey stating how an immovable cultural heritage object should be registered, examined, documented and reported on (EN 16,096 – Conservation of cultural property – Condition survey of immovable cultural heritage 2012).

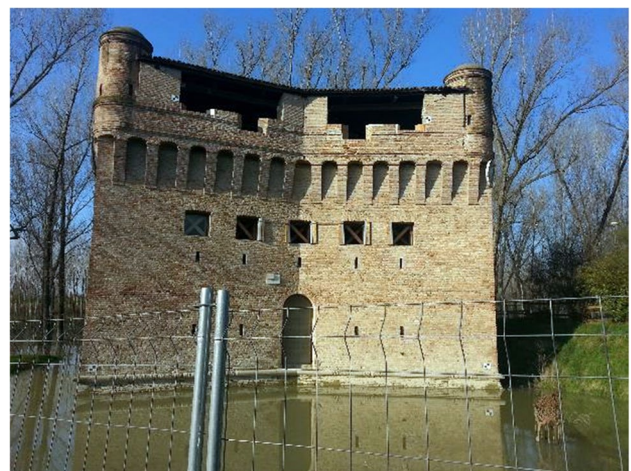
**Fig. 3** The “Rocca Possente” situated in Bondeno, province of Ferrara (IT). Due to its location on the banks of the Po river, this building suffers periodic flooding and problems related to liquid water and capillary rise

against harmful changes (i.e., deterioration). It is much more effective to act on the causes and mechanisms of deterioration than to deal only with the symptoms by strengthening the object, i.e., remedial intervention (Cather 2003b). However, it is often difficult to completely understand the mechanisms of deterioration through a diagnostic process because of complex phenomena and multiple causes. Their effects can be entangled in such a way that the data available to scientists are generally insufficient (Torraca, 1999). In addition, for immovable heritage, such as buildings and their mortars and plasters, both the removal of the causes of deterioration and/or reduction of the deterioration mechanisms through environmental conditioning are rarely possible. For example, in Fig. 3, it is clear that the cause of water damp cannot be removed, because the building is located on the banks of the Po River and thus it suffers periodic flooding.

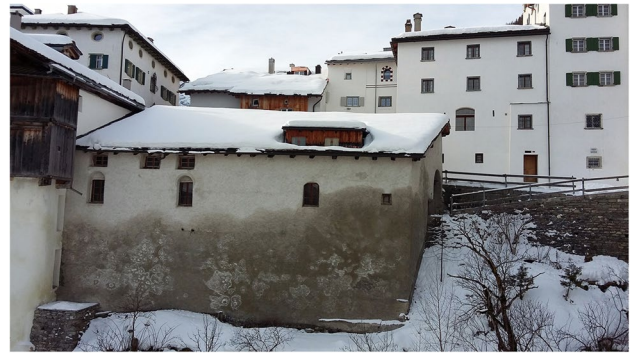
**Fig. 4** Example of snow accumulation around a building, as a source of water and soluble salts. Splügen, CH

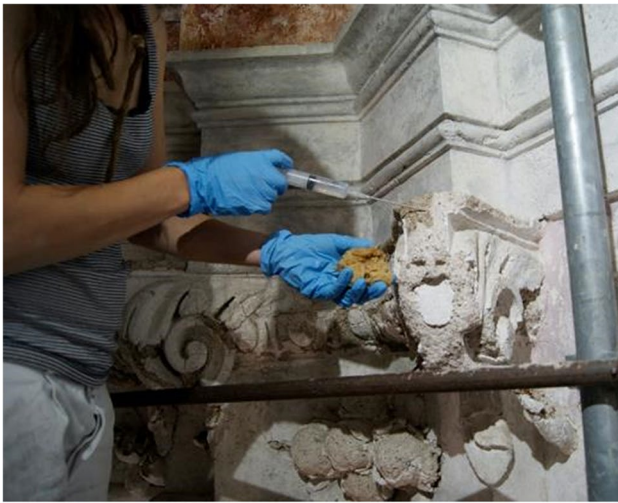
**Fig. 6** Consolidation of a disaggregated mortar using Ethyl silicate applied by syringe

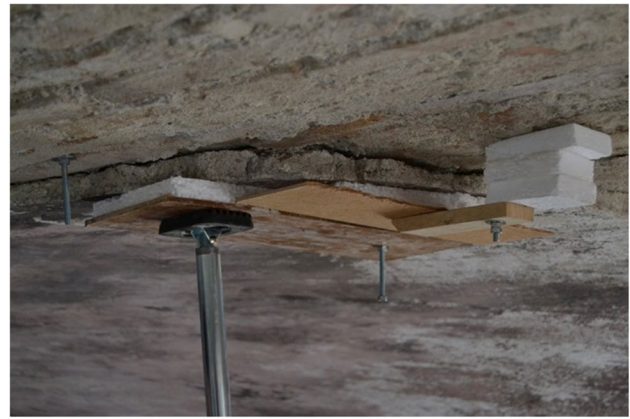
**Fig. 7** Supports of a detached plaster in a vault. Supports must be ready before starting grouting, but have a fundamental role after the intervention while the grout sets

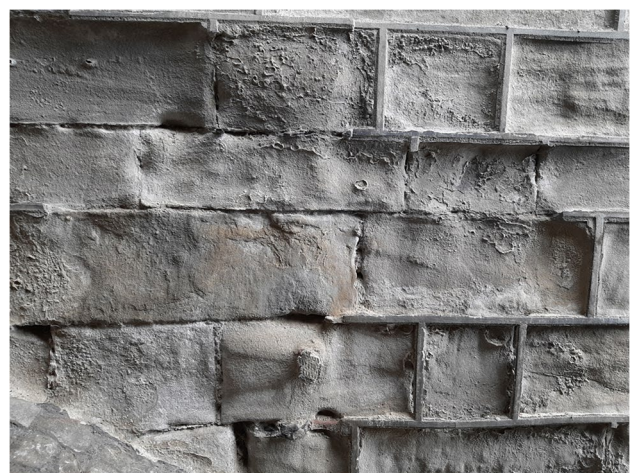
**Fig. 8** Example of a reintegration of a repointing mortar. In this case, the new mortar has remained intact while the surrounding softer stone has eroded due to atmospheric agents
