CHAPTER 14

LANDSCAPE RESTORATION

A case practice of Kushiro Mire, Hokkaido

F. NAKAMURA, Y.S. AHN

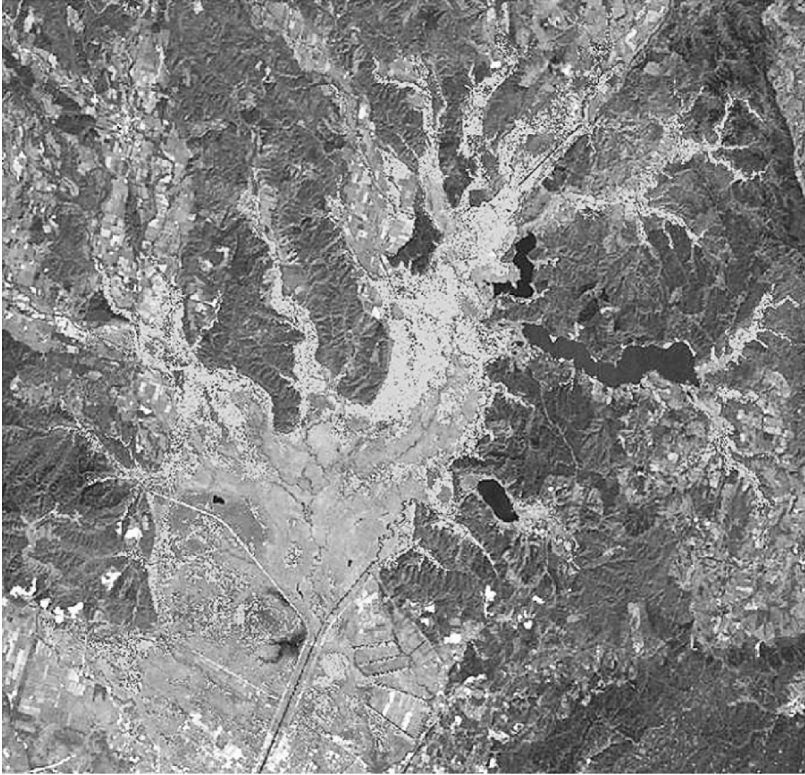
Figure 4. The distribution of tree stands in and around the Kushiro Mire. After removing distortion in about 200 photographs, computer data processing and verification using stereovision extracted trees with canopies greater than 1m diameters. The data is shown against a Landsat image.

Figure 4 presents tree distribution in the Kushiro Mire, which was constructed in the development of an environmental information map described later in this paper.

In the construction, distortion in about 200 aerial photographs was first removed. Using a computer data processing with stereovision, trees with canopies greater than 1m diameters were extracted and shown against a Landsat image. Forest expansion is clearly visible along the edges of the wetlands, particularly at downstream ends of the Kuchoro River and Setsuri River.

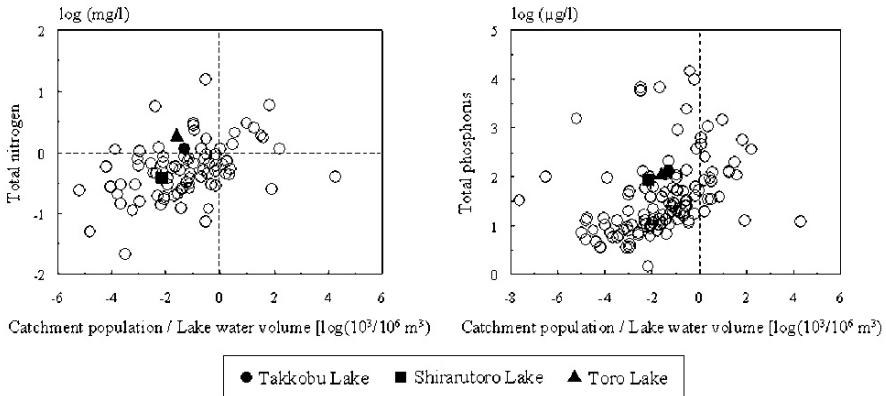
Figure 5. Relationships between population and total nitrogen, total phosphorus in catchments. The nutrient concentrations of the three lakes published by Takamura et al. (2003) were added to the relationships derived from the International Lake Environmental Committee (2001).

To compare the effects of watershed landuse on water quality, we plotted relationships of total nitrogen, total phosphorus and population for the three lakes (Takamura et al., 2003) against data produced by the International Lake Environmental Committee (2001) (Figure 5). The larger populations, the higher nutrient concentrations. However, nutrient concentrations in the three lakes have relatively higher value despite of the small population size.

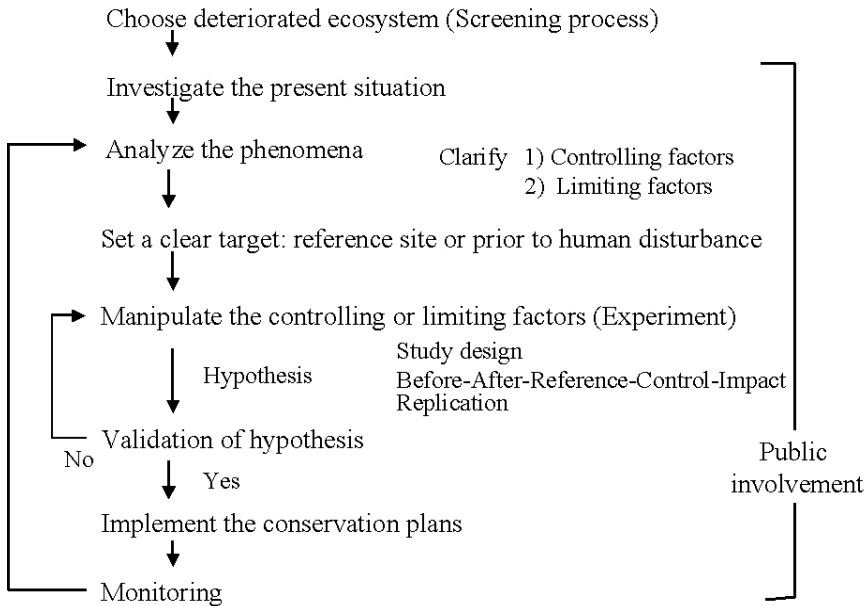
Figure 7. General flow of restoration projects in Kushiro Mire.

Before implementing any restoration, it is important to evaluate current conditions of existing ecosystems (Figure 7). This preliminary assessment identifies degraded ecosystems to be restored and remaining intact ones to be preserved, providing a clear criterion in site selection. Intact ecosystems serve as a reference for understanding the processes and relationships between biotic and physical factors of naturally self-sustaining ecosystems. This understanding is essential for determining causes of the degradation and restoration strategies to allow for natural recovery to occur. For spatial analyses, geographic information systems (GIS) are effective to integrate a variety of data based on aerial photographs, topographic maps, satellite images, and land use information. Existing governmental reports and literature also provide valuable sources for the assessment.

If any symptoms that indicate the deterioration of objective ecosystems could be found through the above screening process, we should examine more intensively to identify the controlling or regulating variables in the fields (Figure 7). Once we clarify these key variables deteriorating the ecosystems, we may proceed to set the target of the restoration project. The target ecosystem should be set with an agreement of local public and be feasible to be accomplished by restoration project, considering economical and social constraints. Reference site (intact site) or pictures prior to human disturbance will be instructive information to set the target. So-called ‘adaptive management’, that is using the experiment as management strategy, will be important in this stage, because we cannot predict perfectly the response of restored ecosystems (Figure 7). This process is not just a trial-and-error procedure; rather it should be the validation procedure with a clear hypothesis. If the hypothesis is validated by the experimental results, we can extend the techniques over a broad restoration area.

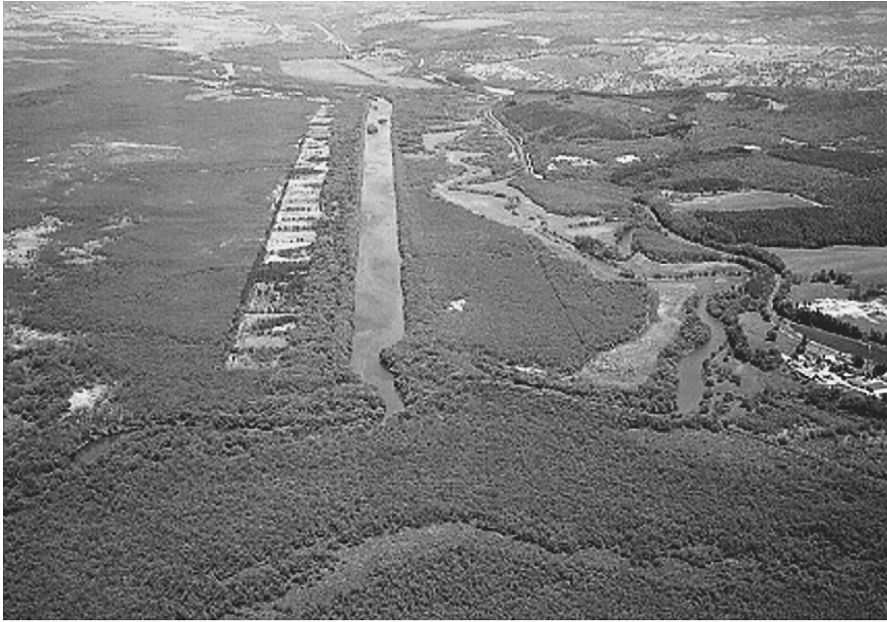
Figure 8. The restoration project of meandering river. River flows from up to bottom of the picture. The meandering section (right side) will be connected to the main channel.

As a pilot plan, a river section extending about 2 km of the Kushiro River in the Kayanuma area is planned to restore from a straightened channel to a meandering stream and floodplains (Figure 8). The artificial dike built at the right-side bank (left

side of the figure) will be removed to allow flooding over the floodplains. The abandoned meandering section created by channelization project will be re-connected with the main channel and the straightened channel will be partially buried with the dike sediment. The restoration project will be monitored and evaluated based upon the scientific research results before and after the project and comparison with reference section existing downstream reaches.

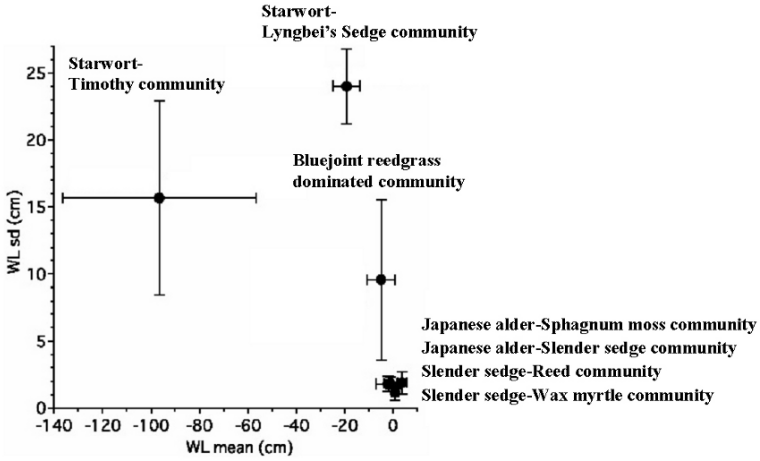
Figure 10. Biplot of mean water table (WL mean) and water table variation (WL sd), as well as its variation in dominant plant communities in the Hirosato wetland. Vertical and horizontal bars show the standard deviation of each mean. (after Nakamura et al., 2003)

Dominant plant communities changed over the space from a relatively natural portion of the wetland, an abandoned farmland, and a transitional area between them. Representatives were the community of alder - slender sedge (*Carex lasiocarpa*), bluejoint reedgrass (*Calamagrostis langsdorffii*) and starwort (*Stellaria radicans*), respectively. This vegetation shift in space was also correlated with the gradients of groundwater tables and nutrient concentrations in wet soils (positive correlations) and variation in groundwater tables (negative correlation). Particularly, the differences in groundwater tables was prominent among the natural area, old field, and transition between these; the plant communities in old field had extremely low in water tables and high in its variation (Figure 10). Hydrological characteristics at a larger scale than the project area were further examined. The cross sectional profile of groundwater table showed a bell curve, with a highest water table in the center of the wetland. Water table decreased rapidly towards the agricultural drainage and an old channel of the Setsuri River that has been disconnected from its main channel (Figure 11).

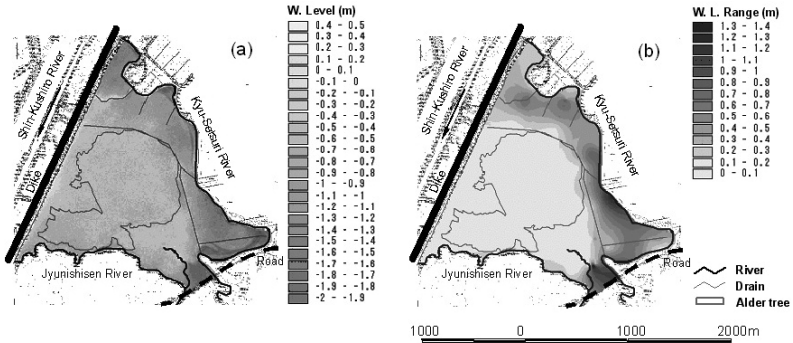
Figure 11. Spatial distributions of (a) groundwater tables at an instance of measurement in June and (b) variation in groundwater tables during the period of measurement. (after Nakamura et al., 2003)

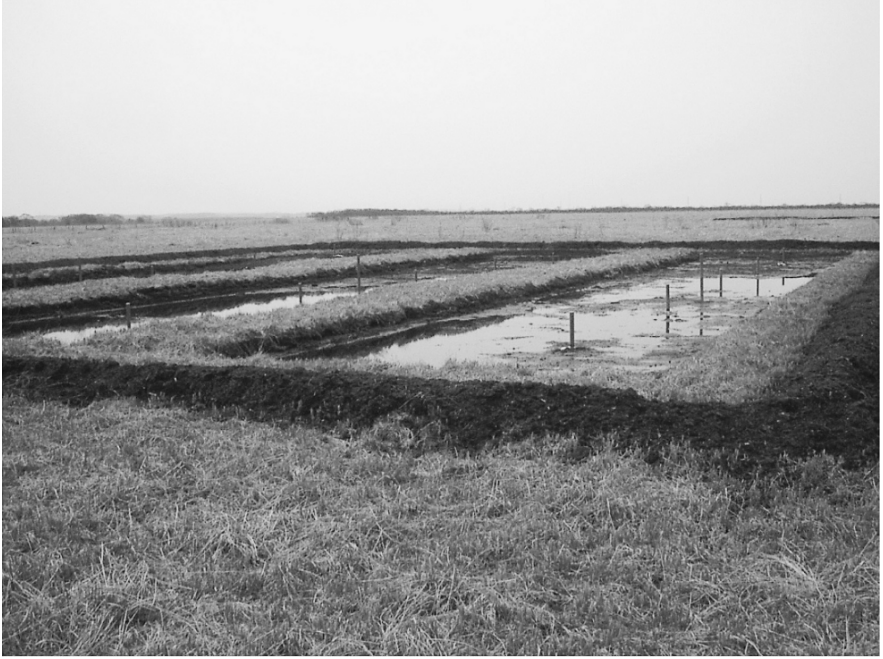
Figure 12. An experimental excavation site in the Hirosato wetland.

The soil excavation experiment was begun in 2002. The depth of excavation was determined so that the water table could be equivalent to that in the reference site. This excavation test was designed to evaluate various alternatives in order to find a most appropriate method for vegetation recovery (Figure 12). For example, one experiment plot was excavated with a slope to test seedling emergence at various soil depths, and another was seeded with reeds. To minimize adverse impacts of excavation on the natural wetland, it was carried out in a winter when soil was frozen. For an access to the experimental site, a 1.5 km-long bridge was manually made by from ice in the winter, which melted away in the following spring.
