Bio-Based Self-Healing Concrete: From Research to Field Application

Eirini Tziviloglou, Kim Van Tittelboom, Damian Palin, Jianyun Wang, M. Guadalupe Sierra-Beltrán, Yusuf Çagatay Erşan, Renée Mors, Virginie Wiktor, Henk M. Jonkers, Erik Schlangen, and Nele De Belie

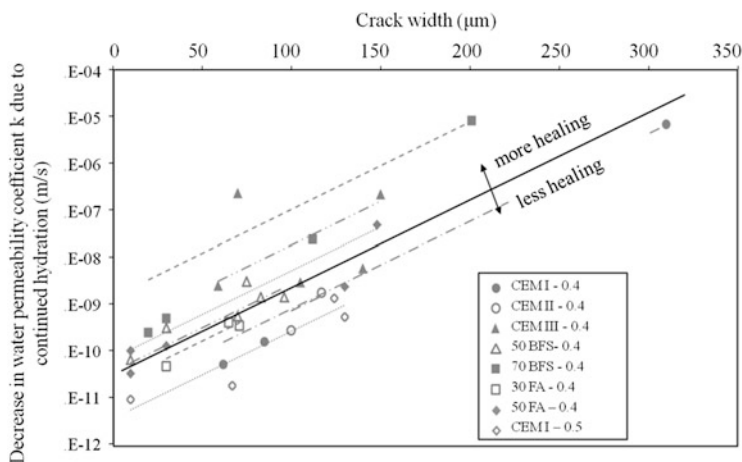
Fig. 1 Difference in water permeability as a result of autogenous crack healing for different mixes [9]. Codes 30, 50 and 70 in the legend refer to the percentage of BFS or FA in the binder; 0.4 and 0.5 refer to the water/cement ratio of the specimens

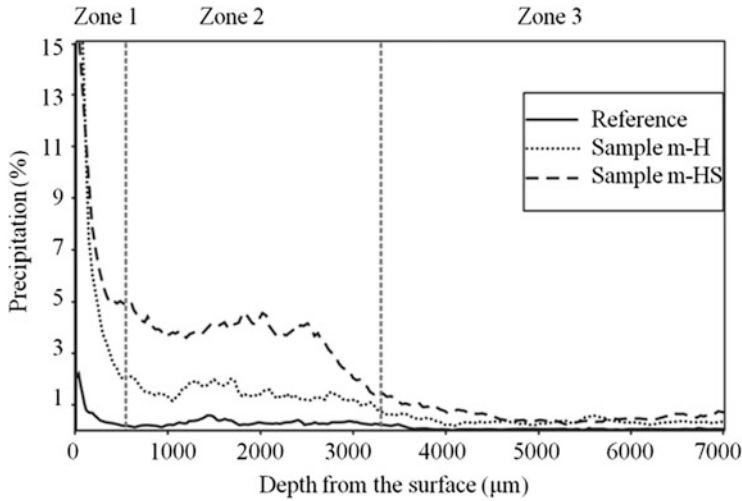
Fig. 5 Quantification of precipitation as a function of depth of the specimen. Three different zones were distinguished: surface, subsurface and internal [21]

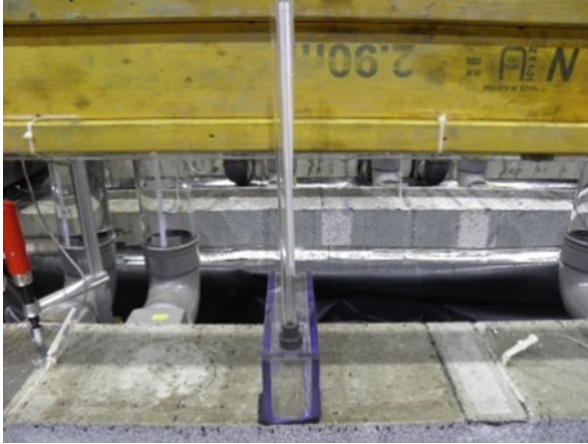
Fig. 6 Test setup for measuring water permeability

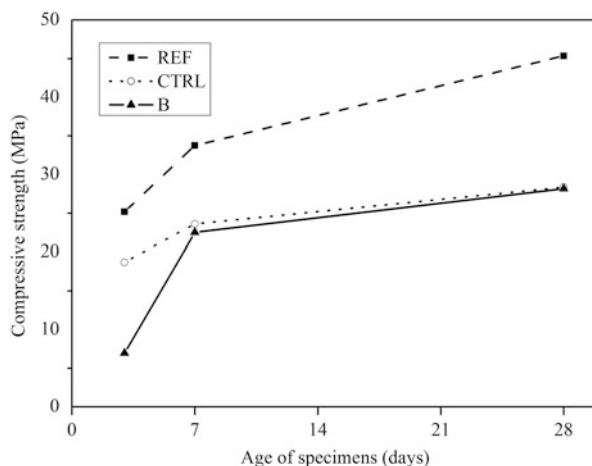
Fig. 8 Compressive strength for REF, CTRL and B specimens (see Table 1 for descriptions)

Investigation of the influence of the healing agent on the compressive strength of mortar was conducted on prisms (40 × 40 × 160 mm). All specimens were demoulded 24 h after casting and kept in a room with standard temperature (20 ± 2°C) and > 90% relative humidity for 28 days. Compressive tests were performed on 28-day-old specimens. The results (Fig. 8) revealed that replacement of sand with LWA leads to substantial reduction in compressive strength, as expected. Furthermore, the healing agent seems to delay the development of compressive strength of mortar (at the age of 3 days), but has no significant effect after 7 days.

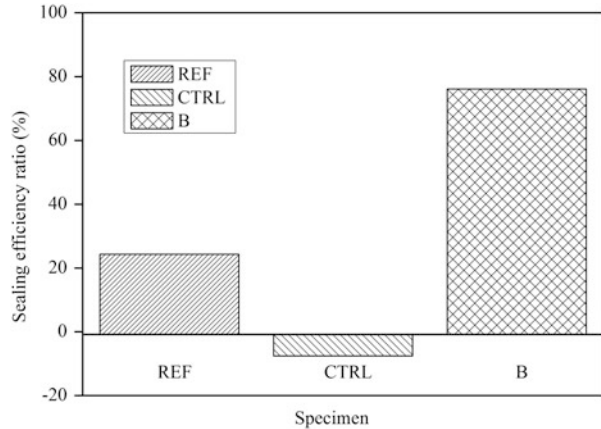
Fig. 9 Average sealing efficiency ratio for REF, CTRL and B specimens (see Table 1 for descriptions)

After test completion, the sealing efficiency ratio (SER) was calculated according to a reported method [24]. This ratio indicates the amount of healing that has taken place inside the crack during the 28 days of healing treatment. Figure 9 presents the average SER values calculated after completion of crack permeability tests via water flow. The graph shows that there is a noticeable difference in crack sealing between specimens with and without healing agent. Specimen B exhibited more than three times higher sealing performance than REF and CTRL specimens, as a result of the presence of the bio-based healing agent.

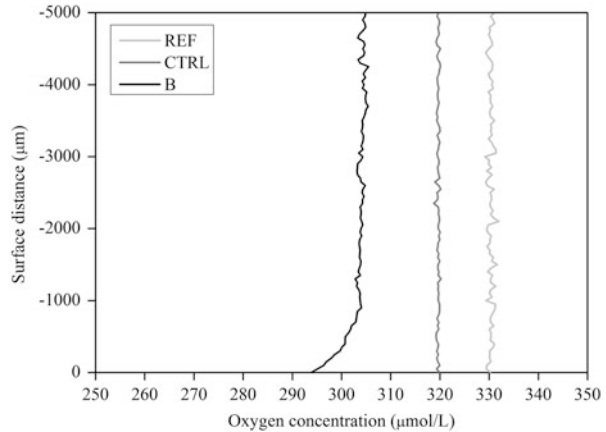
Fig. 10 Oxygen profile measurements for REF, CTRL and B specimens (see Table 1 for descriptions)

specimen provides evidence that metabolically active bacteria (germinated bacterial spores) were degrading the available organic carbon inside the mortar.

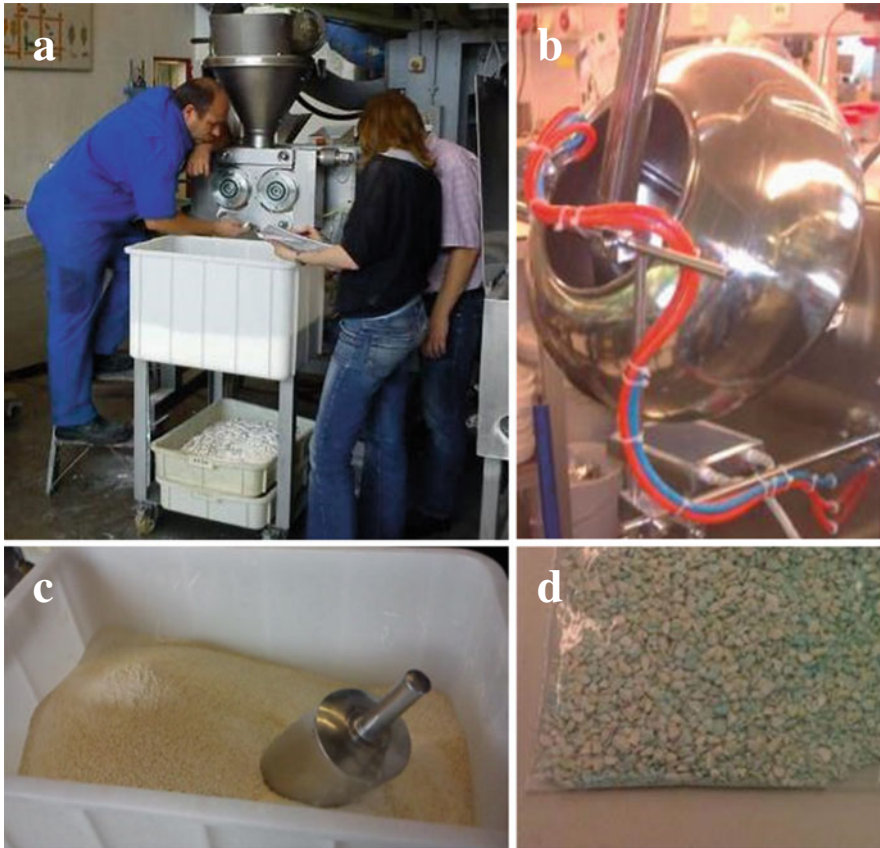
Fig. 11 (a) Roller compaction of powders, (b) coating of particles, (c) uncoated powders and (d) coated powders

Although proof of concept was shown for healing agent components contained in LWA, the application range may be limited because of incorporation of volumes of expanded clay, which influence the mixture design. In order to extend the applicability range, the volume of added healing agent was reduced by increasing the content of efficient healing agent component in particles. For this reason, scalability of production is an important factor to take into account. A way of producing scalable particles almost fully consisting of active ingredients is by roller-compacting powders to sheets, with subsequent milling to flakes that are in the size range of the sand fraction (1–4 mm) [27]. A typical property of these flakes is solubility in water, which is beneficial for matrix cracking and water ingress, dispersing the healing agent in the crack volume. It is challenging, however, to retain particle integrity during the wet mixing stage of mortar or concrete production to prevent premature incorporation of nutrients in the cementitious matrix. Partial particle dissolution can be prevented by application of a protective barrier around the soluble particle, in the form of a coating. The coating material can be inorganic (e.g. cement paste or geopolymer) or organic (e.g. calcium cross-linked polyvinyl alcohol alginate or lactic acid derivatives) (Fig. 11) [28–30]. To retain

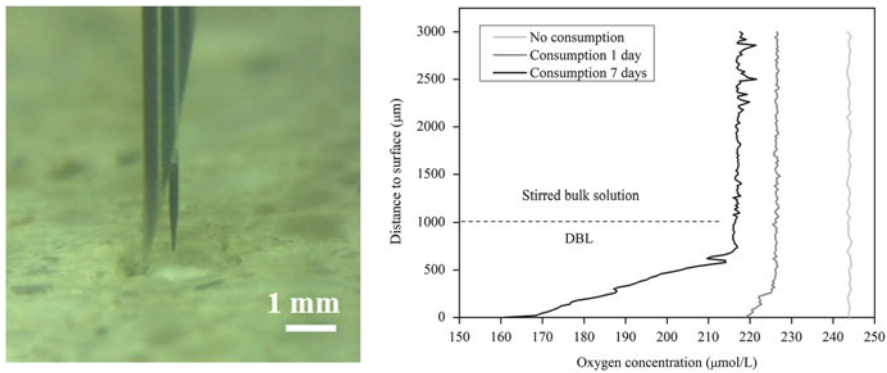
Fig. 13 *Left*: Oxygen microsensor approaching the surface of the mortar slice. *Right*: Profile measurement for surface oxygen consumption in time, showing a decrease in oxygen concentration in time towards the surface. *DBL* diffusive boundary layer

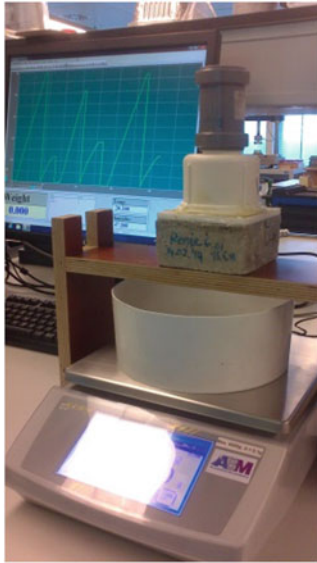
Fig. 14 *Left:* Set-up for the water leakage test. *Right:* Residual water flow through cracks at various water curing times. *M* control mortar, *M+HA* mortar with healing agent flakes

room. For specimens with similar crack widths, significantly higher recovery of water tightness was found in mortar containing healing agent flakes (Fig. 14).

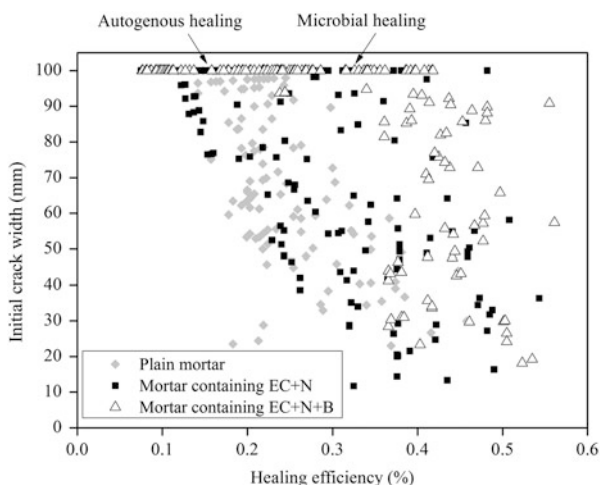
Fig. 18 Self-healing capability of mortar specimens with and without *Diaphorobacter nitroreducens*. EC expanded clay particles, N nutrients $\text{Ca}(\text{HCOO})_2$ + $\text{Ca}(\text{NO}_3)_2$, B *Diaphorobacter nitroreducens*)

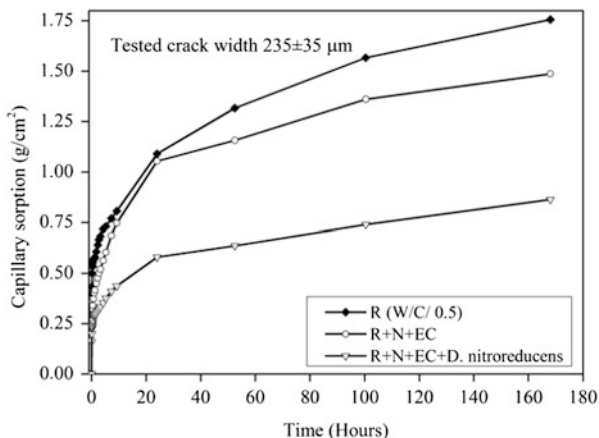
Fig. 19 Microbial self-healing through NO_3^- reduction provides higher water tightness than autogenous healing. *R* plain mortar (0.5 water-to-cement ratio), *EC* expanded clay particles, *N* nutrients $\text{Ca}(\text{HCOO})_2 + \text{Ca}(\text{NO}_3)_2$

At the end of the healing period, capillary sorption tests were conducted to check the water tightness of the healed crack (235 ± 35 μm original crack width). Mortar prisms containing healing agents absorbed 51% less water than the reference specimen in the first 24 h (Fig. 19).

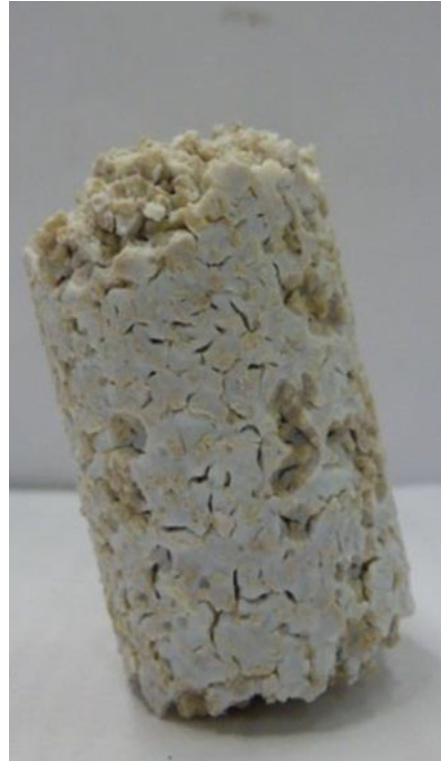
Fig. 22 Consolidation of Euville stone powder in Falcon tubes, using SiO₂ nanoparticles in combination with *Bacillus sphaericus*

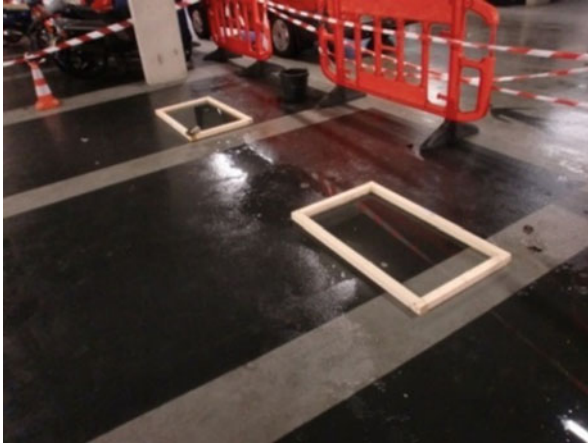
Fig. 26 Second leakage test on crack AB

Based on the results from the leakage test, a second treatment with the repair system amended with bacteria adapted to cold temperatures was performed on 17th December 2014. One crack (AB) was impregnated manually with the repair system. Inspection from the level below showed that the repair solution was dripping through and thus had penetrated through the full length of the crack. The second leakage test (Fig. 26) was performed on crack AB 7 weeks after the second treatment, on 10th February 2015. Two cores were also drilled for analysis. Results of the leakage test were encouraging as the crack was leaking significantly less. Location A had 43% less leakage compared with the previous test and location B, which was dripping heavily, had 80% less leakage. Moreover, the leakage at location B only came from specific spots along the crack. Figure 27 shows ESEM observations of the core drilled after the second treatment. Calcium-based mineral (Fig. 27a) and distinctive morphologies, small rod-like imprints (Fig. 27b), were
