Mountain Watersheds, Torrents, and Torrent Control in Slovakia

M. Jakubis and M. Jakubisová

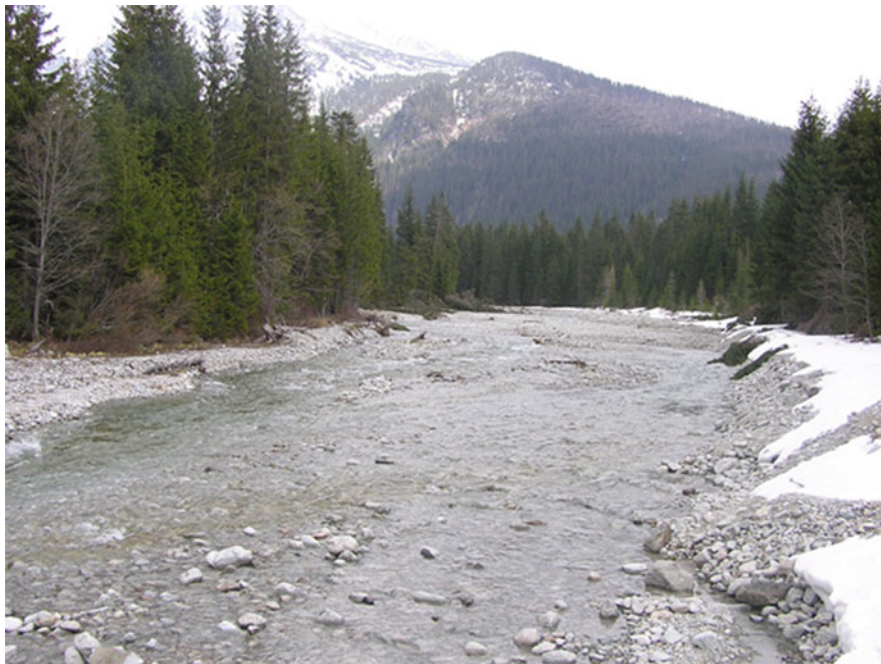
Fig. 1 Tichý potok torrent in the Western Tatras (photo M. Jakubis)

The Slovak Republic with an area of 49,035.81 km² is in most of its territory a mountain landscape (Table 1) and has watercourses extending a length of 61,147 km. Of that length, approximately 24,000 km (39.25%) have the character of torrents (see Figs. 1 and 2).

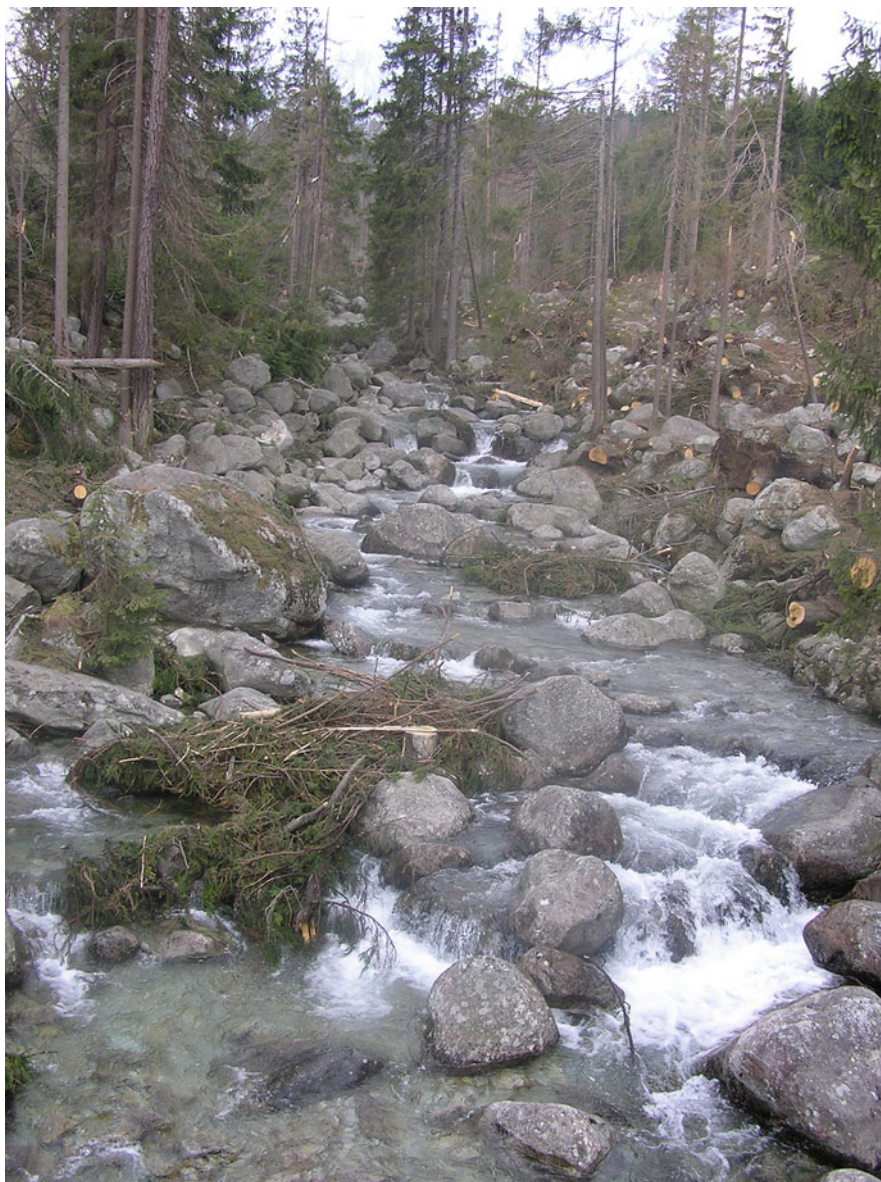
Fig. 2 Natural bed of Studený potok torrent in the High Tatras with damaged riparian stands after wind calamity in 2004 (photo M. Jakubis)

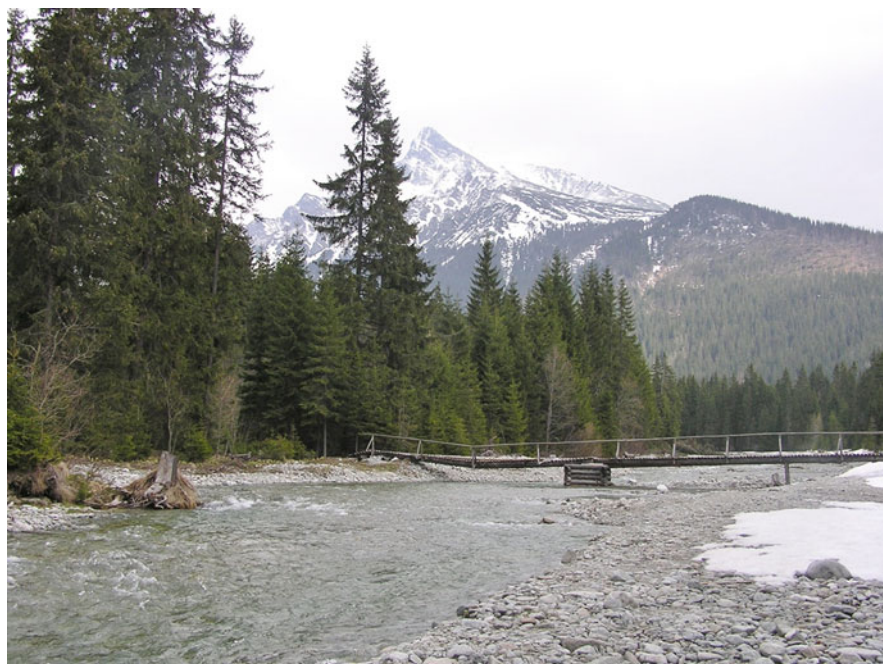
**Fig. 3** Tichý potok torrent in the Western Tatras, watershed area of 50.38 km², discharge $Q_{100} = 140.0 \text{ m}^3 \text{ s}^{-1}$, watershed torrentivity coefficient $C_{wt} = 0.81$ (photo M. Jakubis)

Based on the research in 145 mountain watersheds with an area S_w from 0.25 to 50.38 km^2 (Fig. 3) and discharges Q_1 from 0.20 to 12.0 $\text{m}^3 \text{s}^{-1}$ and Q_{100} from 1.0 to

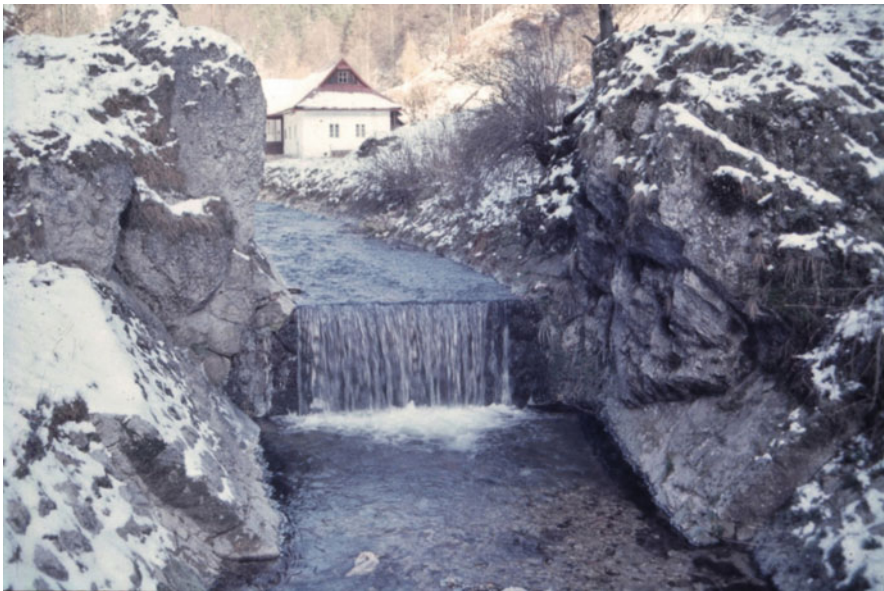
Fig. 4 The weir built in natural rock of oldest torrent control in Hornojelenecká Valley from 1926 to 1927 and the torrent Jelenec in Slovakia (photo M. Jakubis)

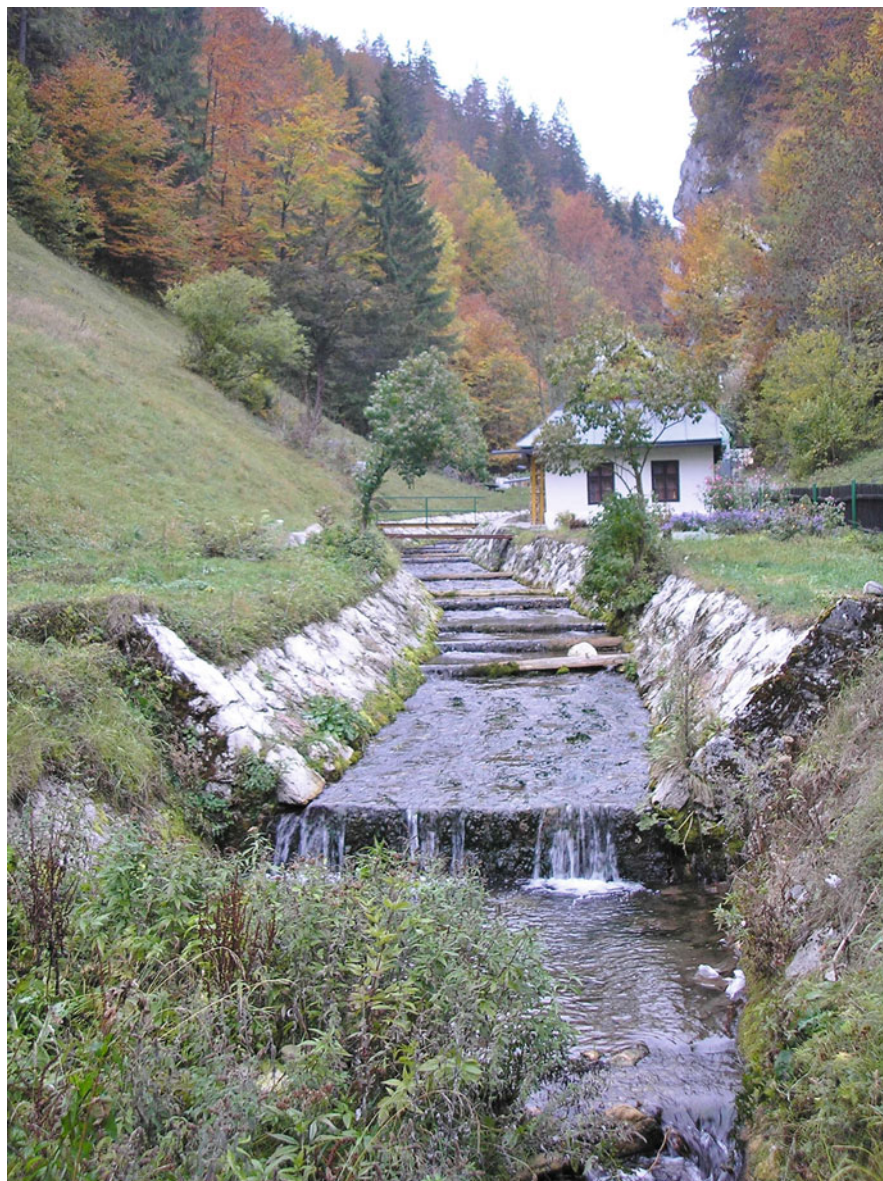
Fig. 5 Longitudinal reinforcement by pavement stone, the stone weir, and system of wooden sills in the oldest torrent control – Jelenec in Hornojelenecká Valley from 1926 to 1927 (photo M. Jakubis)

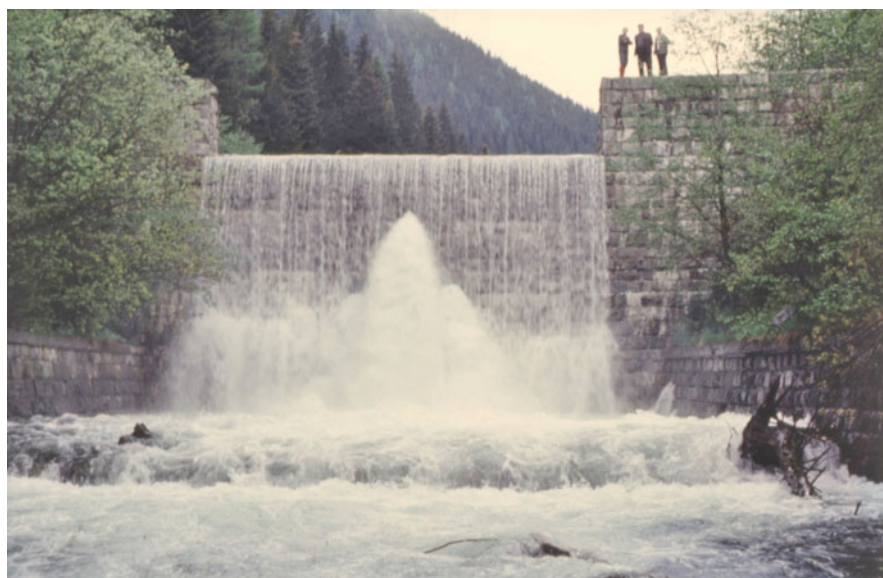
Fig. 6 Highest torrent dam of Slovakia built (1938) in Račková Valley in the Western Tatras (photo M. Jakubis)

The first more precisely documented flash flood in the territory of today's Slovak Republic was the mentioned flood in Hornojelenecká Valley (geomorphologic unit Velká Fatra) on May 30, 1925. Another documented torrential flood occurred in the watersheds of torrents Račková (35.8 km²), Tichý potok (54.6 km²), Kôprovský potok (30.5 km²), and Belá (85.1 km²) in the Váh river basin. On August 11, 1929, on the southern slopes of the Western Tatras, 83 mm of precipitation fell in 3 h [8, 9]. The floodplains were affected by a catastrophic flash flood that devastated the area along the sides of the watercourse Belá and caused major flood damages in the municipalities of Pribylina, Liptovská Kokava, Vavrišovo, Dovalovo, Liptovský Peter, and Liptovský Hrádok. In the territory under the confluence of the Tichý potok and Kôprovský potok (Belá), the width of the channel reached more than 40–50 m (normally it is about 8–10 m). This flood was an incentive to build a second significant torrent control Račková on the territory of today's Slovak Republic in 1938–1940 (Figs. 6 and 7).

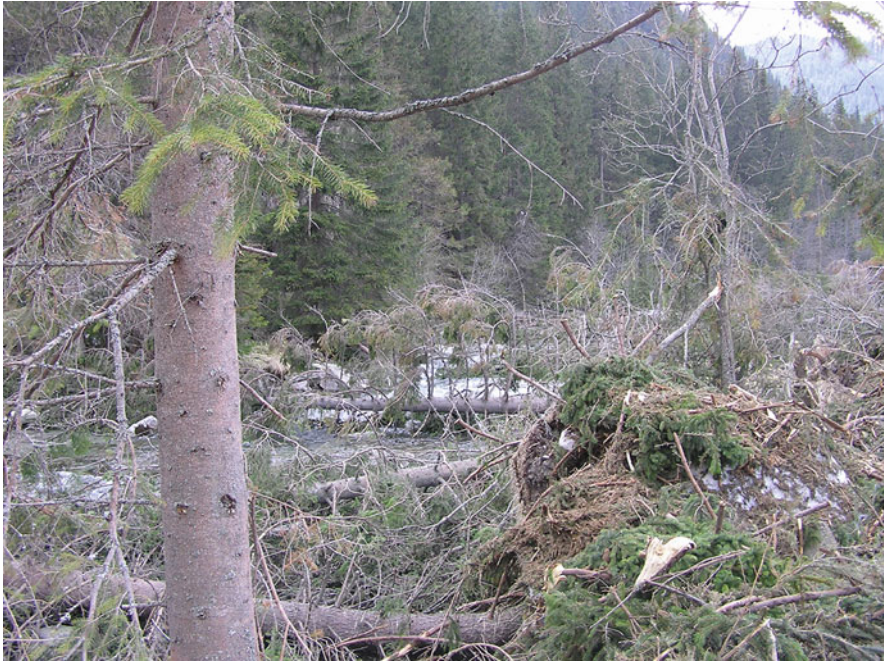
Fig. 8 The damaged riparian stands of Kôprový potok (torrent of Western Tatras) after wind calamity on November 19, 2004, need urgent tending (photo M. Jakubisová)
