# Dynamics of Water Bodies of the North Caucasus by Remote Sensing Data in 2015–2017

Vitaly I. Sychev

Murat K. Bedanokov, Sergey A. Lebedev, and Andrey G. Kostianoy (eds.),  
*The Republic of Adygea Environment*, Hdb Env Chem (2020) 106: 497–524,  
DOI 10.1007/698\_2020\_594,

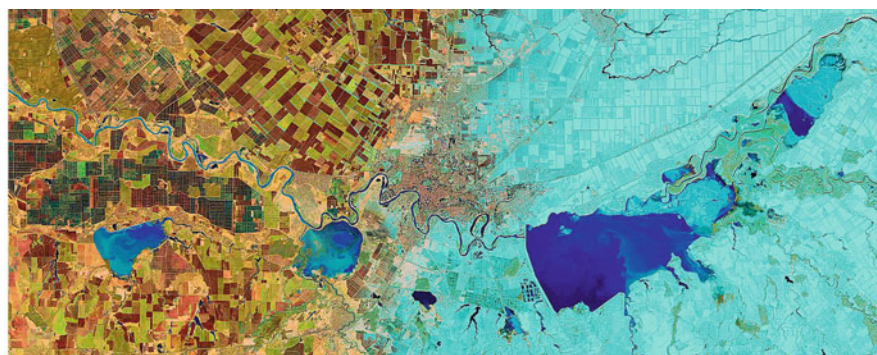
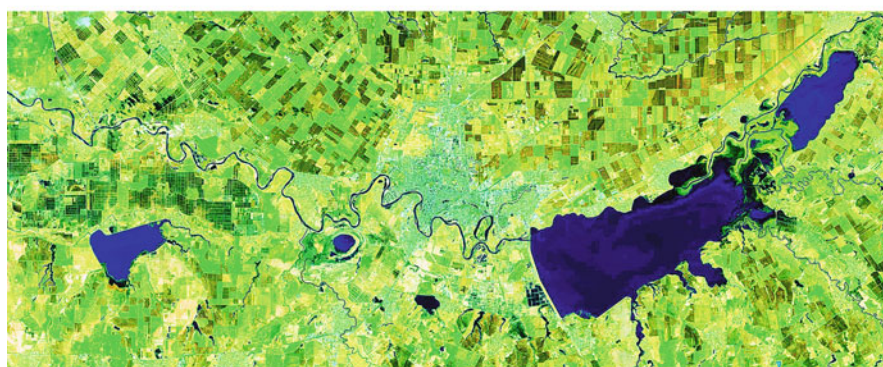
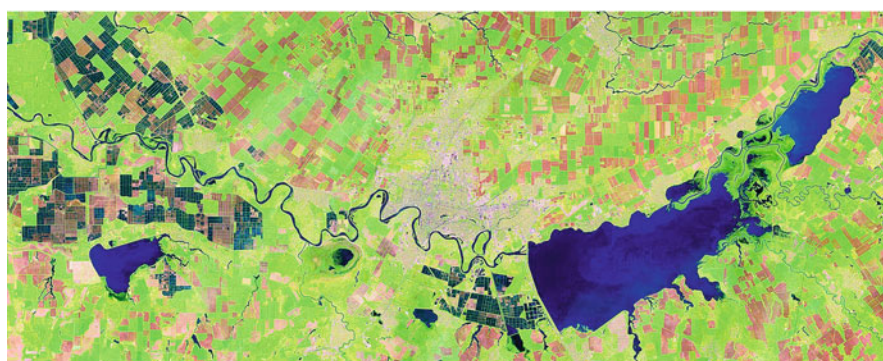
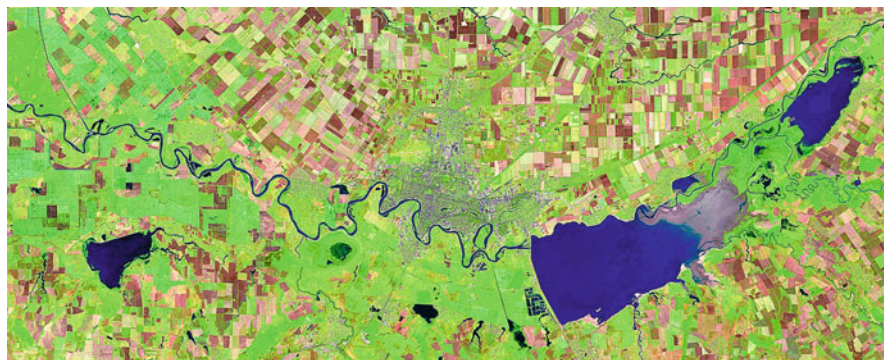
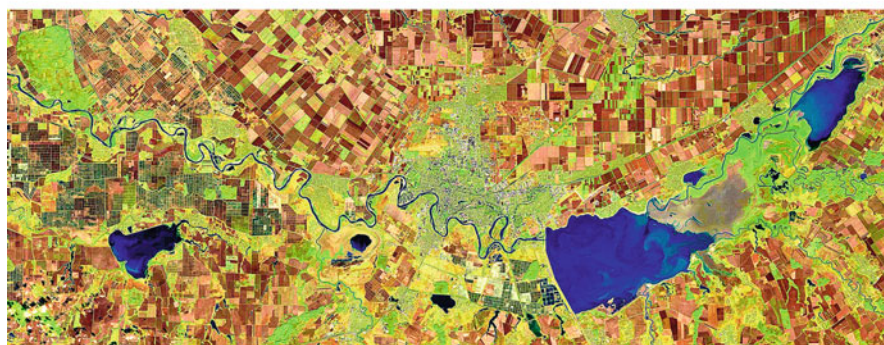
**Fig. 2** The dynamics of the coasts of the Krasnodar, Shapsugkoye, and Kryukovskoye reservoirs according to OLI Landsat 8 in 2015: (a) 15 January 2015, (b) 20 March 2015, (c) 23 May 2015, (d) 27 August 2015, (e) 30 October 2015

Analysis of satellite images of the Krasnodar, Kryukovskoye, Varnavinskoye, and Shapsugkoye reservoirs allowed us to show their condition at a NPU (32.75 m abs.), as well as with a significant decrease in the level in emergency situations at water bodies. For example, at the beginning of 2015, the water level in the Krasnodar Reservoir was 28.69 m, and the volume ( $V$ ) was 648 million  $m^3$ . In accordance with the Rules for the Use of Water Resources, the Krasnodar Reservoir at the beginning of the year usually operates in the filling mode. With heavy rainfall on 12 January 2015, there was a rise in water level and river spills in the Abinsky and western regions of the Krasnodar Territory, resulting in partial flooding of some territories. There were no casualties or destruction. In Fig. 2 shows Landsat-8 OLI data from 15 January to 30 October 2015.

By the end of March, the water level in the reservoir was 31.98 m, and the volume was 1,512 million  $m^3$ . The intermediate values from January 15 and March 20 (Table 2) correspond to the Landsat-8 OLI satellite data shown in Fig. 2a, b.

Table 2 shows the characteristics of the Krasnodar Reservoir in 2015, corresponding to satellite images in Fig. 2. Note that in the high-resolution image dated March 25 (inflow of 156  $m^3/s$ , discharge of 110  $m^3/s$ , water level is 31.91 m abs., and the volume of water in the reservoir is 1,489 million  $m^3$ ) at a level 74 cm lower than the NPU, the gulf near the village of Starokorsunskaya is still connected by a narrow strait with the Krasnodar Reservoir (see Fig. 3). The color of the water of the Belaya River and the canals differs from the water of the Kuban River, the color of which at a distance of about 1 km returns to the original. In the southern part of the image, the color of Belaya mineral suspension characterizes the growing influx of water into the reservoir.

Subsequently, the average discharge was lower than the inflow, which led to an increase in the reservoir capacity. Due to heavy rainfall on the rivers of the Kuban River basin, in the southeastern part of the Krasnodar Territory, floods occurred in May, which were accompanied by an increase in the average inflow into the reservoir. This contributed to raising the level in the upper pool of the reservoir above the level of NPU. Table 2 shows the level (32.12 m) and the volume of water in the reservoir (1,563 million m<sup>3</sup>) on 23 May 2015, and the corresponding satellite Landsat-8 OLI is shown in Fig. 2c). Due to the lack of precipitation in the

By the end of September, according to the data of the Kuban Basin Water Administration (BWA), one of the lowest water levels in the reservoir in recent years was 25.93 m ( $V = 199$  million  $m^3$ ), and on September 28, a level close to the minimum was 25.97 m (Table 2), which is 6.90 m lower than the oil treatment facilities and only 0.12 m higher than the dead volume level (DSL) of 25.85 m. In Fig. 4 shows a Landsat-8 OLI photograph illustrating the advancement of the boundary of the fixed channel ramparts of the Kuban River, which at a level close to the NPU forms a small coastal bay (region 4 in Fig. 3). However, as the level near the village decreases, the Starokorsunsky Bay completely separates from the reservoir, and the area of the isolated basin decreases. The Kuban remote delta continues to move westward. Only the Pshish River, despite the siltation of the estuary, restored the channel and, like the Kuban, carries water to the reservoir. The remote delta of the Belaya River, at values close to the NPU, which usually dumped water into the reservoir (Fig. 2), no longer reaches it.

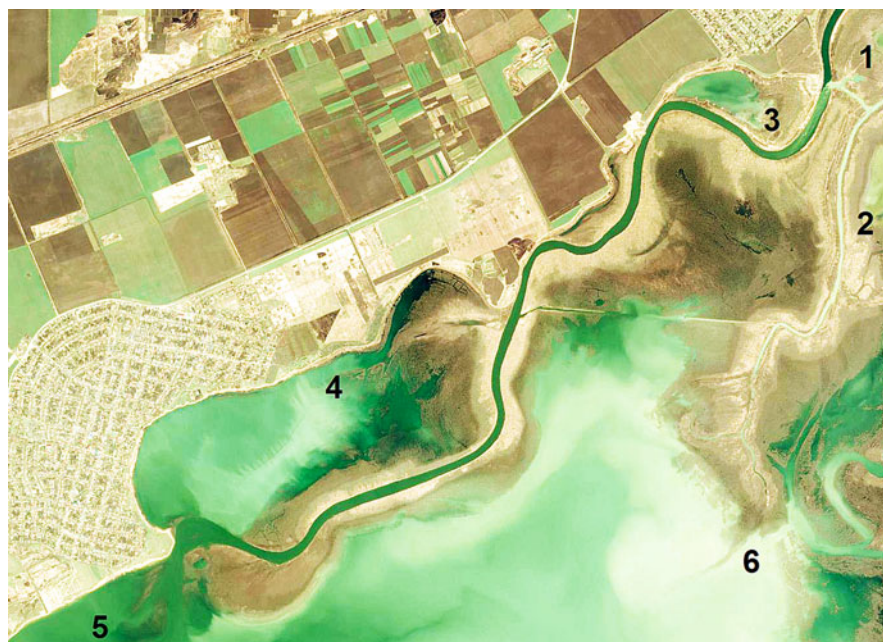
**Fig. 3** The northern part of the Krasnodar Reservoir on 25 March 2015: a channel (1) between Belaya River (2) and Kuban River (3), a bay near the village of Starokorsunskaya (4), remote deltas of the Kuban (5) and Belaya (6) rivers. (Image2016 © DigitalGlobe)

Short-period changes in the level and volume of water in the Krasnodar Reservoir were analyzed for the period 2014–2017. Comparison of satellite images of the coastal zone of the Krasnodar Reservoir (plot 4 in Fig. 3) with photographs of the

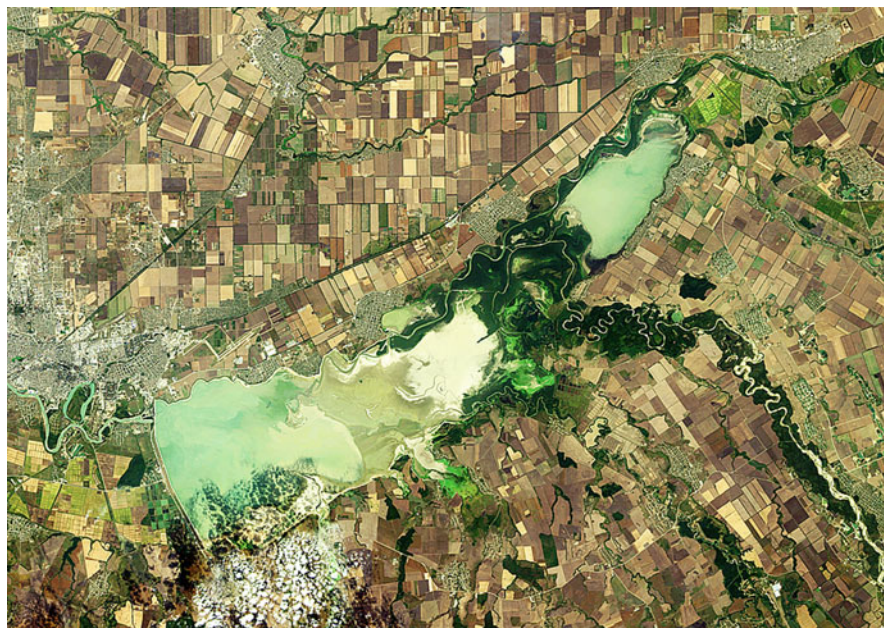
**Fig. 4** Dynamics of the coastal zone of the Krasnodar Reservoir according to OLI Landsat 8 28 September 2015

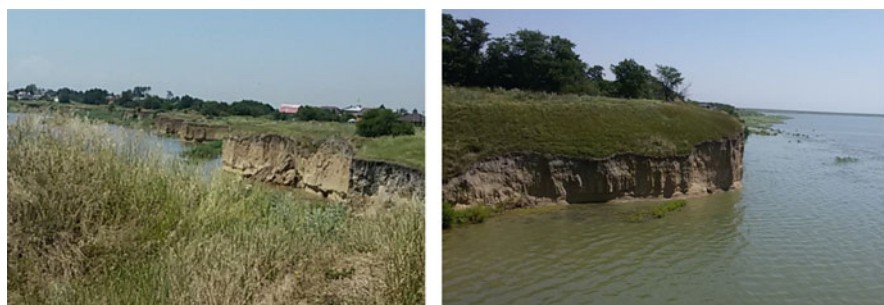
**Fig. 5** The coastal region of the Krasnodar Reservoir in the area of the village of Starokorsunskaya on 7 July 2016, at the level of 33.06 m. (Photo by V.I. Sychev)

area of the village of Starokorsunskaya (Fig. 5) shows its dynamics in 2014–2016 (Fig. 6).

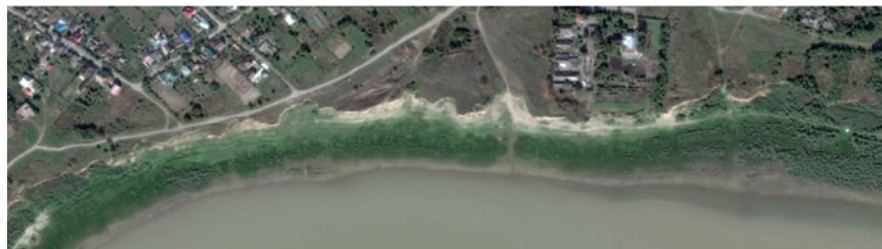
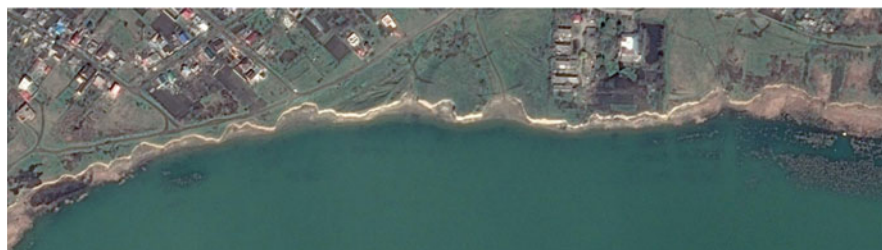
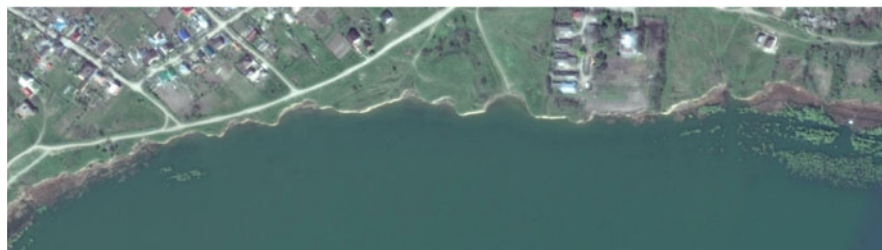
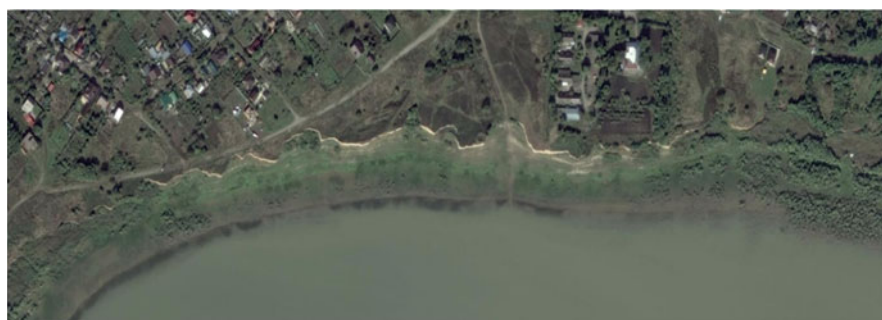
**Fig. 6** The coastal zone of the Krasnodar Reservoir in the vicinity of the village of Starokorsunskaya: (a) 23 September 2014, (b) 25 March 2015, (c) 8 April 2015, (d) 1 October 2016 (Image2016 DigitalGlobe)

**Table 3** Characteristics of the level, inflow, and discharge of water in the Krasnodar reservoir, corresponding to the data in Fig. 6

31.91 m (Table 2) and 8 April 2016 – 32.91 m. Moreover, in Fig. 6b, c, there is a noticeable difference in the coastal area at different levels of the reservoir. Prior to flooding, the modern Kuban floodplain towered 0.5–2 m above the water edge. Several steps of various heights, corresponding to seasonal fluctuations in the water content of the river, stood out on its surface. The floodplain terrace of the right bank of the Krasnodar Reservoir was separated from the floodplain by a steep ledge with a height of 5–15 m. Currently, the most intensive reformation process takes place along the right steep and deep bank. In Fig. 5 a steep coast is clearly visible at a level of 33.06 m on 7 July 2016 (Table 3).

From the side of the village Starokorsunskaya, there is a free passage to the water. In winter, the water level drops, and there forms an extensive sandbank (Fig. 6a, d). In some places, the remains of the banks washed up by the water look like fantastic ruins. Locals sometimes find ancient vessels washed out of a powerful cultural layer located from Starokorsunskaya and further along the former channel toward Ust-Labinsk town. Layers of clay earth fall off the steep banks into the water every spring, exposing traces of the culture of the past millennia, and carry them to the bottom.

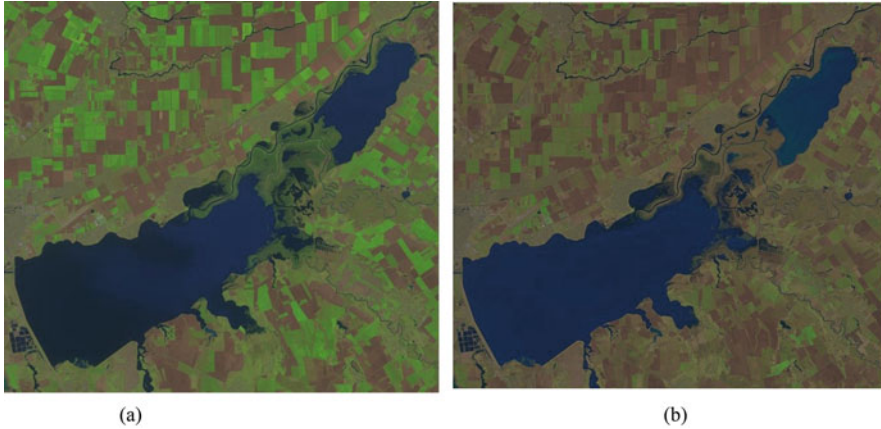
**Fig. 8** Composite images of OLI Landsat 8 corresponding to level marks 31.85 m on 20 March 2015 (a) and 32.97 m on 7 April 2016 (b)

As an example of assessing the nature of siltation of the reservoir, a satellite image (Fig. 8d) dated 28 July 2016 was used. The water level in the reservoir at the time of the survey (according to the Kuban BWA) was 32.87 m and was 12 cm higher than the NPU. The Belaya Belt Delta continued to form a powerful jumper. Its dry areas are covered with a continuous cover of vegetation. The waters of the Kuban River with the growth of the jumper zone cut mud deposits in the places of their old riverbed, which existed before its flooding by the reservoir. It completely restored the section of this channel from the village of Vasyurinskaya to the village of Starokorsunskaya, formed the river banks, and secured with woody vegetation,

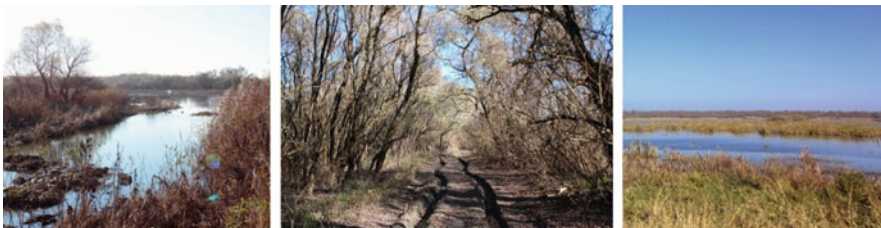
**Fig. 9** Vegetation on the bridge between the Krasnodar and Tshchikskoye reservoirs, November 2013 (Photo by V.I. Sychev)

The jumper is practically impassable for foot, land, and water transport sites. A strip of old trees is visible along the former dam of the Tshchikskoye Reservoir. In open moist places, reeds and other marsh vegetation interspersed with young willow shoots (Fig. 9).

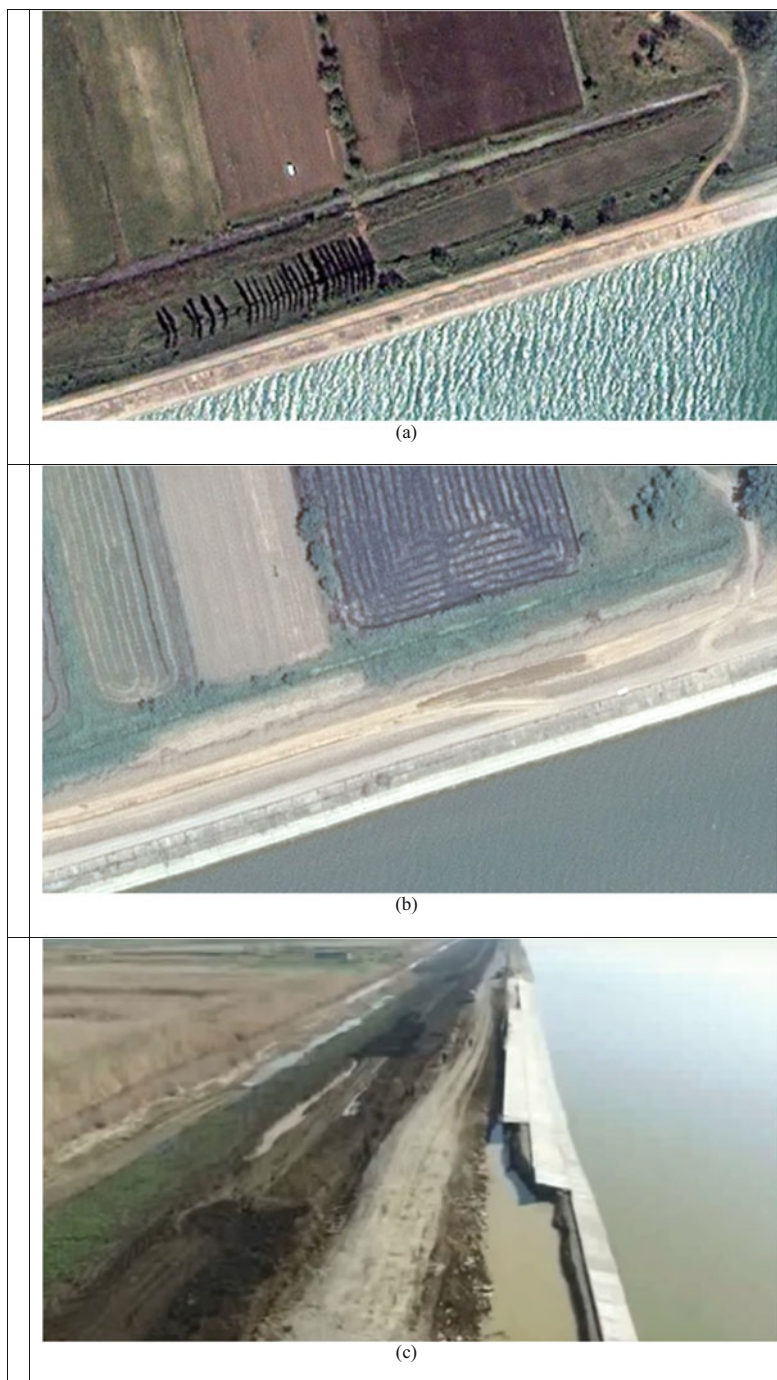
**Fig. 11** Section of the northern dam of the Kryukovskoye Reservoir: (a) before its damage on 3 March 2013, (b) after work to strengthen it on 2 August 2014, (c) the damaged section, 1 April 2017

Kryukovskoye Reservoir on 30 March 2017. The water management situation in the Krasnodar and Kryukovskoye reservoirs did not cause serious concern: their characteristics were close to the NPU. At 1 km from the village of Mikhailovsky Seversky district at 14 h 35 min on 30 March 2017, in the body of the northern dam of the Kryukovskoye Reservoir, soil subsidence to a depth of 1.5–2 m, and a length of up to 150 m occurred. Engineering work was carried out on this site in 2014, which can be obtained by comparing Fig. 11a, b according to satellite imagery data dated 3 March 2013 and 2 August 2014. A photo of the damaged area dated 1 April 2017 is shown in Fig. 11.

At the site of the damage, engineering work was carried out to strengthen the dam, which was completed on 6 April 2017, and the emergency mode on the Kryukovskoye Reservoir was canceled. By April 7, the water level in the Krasnodar Reservoir was 32.82 m and was 7 cm higher than the NPU.

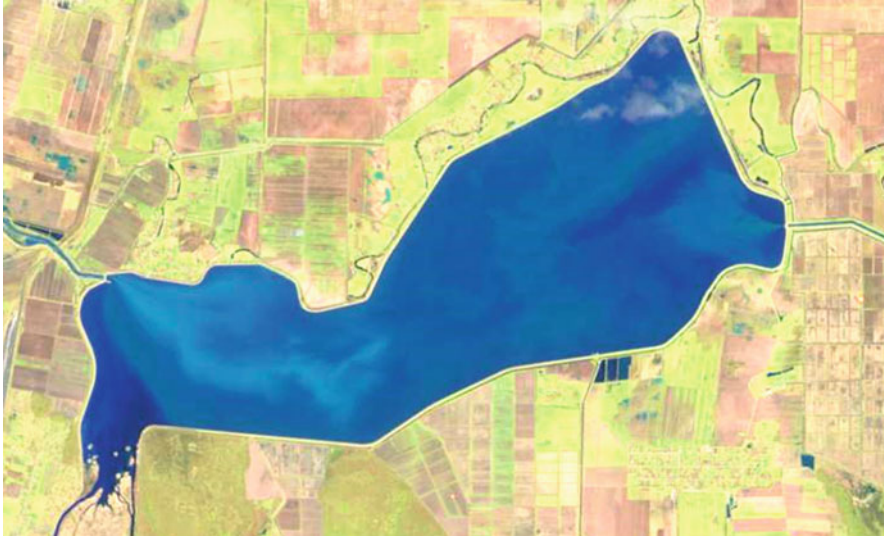
**Fig. 13** Varnavinskoye Reservoir according to Sentinel-2 on 1 April 2017

For example, in the fragment of the image (Fig. 13), you can determine the area of the Varnavinskoye Reservoir, which is close to the maximum, as well as determine the flow characteristics of the water entering the Varnavinskoye Reservoir. After the damage, to avoid breaking the dam, the discharge of water from the Kryukovskoye Reservoir was more than doubled from 28.4 to 70 m<sup>3</sup>, and more than nine million m<sup>3</sup> were discharged from the reservoir in 2 days, which was on 1 April 2017. An appropriate message was received from the Krasnodar Territorial Headquarters of EMERCOM (the Ministry of the Russian Federation for Affairs for Civil Defence, Emergencies, and Elimination of Consequences of Natural Disasters). In Fig. 13, water flows are visible, both from Kryukovskoye and from the Varnavinskoye discharge channel. Analysis of satellite images of the Krasnodar, Kryukovskoye, Varnavinskoye, and Shapsugkoye reservoirs allowed us to show their condition at NPU, as well as a significant decrease in the level in cases of emergencies at water bodies, and provide examples from Landsat-8 and Sentinel-2 satellites.

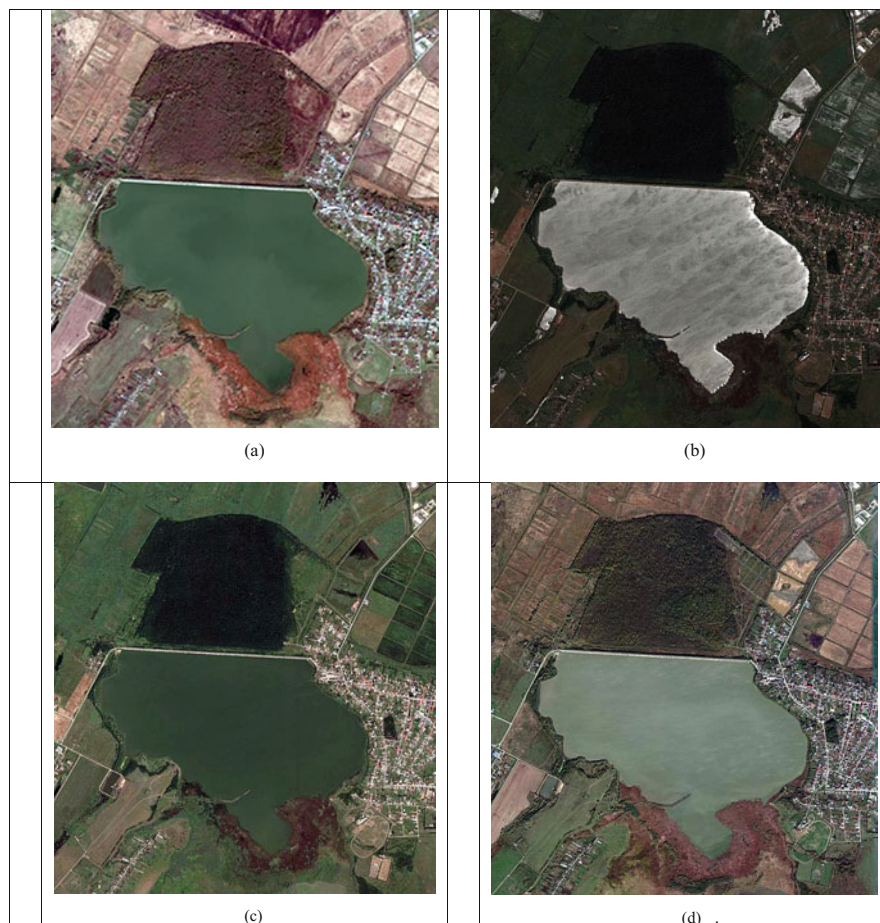
**Fig. 15** Oktyabrskoye (Takhtamukayskoye) Reservoir area according to Image2016 © DigitalGlobe: (a) 29 October 2014, (b) 3 October 2016, (c) 4 October 2016, (d) 26 October 2016

Figure 15 shows an example of changes in the area of a reservoir. The scenes obtained for the neighboring dates on 3 and 4 of July 2016 are of interest. Figure 15b represents the water surface in solar flare, which allows us to evaluate its heterogeneity in detail and also to determine the area of the reservoir and rice checks with greater accuracy. Figure 15c allows to determine the heterogeneity of the land surface and, using the data of the thermal range, to assess the degree of its humidity.

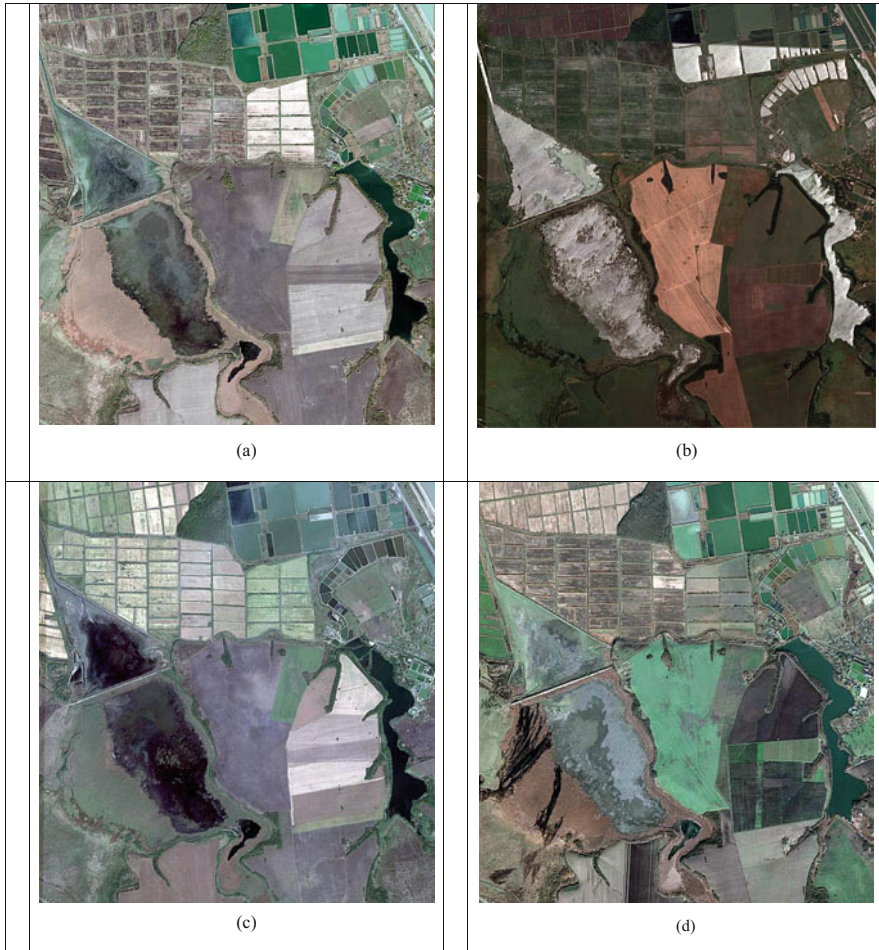
**Fig. 16** The area of the Shendzhiyskoye and Cheytukskoye reservoirs according to Image2016 © DigitalGlobe: (a) 17 September 2014, (b) 29 October 2014, (c) 3 July 2016, (d) 24 November 2016

For the region of these shallow water reservoirs, sufficiently detailed information can also be obtained on their area, as well as on the condition of field lands and rice receipts (Fig. 16).

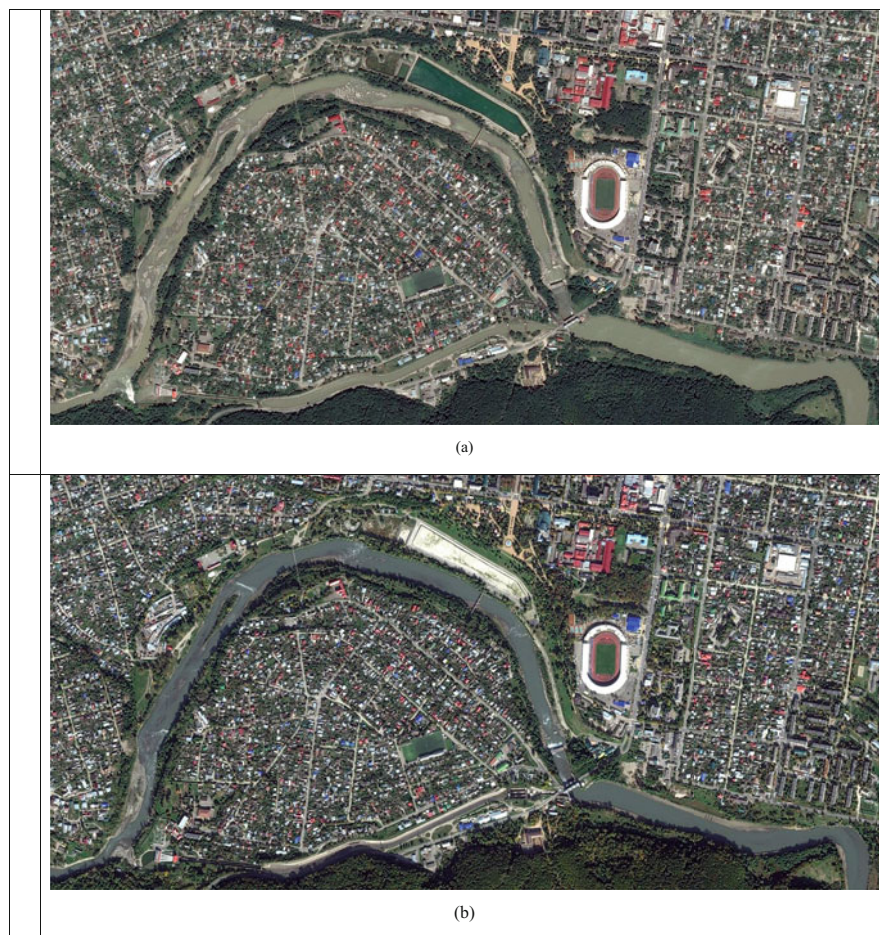
**Fig. 17** The area of the City of Maykop, Maykop hydroelectric power station and reservoir according to Image2016 © DigitalGlobe: (a) 12 July 2016, (b) 7 October 2016

Figure 17 shows the scenes of the Maykop City region of 12 July and 7 October 2016. Figure 18 illustrates the state of Maykop's water bodies in 2014–2016. The bottom of the images shows a derivation channel filled with water in summer with traces of water discharge below the hydroelectric station building (Figs. 17a and 18b) and drained in the image in the autumn (Figs. 17b and 18d) – there are no traces of water discharge below the hydroelectric station.

In the upper part of the images (Fig. 17), a regular-shaped design attracts attention. This urban swimming pool (length 500 m, width 50 m, depth 3 m) is the only one preserved in the country of this size. The pool is filled with running water during the hot summer period (Fig. 17a) and drained in the fall (Fig. 17b). Despite significant costs, local authorities are trying to keep it clean and ensure the safety of

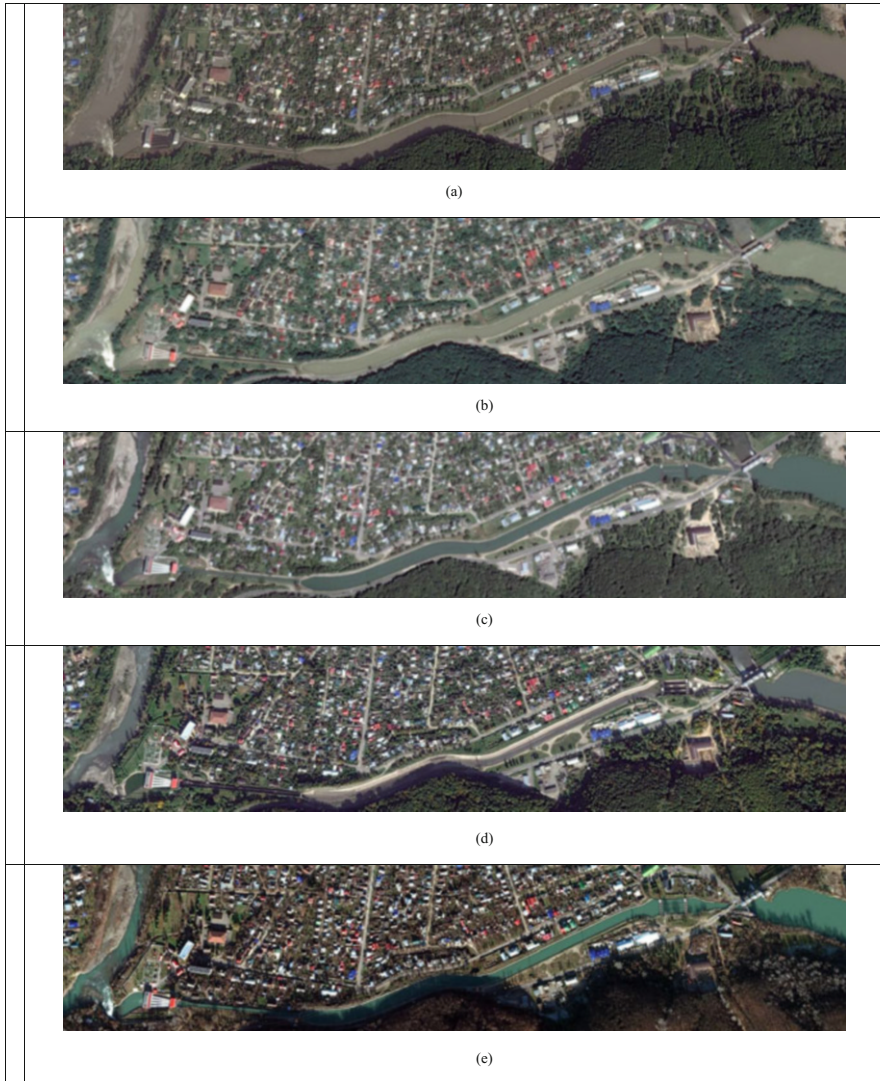
**Fig. 18** Maykop hydroelectric station and reservoir according to Image2016 © DigitalGlobe: **(a)** 30 September 2014, **(b)** 12 July 2016, **(c)** 15 July 2016, **(d)** 7 October 2016, **(e)** 25 November 2016

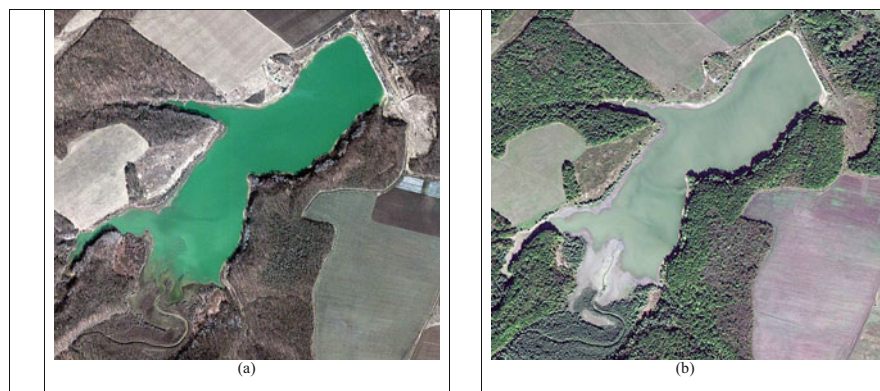
**Fig. 19** The area of the Kuzhorskoye Reservoir according to Image2016 © DigitalGlobe: (a) 1 March 2013, (b) 18 October 2015
