## LANDSLIDES FROM MASSIVE ROCK SLOPE FAILURE AND ASSOCIATED PHENOMENA

### Abstract

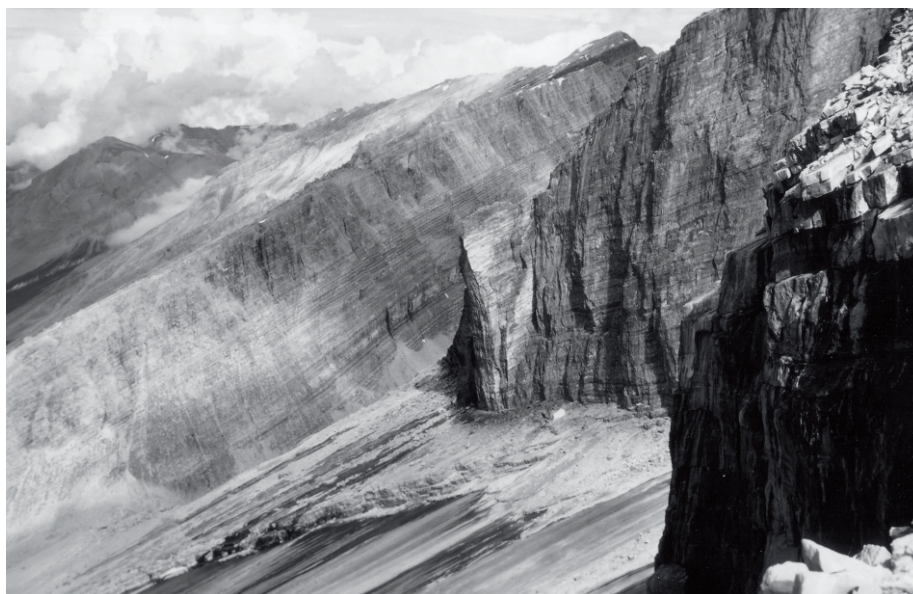
*Figure 2.* The breakaway scarp and sliding surface of the Avalanche Lake rock avalanche, Mackenzie Mountains, North West Territories, Canada [102]. The sliding surface consists of a bedding plane in Paleozoic carbonates that form a dip slope, evident in background.

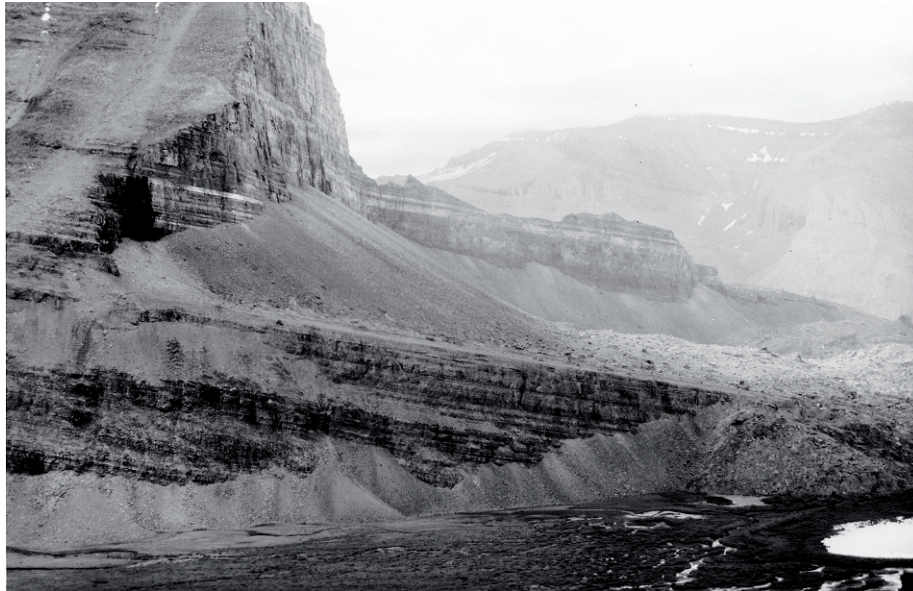
*Figure 3.* Sliding surface and breakaway scarp of the massive Rockslide Pass rockslide, Mackenzie Mountains, N.W.T., Canada. Sliding surface is a bedding plane in Paleozoic carbonates that dips at only 14 degrees.

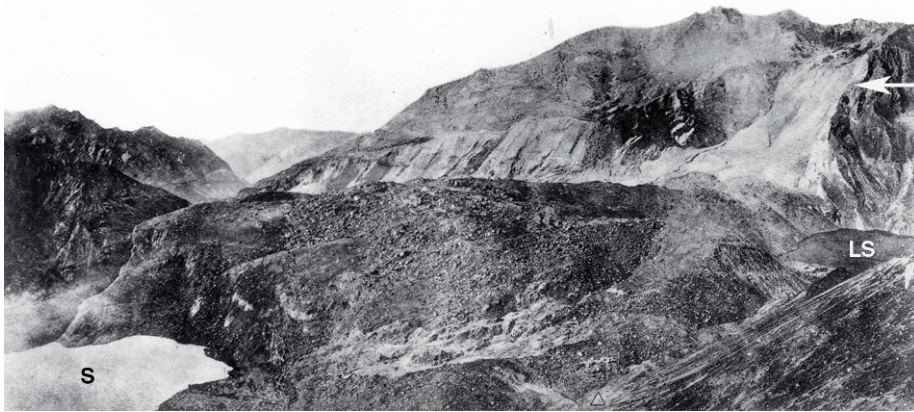
*Figure 4.* The Usoi rockslide shortly after it occurred. Scar is arrowed (white arrow at right). View is downstream. Lake Shaddau is to the left (S) and Lake Sarez is at the right (LS). Photograph was taken before the complete filling of Lake Sarez behind the rockslide dam (Plate I in Preobrajensky, 1920 [256]).

The rockslide of ca.  $2.2 \text{ B m}^3$  in volume, blocked the Murgab valley and formed 75 km long Lake Sarez [272]. It also blocked its left tributary – the Shaddau creek and formed a minor lake of the same name (Figures 4 and 5).

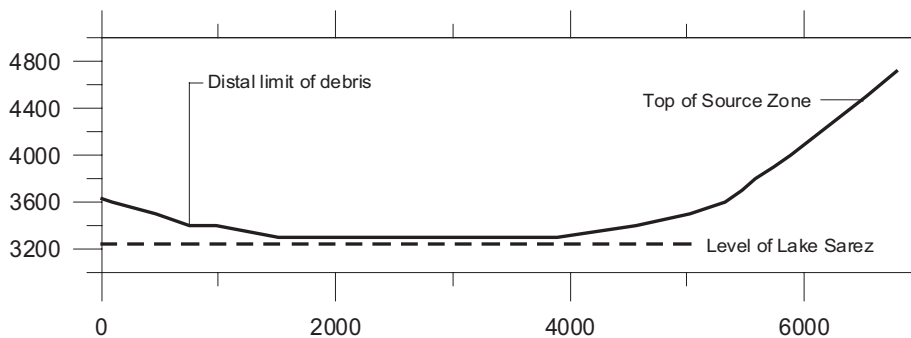
Figure 7. Profile of Usoi rockslide. Level of Lake Sarez (~ 3255 m.a.s.l.) is indicated. Profile suggests a *fahrboschung* of ~ 12 degrees.

The main part of the landslide body (Figures 5, 6, and 7) is composed of the debris of the Sarez Formation and its proximal part - of marble and shale with some subordinate gypsum, anhydrite and dolomite debris. Since the uppermost part of the source zone affected moraines of local hanging glaciers it is expected that some glacier ice may be buried in the proximal part of the landslide body. However, the internal composition of the Usoi Dam is not known. According to surface observations,

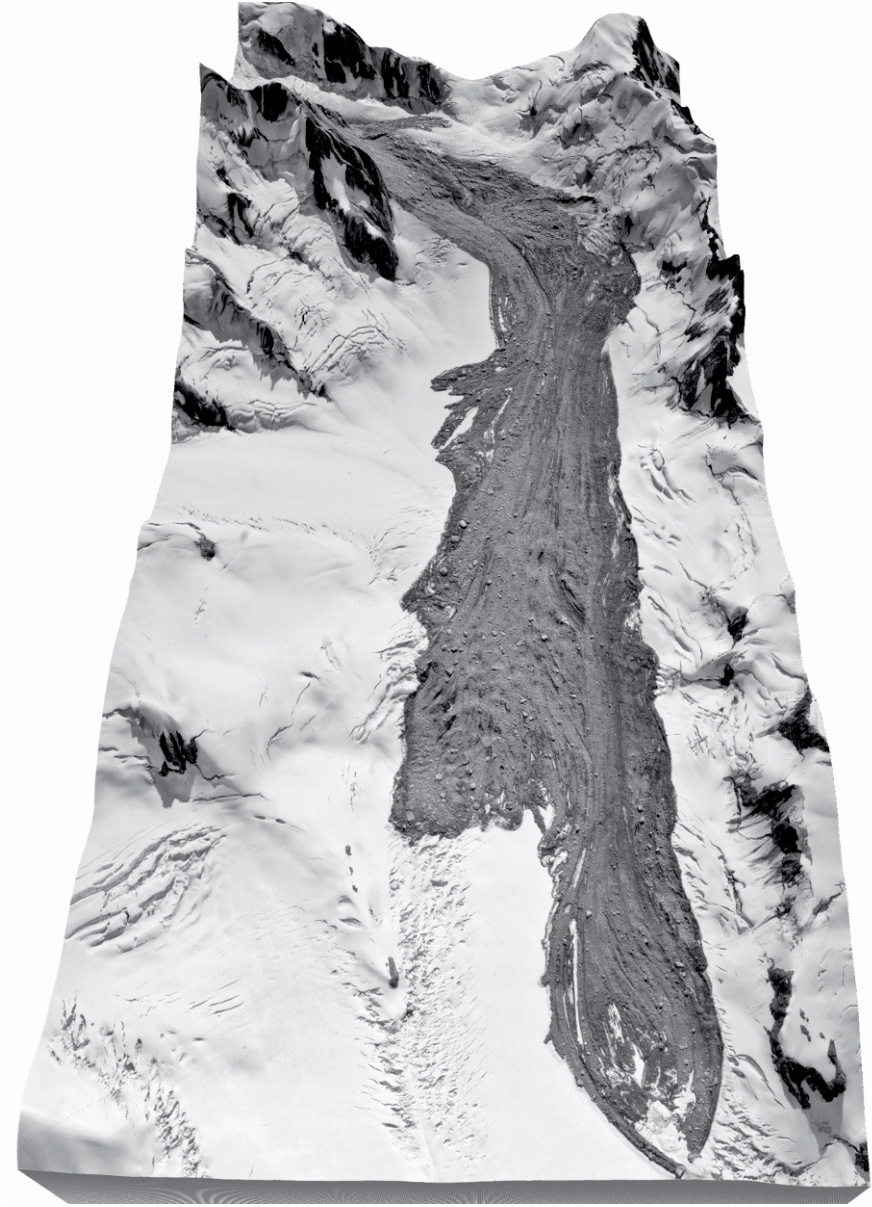
*Figure 9.* Perspective view to the southeast of the 1997 Mount Munday rock avalanche on Ice Valley Glacier, Waddington Range, southern Coast Mountains. This digital image was prepared from aerial photographs flown on August 20, 1997, and consists of a DEM with an orthophoto drape. Note flow lines in the debris. Elevation of the top of the source area is 3000 m.a.s.l. and the lower tip of the debris is at 2100 m.a.s.l. The length of the rock avalanche path is 4.7 km [95].

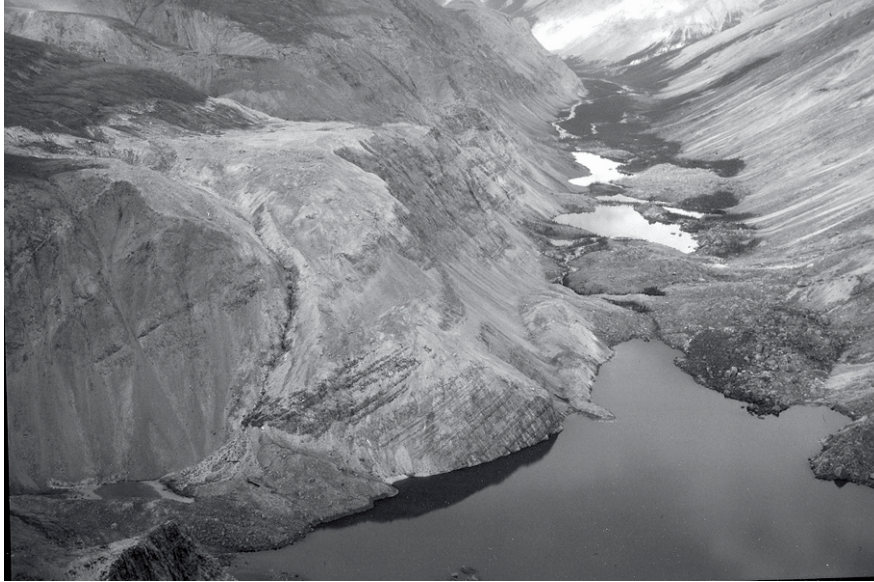
*Figure 10.* Excessive run-up at Avalanche Lake rock avalanche, Mackenzie Mountains, N.W.T. The landslide moved from the right and ran up the steep slope of the wall running out on the surface of The Shelf, 640 m above the pre-landslide valley floor [84, 91, 102].

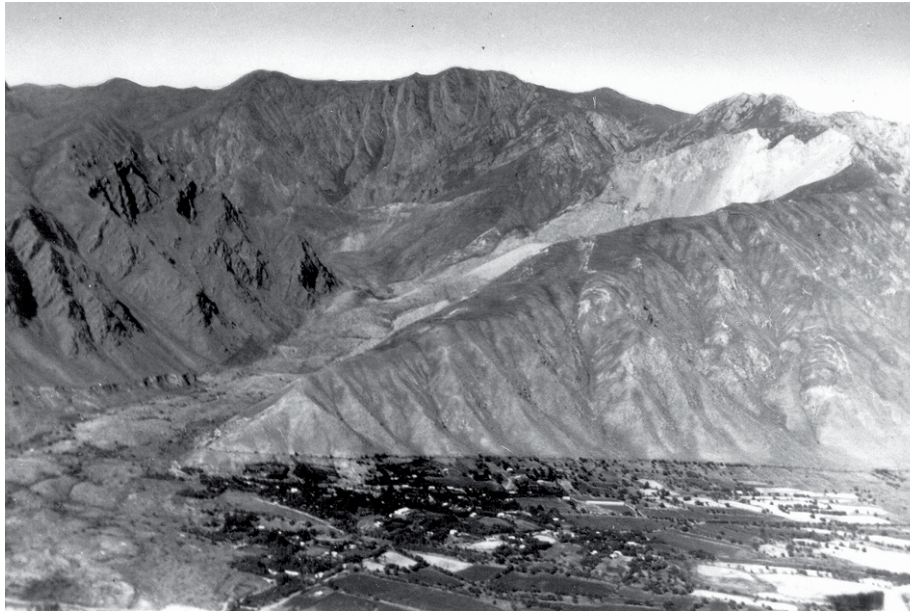
*Figure 12.* Aerial view of the Khait rock avalanche showing the source massive rock slope failure (top right) the middle path, where massive entrainment of loess took place, and part of the deposit which buried the town of Khait (bottom left) (USGS photograph).

The debris buried the town of Khait and the neighbouring small village of Khisarak (Figures 11 and 12). As many as 24,000 people may have been killed in these settlements. The total runout of the Khait rock avalanche was about 11 km over a
