Chapter 3.4

COMPATIBILITY OF MATERIALS USED FOR REPAIR OF MASONRY BUILDINGS: RESEARCH AND APPLICATIONS

Luigia Binda, Antonella Saisi and Cristina Tedeschi

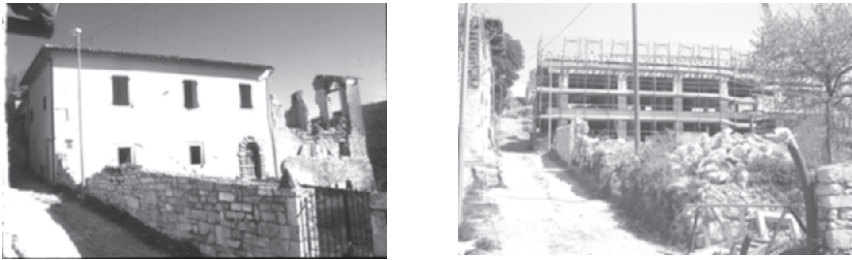
Figure 3. The building repaired in the 80s and partially failed, has been demolished and an r.c. structure rebuilt.

In this context a further problem has been defined, that is the modality of intervention on buildings repaired in the past with unsuccessful techniques. Up to now, the question was often solved by the complete demolition of the building and the volume reconstruction in concrete (Figure 3).

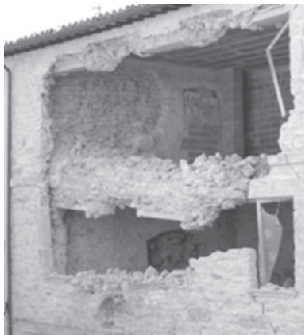
Figure 6. Out-of-plane collapse of a wall with r.c. tie beams.

The damages observed more frequently were the following: (i) partial eccentric loading of the walls (Figure 4), (ii) lack or poor connection of the tie beam to the walls (Figure 5). The seismic events, then, showed that these elements cannot transmit the horizontal actions to the walls and neither can connect the two masonry leaves, of which one remains free and can rotate freely and overturn (Figure 6).

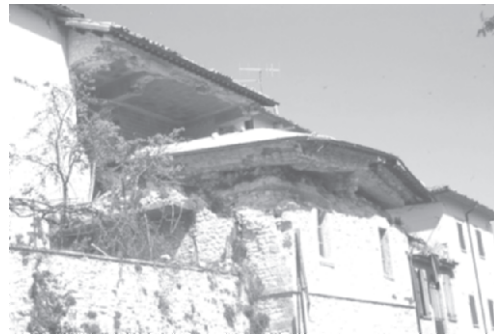
Figure 7. Roof hammering the masonry walls.

In this technique it is important to realise an effective connection between the tie beam and the masonry. In the case of the tie beam at the roof level, which can rest on the whole section of the wall, the connection is difficult because it should be realised by vertical metal connectors inserted in the wall from the top. Once again, this connection is seldom possible in a multiple leaf stone masonry. Furthermore the stiffness of the concrete roof can be too high compared to the one of the existing wall and the roof can hammer the wall and cause a partial collapse (Figure 7).

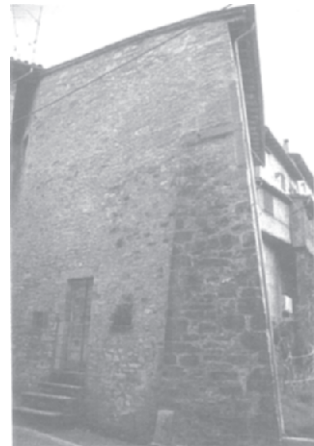
Figure 19. Addition of buttresses

Another system largely adopted in Umbria was the use of buttresses against the existing walls (Figure 19).
