# **WATER-RELATED NATURAL DISASTERS: STRATEGIES TO DEAL WITH DEBRIS FLOWS: THE CASE OF TSCHENGLS, ITALY\***

**Abstract:** The chapter reports on a case study of how people and public administrations dealt in the past and currently deal with the danger of debris flow. After a brief description of main debris flow features, the time series of debris flow events and the history of training works at the Tschengls torrent are reported. Finally, a modern approach based on a theoretical background of debris flow research is described. The integral analysis allows us to assess the debris flow activity and intensity in satisfactory detail and therefore allows us to derive recommendations for structural and nonstructural measures.

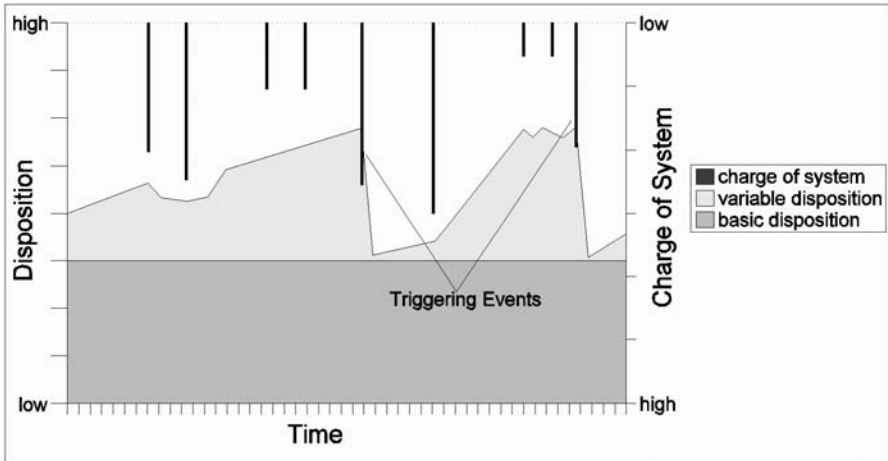
Figure 3: Link between Basic Disposition, Variable Disposition and Triggering Events (Kienholz 1995).

For the occurrence of debris flows in a watershed, two conditions must exist: debris sources and a minimum torrent slope. According to Kienholz (1995), the presence of these conditions represents the basic disposition (long-term tendency) of a torrent to show debris flow activity.

The variable disposition represents the short-term readiness for a debris flow event, for example, the saturation of the underground material or the accumulation of loose materials on the torrent bed (due to continuous sediment delivery or due to a sudden event, for example, a landslide).

The initiation of a debris flow finally is caused by a triggering event. In the Alps, these events are primarily intense precipitations. Alternatively, catastrophic flows can be originated by the collapse of a glacial moraine, by dam failures, by strong snow melting, or even by soil liquefaction caused by seismic events. As shown in Figure 3, the triggering intensity required to initiate an event is not constant in time and is directly related to the total disposition, i.e., the sum of basic and variable disposition, in the torrent at the moment of the triggering event.

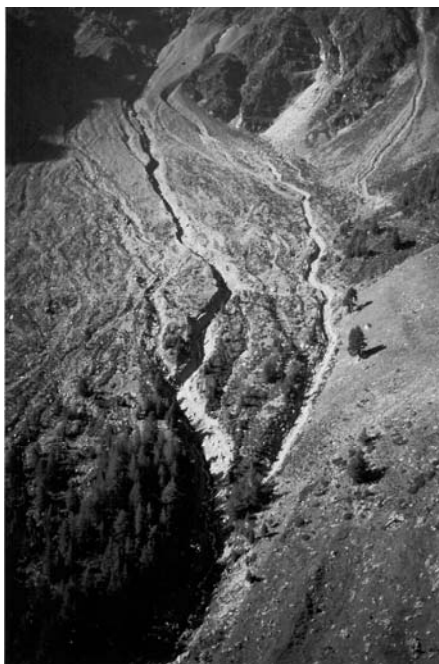
*Figure 5: The Watershed and the Upper Basin Area of the Tschengls Torrent.*

The Tschengls torrent has a catchment area of 10.6 km<sup>2</sup> and is a tributary of the Etsch, the river with the second largest catchment area of Italy. The highest point of the watershed is at an altitude of 3,375 m a.s.l., the lowest point is at 875 m a.s.l. The main reach of the torrent has a length of 7.1 km with a mean slope of 34 percent.

The Tschengls torrent is a typical alpine mountain torrent. The main debris sources are in the upper basin area and have a total surface area of around 0.75 km<sup>2</sup>. Several secondary creeks run through the debris sources and, after having passed a rocky portion with cascades, they join and form the main reach of the Tschengls torrent. Both the steep slope and the large volume of available debris in the upper basin area contribute to a high likelihood of the occurrence of debris flows in the Tschengls torrent.

The upper basin area of the Tschengls torrent is surrounded by very steep rocky walls that provoke thunderstorm cells to burst, resulting in intensive precipitation, which is an important triggering condition for the initiation of debris flows (Figure 5). Therefore the upper basin area is characterized by a high debris flow activity.

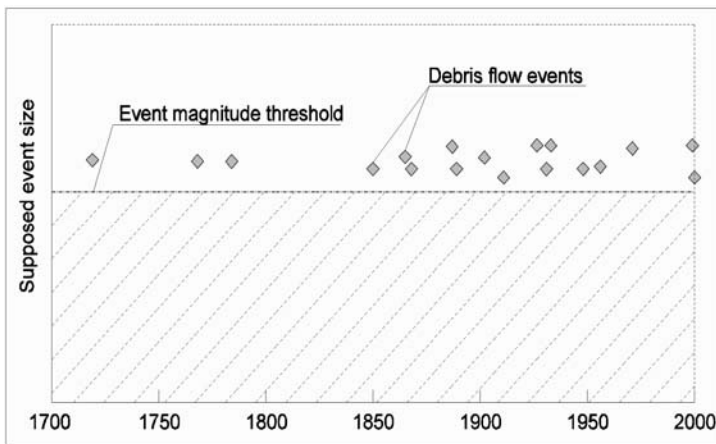
Figure 6: Time Series of Debris Flow Events at the Tschengls Torrent.<sup>1</sup>

However, as shown in Table 1 and Figure 6, debris flow activity on the Tschengls torrent is rather erratic. Frequently after big debris flow events, a series of smaller events occurs (for example after the events in the years 1865, 1887, 1929, and 1999). This observation leads to the hypothesis that the zone where debris flows develop is destabilized by the first event, encouraging the development of subsequent smaller debris flows.

<sup>1</sup> The graph shows the debris flow that exceeded the threshold of event magnitude which is necessary to reach the village of Tschengls (according to Ouarda et al. 2002). Beneath the threshold other events that did not reach the village might have occurred.

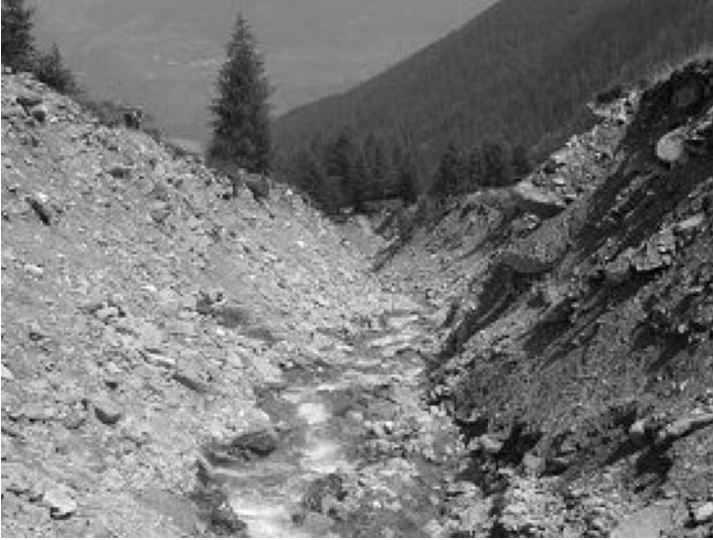
*Figure 7: Erosion Channel in the Initiation Zone of Debris Flow Events in 1999.*

Figures 7 and 8 show the initiation zone and deposition zone respectively of the debris flow events in 1999, whose main characteristics could be reconstructed quite well from field evidence, a video recording and eyewitnesses accounts.

The total volume of the two debris flows was estimated by comparing the volume of channel erosion with the volume of the deposits. Both debris flows together mobilized a volume of 70,000 to 100,000 m<sup>3</sup>. Based on their duration, velocity, and depth, as observed by eyewitnesses, the volume of the first event was estimated to be twice the volume of the second event.

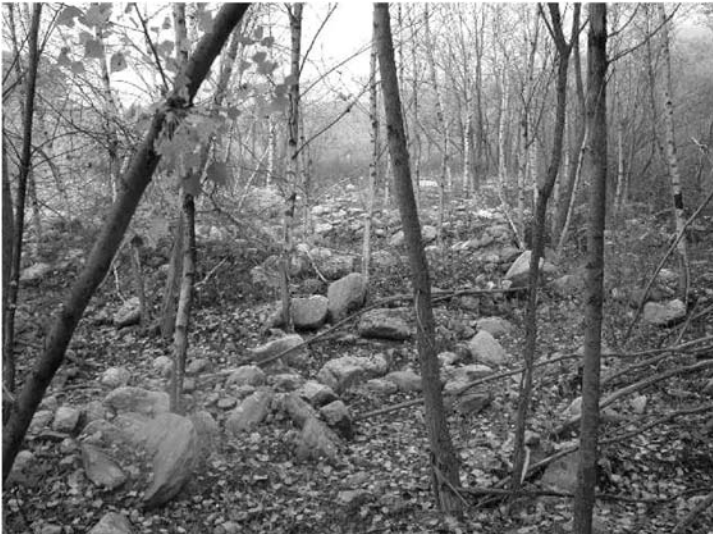
*Figure 8: Deposition Zone of Debris Flow Events in 1999.*

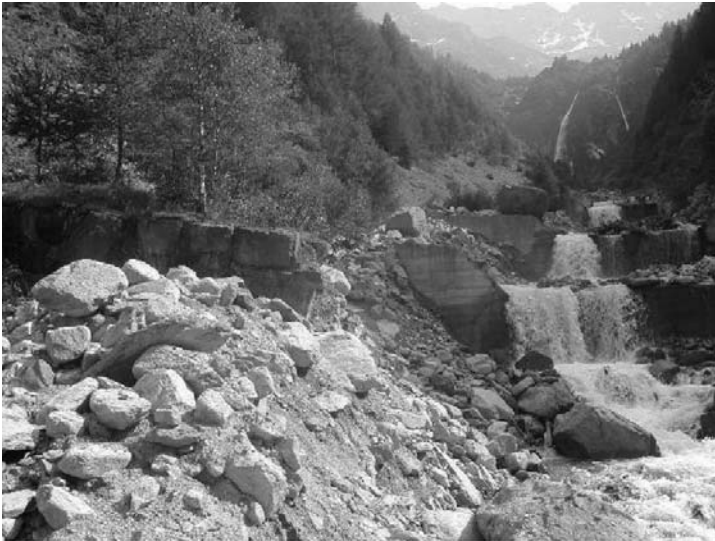
*Figure 10: Check Dam Series in the Transition Zone of the Torrent (construction: 1972–1973).*

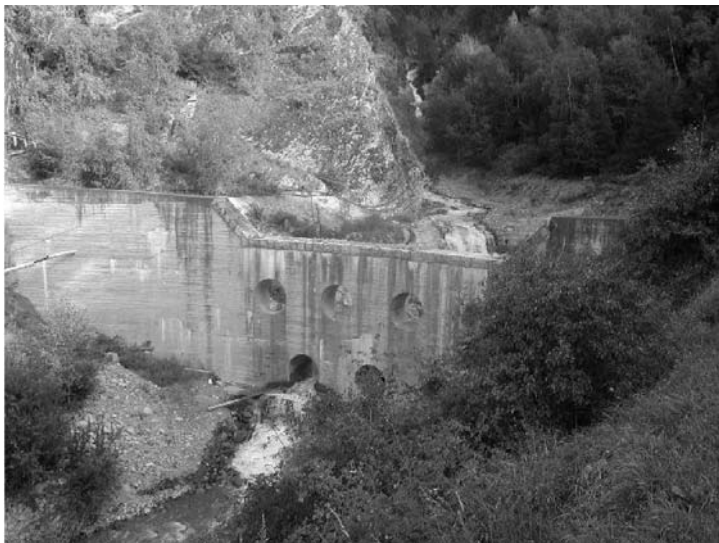
*Figure 11: Debris Retention Basin Immediately Upstream of the Village (construction: 1973)*

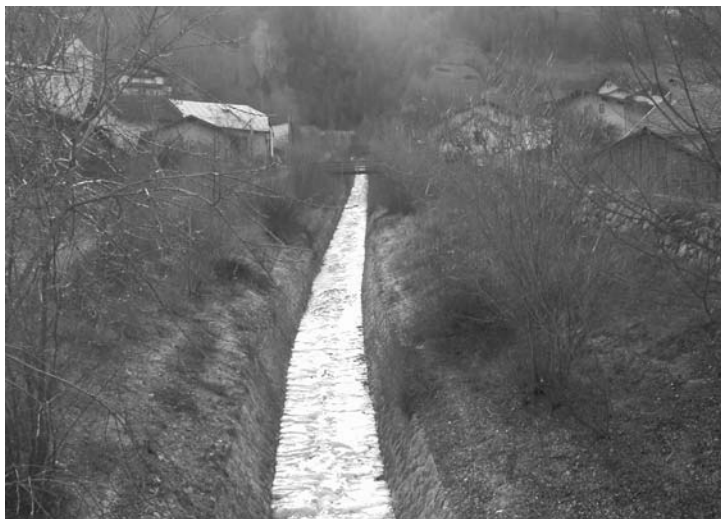
*Figure 12: Trapezoidal Channel through the Village (construction: 1974–1975).*

1. The side walls on both sides of the trapezoidal channel contribute significantly to the discharge capacity of the torrent. They confine the flow and allow it to pass through the village. Therefore it is necessary to examine their condition since they are around 130 years old and seem weakened in some places.

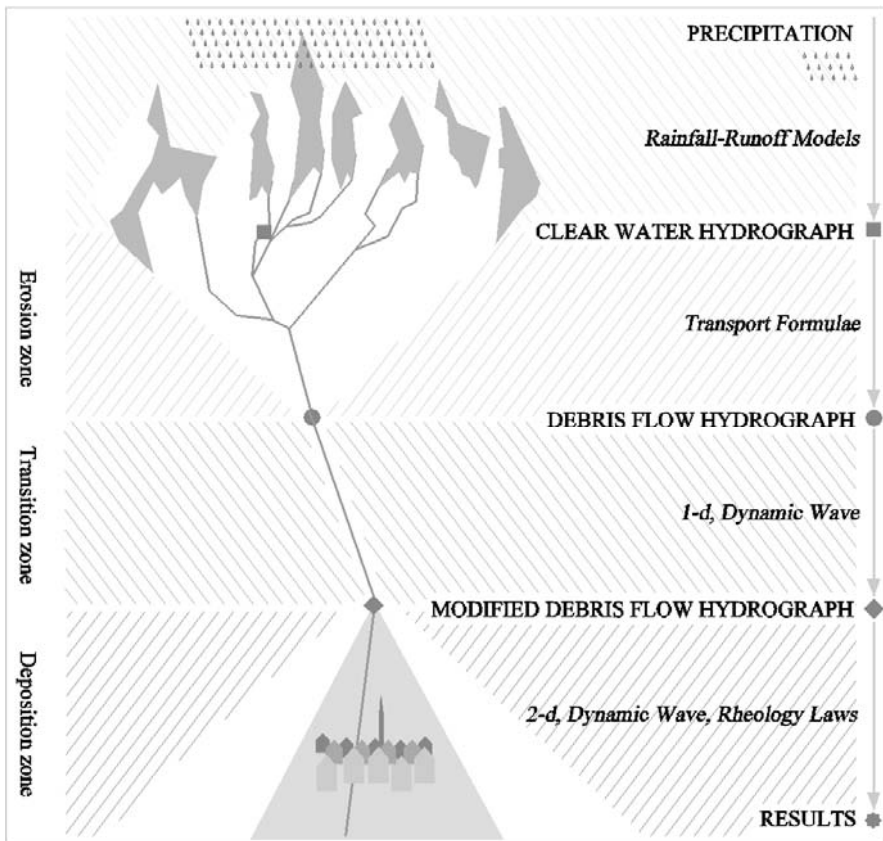
Figure 13: Flowchart of the Adopted Methodology That Takes into Account Debris Flow Initiation, Transport, and Deposition.

Figure 13 presents a flowchart of the adopted methodology. The modular and gradual structure of the physically based approach includes the formation, transportation and deposition of debris flows.

Analysis begins with a rainfall-runoff model. Precipitation data based on the local meteorological conditions are combined with the hydrological characteristics of the watershed to define clear water hydrographs at different points of interest.

Clear water hydrographs serve as input data for the next step of the analysis where debris flow hydrographs are developed, using different sediment transport formulae.

Debris flow hydrographs are routed through the transition zone using a 1D numerical model. Debris retention basins are considered in a simplified way.

The modified debris flow hydrographs represent the input for the 2D numerical model of the urbanized area. The simulation of different scenarios provides a series of results that allow to the proposal of mitigation measures.
