Review of the 1755 Lisbon Earthquake Based on Recent Analyses of Historical Observations

C. S. Oliveira

Abstract The importance of the 1755 Lisbon earthquake is known worldwide not only among the scientific and technical communities but also in many other disciplines of human kind related to the effects and consequences of the earthquake. A re-visiting of the 1755 Lisbon earthquake is made based on the historical descriptions in what regards the multiple aspects of scientific and technological background in his smaller details as, for example, the predominant direction of shaking, the duration of the event, the anisotropy in propagation, the enormous area of perception with its direct effects along all the Iberian Peninsula and Morocco, the water movement in Scotland (seiches), the enormous tsunami that affected the Portuguese, Spanish and Morocco coast, being remarkable the waves in the other side of the Atlantic, in New Jersey. These examples illustrate that the 1755 earthquake was a unique seismologic event for which a great deal of information already exists but, on the other hand, still contains many unresolved problems.

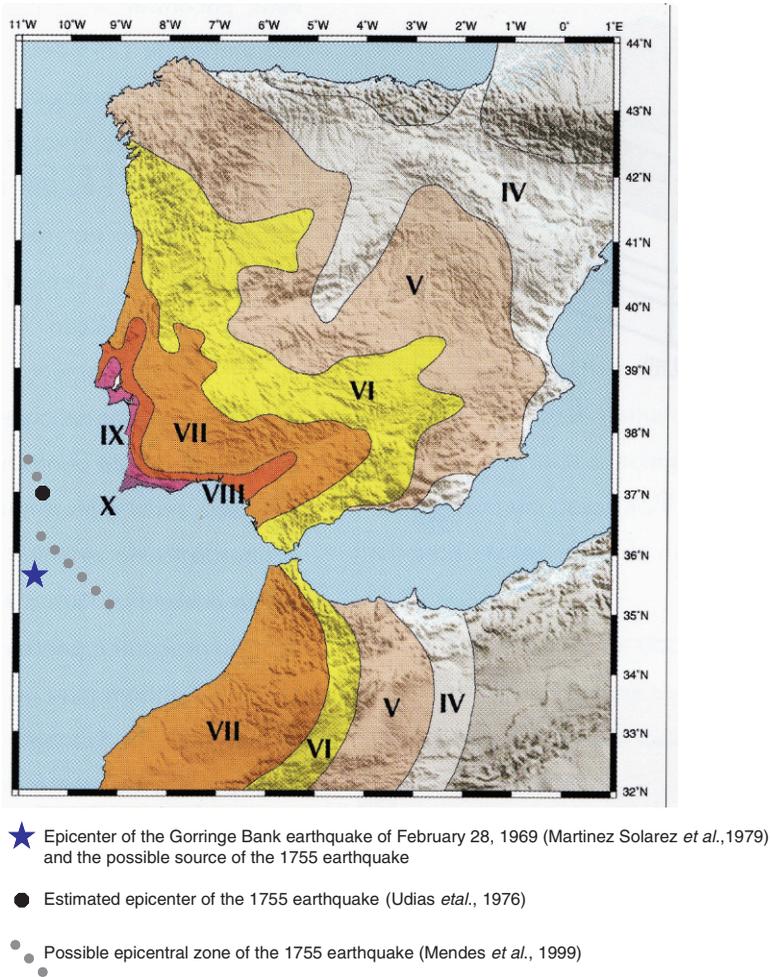
Fig. 1 Map of isoseismals (MSK Intensities) from the earthquake of November 1st 1755, with some possible localizations of the seismic source (based on Martinez Solares *et al.* (1979); Levret (1991); Moreira (1984) and Mendes *et al.* (1999)

we should mention Choffat (1904), Reid (1914), Pereira de Sousa (1919–1932), Moreira (1984) and Martinez-Solares (1979). Figures 1 and 2 summarize some of those studies, presenting the isoseismals and the possible localizations of epicentres of 1755 and of February/28/1969 event, which, until a few years ago, was considered as belonging to the same geo-morphological fault system.

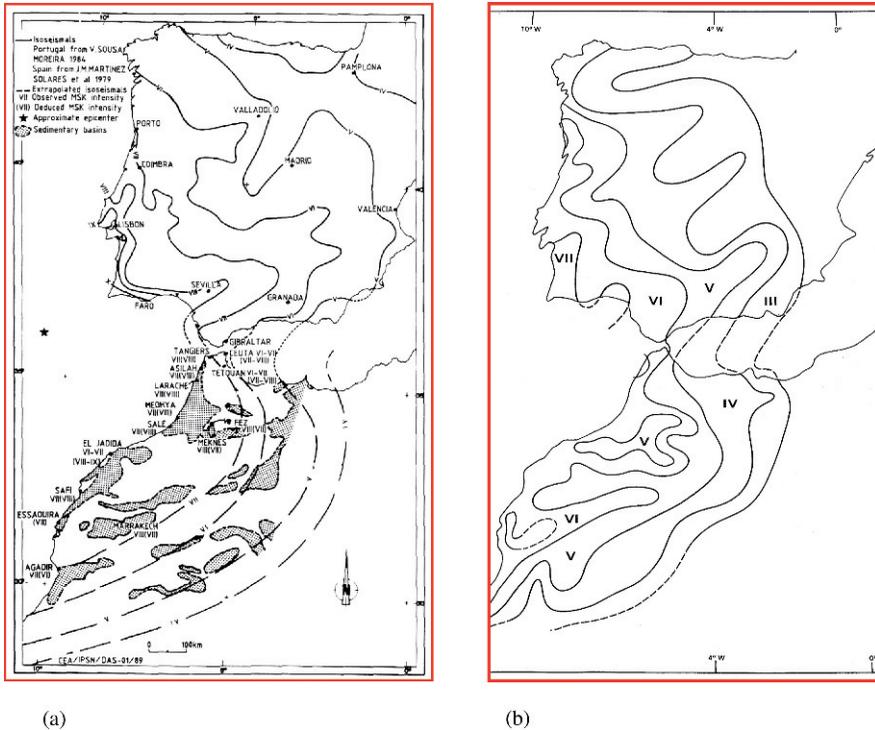
Fig. 2 Isoseismals of two large intra-plate events: a) 1755 (Levret 1991) and b) 1969 (Moreira, 1984). Note the similarities (the Guadalquivir valley) and dissimilarities (the southwestern Iberia) in the propagation of these two events

The analysis of the isoseismals in Fig. 2, which joins large consensus among specialists, shows clearly that the vibrations were more intense in the south of the Mainland and in the area of Lisbon, attenuating rapidly from coastal line of the country both in the west and south. The geometric pattern of the attenuation is clearly away from the typical patterns of other earthquakes where the attenuation

is more regular and concentric, emphasizing the possible role of the source mechanism, the wave attenuation anisotropy and the site effects. This latter effect is remarkably well illustrated in the positive irregularity (higher values than we could expect) in the Guadalquivir valley, showing an effect of amplification due to the presence of thick alluvial layers in that region.

Figure 2 was used as basis to define the outline of the seismic areas established in the Construction Regulation (RSCS 1958) promoted after the meeting of 1955 (Symposium about the action of the earthquakes 1955).

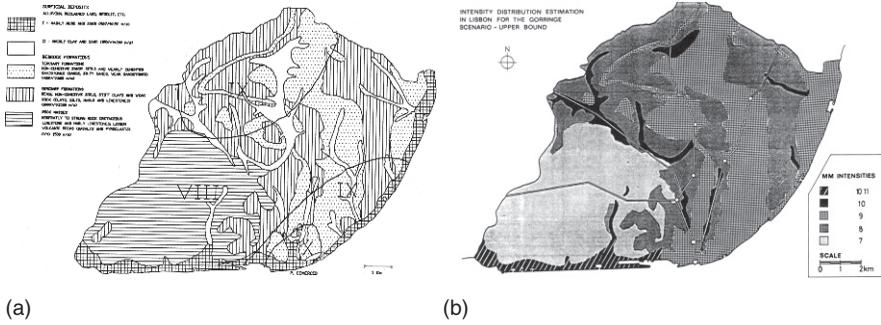
Fig. 4 a) Isoseismals of 1755 in the current district of Lisbon over the geological map, according to Pereira de Sousa (1929); b) Chart of intensity (Mercally Modified), done from a possible similar scenery to 1755 (scenery of Gorringe) (Mendes-Victor *et al.* 1994)

From general patterns to details for the city of Lisbon (in Fig. 3 we present the main localities mentioned throughout this paper), we find in Figs. 4 and 5 different aspects of the distribution of the damages in the interior of the city. The first Figure outlines the isoseismals according to Pereira de Sousa (1929) for the area corresponding to the entire district, overlapping once more the type of superficial geology, higher intensities being shown in the area of downtown and in the northern part of the district. Figure 5 presents in detail the most damaged areas (intensity X) corresponding to the outline of the city by that time, as well as the area of the impact of the fire (França 1978). As we can see, there is a big overlap in the outlines of the most damaged areas by shaking and by the fire, being hard to distinguish the main causes from the damages suffered. Also we can not forget the effect of the tsunami, responsible by the damages from flooding along the river.

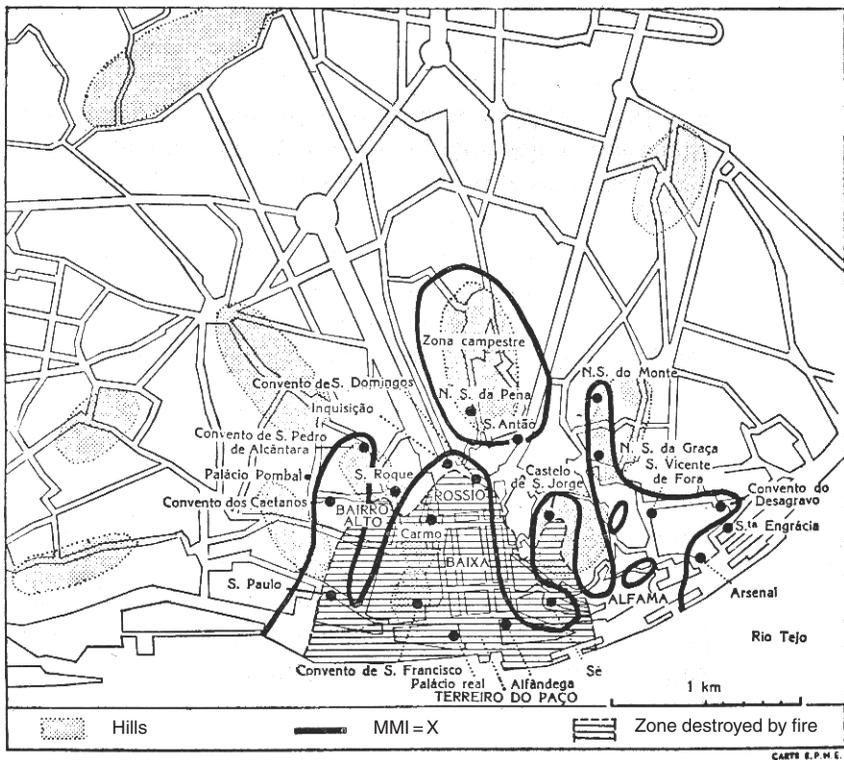
Fig. 5 Detail of the damages in the downtown Lisbon due to the vibration and fire (according to França, 1978)

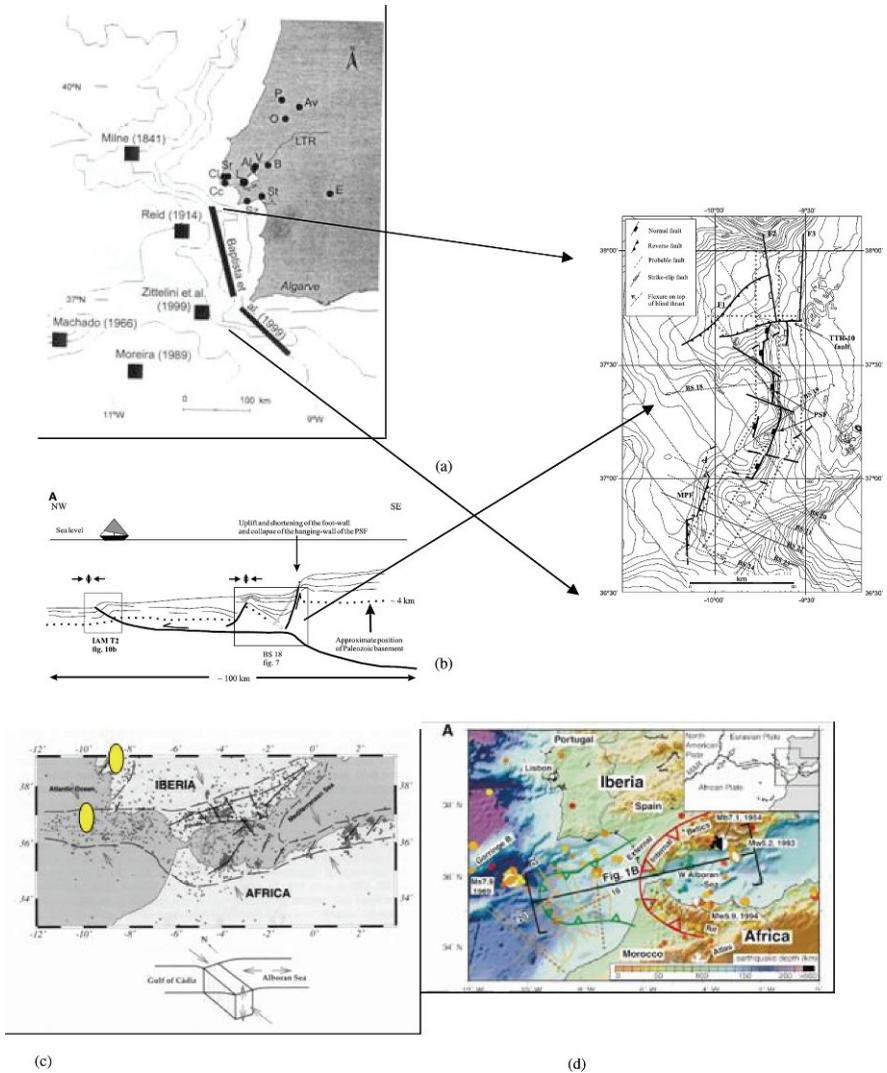
Fig. 6 Geodynamic models in contact with the Euro-Asian, African and of Alborn plates, to explain the seismic source that generated the 1755 earthquake: a) epicentres defined by several authors, along the XXth century (Zitellini *et al.*, 1999 and 2000); b) western area of the portuguese coast controlled by the phenomenon of compression between the plates (Terrinha *et al.*, 2003); c) model of multiple rupture Southwest of Cape São Vicente and in the Lower Tagus Valley (Vilanova *et al.*, 2003); d) interaction of the mini Plate of Alboran with two other plates, as a possible trigger to initiate the rupture (Gutscher, 2004)

If it is difficult to identify a seismic source for 1755, it is no less difficult to attribute it a magnitude. Nowadays, the magnitude parameter is obtained from instrumentation which became available only a long time after the 1755 earthquake. Thus the difficulty in establishing the magnitude of historical earthquakes, for which the most accurate data is the distribution of damages or the knowledge of any simple structure that functioned as a seismograph. In this case, we should appeal to all available information of different origins, to essay an evaluation. Besides the geographical distribution of the damages, other elements of great importance are: the duration, the area of perception of the vibrations, the effects on long distances, and, finally, the comparison to other events of recent times occurred in seismo-tectonic environment similar to those of the contact of the Euro-Asian and African (Nubia) plates (Figs. 6 and 7).

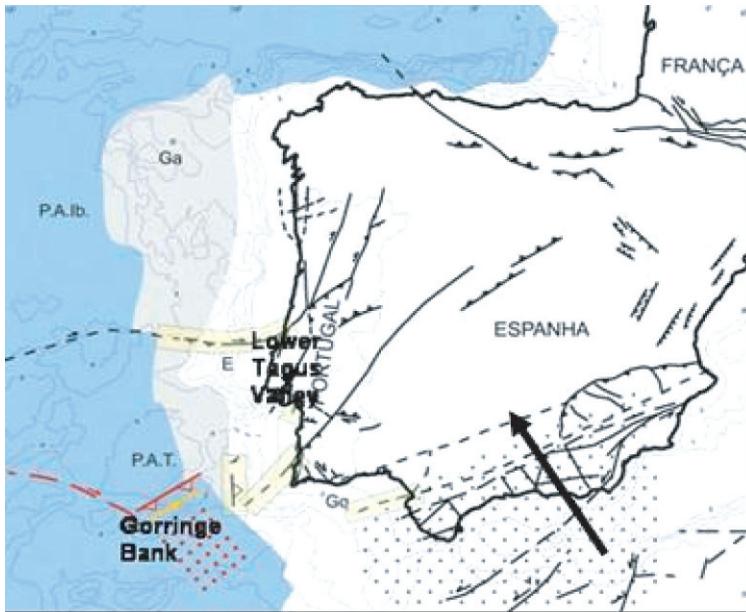
Fig. 7 Contact between the two Euro-Asian and African Plates and the main geological structures (Cabral, 1993) – the arrow indicates the predominant movement of the African Plate in relation to the Euro-Asiatic Plate

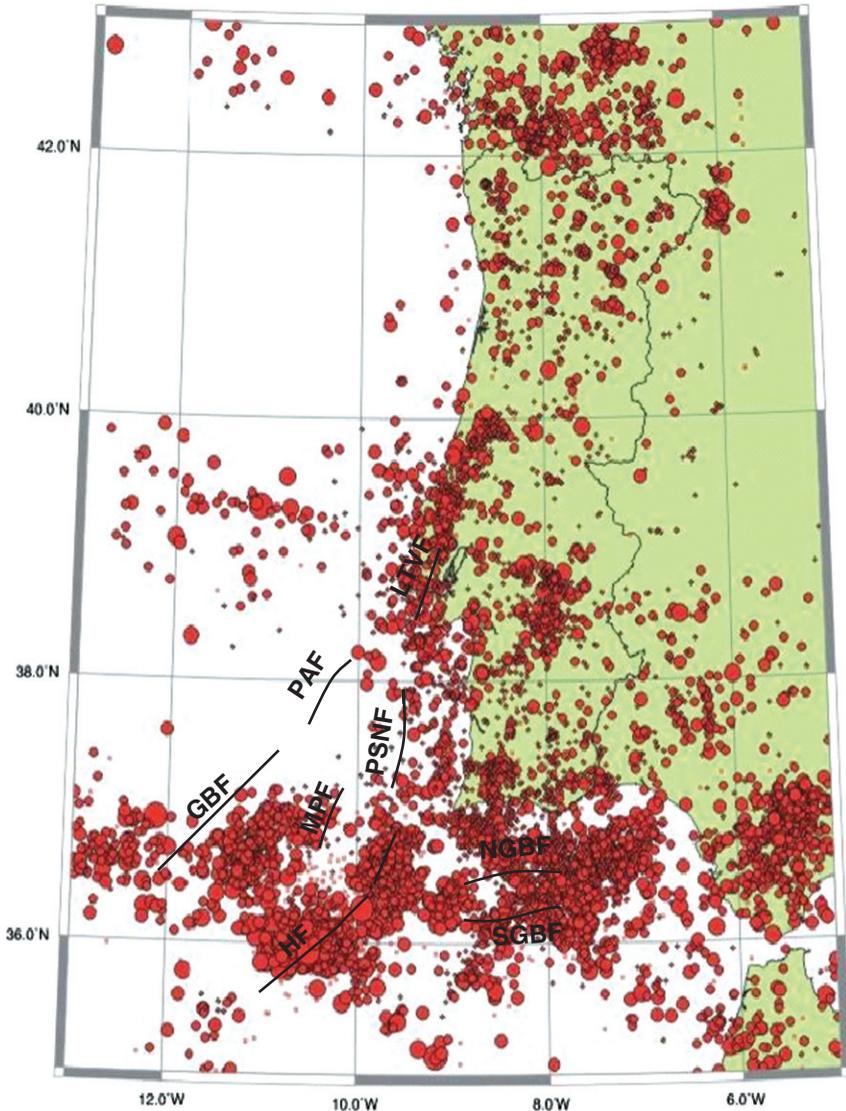
Fig. 8 Epicenters during the period of 1960-2003 (IM, 2007 and Carrilho *et al.*, 2004). MPF – Marquês de Pombal Fault System; PSNF – Pereira de Sousa Normal Fault System; GBF - Gorringe Bank Fault; PAF – Príncipes de Avis Fault; HF – Horseshoe Fault; NGBF – Northern Guadalquivir Bank Fault; SGBF – Southern Guadalquivir Bank Fault; LTVF – Lower Tagus Valley Fault

(Fig. 8). However, we can say, for the first time, that epicentral alignments (1960–2003) in that area are becoming apparent, showing some “plausible sources” where large magnitude events may take place. Only the years to come will or will not confirm these patterns, and relate them to the 1755 seismic source.

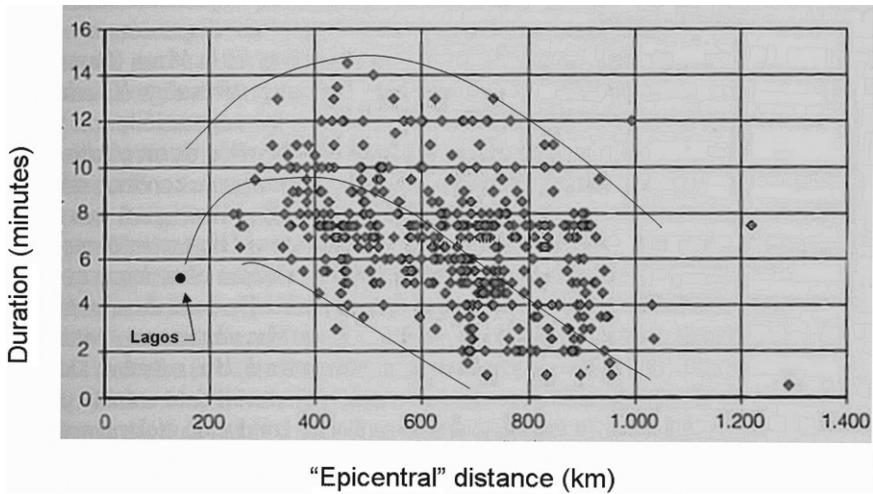
Fig. 9 Duration of vibrations as function of distance (composed after Martinez-Solares, 2000)

Based on Spanish data (Martinez-Solares 2000, Fig. 9), the correlation of duration with epicentral distance³ is very poor: the larger durations were observed in places with epicentral distances between 300 and 500 km, decreasing for larger distances. For shorter distances the duration was smaller, as the cases of Lagos and Lisbon.

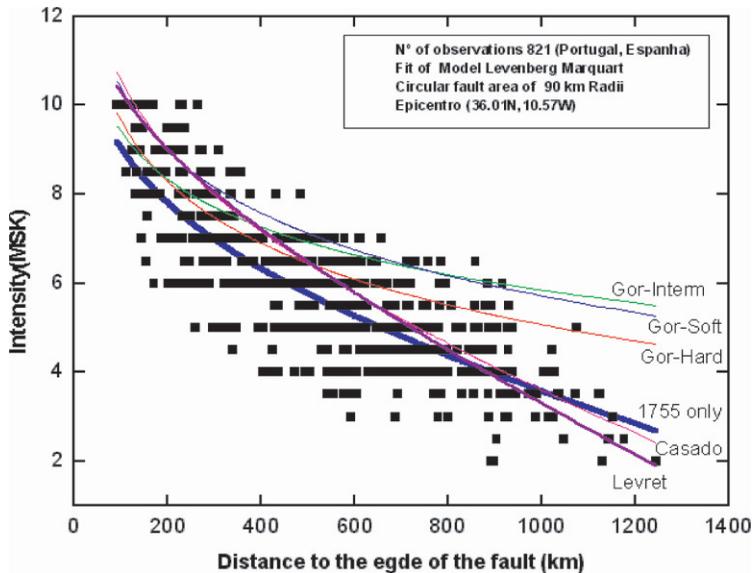
Fig. 10 Models of attenuation of the intensities seen during the seism of 1755 (Baptista *et al.*, 2001)

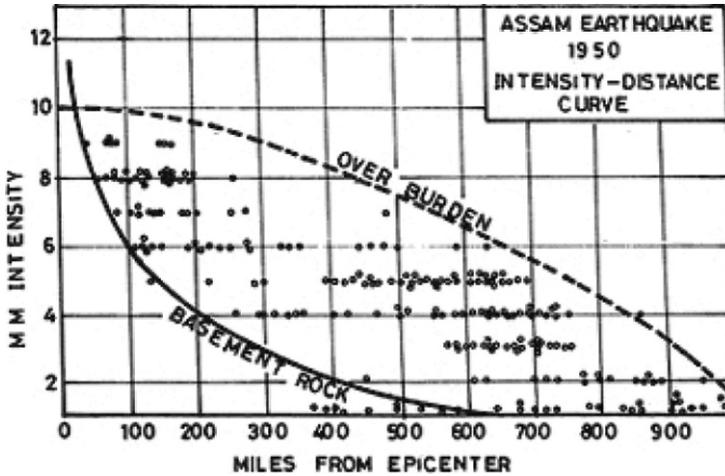
Fig. 11 The dispersion of the results is well referred in the data of the seism of 1950 in India (Mw 8.6; distance in miles)

Once again, we make a comparison with another earthquake, now to emphasize the existence of large dispersions (Fig. 11) for the attenuation of intensities in the 1950 earthquake of Assam, India, one of the biggest occurred in the boarder India-China (Arunachal Pradesh) (http://asc-india.org/gq/19500815_indochina.htm). Although the seismo-tectonic situations between the 1755 and this earthquake are different in several aspects, it can be noticed, by comparison of Figs. 10 and 11, that there are similarities in the general pattern of attenuation and in the dispersion of the results, with the difference that for the earthquake of Assam the closest distances to the epicentre are nearer than those in 1755. The average values for 1755 are slightly above those of the Assam earthquake, which shows a magnitude larger than Mw8.6, as referred above. The fact that the seism of Assam has a radius of perception around 1,800 km (against 2,500 km in 1755) and duration of the vibrations between 4 and 8 min (against 5–15 min in 1755) just proves this statement. Concerning the interpretation of the dispersion observed in Fig. 11, the lower line intends to represent the cases of “stiff” soils, while the upper line is a limit related with the phenomenon of soil amplification. Dispersions of this order of magnitude are observed in other earthquakes of the Portuguese catalogues (Sousa *et al.* 1992, Paula *et al.* 1996), and therefore can correspond to phenomena of amplification inherent to the complex processes of propagation and of local effects in Mainland Portugal.

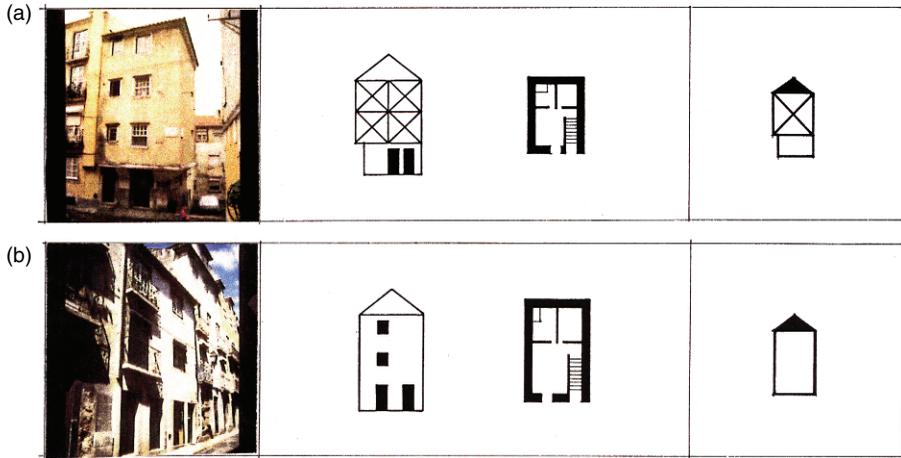
Fig. 13 Constructive typologies used before the earthquake: a) house of narrow front with an external wall forming a “bump”; b) house of narrow front with a roof of “four attics”

Figure 13 shows two examples of the typologies of the houses above described, presenting photos, elevations of the buildings and schematic cross-sections (Santos *et al.* 1993).

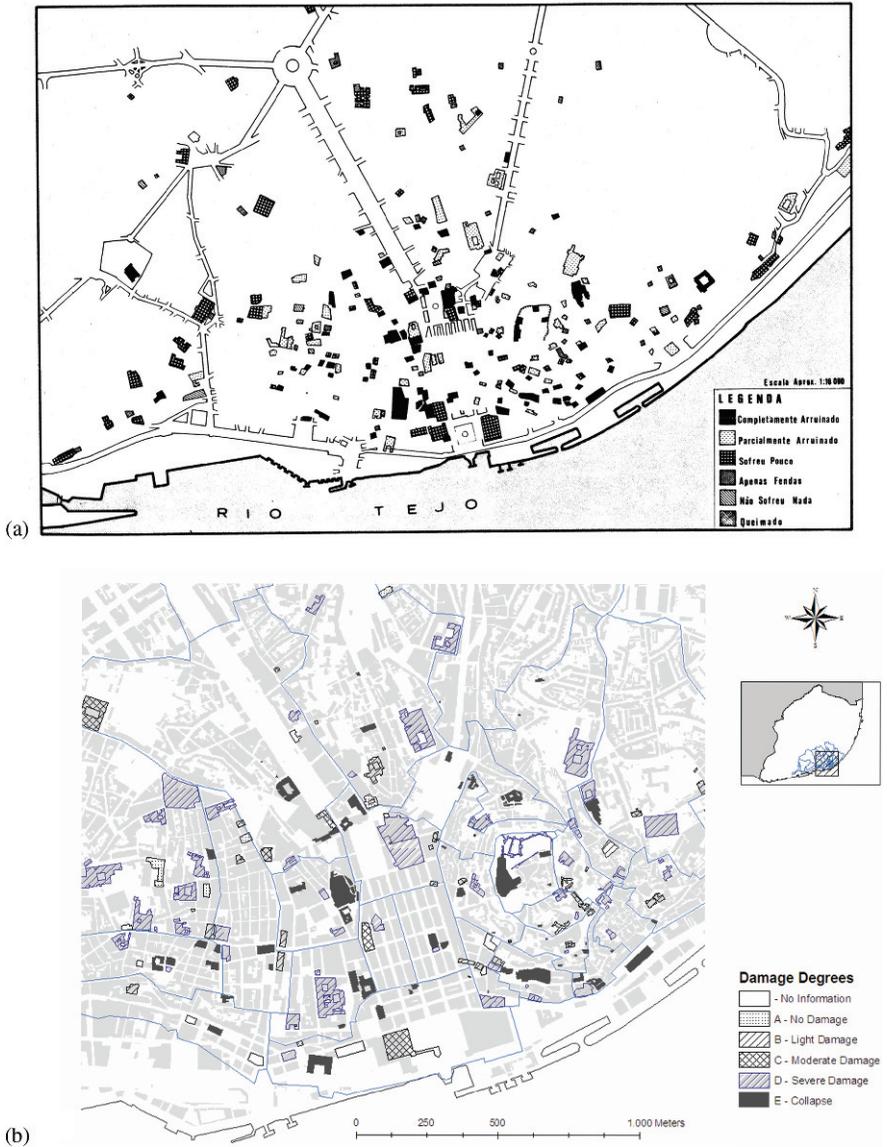
Fig. 14 Damage distribution in monuments in the City of Lisbon: a) work by Oliveira (1986); b) work by San-Payo *et al.* (2005)

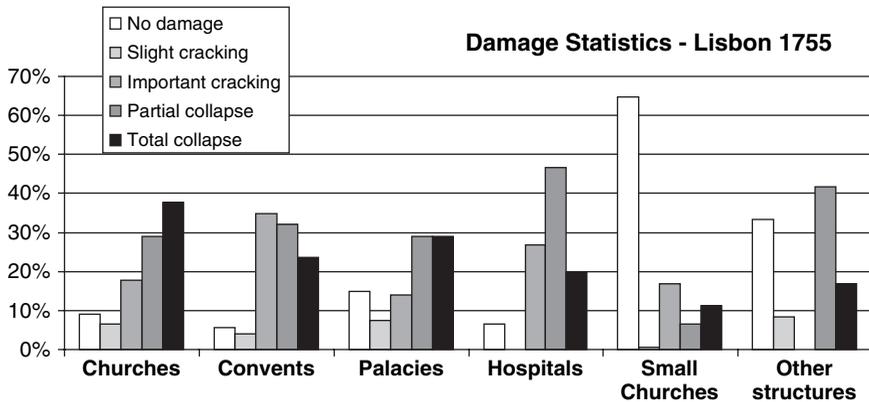
Fig. 15 Damage statistics in monuments

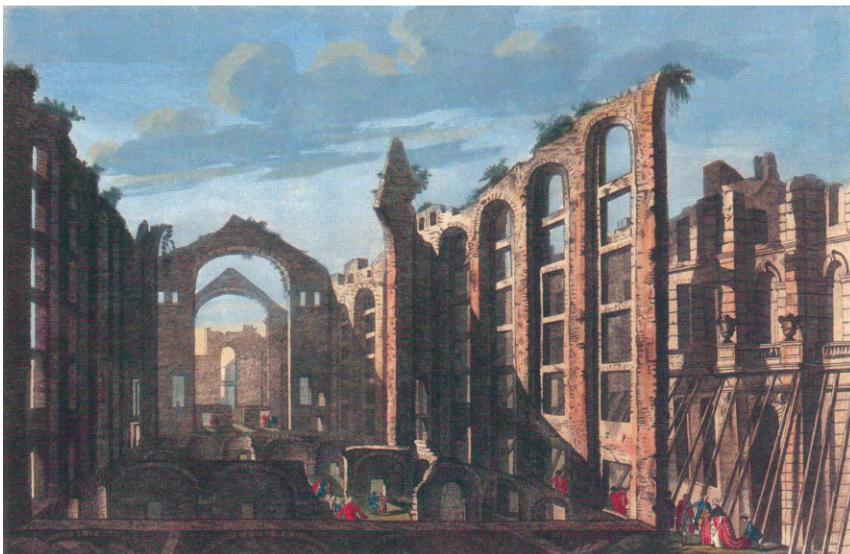
Fig. 16 Structure with slender walls without falling (Opera House or Real Theater) denoting damage caused essentially by the fire

the tsunami, even though, in many instances, this is quite difficult to achieve. We use engravings such as the one in Fig. 16, representing a construction having very slender walls standing alone, to analyse the cause of damage. It seems that, for this case, the fire may have destroyed the roof and the shaking was not responsible for the inflicted damage.

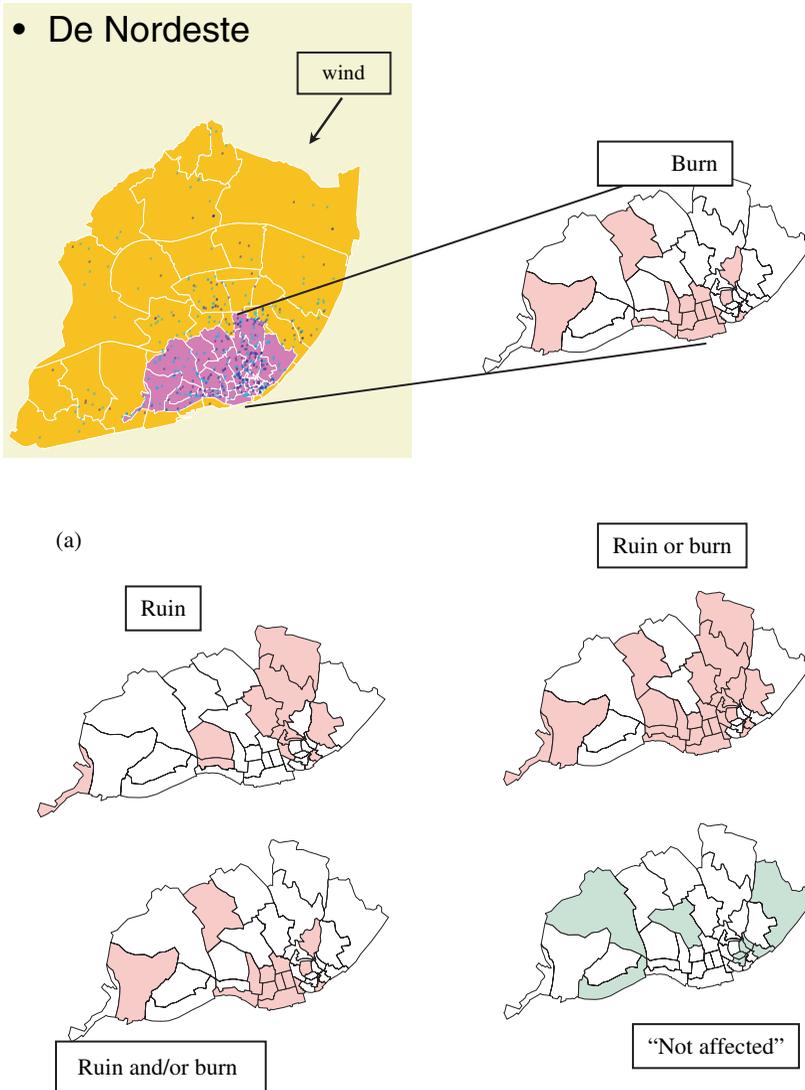
Fig. 17 Lisbon parishes more affected by shaking or fire

The fire seems to be responsible for destroying one third of the housing stock, mainly the one localized in the centre where the concentration of houses was higher. Figure 17 presents the parishes that were most affected by shaking or fire.

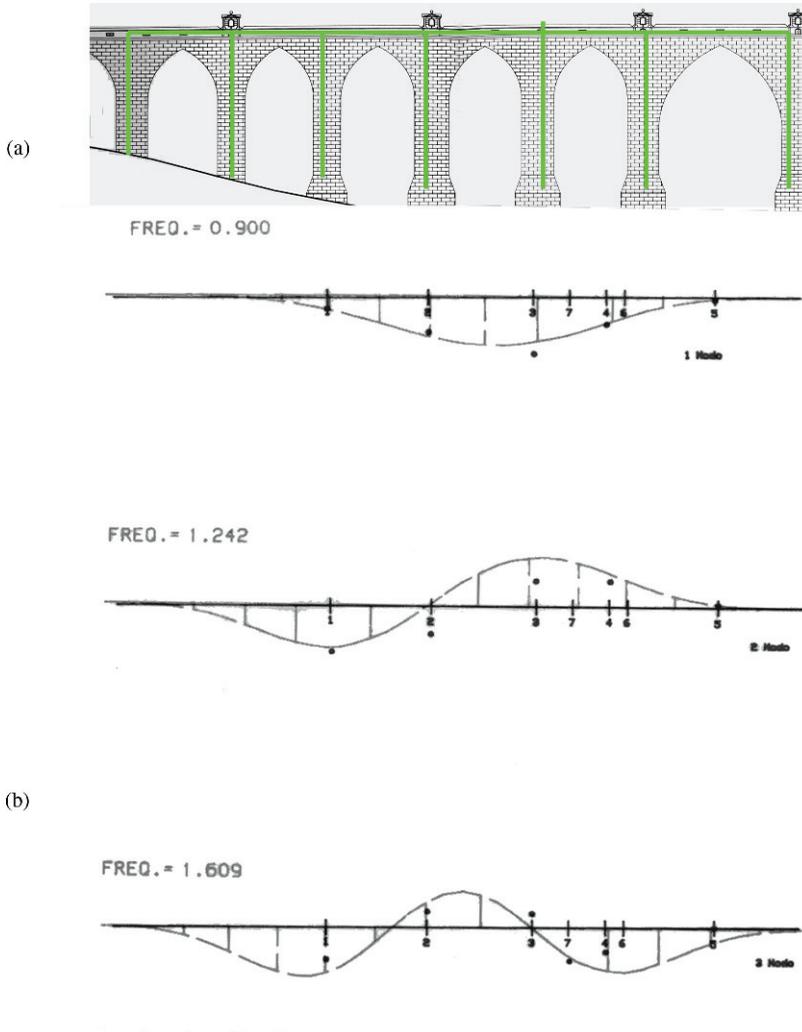
Fig. 18 Aqueduto das Águas Livres: a) 2-D model and b) *in-situ* testing to determine frequencies and modal shapes (Oliveira, 1986)

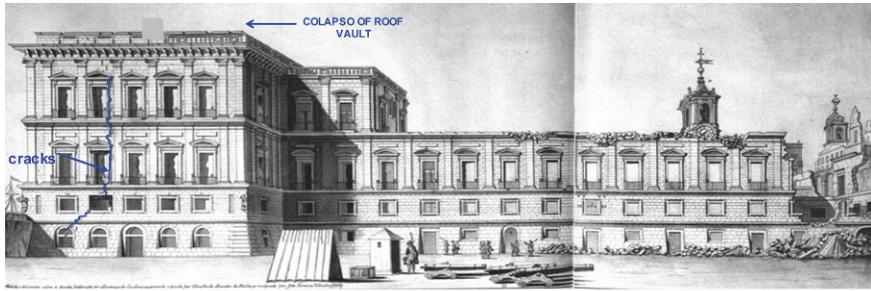
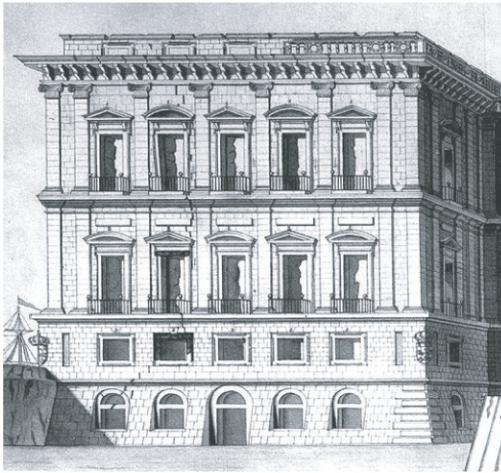
Fig. 19 Damage caused to the “Torreão do Terreiro do Paço” and West wing of “Terreiro do Paço”: a) vertical cracking caused by strong motion and soil settlement (on the left hand side). Damage due to fire (on the right hand side). b) detail of “Torreão”

The “Torreão do Terreiro do Paço” was a magnificent structure built just prior to the 1755 earthquake. As today, it is a massive good masonry structure (Fig. 19) founded in a soft soil of a few tens of meters. The fundamental frequency of this structure measured nowadays is on the order of 4–5 Hz. Assuming that the original structure was similar to the present one, we can say that damage to the “Torreão” was not very important. It seems that the vertical crack observed in Fig. 19 was essentially due to settlement of the foundation soil, and the part at the lower section with diagonal pattern denotes the N–S movement of incoming waves. In the adjacent cloister type

section, to the right, the soil layer is thinner, and the damage is observed at the upper floors and might be due to fire, and not so much due to shaking.

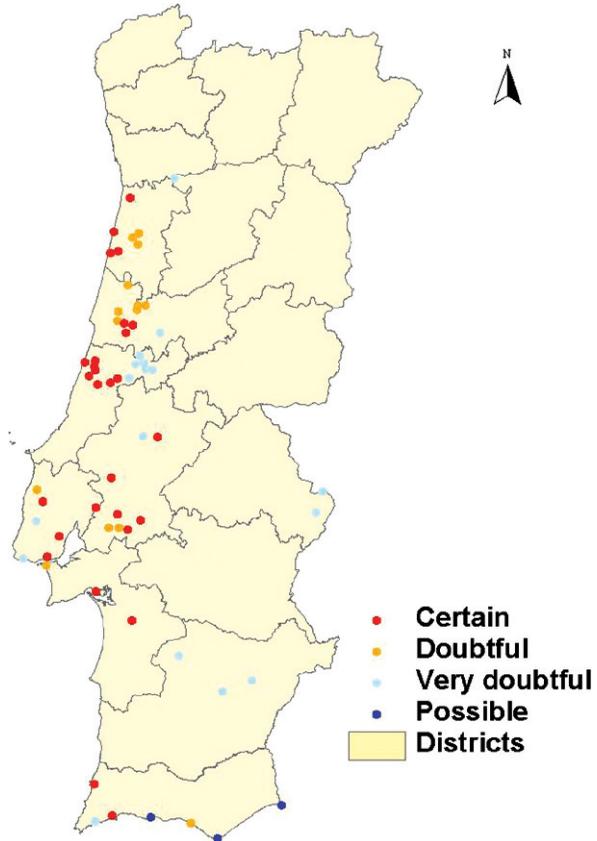
Fig. 20 Sites where liquefaction was observed (after Jorge, 1994)

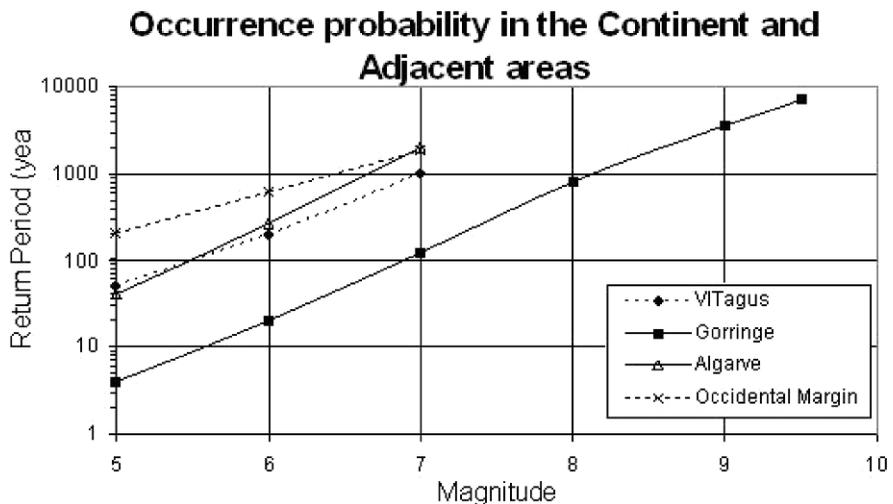
Fig. 21 Recurrence rate for events in the most important seismic sources of Portuguese region (adapted from Rio, 1996)

All this information, together with instrumental and historical data for the Gorringe area led to the hypothesis that the Mw9 1755 earthquake may occur every 2,000–5,000 years. Figure 21 gathers all the recurrence rates for events in the most important seismic sources in the Portuguese region, including that of 1755. The above mentioned return periods seems to be in agreement with the 5 mm rate of collision between Plates and the $M_w > 9$.
