George C. Babis and Vasileios I. Sakellariou

Introduction

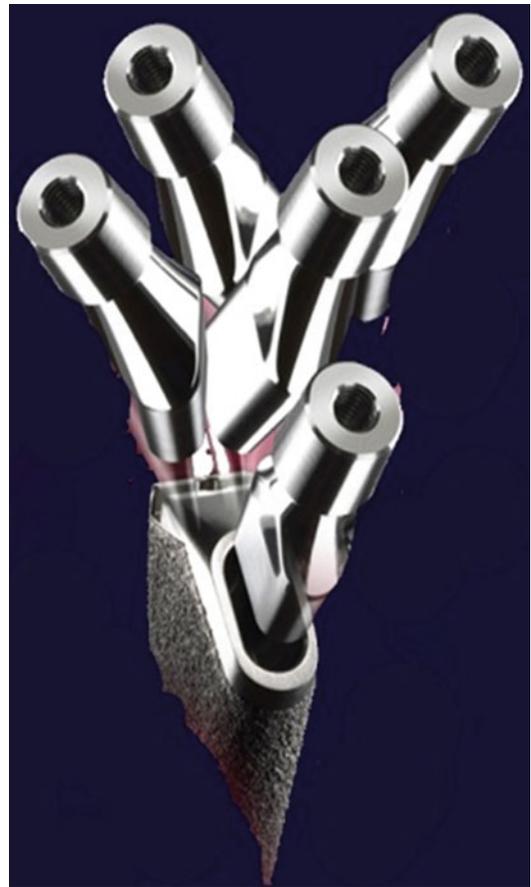
Fig. 18.1 Neck-stem modularity. A variety of necks facilitates leg length and joint stability

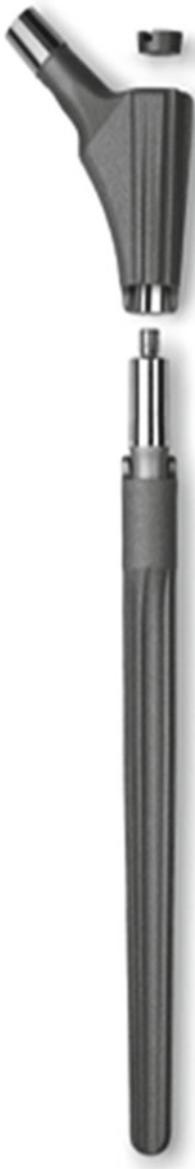
Fig. 18.2 A modern modular revision femoral stem is shown

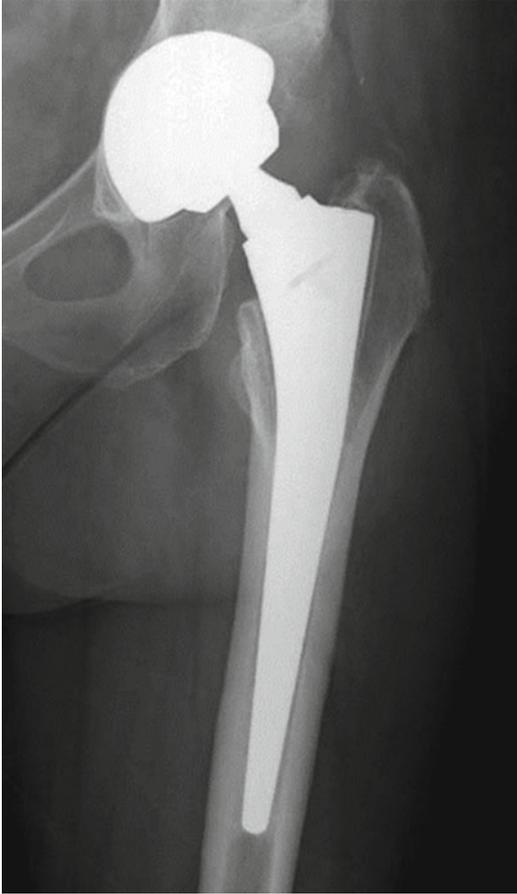
Fig. 18.3 Cementless femoral stem with a modular neck. Satisfactory clinical and radiological outcome at 5 years follow-up

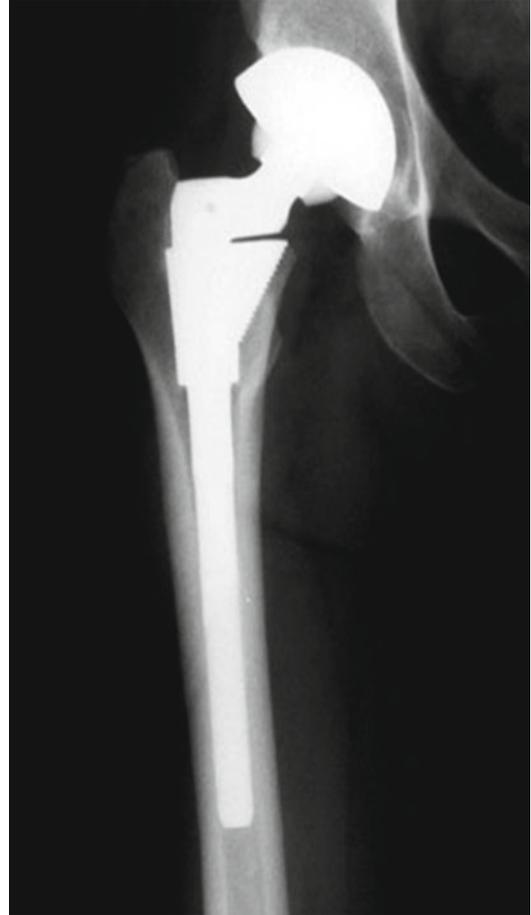
Fig. 18.4 Cementless modular S-ROM stem for primary hip arthroplasty. Satisfactory clinical and radiological outcome at 9 years follow-up

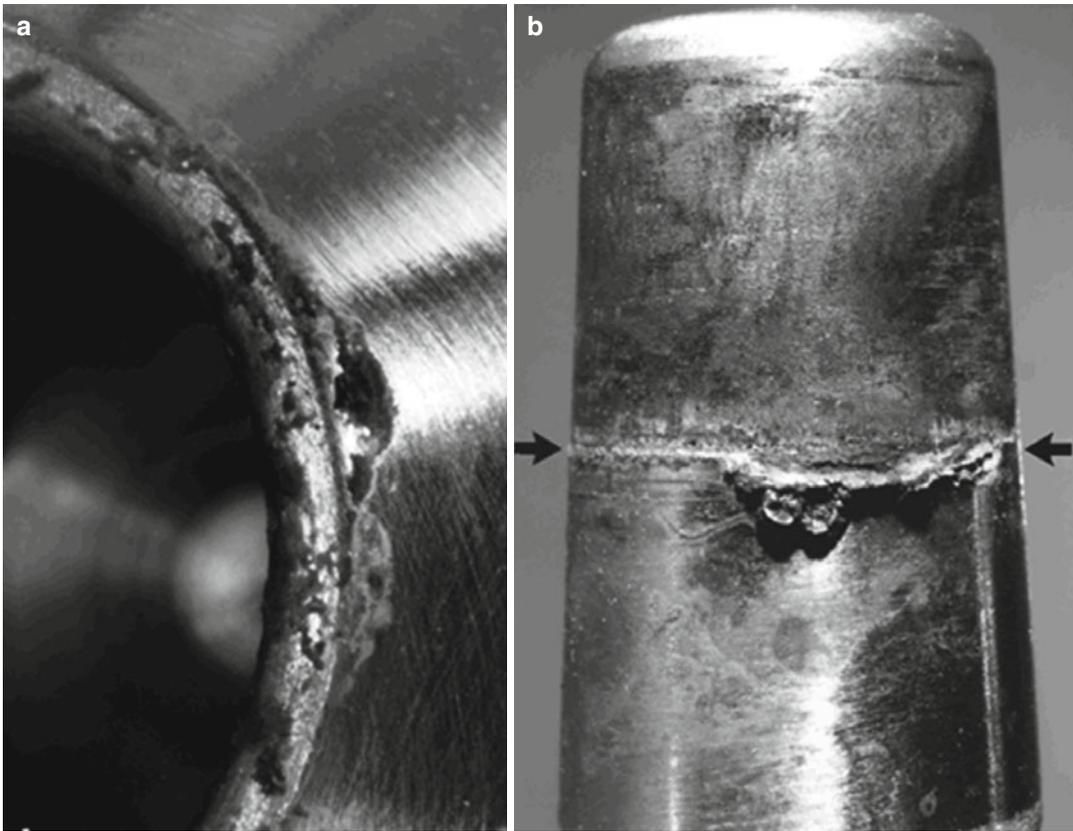
Fig. 18.5 Damaged head-neck junction. (a) Head, (b) neck

Corrosion products and wear debris generated at the head-neck (Fig. 18.5) and neck-stem interfaces are well documented in the current literature [53–56]. It is generally agreed that the surface damage seen at the head-neck taper is initiated by fretting. Fretting has been demonstrated in 100 % of test specimens *in vitro* and in over 50 % of retrieved implants [46, 55, 56]. Fretting increases the development of crevice and galvanic corrosion by disrupting the passive oxide layer of the taper interface. Gilbert et al. tried to document the taper corrosion processes better using metallographic sectioning techniques and scanning electron microscopy [54]. They showed that a pitting attack on both sides of the taper interface evolves into plunging pits. The latter ultimately develop into cracks where the crack propagation process
