The Implant-Cement Interface in Total Hip Arthroplasty

Georgios Digas and Johan Kärrholm

Introduction

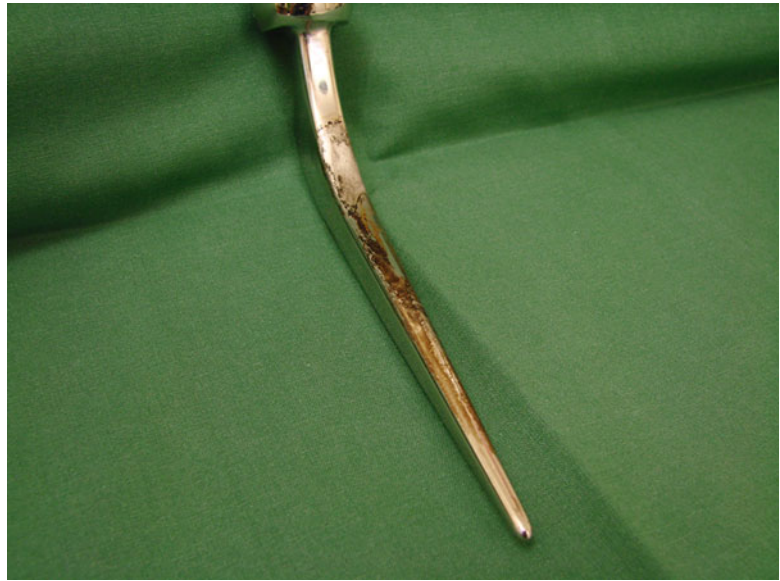
Fig. 4.1 This photograph shows an Exeter stem extracted 10 years postoperative. Note the severe crevice corrosion at the medial surface of the stem

but these are also sensitive to changes of design, especially if used with high offset or in small sizes [8]. Titanium–alumina–vanadium alloy has a stiffness of about 50 % relative to CoCr or stainless steel (elastic modulus $E=230$ GPa for CoCr and 110 GPa for titanium). It is therefore more flexible, but it is uncertain whether this feature influences the frequency of stem–cement bonding in vivo. The higher flexibility of the stem will increase proximal cement stresses. For designs with small proximal dimensions, particularly in the M-L direction, cement stresses may become too high in the stem–cement interface resulting in debonding and cement failure. Titanium alloys have a high resistance against corrosion [9]. They are, however, comparatively soft and susceptible to abrasive wear of the oxide film as well as fretting and crevice corrosion. This type of corrosion is driven by the generation of a gap (the crevice) between the stem and the cement. It has often been reported to occur at the taper of modular implants. There are some reports of early failure of cemented titanium stems showing severe crevice corrosion at the stem–cement interface [10–12], but only a few studies show this type of corrosion for designs made of stainless steel [13], whereas reports of crevice corrosion of CoCr seem to be restricted to the head taper junction (Fig. 4.1). Even if it is not completely clear to what

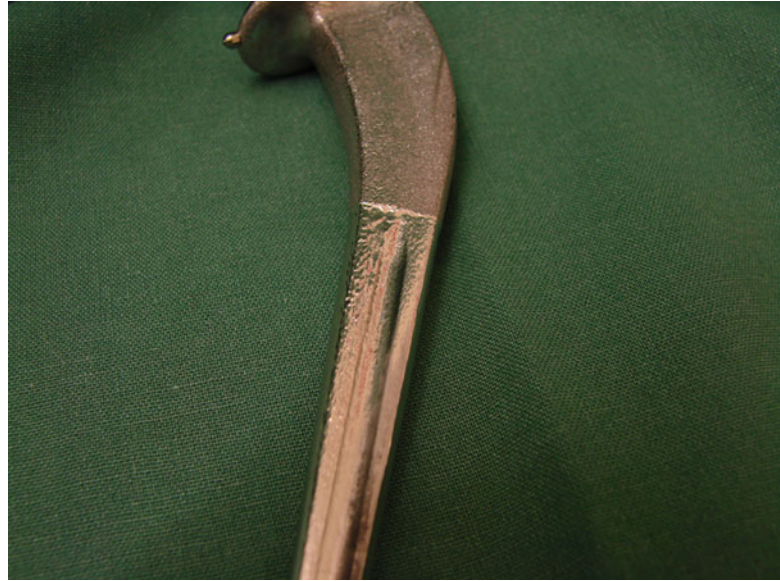
Fig. 4.3 This photograph shows a Spectron stem size one revised 8 years postoperative. The subsidence and rotation in the cement mantle had abrasive polishing effect on the matt surface on this particular stem leading to loosening and revision surgery

there is a certain lower limit for downsizing. If a matte or grit-blasted cemented stem becomes too small, it cannot withstand external forces sufficiently, resulting in abrasive wear, loosening, and osteolysis (Fig. 4.3). This limit probably varies depending on the activity of the patient and the time frame of the observation period. This means that special consideration should be given to active and heavy patients with a narrow femoral canal, especially if a large offset is required. For these cases, alternatives other than a small-sized non-polished cemented stem should be considered.

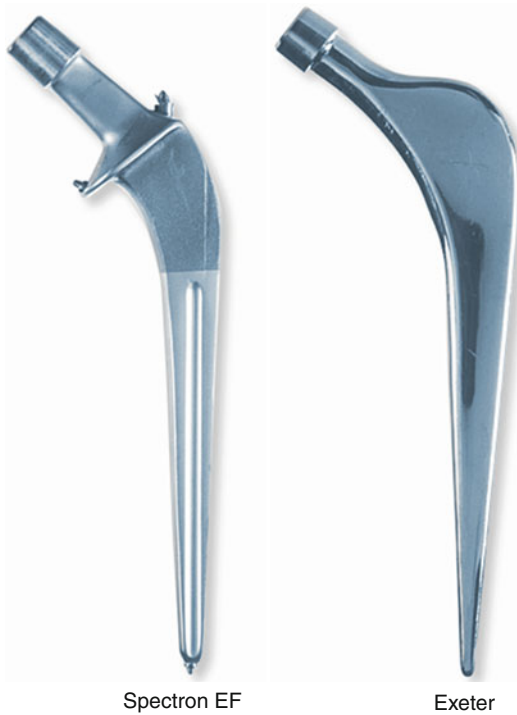
Fig. 4.4 The Spectron EF and Exeter stems are examples for shape-closed and force-closed fixation system, respectively

A shape-closed fixation design (Fig. 4.4) is one in which the stem achieves fixation at the stem-cement interface through a match in the shape of the surfaces of the stem and the cement with the cement gripping the surface of the stem. The aim is to achieve a rigid interlock between the stem and cement and thereby nullify movement at this interface. These designs have matte, grit-blasted, and beaded or porous surfaces into which the cement is intended to penetrate, thus achieving a solid bond between the stem and the cement. Attempts have been made to improve bonding between stem and cement by pre-coating the stem surface with cement applied onto the surface during manufacture of the stem [24]. This pre-coated stem is then inserted into the cement in the femoral canal, which binds with the pre-coated surface. Early clinical trials have suggested that the use of pre-coated stems is associated with favorable short- to medium-term survival in some studies [25, 26]. However, Callaghan et al. [27] have found that the use of a pre-coated stem is associated with poor survival,

A force-closed system (Fig. 4.4) is one in which the fixation of the stem within the cement is achieved through the balance of forces without the need for the existence of a bond between the stem and the cement. A stem may act as a taper within the cement, in which case fixation is achieved through the balance of forces across the stem-cement interface and bonding between the stem and cement is neither necessary nor desirable. The balance of forces arises from the ability of a polished tapered stem to subside over short distances within the cement mantle. Retrieval

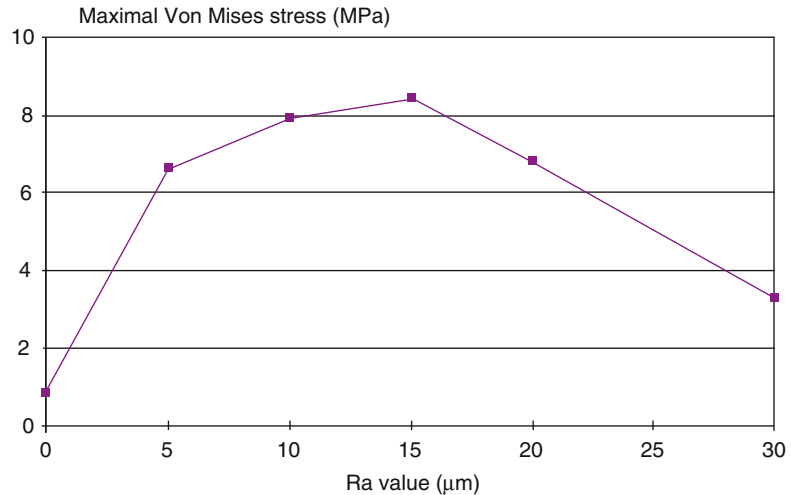
Fig. 4.6 Results from a finite element micro-analysis of the surface roughness of a straight-tapered unbonded stem. The local stresses around the asperities of the stem surface did show a maximum at 15 μm ; beyond that value the local stresses were reduced (Adapted from Verdonschot et al. [39])

stresses reduced again because of reduced cyclic motions caused by the better "grip" of the metal surface on the cement (Fig. 4.6). These studies by Verdonchot show the complexity of stem-cement interface mechanics and cement abrasion. The surface roughness beyond which the abrasive potential diminishes depends on many other factors such as prosthetic design, offset, loading conditions, location, cement characteristics, and other patient-related factors.

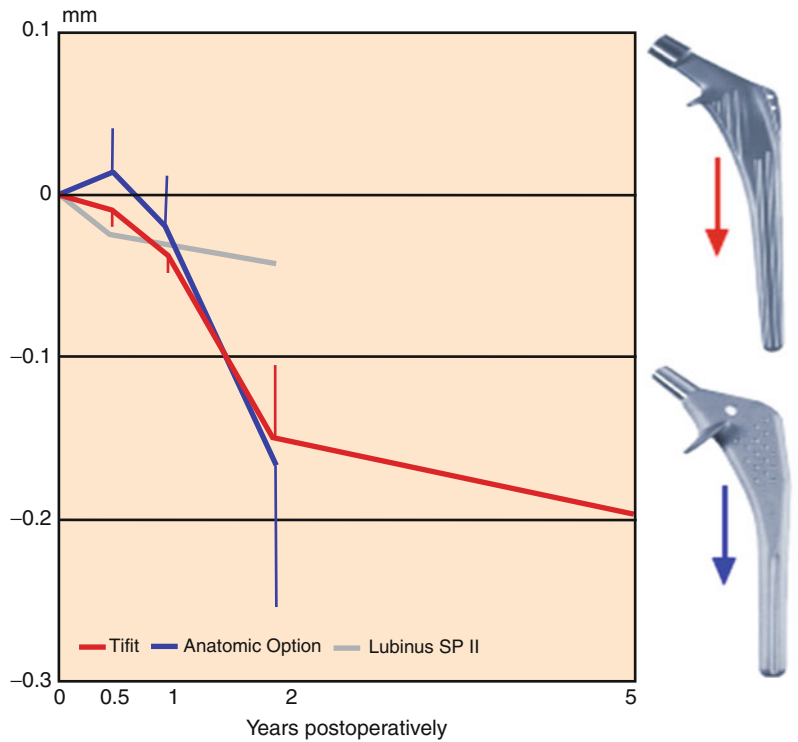
Fig. 4.11 Subsidence of the Tifit and Anatomic-Option stems
