An Atlas of Mitral Valve Imaging

Milind Desai • Christine Jellis
Teerapat Yingchoncharoen
Editors

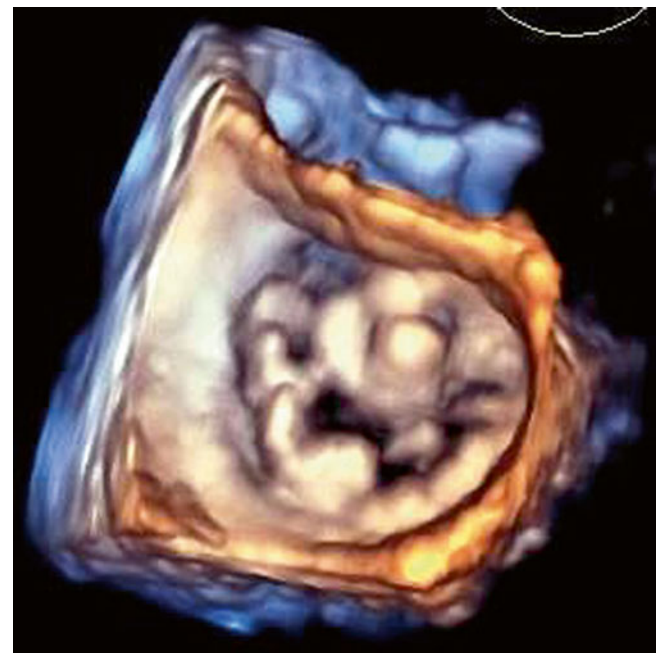
Fig. 1.4 Three-dimensional (3D) transesophageal echo (TEE) image of the mitral valve

The mitral annulus is part of the fibrous skeleton of the heart. It is a complex, saddle-shaped, nonplanar geometric structure with greater commissure-commissural diameter (long axis) and smaller septolateral diameter (short axis) (Fig. 1.3). The leaflets do not normally protrude above the annular plane. Three-dimensional (3D) echocardiography has revolutionized visualization and appreciation of the mitral valve annulus (Fig. 1.4).

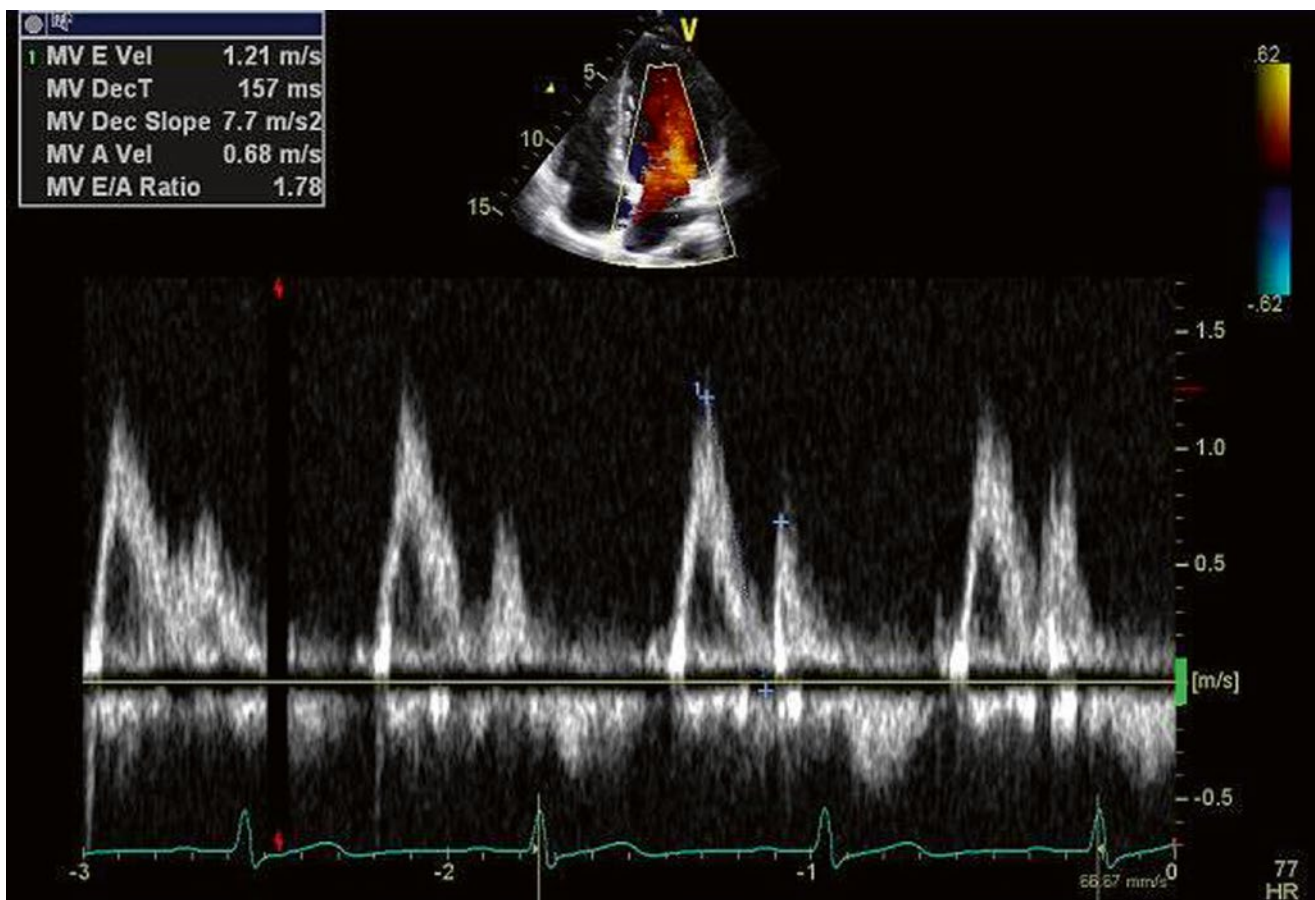
Fig. 2.3 Spectral Doppler image demonstrating inflow through the mitral valve during diastole

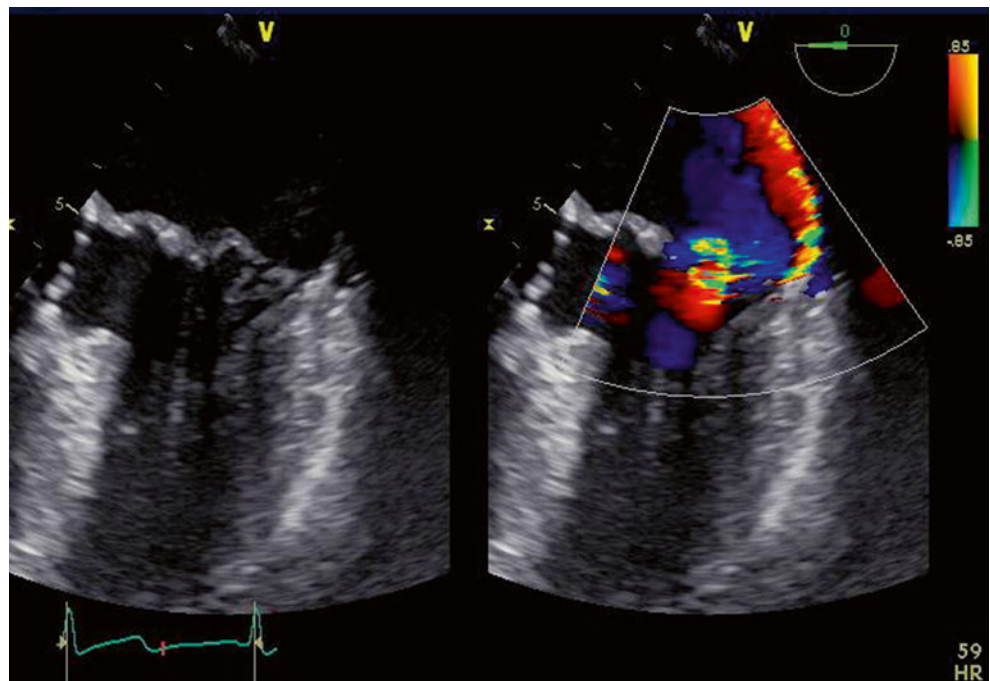
Fig. 4.27 Preoperative simultaneous 2D and color Doppler imaging of the mitral valve viewed at 0° by transesophageal echocardiography. Flail of the middle scallop of the anterior leaflet (A2) is seen, with a resultant highly eccentric jet of severe, posteriorly directed mitral regurgitation

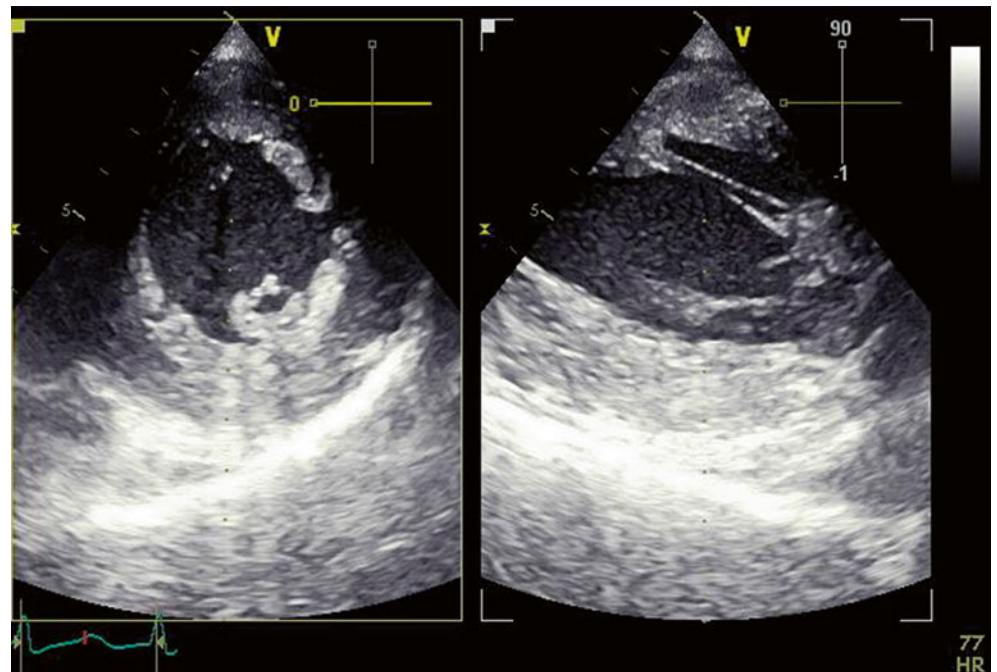
Fig. 4.29 Transgastric biplane view (short-axis and 90° views) on transesophageal echo. The right 90° image best demonstrates the neochordae attaching from the papillary muscles to the repaired mitral valve

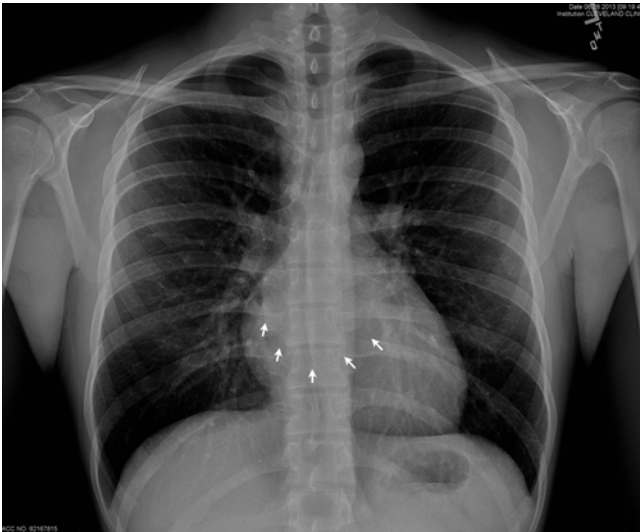
Fig. 5.1 Posteroanterior (PA) chest x-ray showed straightening of the left cardiac border with double contour sign (*arrows*) indicating left atrial enlargement as well as prominent pulmonary venous blood flow

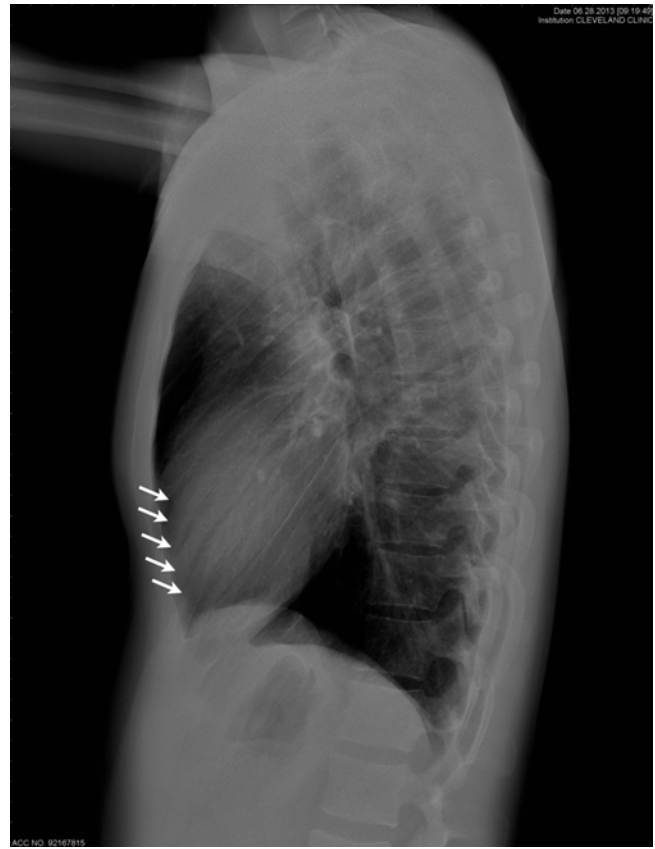
Fig. 5.2 Lateral chest x-ray showed obliteration of retrosternal space (*arrows*) consistent with right ventricular enlargement

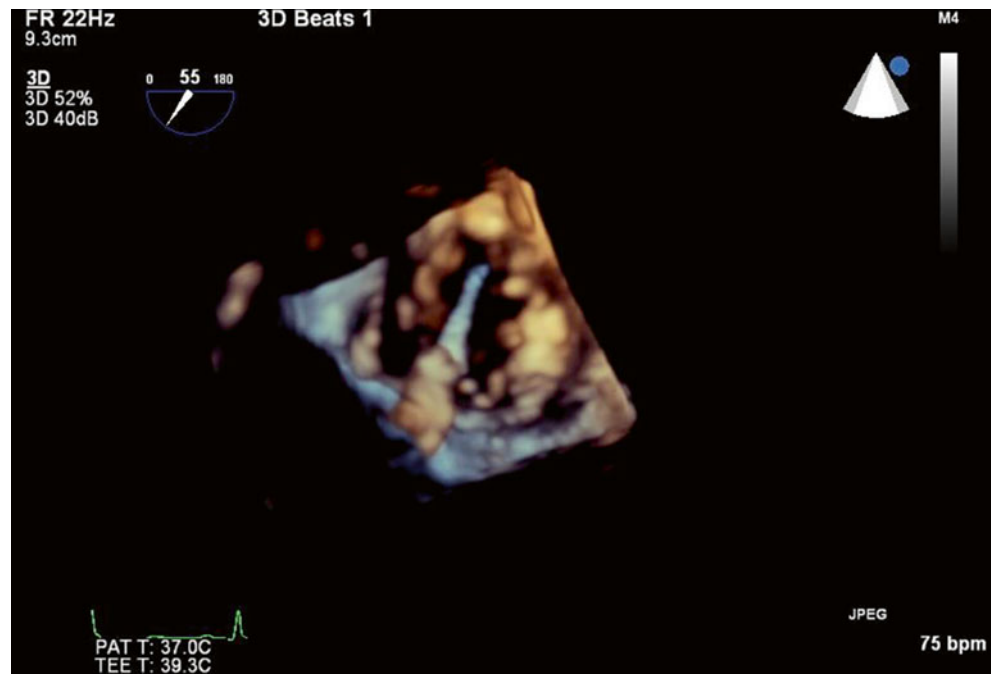
Fig. 6.14 When both clip arms are adequately aligned, the clip is positioned perpendicular to the line of leaflet coaptation. Both leaflet tips must be fully inserted between the grippers and clip arms to ensure stability of attachment

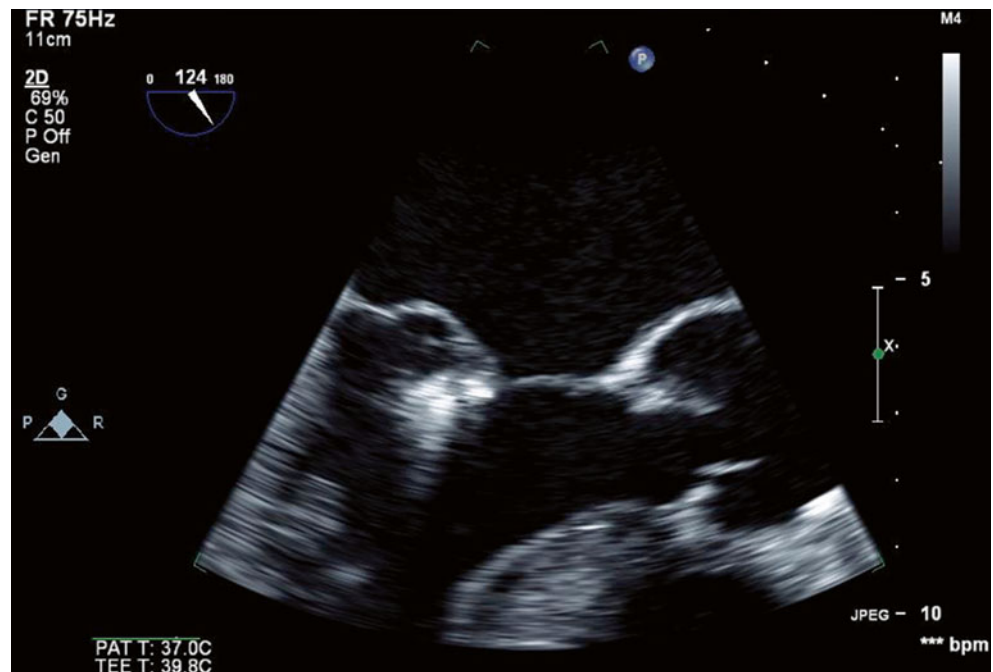
Fig. 6.26 TEE 120° view demonstrates mild (1+) residual central MR

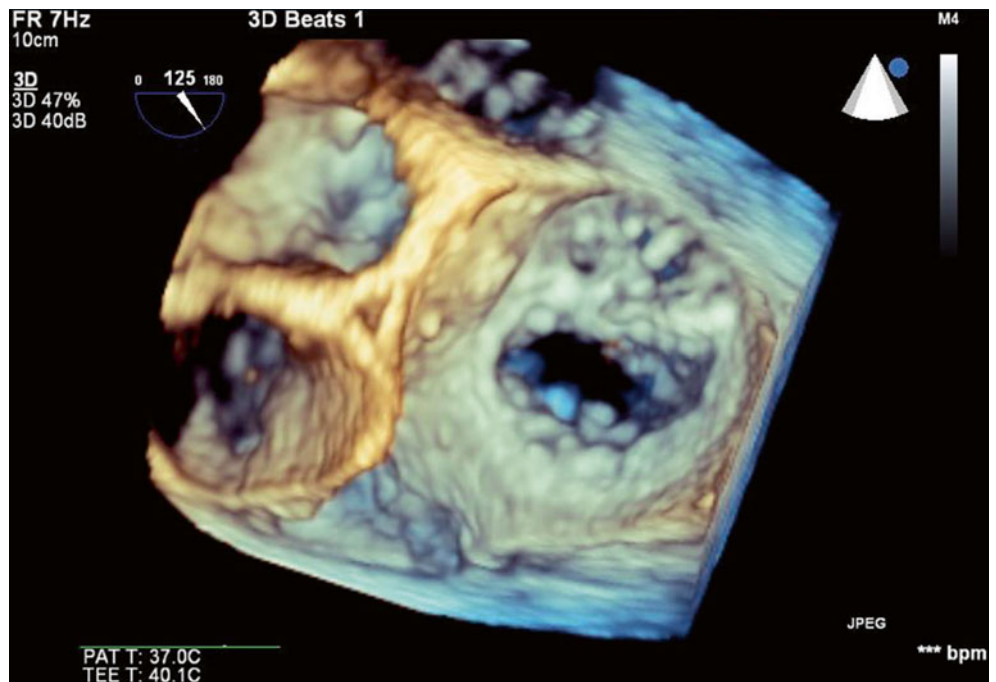
Fig. 6.30 Use of Philips 3DQ reconstruction software demonstrates a multiplanar view of the mitral valve with the MitraClips in situ

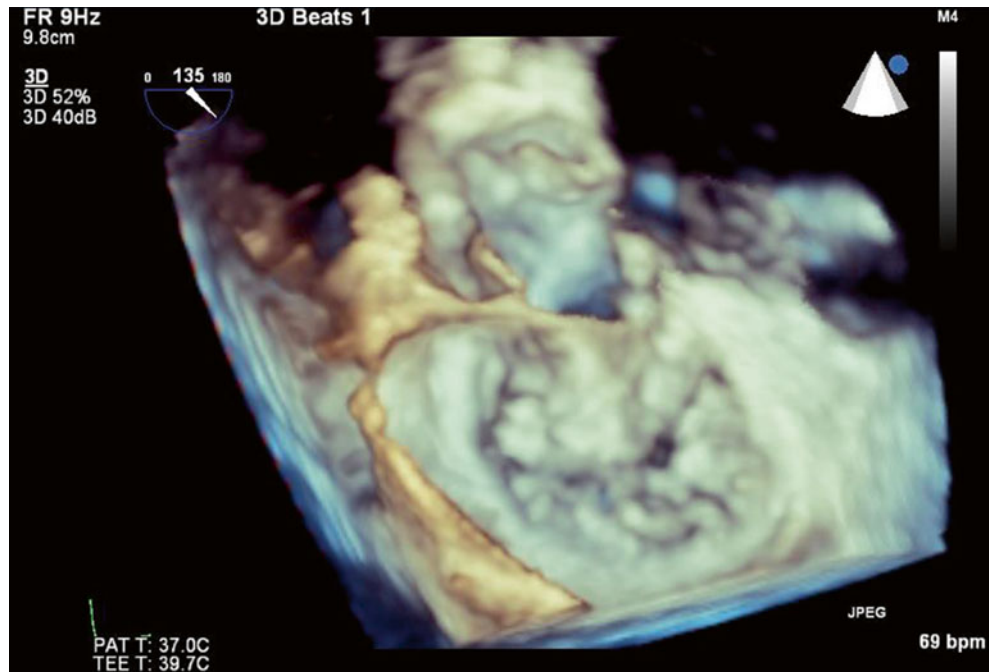
Fig. 6.46 3D image showing the guide catheter in the left atrium approaching the mitral valve. The position and trajectory are adjusted to optimize perpendicular alignment of the MitraClip with the valve leaflets

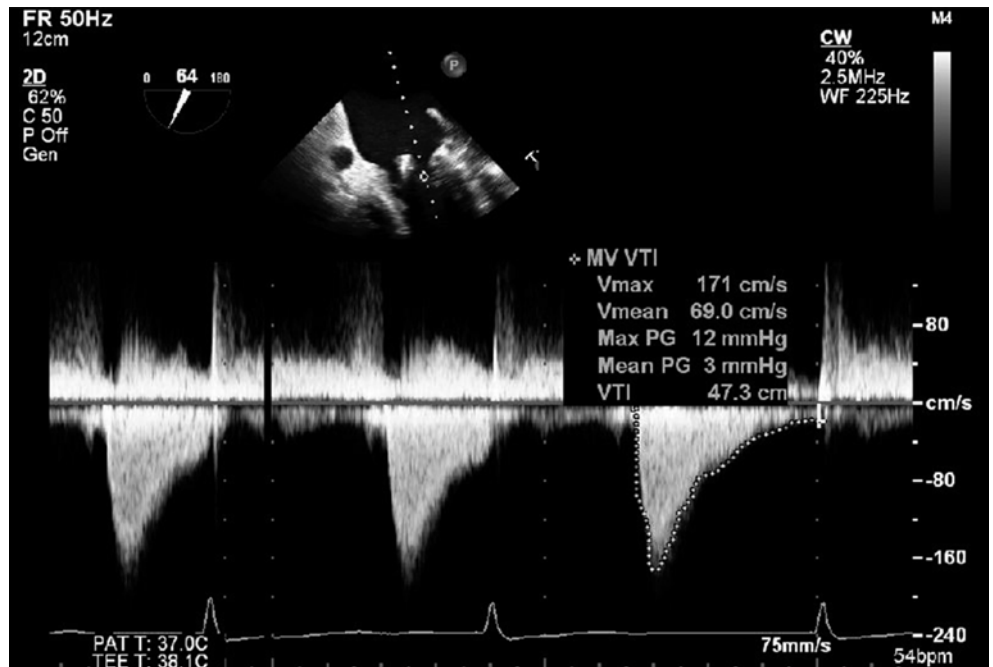
Fig. 6.50 Continuous wave Doppler through the mitral valve confirms that the MitraClip is not causing hemodynamically significant stenosis (peak/mean gradients of 12/3 mmHg)

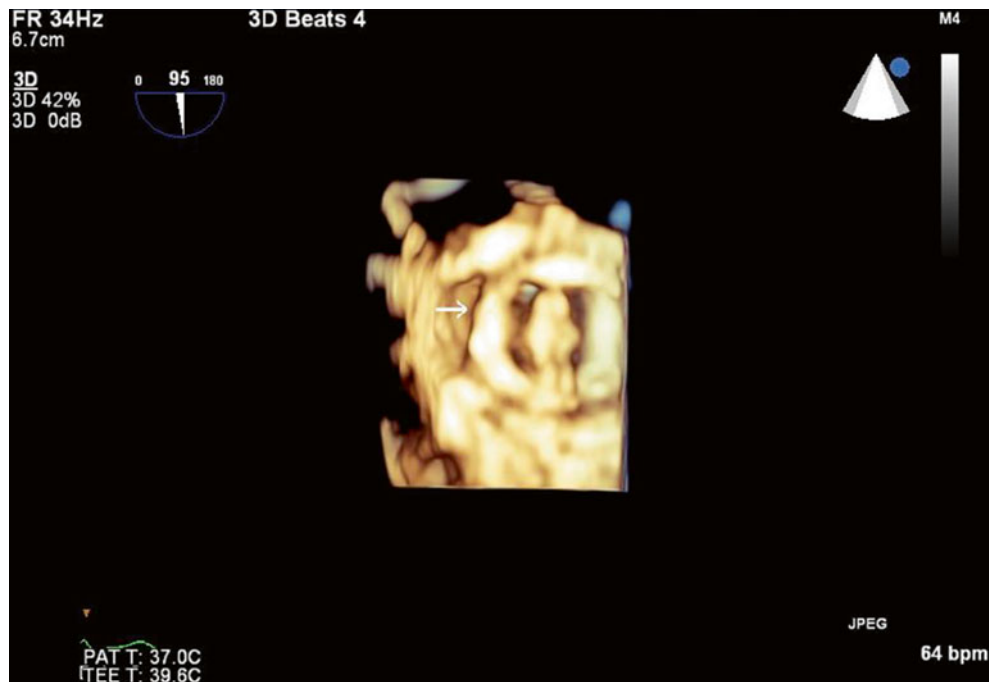
Fig. 6.54 Color 3D imaging demonstrates color flow through the region of dehiscence, representative of the paravalvular leak

- Video 6.44** Color 3D imaging demonstrates color flow through the region of dehiscence, representative of the paravalvular leak
- Video 6.45** A 3D view of the mitral valve from the anterolateral aspect demonstrates the region of dehiscence

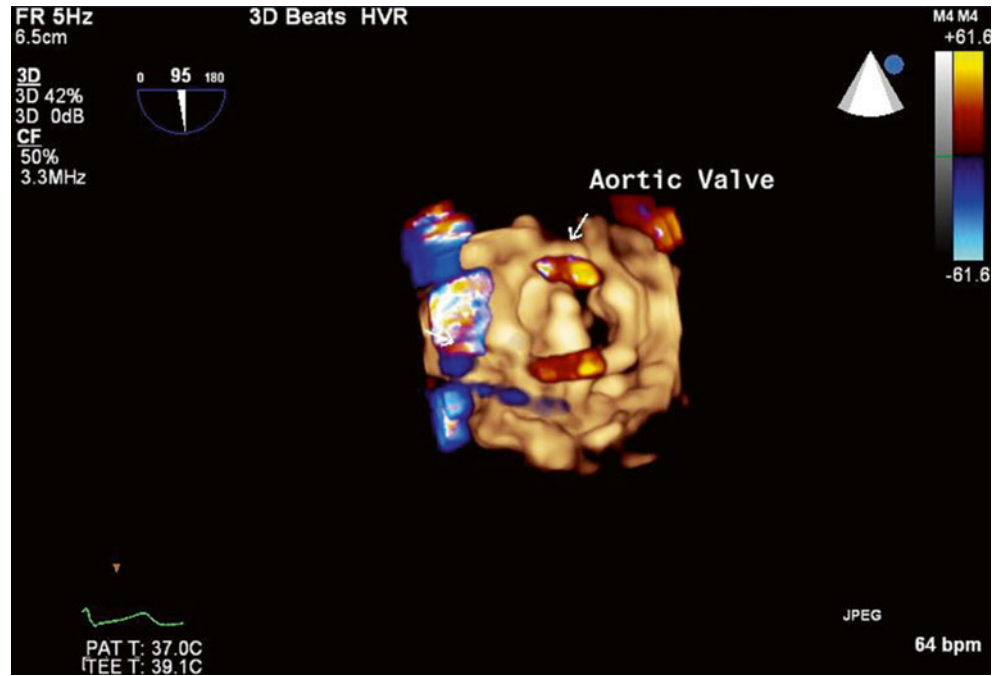
Fig. 6.55 A 3D view of the mitral valve from the anterolateral aspect. The arrow demonstrates a small region of dehiscence

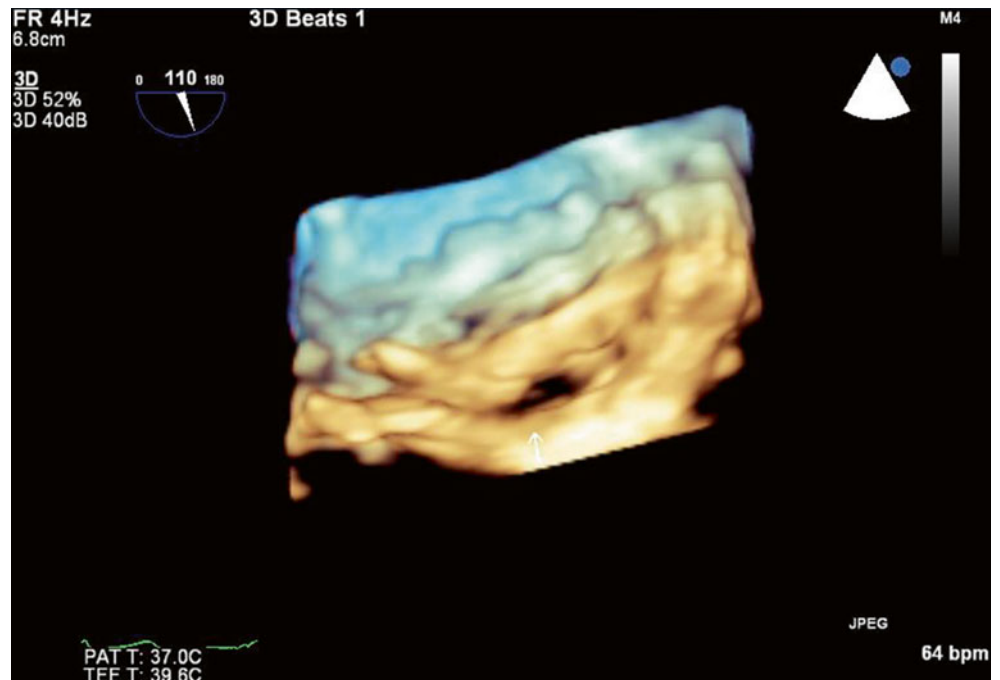
Fig. 6.56 3D image of the bileaflet mitral valve prosthesis with the occluder device in situ, adjacent to the anterolateral aspect of the valve

- Video 6.46** 3D image of the bileaflet mitral valve prosthesis with the occluder device in situ, adjacent to the anterolateral aspect of the valve
- Video 6.47** Biplane color Doppler TEE image at 130 and 11°, showing a bileaflet prosthetic mitral valve with moderate (2–3+) anterolateral paravalvular leak

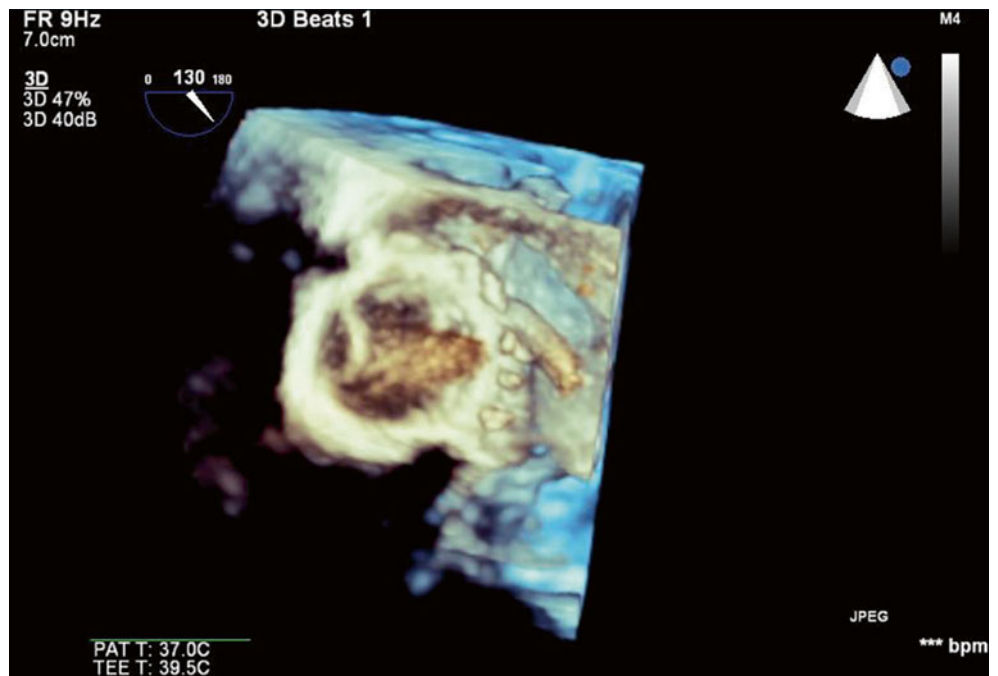
Fig. 6.60 3D reconstruction of the mitral valve from the left atrial view. The paravalvular leak was successfully closed using 10 and 12-mm Amplatzer Vascular Plug II devices at the 2 and 3 o'clock positions

- Video 6.50** 3D reconstruction of the mitral valve from the left atrial view. The paravalvular leak was successfully closed using 10-mm and 12-mm Amplatzer Vascular Plug II devices at the 2 o'clock and 3 o'clock positions

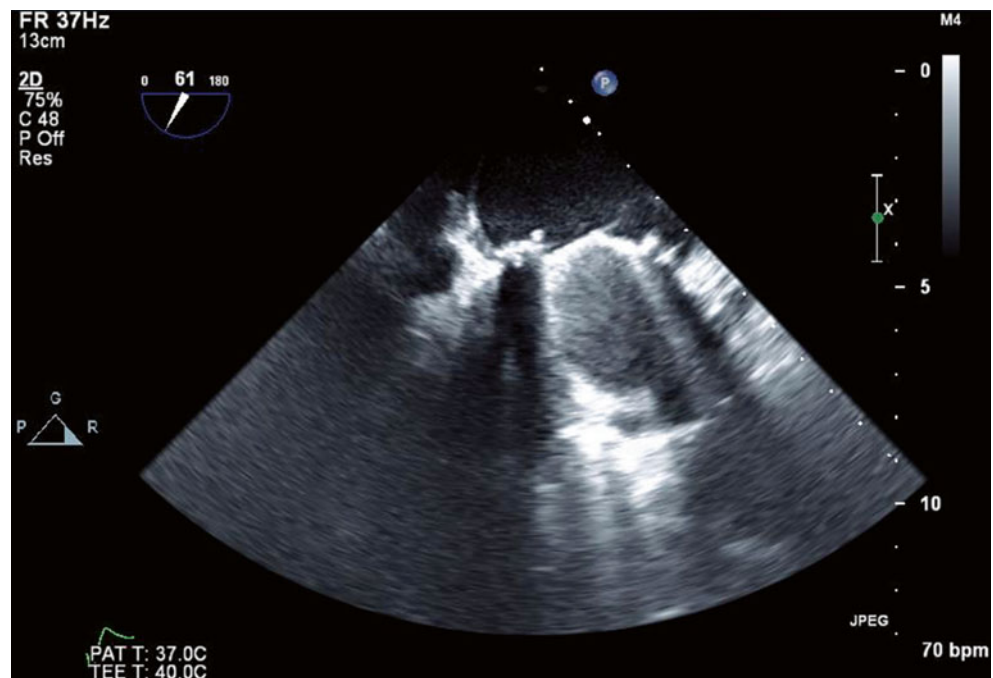
Fig. 6.63 TEE image at 61° demonstrating the mild to moderate paravalvular leak

- Video 6.52** TEE image at 61° demonstrating a normally functioning bileaflet St. Jude prosthetic mitral valve
- Video 6.53** TEE image at 61° demonstrating the mild to moderate paravalvular leak

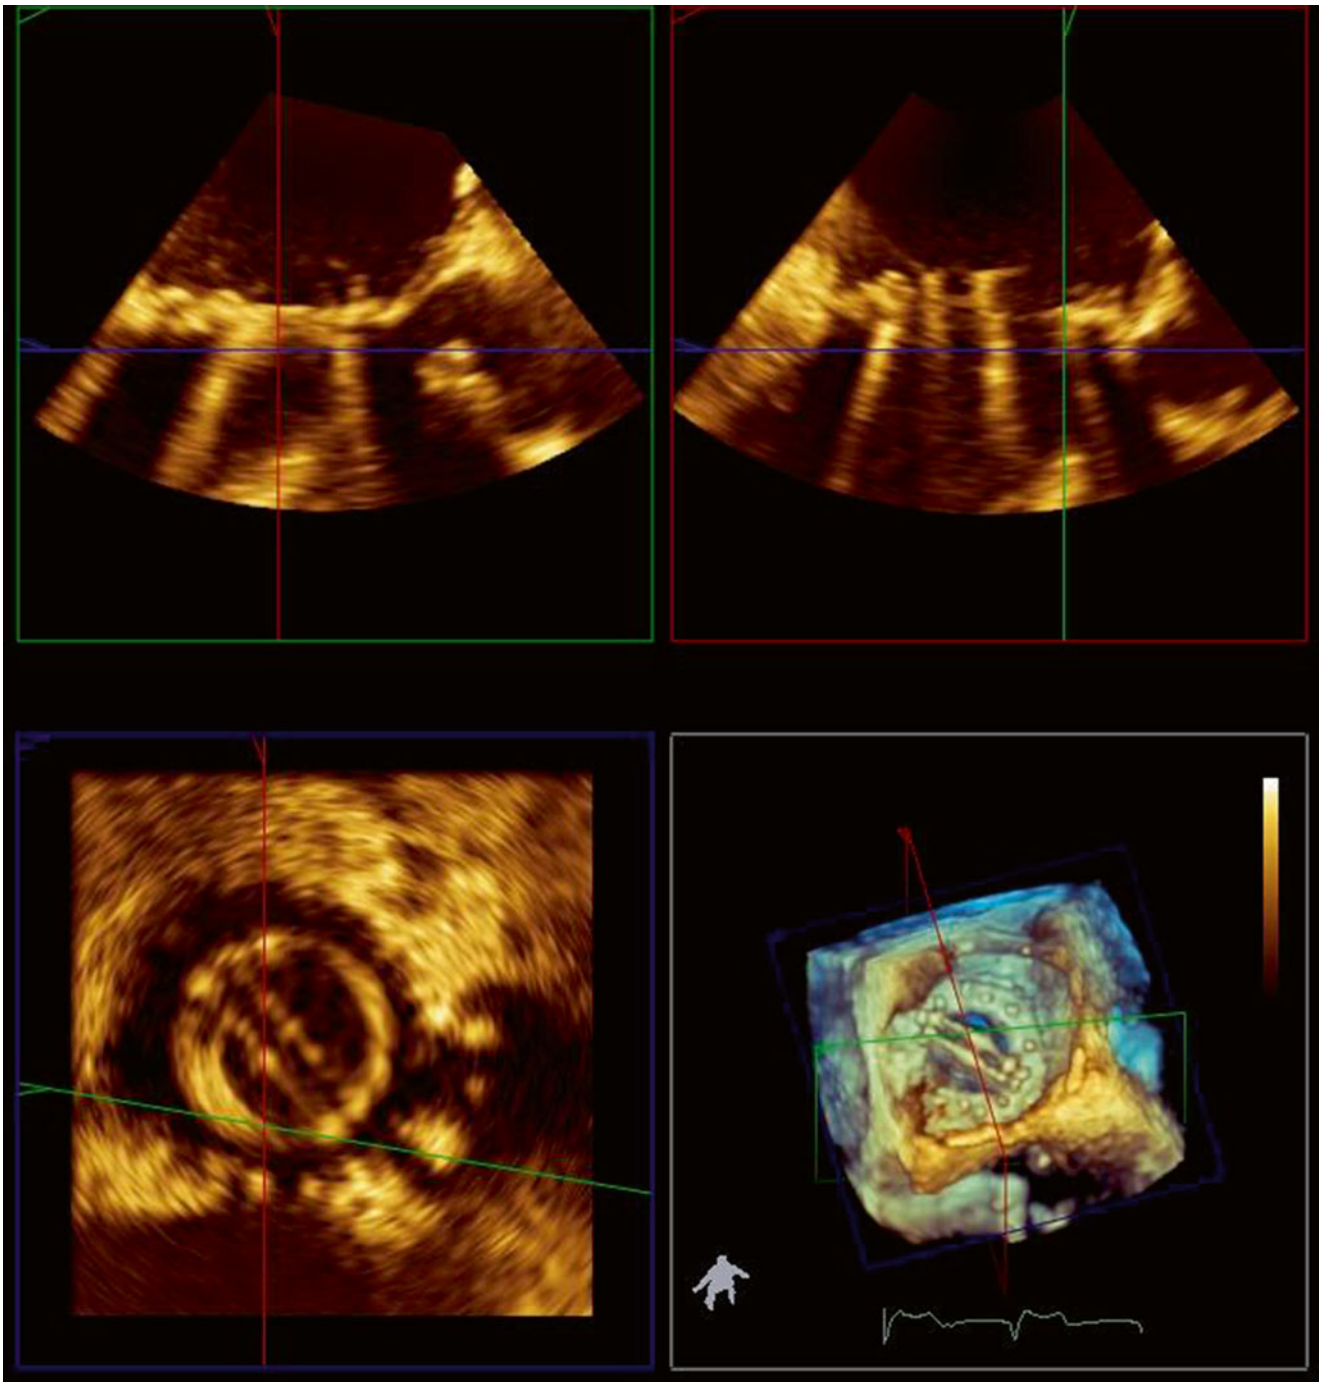
Fig. 6.64 Valve dehiscence is not evident on 3D reconstruction (Philips 3DQ) of the mitral valve replacement from a left atrial view, owing to the small size of the orifice of the leak

- Video 6.54** Valve dehiscence is not evident on 3D reconstruction (Philips 3DQ) of the mitral valve replacement from a left atrial view, owing to the small size of the orifice of the leak

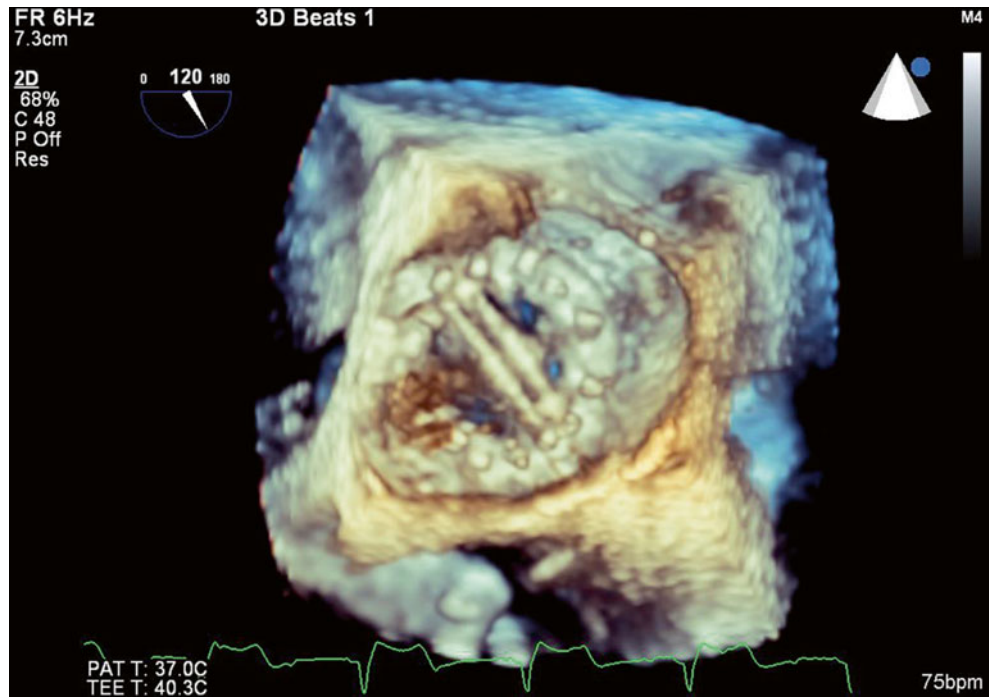
Fig. 6.66 Transesophageal 72° view demonstrating no significant residual paravalvular leak after deployment of the occluder device

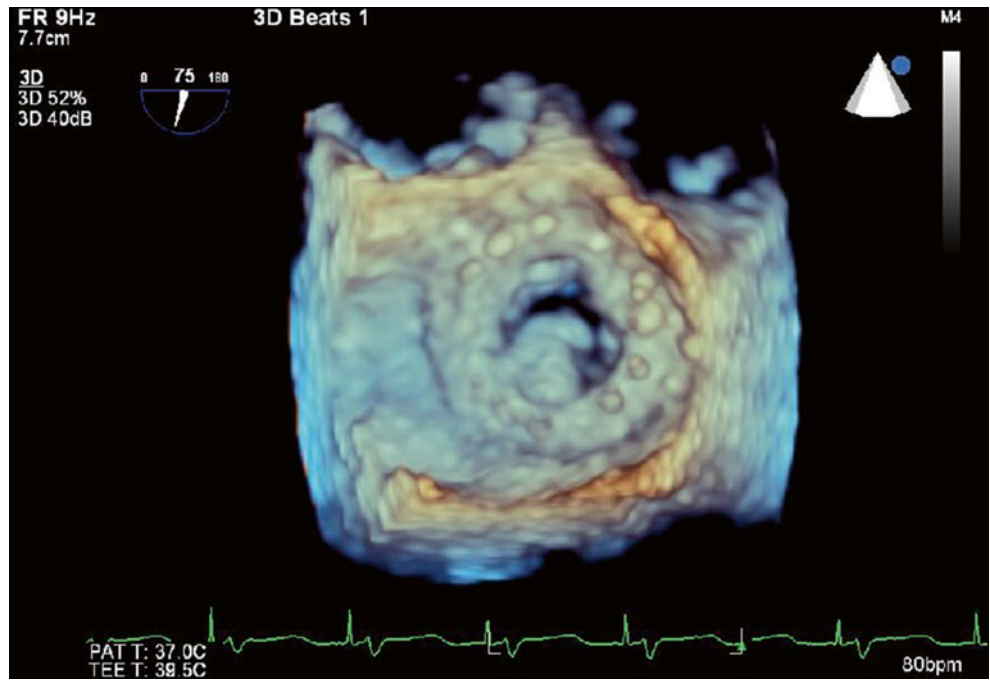
Fig. 6.72 3D imaging of the guidewire across the mitral valve

- Video 6.62** 3D imaging of the guidewire across the mitral valve
- Video 6.63** 3D imaging of the mitral valve prosthesis being fed along the guide wire into position

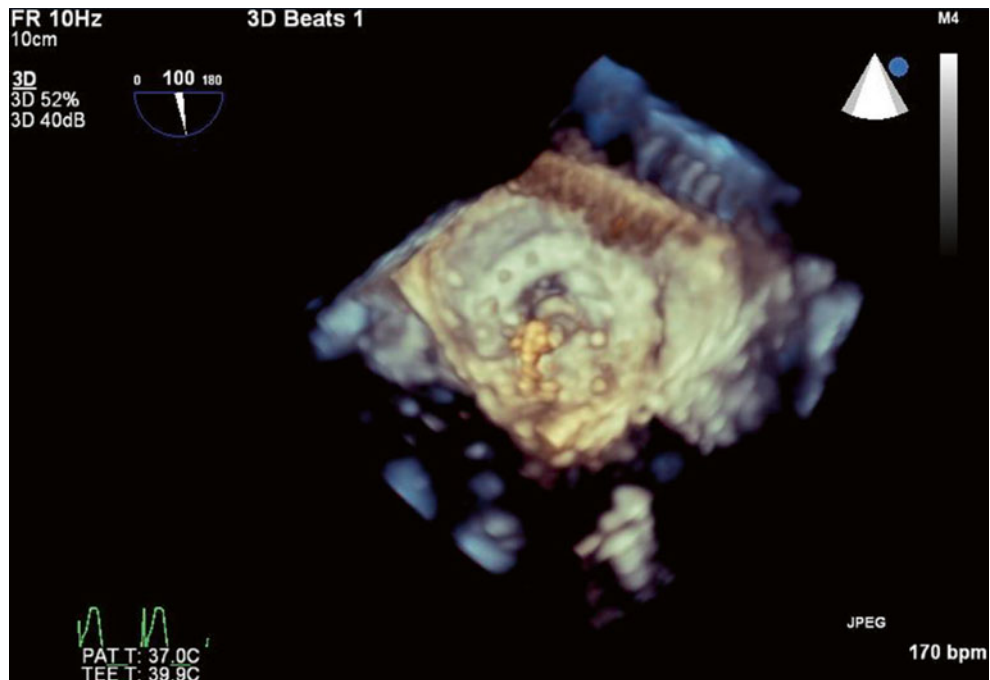
Fig. 6.75 3D imaging after deployment of the fully expanded and normally functioning mitral valve prosthesis; the guidewire is still in situ

- Video 6.64** 3D imaging during balloon inflation and deployment of the new 26-mm Edwards Sapien bioprosthetic valve prosthesis
- Video 6.65** 3D imaging after deployment of the fully expanded and normally functioning mitral valve prosthesis; the guidewire is still in situ

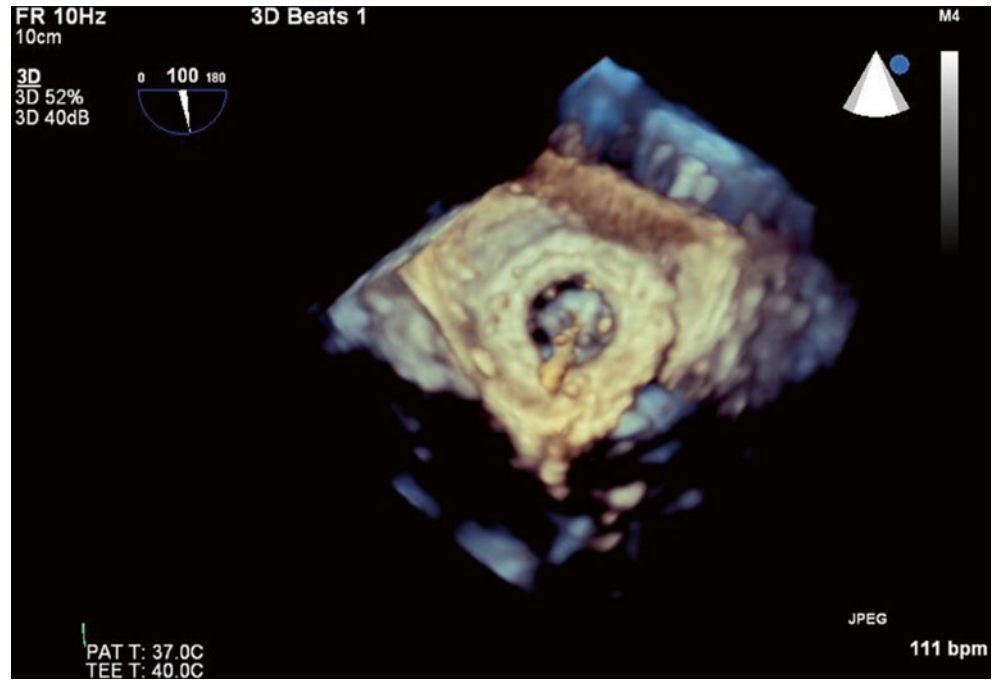
Fig. 6.76 3D imaging after removal of the guidewire demonstrates unrestricted opening of the new transcatheter “valve in valve” mitral valve replacement

- Video 6.66** 3D imaging after removal of the guidewire demonstrates unrestricted opening of the new transcatheter “valve in valve” mitral valve replacement

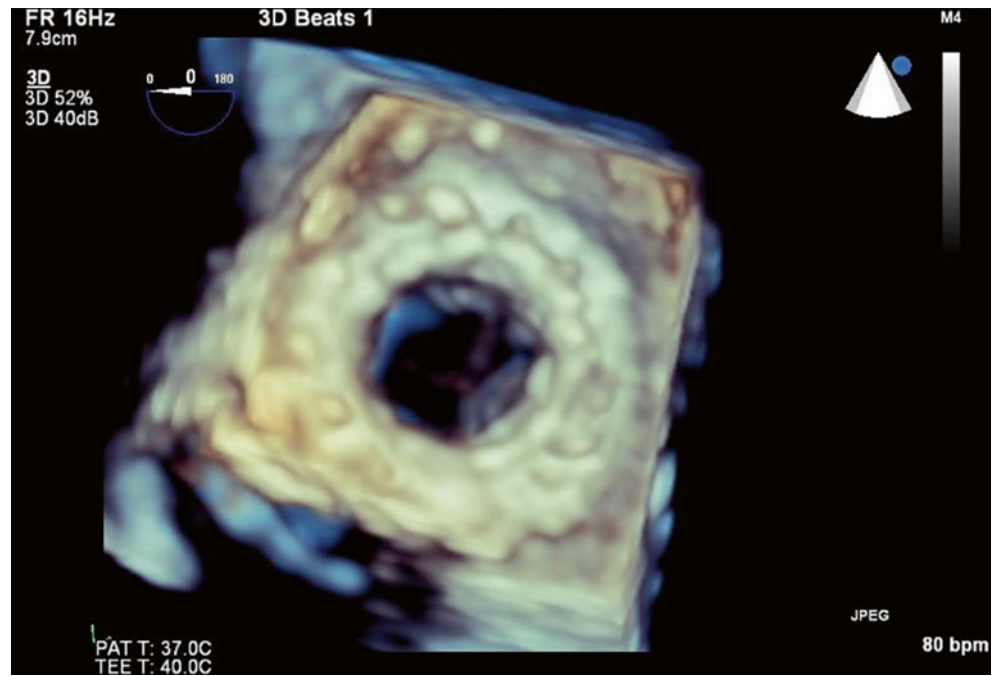
Fig. 6.77 Transesophageal 2D biplane view (0° and 90°) demonstrating the new transcatheter mitral valve replacement opening normally

- Video 6.67** Transesophageal 2D biplane view (0° and 90°) demonstrating the new transcatheter mitral valve replacement opening normally
- Video 6.68** Transesophageal biplane view (0° and 90°) with color Doppler imaging demonstrating mild residual valvular mitral regurgitation and a trace anterior paravalvular leak

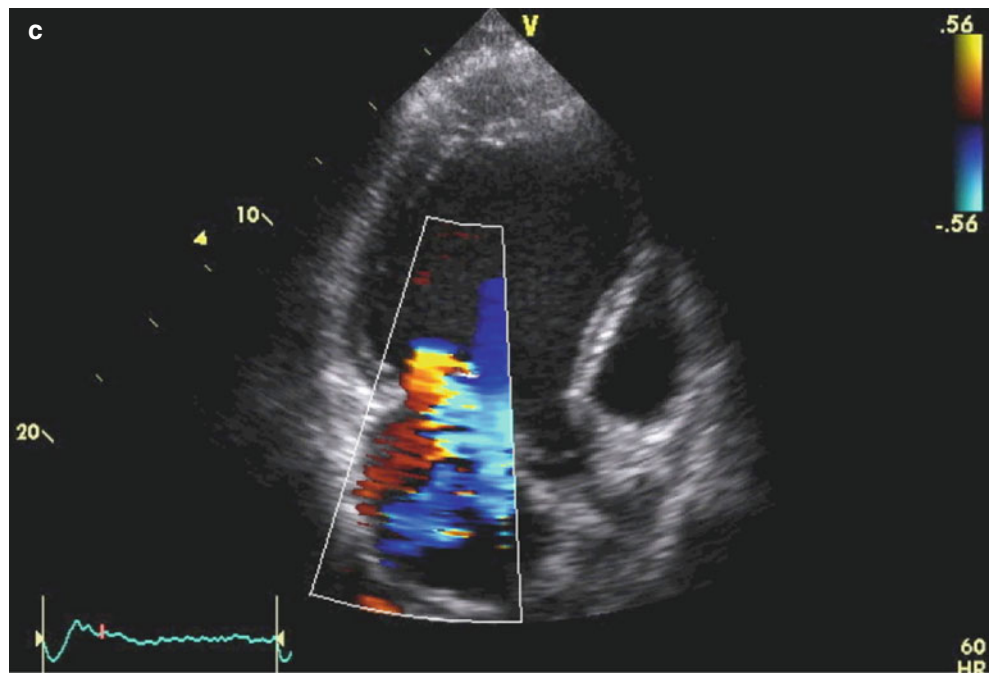
Fig. 6.88 After 6 months of cardiac resynchronization therapy, a marked decrease in left ventricular size, improvement in left ventricular function, and reduction in mitral regurgitation severity to mild to moderate (1–2+) were observed and can be seen on the 4-chamber (a) and 2-chamber (b) apical long-axis views

- Video 6.78** After 6 months of cardiac resynchronization therapy, a marked decrease in left ventricular size, improvement in left ventricular function, and reduction in mitral regurgitation severity to mild to moderate (1–2+) were observed

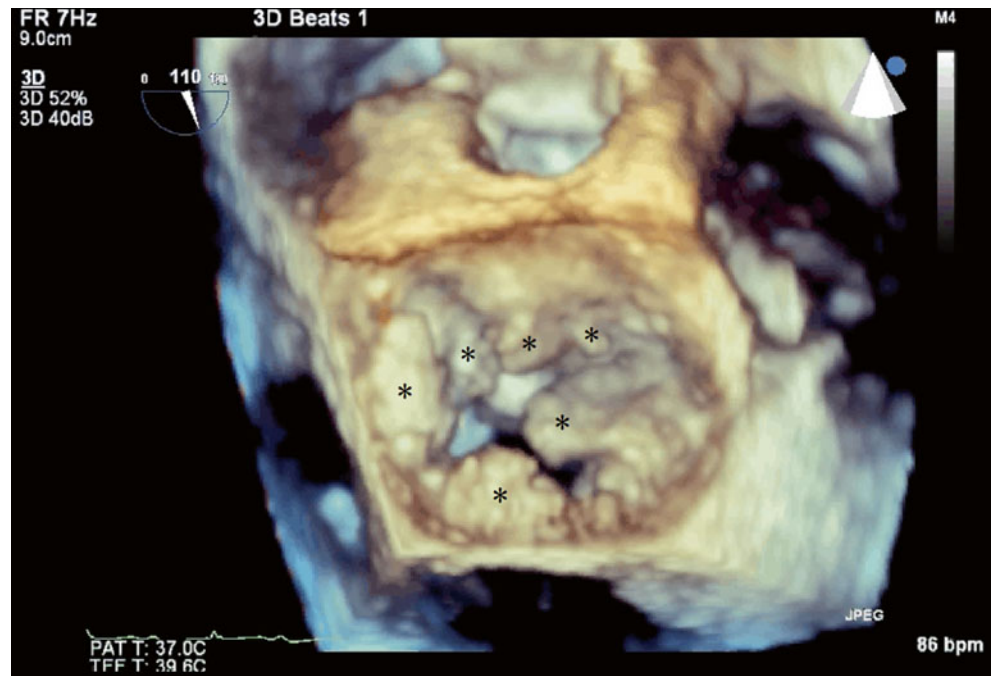
Fig. 7.11 Three-dimensional (3D) TEE of the mitral valve (LA view) showing multiple vegetations (*asterisks*)

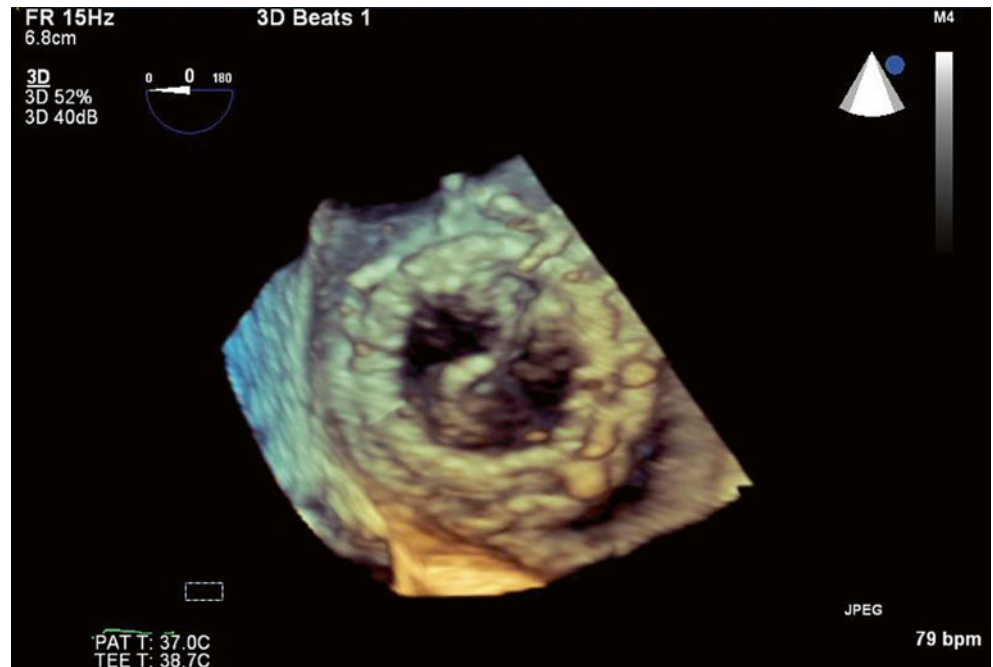
Fig. 11.1 A 3D image of a normally functioning, trileaflet, Biocor bioprosthetic mitral valve replacement viewed from the left atrium. High image resolution enables the leaflets, annulus, and even sutures to be clearly demonstrated. The 3D image is conventionally orientated with the aortic valve at the 12 o'clock position, thereby allowing consistency of image description and better ease of interpretation

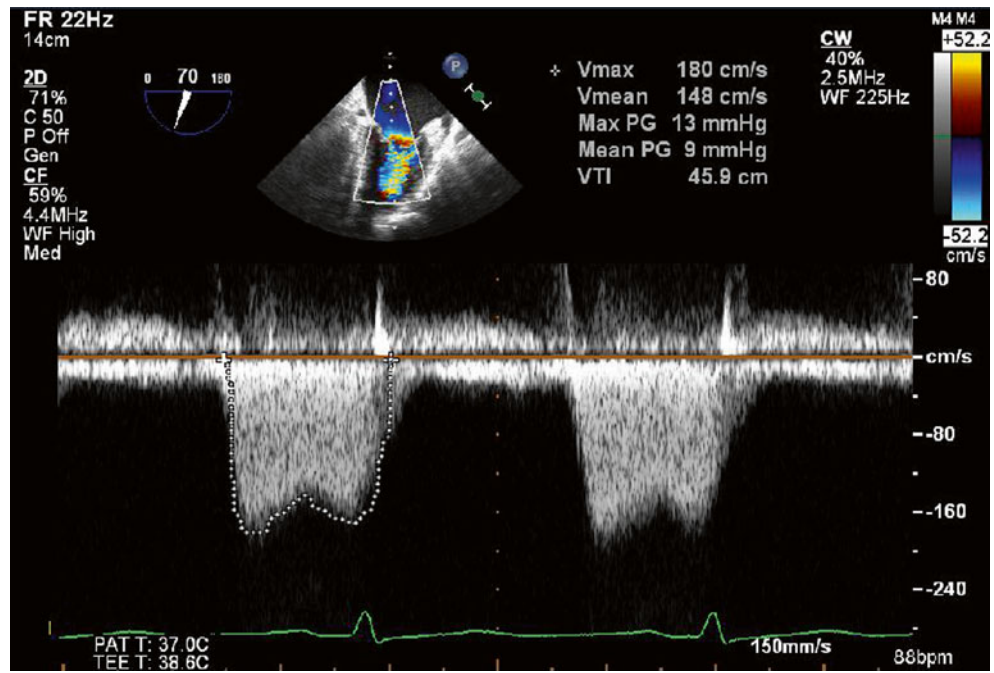
Fig. 11.13 Continuous wave Doppler through the mitral valve after valvuloplasty demonstrates an improvement in transmitral gradients to a peak of 13 mmHg and a mean of 9 mmHg

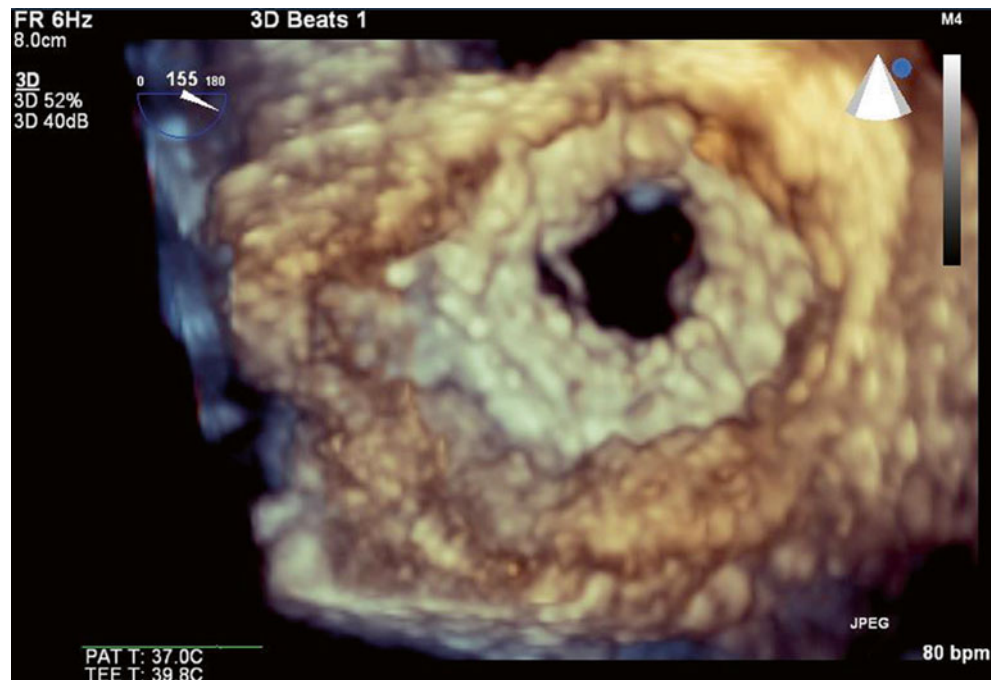
Fig. 11.61 3D reconstruction of the mitral valve immediately after initial implantation, demonstrating a normal, functioning valve

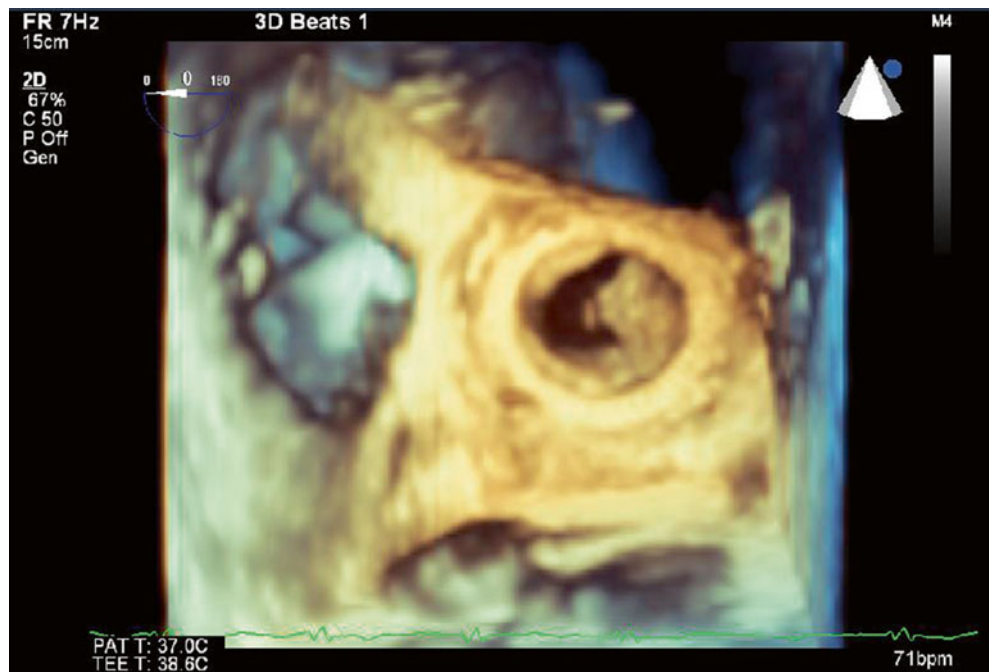
Fig. 11.73 Despite leaflet restriction, the transvalvular gradients were only mildly increased overall (peak, 11 mmHg; mean, 4 mmHg)
