Christine Jellis

Mitral valve surgery is one of the most technically demanding aspects of cardiac surgery, owing both to the valve's location and to its complicated structure. Overall cardiac surgical performance is gauged by the rate of successful mitral valve repair. Typically, the best short-term and long-term outcomes are achieved by surgeons who have a subspecialized interest in mitral valve surgery and perform large numbers of repairs in high-volume centers. A repair is usually preferred over a replacement, owing to both longevity and the avoidance of anticoagulation, but repair is not always technically feasible if the valve is stenotic, calcified, significantly thickened, or morphologically unsuitable. A good replacement is always better than a poor repair, which may lead to premature redo surgery. Mitral valve repairs typically involve plication of the posterior leaflet and insertion of an annuloplasty ring. An Alfieri stitch is sometimes included to optimize leaflet coaptation. Mitral valve replacements can be both bioprosthetic and mechanical. Individualized factors including the patient's age, suitability for anticoagulation, and plans for future pregnancies are all im

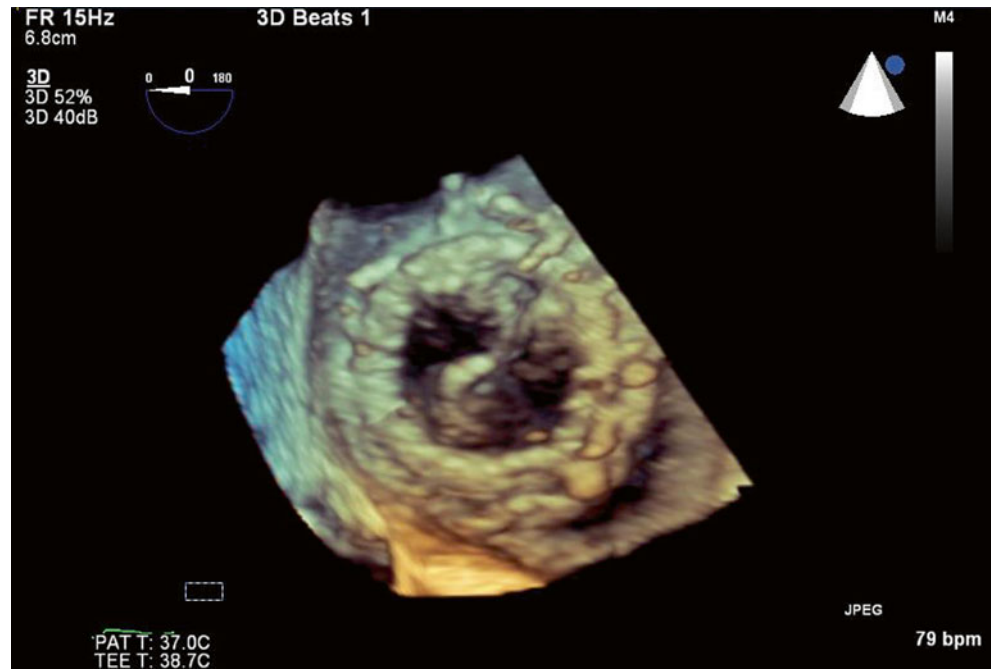
**Fig. 11.1** A 3D image of a normally functioning, trileaflet, Biocor bioprosthetic mitral valve replacement viewed from the left atrium. High image resolution enables the leaflets, annulus, and even sutures to be clearly demonstrated. The 3D image is conventionally orientated with the aortic valve at the 12 o'clock position, thereby allowing consistency of image description and better ease of interpretation

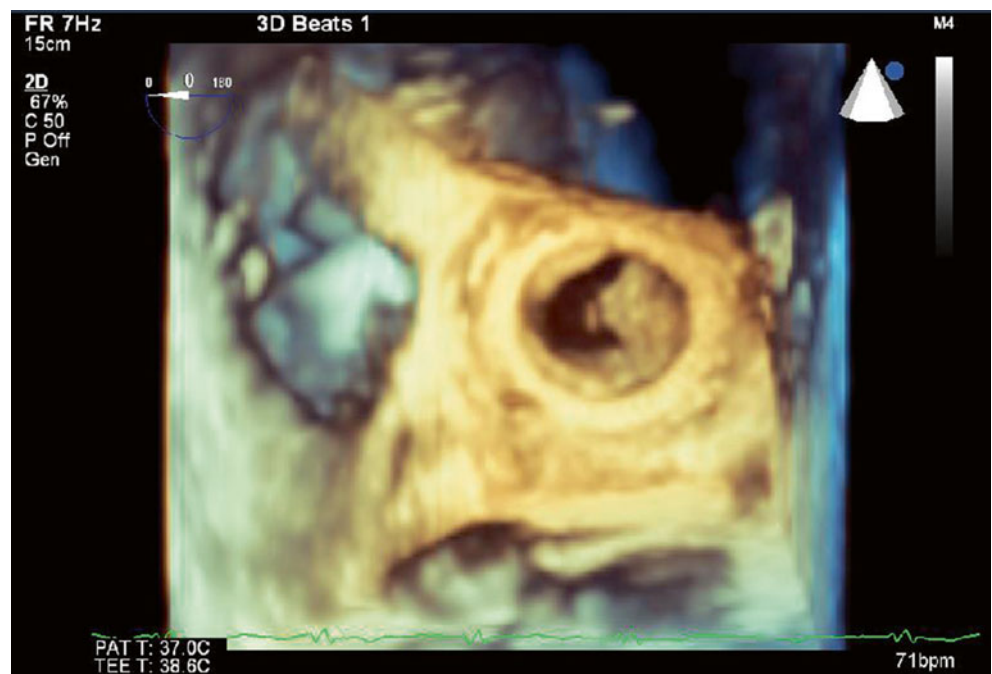
**Fig. 11.73** Despite leaflet restriction, the transvalvular gradients were only mildly increased overall (peak, 11 mmHg; mean, 4 mmHg)
