Phillip Williams, Gabrielle Konin, and Lawrence V. Gulotta

In this chapter, we will discuss some of the more common causes of TSA failure and the utility of MRI in the diagnosis and management of them. When possible, case vignettes are used to demonstrate the correlation between MRI results and the findings during revision surgery.

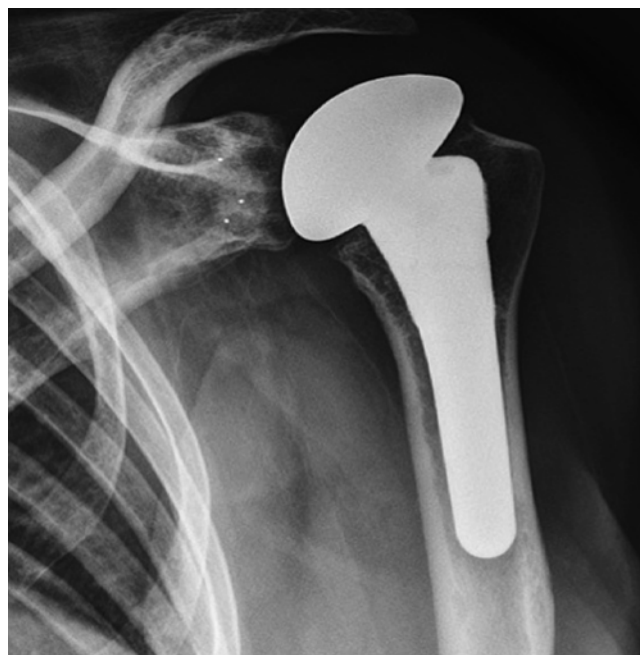
Fig. 19.1 Glenoid component loosening with radiolucent lines

A 67-year-old right-hand-dominant man who underwent a left total shoulder replacement approximately 5 years prior to presentation. He now complains of pain with range of motion. His physical exam shows forward flexion to 160°, external rotation of 45°, and internal rotation to the lumbar spine. He demonstrates excellent strength with rotator cuff testing including a negative belly press. Radiographs show some radiolucency around the glenoid component but without

frank loosening (Fig. 19.1). MRI shows evidence of loosening around glenoid component (Fig. 19.2a, b).

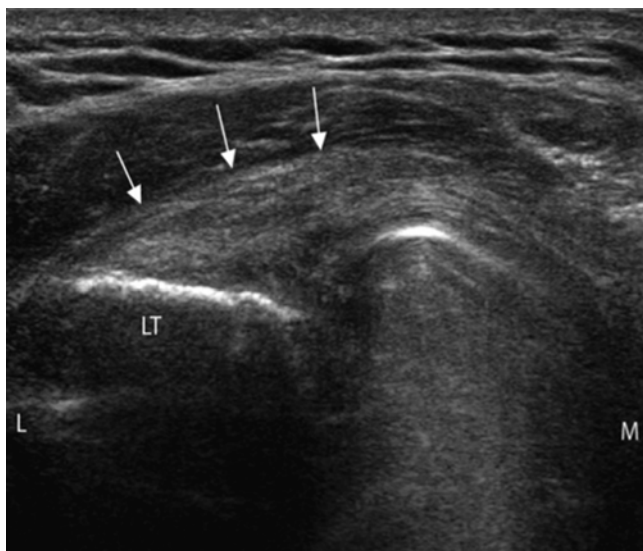
Fig. 19.4 Ultrasound image depicts an intact subscapularis tendon (arrows) in the long axis. *LT* lesser tuberosity, *L* lateral, *M* medial

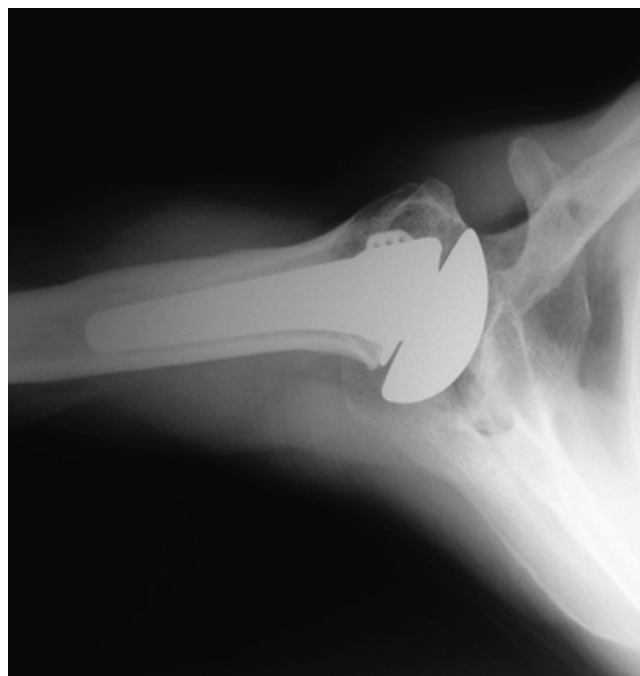
Fig. 19.5 Axillary radiograph showing posterior subluxation of the humeral head component secondary to eccentric posterior glenoid wear

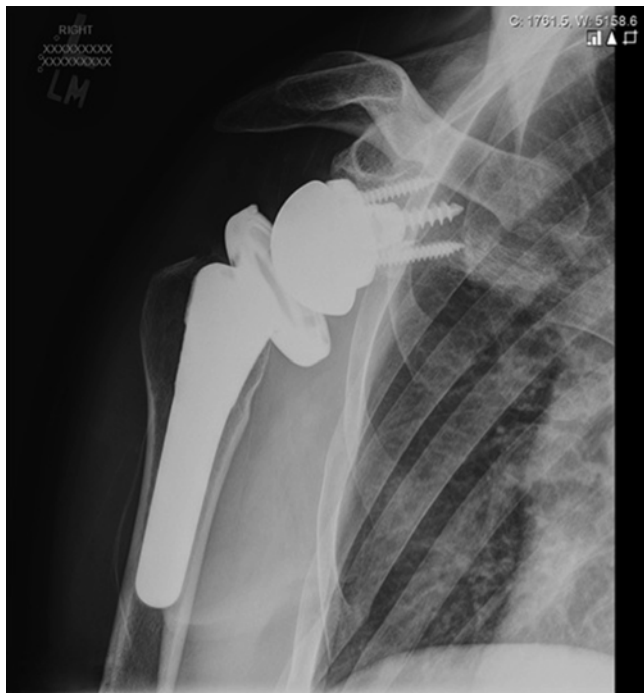
Fig. 19.8 Anteroposterior radiograph after conversion of the total shoulder replacement to a reverse shoulder arthroplasty

Patient underwent conversion of his total shoulder replacement to a reverse shoulder arthroplasty (Fig. 19.8). Four years later the patient now has 150° of forward flexion, 15° of external rotation, and internal rotation to the back pocket all with minimal pain.

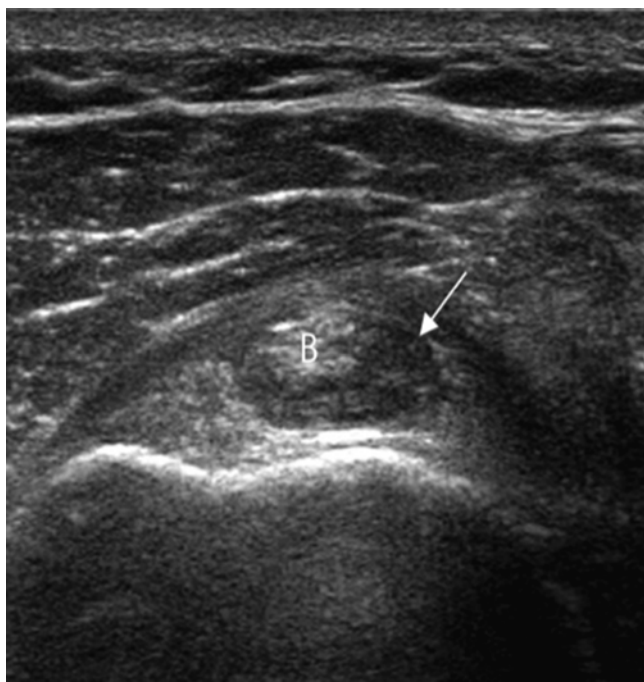
Fig. 19.10 Ultrasound image demonstrates the long head of the biceps tendon (B) in short axis with a hypoechoic rim of synovial fluid and debris (arrow)—“halo” sign
