SCAN to HBIM-Post Earthquake Preservation: Informative Model as Sentinel at the Crossroads of Present, Past, and Future

Department of Architecture, Built Environment and Construction Engineering,
Politecnico di Milano, Via Ponzio 31, 20133 Milan, Italy
{raffaella.brumana, stefano.dellatorre, daniela.oreni,
lorenzo.cantini, mattia.previtali, luigi.barazzetti,
fabrizio.banfi}@polimi.it

Abstract. In the last years it has been progressively invested many efforts in the cultural heritage digitization: surveying, modeling activities, diagnostic analysis and historic data collection of architectural heritage. Such actions have been mainly acquired for the preservation process, during the restoration and construction site. Unfortunately, many of them are left abandoned in a latent status without any connection with the long life cycle of the historic architectures or connection to the dissemination. The paper presents the case of an informative model for the Basilica di Collemaggio generated on high resolution surveying (laser scanning, photogrammetric point clouds and IRT Infrared Thermography) to manage the knowledge acquired on the geometry and the collected information on materials,

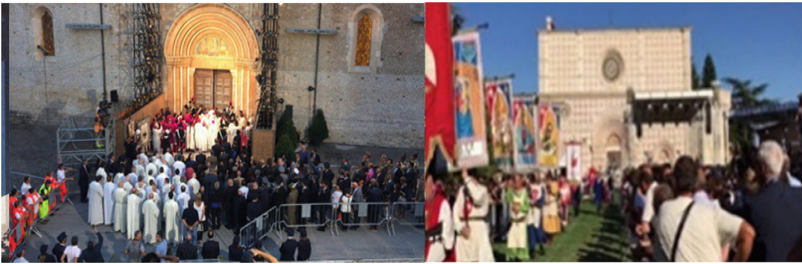
Fig. 3. The opening of the Holy Door during the Forgiveness Feast procession: the provisional structure to put in safety people during the restoration (August 2017).

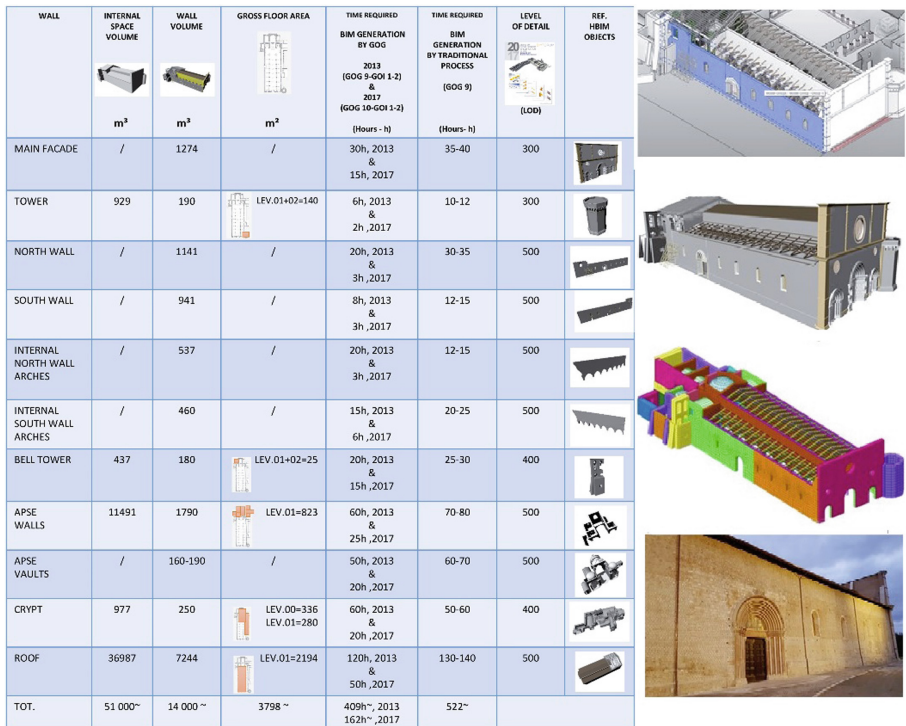
Fig. 6. The HBIM NURBS based model objects (volumes and hours effort). On the right, the case of restored north wall with the BIM to FEA (Finite Element Analysis).

The HBIM obtained is the sum of each element (Fig. 5) modelled in function of its geometry. It is interoperable with the construction site management (CO.SI.M), with the finite element analysis (BIM-to-FEA) [11], Design Tools, and Conservation Plan purposes, thus contributing lowering the impact cost of the HBIM generation (Fig. 6).
