Non-invasive Investigation and Documentation in the Bieliński Palace in Otwock Wielki

Abstract. The paper presents the ongoing project conducted by an interdisciplinary team at the Bieliński Palace in Otwock Wielki, near Warsaw (Poland). The main aim of the project is to document the architecture and architectural elements with the use of digital methods such as photogrammetry and 3D scanning, as well as investigating the construction phases of the palace, through the analysis of the digital data collected.

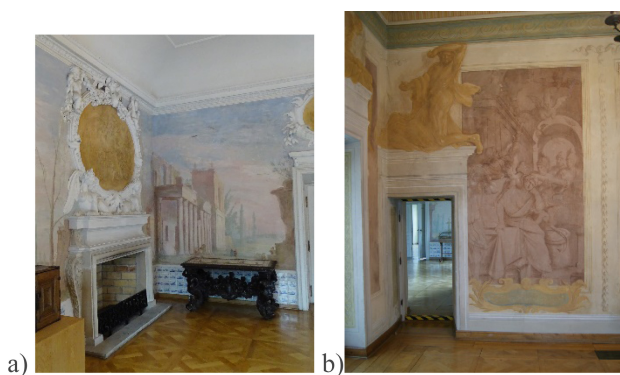
Fig. 4. (a) Fresco decoration of Room 2 and the fireplace, (b) Detail of the decoration in Room 1. (Color figure online)

location to begin our investigation into the construction phases of the palace. Additionally, the walls of both rooms are entirely decorated with frescoes, which were the second focus of our investigation. The decoration of Room 2 comprises mostly of pastel landscapes with elements of architecture (Fig. 4a), while the main architectural element is a fireplace with a simple stone frame, crowned with antithetic winged stucco sphinxes, carrying on their back a tondo, which once contained a fresco now missing. Room 1 has a different type of decoration, in which the main elements are 9 figurative panels with allegorical scenes (Fig. 4b). Each scene is accompanied by a short Latin sentence within a decorative baroque frame. The additional painted decoration imitates stucco elements around the windows and doors with large gold figures crowning them. The scenes in the panels are executed in monochromatic brownish colours. Preliminary examination of the frescos revealed incised sketches done in wet plaster. The technique of the fresco still needs to be established.
