# Slope Stability Analysis and Suggestive Measures for an Active Landslide in Indian Himalaya

Shantanu Sarkar<sup>(✉)</sup>, Manojit Samanta, Mahesh Sharma,  
and Ajay Dwivedi

Geotechnical Division, CSIR-CBRI, Roorkee, Uttarakhand, India  
shantanu\_cbri@yahoo.co.in

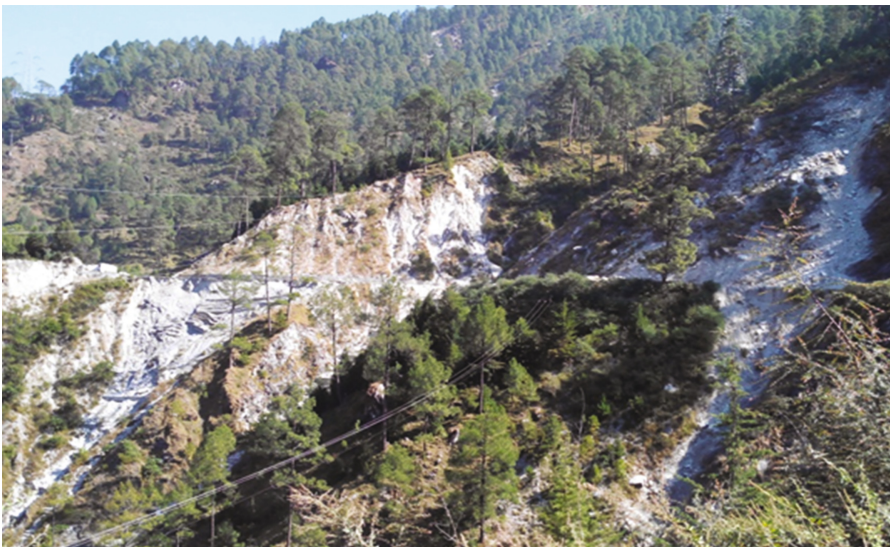
**Fig. 2.** A panoramic view of the landslide

Landslide disasters causing loss of life and property are enormous in Indian Himalayas. The complex geology and tectonic set up supplemented by heavy rainfall and anthropogenic activities made the Himalayan region very prone to landslides. There are many locations where human lives are in danger due to landslides. A large number of slope failures have affected the major highways in the Himalayas, which are also important routes for pilgrims. One such National Highway (NH-58) Rishikesh-Badrinath road in the Alaknanda river valley is very prone to landslides particularly in the vicinity of Main Central Thrust (MCT) zone. A few hazard zones were identified as most potential zones, where number of landslides is affecting the traffic and thereby posing threats to lives (Sarkar et al. 2005). Such landslides were mapped on the high resolution CARTOSAT I remote sensing image and a small segment of this region is shown in the Fig. 1. In the present study, one active landslide in this region near Pipalkoti along the same highway has been investigated for stability analysis and suggestive control measure (Fig. 2).

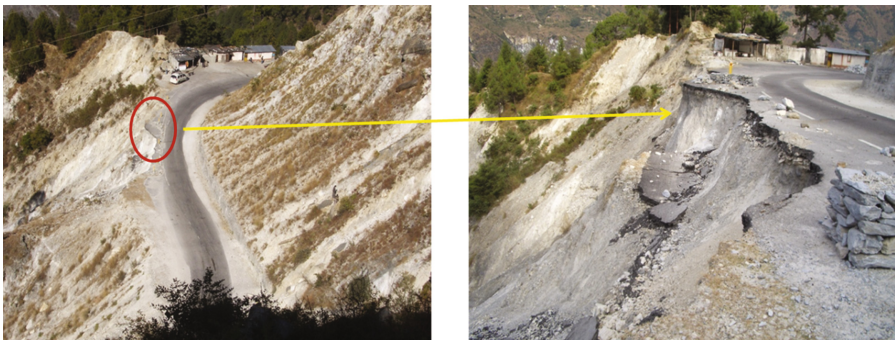
**Fig. 3.** Highway at risk due to debris slide

The studied landslide is a debris slide including debris materials and a few rock boulders on a steep slope. The rock types exposed in the slide area are dolomites which primarily consist of calcites and quartz. Topographic survey of the landslide was carried out to know the topographic features and to generate a contour map on 1:500 scale with 1 m contour interval. A DEM was prepared in GIS from the contour map and a slope map was generated. From the slope map it was observed that maximum area in the landslide site is having the slope angle 35–45°, however, there are a few escarpments with very steep slope of 45–60°. The landslide is divided into two parts by a seasonal drain. The road has been severely damaged on the downhill slide due to the ongoing landslide activities (Fig. 3).

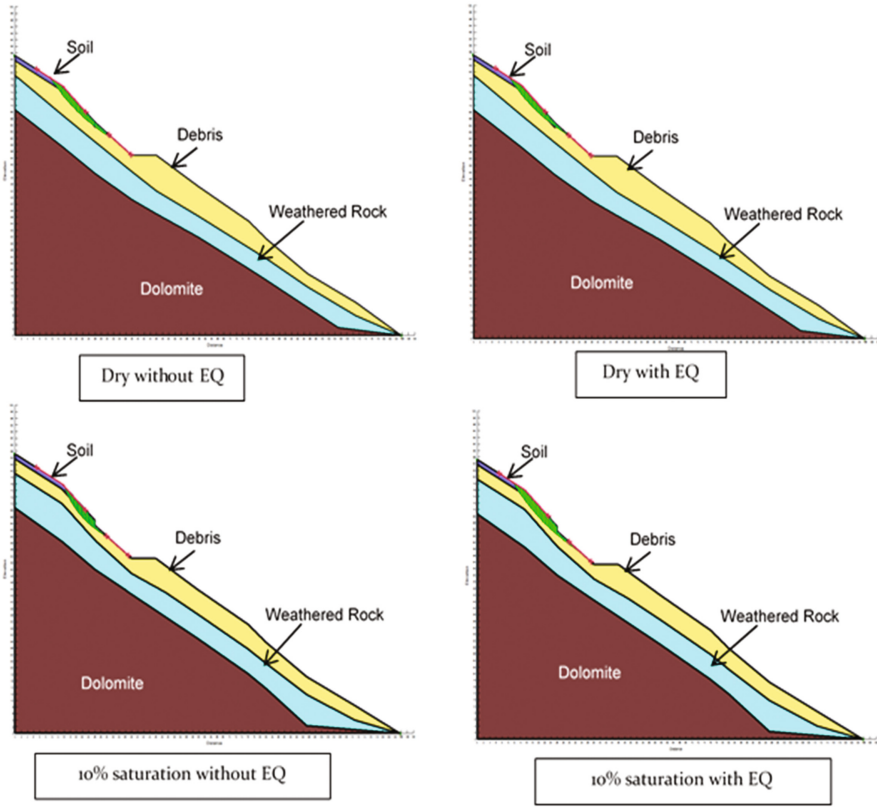
**Fig. 6.** Slope stability analysis without considering remedial measures

Stability analysis of the landslide was carried out to know the state of stability condition of the landslide so that suitable control measures can be designed. The failure mechanism of the slide appeared to be a circular failure as observed from the field observations. Limit equilibrium methods were used to determine the factor of safety of the landslide slope under different condition. The analysis was carried out for two most probable failure profiles. Two sections as shown in the Fig. 5 of the slide area were selected to carry out slope stability analysis. Factor of safety were calculated using GeoStudio software (SLOPE/W) at different moisture conditions and without earthquake and with earthquake loading. The results of the analysis are shown in the Fig. 6 and the values of factor of safety are tabulated in the Table 3. From the table it can be inferred that the factor of safety of both the sections are marginally stable under dry and static conditions but it drastically decreases in the range of 0.8 to 0.5 under partial saturation and earthquake loading. Selection of an appropriate remedial measure depends on several factors such as engineering feasibility, economic feasibility, social

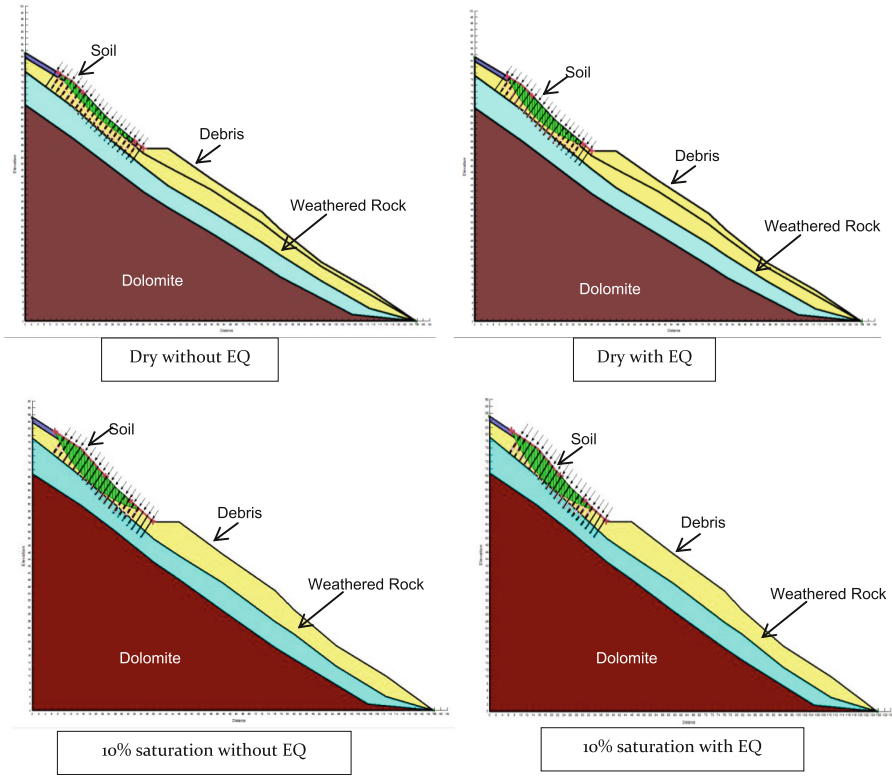
**Fig. 7.** Slope stability analysis with inclusion of soil nails (Geo-Slope International Ltd., GeoStudio 2007)

Soil nailing is an in situ soil reinforcing technique adopted for stabilizing unstable slopes (Sharma et al. 2019). It increases the overall shear strength of unsupported soils and is relatively flexible and can accommodate large settlements. Also soil nailing is more economical than conventional concrete gravity wall. The soil nail gains pull-out resistance from within the sliding soil mass in front of the slip plane and the stable soil mass located behind the slip plane. The geometric system of soil nail placements creates an internally reinforced soil mass that is stable. The soil nail acts as a passive bearing element, which relies on soil movement and subsequent active earth pressure to mobilize the shear strength along the nail whereas a tieback anchor is pre-stressed to mobilize shear strength (Junaideen et al. 2004). Soil nails were designed suitably and stability analyses were carried out in SLOPE/W module limit equilibrium method using GeoStudio software to see the efficacy of the nails. Different parameters were analyzed by the Morgenstern-Price method. The reasonable design parameters obtained by the analysis are given in the Table 4. The values of factor of safety obtained after inclusion of soil nails are given in the Table 5 and the results of the analysis are shown in the Fig. 7. It is observed from the analysis that factor of safety increases significantly after installing soil nails as stabilization measures. The factor of safety with soil nails increase to 2.4 and 2.8 in dry condition from 0.97 and 1.0 for sections MN and CD respectively. Even under partial saturation the slope is stable after inclusion of nails.
