Digital Scanning and Non-destructive Techniques for Size Recovering and Rehabilitating the Structural Performance of Traditional Stuccoes

Abstract. Nowadays, there is a lack of knowledge regarding the traditional construction technology used in many of some important monuments in Romania. To address this limitation and to assist in their conservation and restoration, this study documents the existing condition of different historic structures. Methods and applications for 3D scanning, image scanning and non-contact and non-destructive methods are applied in this paper for structural analysis of the stuccoes from a patrimony building (Fântaneanu House, Slatina). To record and document the condition of this house, the laser scanning is used in order to identify the initial size and shape of some damaged parts of the monument. Advancement in diagnosis methods (spectral and microscopic analytical methods) for the conservation/restoration of this patrimony building.

Methods and applications of 3D scanning method with image scanning correlated with non-contact and non-destructive investigation methods are applied in this paper for structural analysis of the stuccoes from a patrimony bu

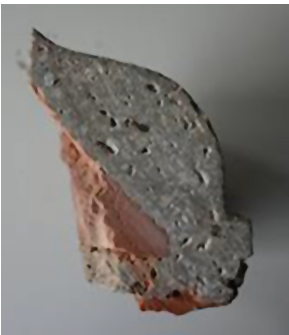
Fig. 1. The aspect of the stucco sample

The prelevated samples have been taken firstly for 3D scanning (Fig. 1) and secondly for analytical investigation (Fig. 2).

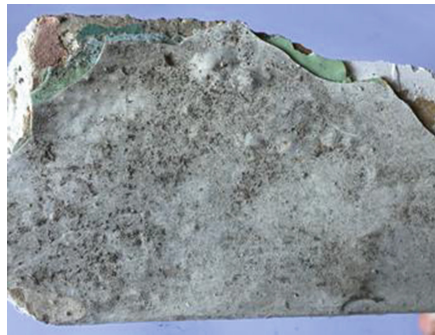
Fig. 2. The multilayer conserved stucco

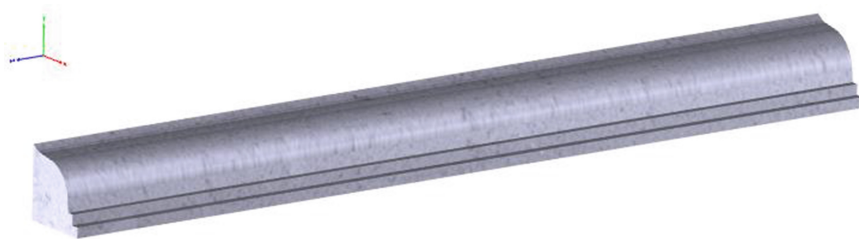
applied. After the scanner was configured, the reference points were scanned. They have the role of keeping the scanned object in a fixed position in 3D space [4, 5]. The next step involved parameterizing the scanning procedure, namely choosing the resolution, optimizing the dot network, optimizing the limits, optimizing the precision, automatically filling the holes and removing the isolated surfaces. The file containing the digitized object was saved and processed in the CATIA program [5]. A series of operations were performed to remove unusable surfaces and for the symmetrical reconstruction the mirroring operation was applied, Fig. 3.

Fig. 3. The aspect of the stucco after 3D scanning

As could be observed, this program analyzes the points and joins them, so the final result being the scanned object in electronic format (digitized), by “Digitized Shape Editor” module in the Catia program [6, 7]. The not useful surfaces have been removed and for the symmetrical reconstruction the mirroring operation was applied.

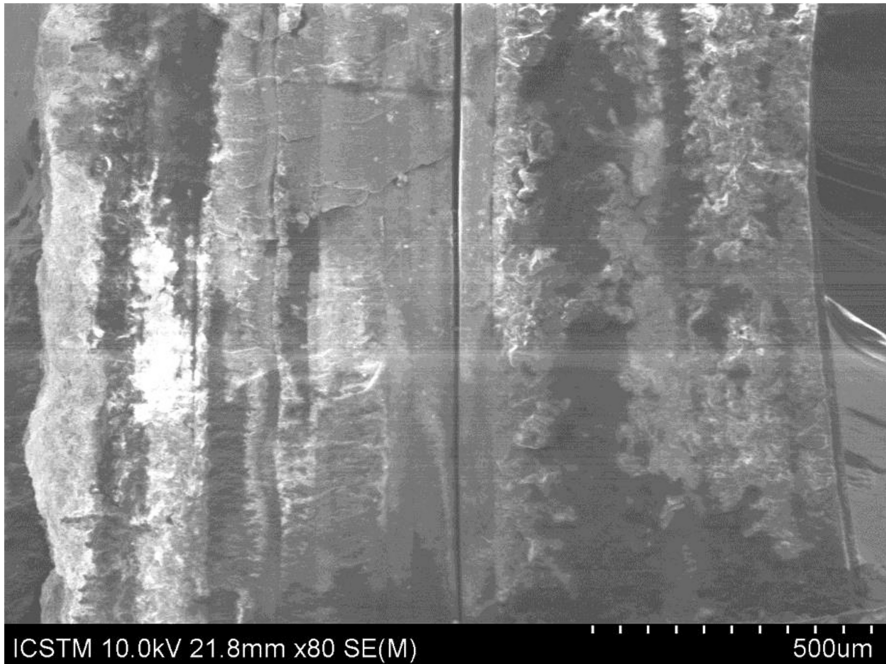
By scanning electron microscopy was possible to identify 7 successive layers of various compositions, Fig. 4.

From the SEM investigations of the whole sample, some results have been obtained: seven layers of various materials, some of the layers without a perfect connection to each other due to the incompatibility of materials or degradation induced by the passage of time and the action of external agents: moisture, freeze-thaw, light or even improper restoration operations with negative effects. These data could be correlated with other chemical techniques, for example FTIR.

Fig. 4. SEM images of the analyzed stucco mortar

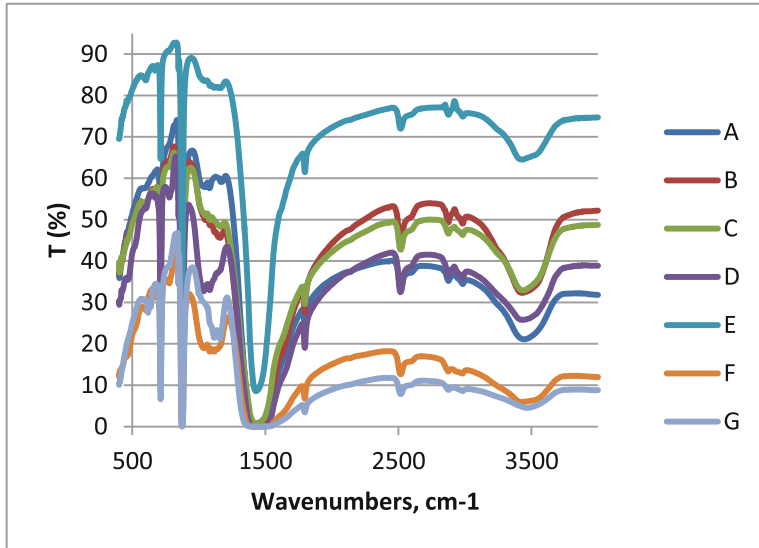
The FTIR spectral data of the MIR-region of the stucco’s layers samples show only little variation and generally a high absorbance (strong signal) at wavenumbers between 500 and 1500 cm^{-1} . This region of the spectrum is characteristic for CO

bonds, such as those originating from carbonates or carboxyl-groups of limestone. The most rich sulphate layers show the most intense band of $1700\text{--}1600\text{ cm}^{-1}$, and an increase of this band can be observed for the most degraded layer. Practically all layers show calcium sulphate, more intense as the most damaged, a sign that the degradation took time over each layer of plaster without cleaning the previous layer, Fig. 5.

Fig. 5. FTIR spectra of the stucco's layers

Within the recorded spectra of all seven clay samples presented a weak absorbance centered on $3600\text{--}3700\text{ cm}^{-1}$ which can be attributed to hydroxyl vibrations.

According with the spectral data for both category of samples it can be concluded that the chemical composition of the layers are is quite similar (hydroxyl, carbonyl and SiO_4 groups) [10–14].

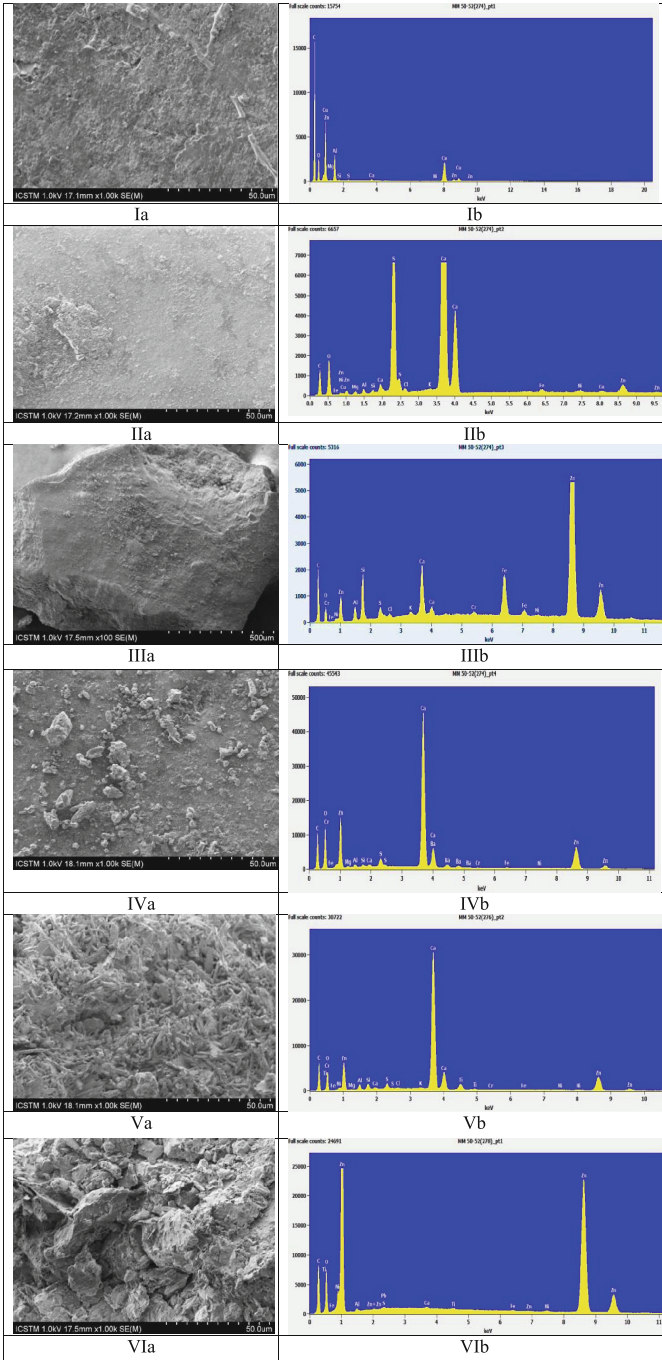
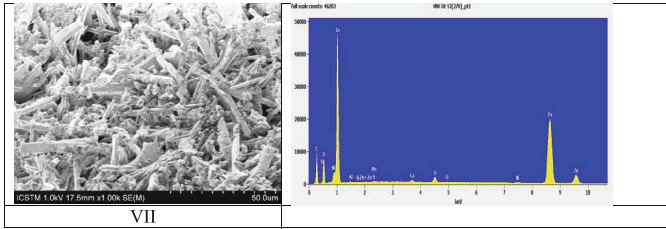
The SEM images led to the following conclusions: the masonry layers from stucco sample present a lamellar structure, with a granular structure with lamellar inclusions as well. The first layer (the oldest one) shows a damaged structure, mostly due to the second layer applied, entirely based on gypsum, the most aggressive agent for masonries in general. The second layer shows a structure of aluminosilicates responsible for implosion, Fig. 6.

Fig. 6. The SEM images (left) and EDS diagrams for the studied samples (Color figure online)

FTIR spectral data are in well compliance with EDS and SEM, Fig. 6.

From elemental analysis through EDS, we can observe the presence of calcium, which leads us to the conclusion that the plaster is lime-based, and in some layers, especially those rich in zinc, a green dye may have been used, Fig. 6.

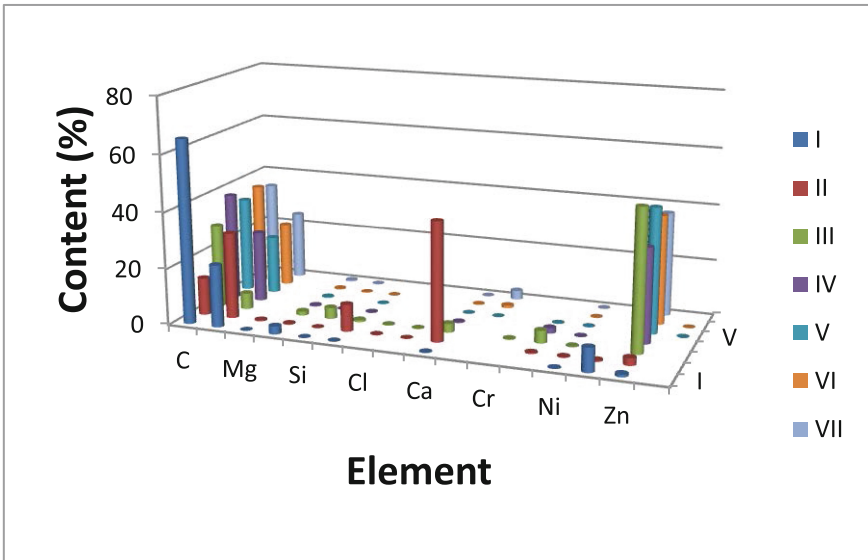
EDS results (Fig. 7) have shown that with the exception of the layers I and II, where are predominant lime and gypsum, in all the other layers, C (40–60%), O (20–25%), Zn (30–50%) are the major constituents of the stucco's masonry sample, but also have been recorded elements as: Ca (0.14–3%), Mg (1.23–1.61%), Ti (1–3.23%).

Fig. 7. The elements distribution from the stucco's layers
