# Evaluation of Damage in RC Bridge Decks Reinforced with Steel Plates by AE Tomography

Yiming Feng, Tomoki Shiotani, Yoshikazu Kobayashi, Takahiro Nishida, Hisafumi Asaue, Katsufumi Hashimoto, and Shigeru Kayano

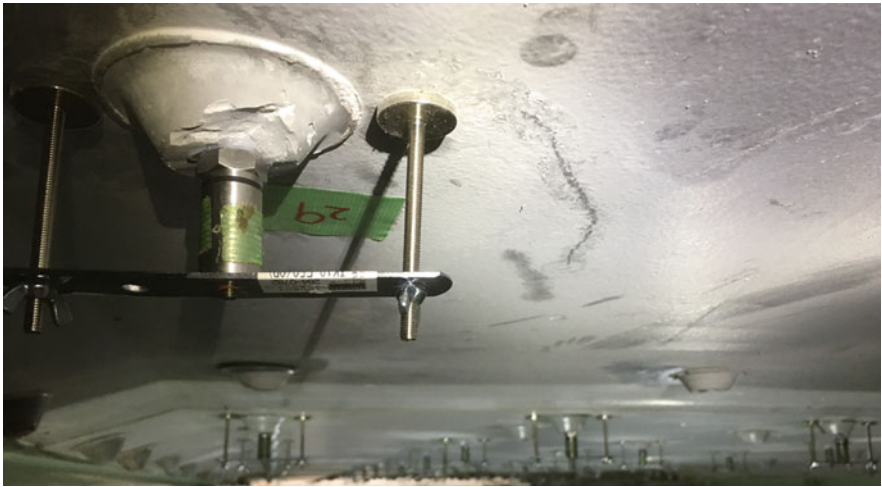
**Fig. 3** The picture of sensors installation

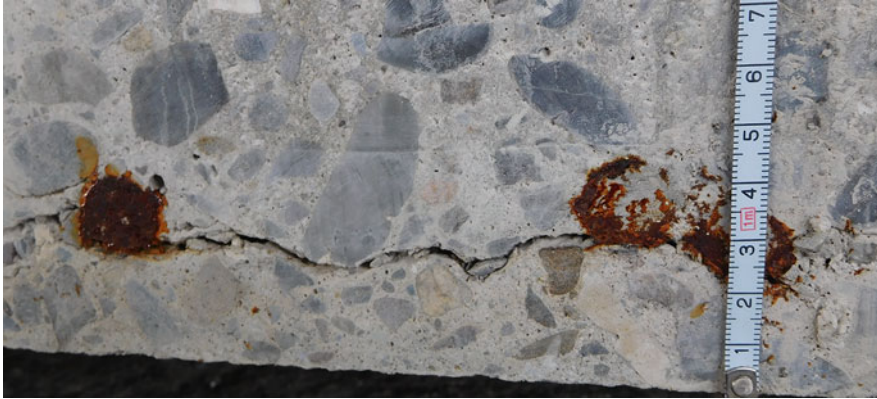
**Fig. 6** Observed horizontal cracks of the cutoff deck

After the measurement of the RC bridge deck reinforced with steel plates by AE tomography, the deck ( $1.5 \text{ m} \times 4.1 \text{ m}$ ) was cut off. As shown in Fig. 6, horizontal cracks were confirmed at the left-side surface and bottom-side surface of the cutoff bridge deck, which is roughly in agreement with the low-velocity area shown in Fig. 5.

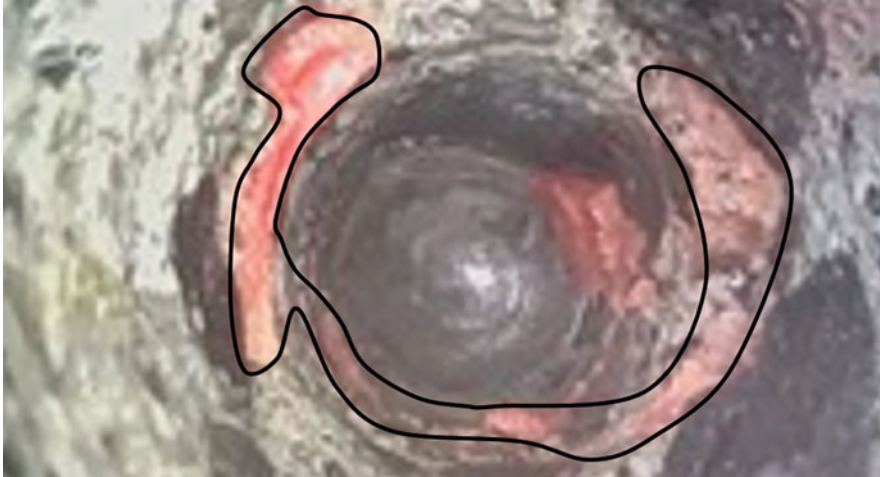
**Fig. 7** Horizontal cracks observed by high-performance endoscope

In order to verify the result of the AE tomography, the damage of the actual cutoff bridge deck was examined by cored holes injected by red epoxy resin [6]. Specifically, a holes of 5 mm in diameter was drilled in eight places as shown in Fig. 5 for the first, and red resin was injected in these holes. After hardening of the resin, a larger holes then previously were drilled at the same eight places (three places are 9 mm in diameter, five places are 10.5 mm in diameter), and the resin injected area was regarded as cracked by high-resolution endoscope in the concrete deck. Figure 7 shows the example of the confirmation of the horizontal cracks by the endoscope. As the results, it was confirmed that large amount of injected resin has entered into existent horizontal cracks and has been observed in all three holes of low-velocity area. This result matches quite well the result of AE tomography. On the other hand, any injected resin was not confirmed at three places of high-velocity area illustrated by the velocity distribution.

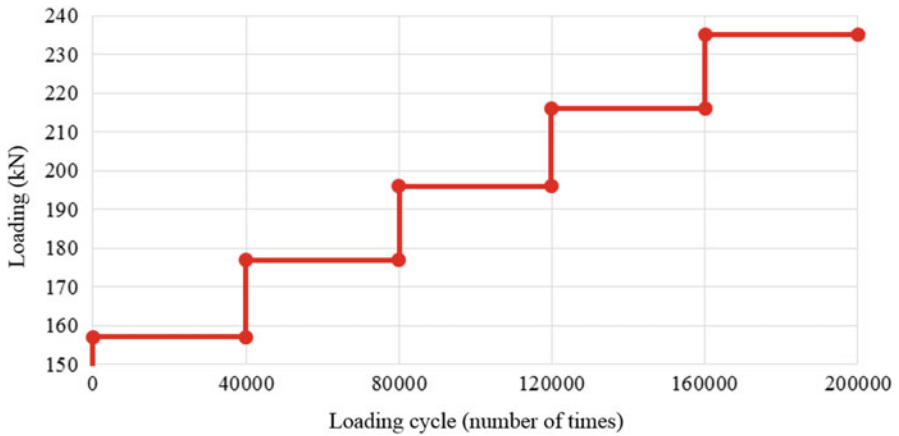
Fig. 10 Loading program

loading program as shown in Fig. 10. In the loading program, the loads of 157, 177, 196, 216, and 235 kN were repeatedly applied for each 40,000 times running, respectively.

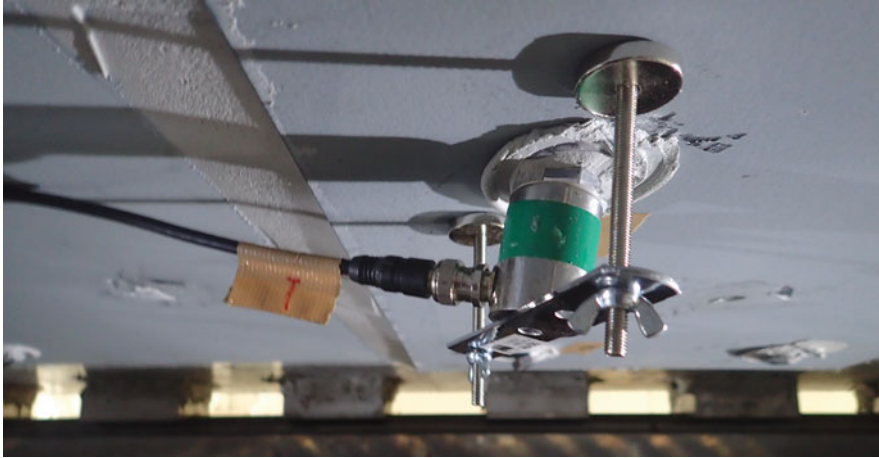
**Fig. 11** AE sensors installation

In this study, the AE tomography analysis is again applied by employing elastic wave excitations. As illustrated in Fig. 9, 18 AE sensors of 60 kHz resonance and 18 piezoelectric accelerometers are installed at 36 locations alternately on the bottom of the specimen. The AE sensors' installation is shown in Fig. 11. In this experiment, the excitations were driven by hammers of 10 mm and 30 mm in diameter, respectively, at random locations on the top surface of the specimen. The wheel loadings were applied at the center area of 560 mm  $\times$  4600 mm between the red lines as shown in Fig. 9.

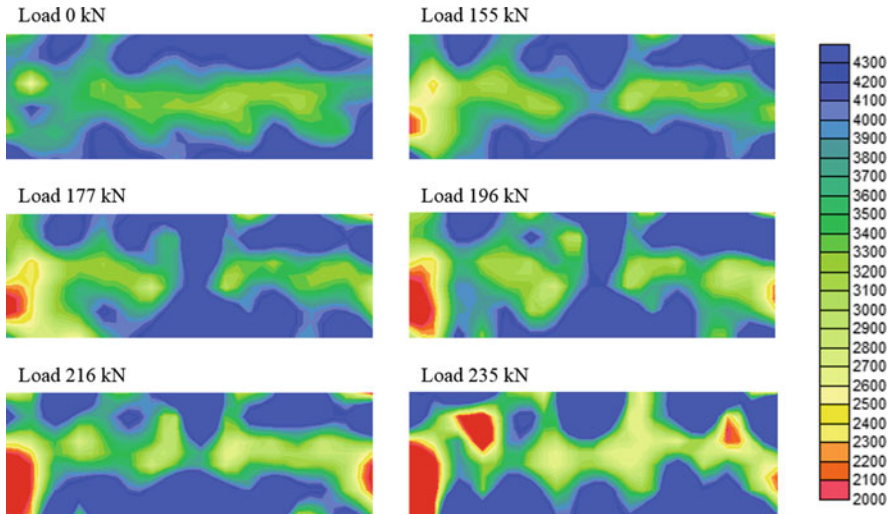
In order to analyze the velocity distributions of the specimen after 40,000 time cycles on each load, AE tomography analysis was conducted in the region of 3.2 m  $\times$  1.2 m of the specimen, which is shown as the blue rectangle in Fig. 9. The results of elastic wave velocity distributions of the RC bridge deck specimen after the wheel loading test on each load step, are shown in Fig. 12. From the figure, it is apparent that the areas of the velocities lower than 2750 m/s are progressing as the applied loads' increase, especially intensively observed at the area of left side of the measurement region. After 40,000 time cycles of 196 kN load, the areas of velocities lower than 2250 m/s are remarkably observed.

Fig. 12 Velocity distributions during the wheel loading test
