# Chapter 16

## State-Subsidised Refurbishment of Socialist Apartment Buildings in Estonia

Kalle Kuusk and Jarek Kurnitski

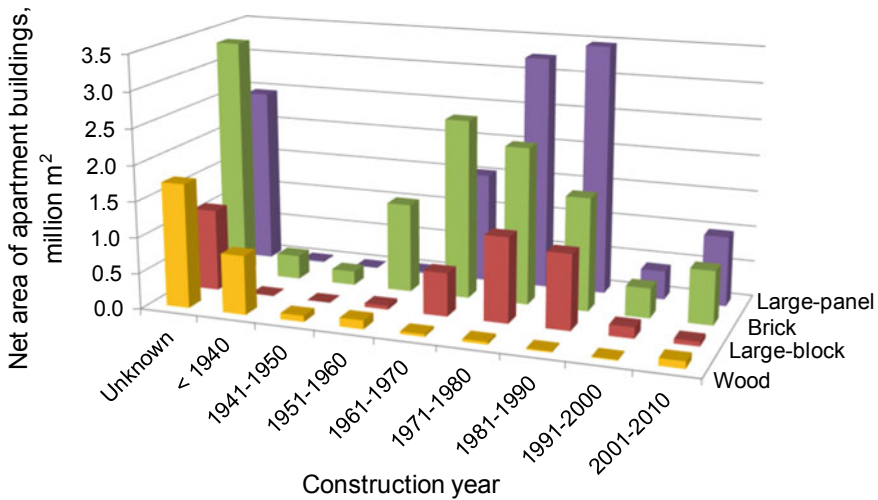
**Fig. 16.2** Distribution of apartment buildings in Estonia according to age and construction type

According to Statistics Estonia, there are 23,600 apartment buildings in Estonia. Most of these apartment buildings were built during the industrialised construction period between 1960–1990, as shown in Fig. 16.2. Large housing estates were the

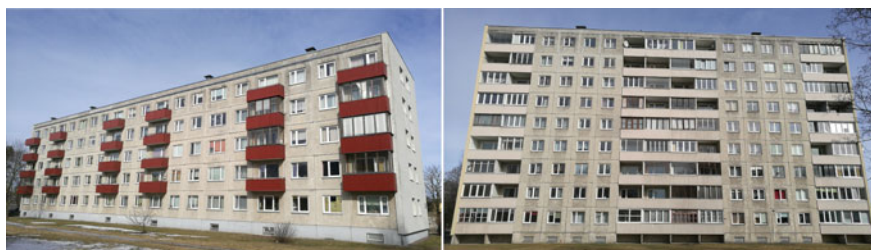
**Fig. 16.4** Large-panel apartment buildings in Mustamäe: 1–464A (left) and 1–464D (right)

are composed of two layers of reinforced concrete (a 50–125 mm inner layer and a 30–70 mm outer core) with low-quality thermal insulation of 100–150 mm in between. Typological series 1–464 apartment buildings in Mustamäe (Fig. 16.4) have five (Type A) or nine (Type D) storeys. A single 1–464 typology building consists of between four and eight sections in a row, each having one staircase. One of the key shortcomings of the five-storey concrete apartment buildings is the absence of lifts. Those buildings which were erected in the Õismäe and Lasnamäe districts were of series 121. The main difference when comparing them to series 1–464 is the design which focuses on sections instead of an entire building. In addition, apartment buildings of series 133 and 66 have been used in various cities around Estonia.

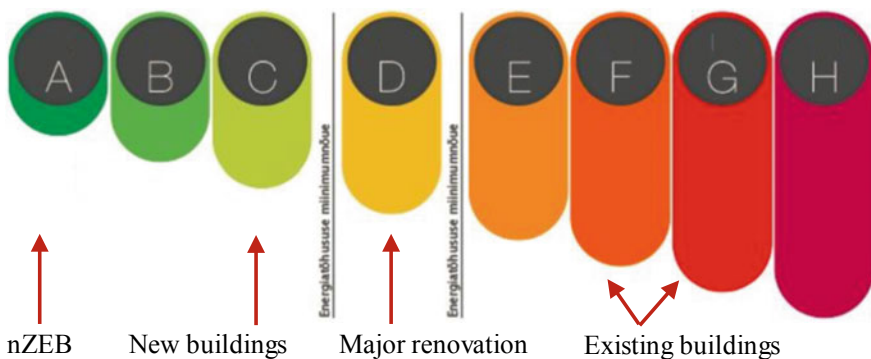
Fig. 16.5 Energy performance certificate classes for apartment buildings

A total of 102 million euros from the European Union Structural Funds was used in the new grant scheme for 2015–2017. Under the new scheme, technical requirements and the application process were further developed and were more detailed. A 15% grant can be applied when an Energy Performance Certificate (EPC) of Class E (covering minor refurbishment work) is achieved after the completion of any refurbishment work, while a 25% grant can be applied when EPC Class D (covering the energy efficiency requirement for major refurbishment work) is achieved after the completion of any refurbishment work, and a 40% grant can be applied when EPC Class C (covering the energy efficiency requirement for new apartment buildings) is achieved after the completion of any refurbishment work.

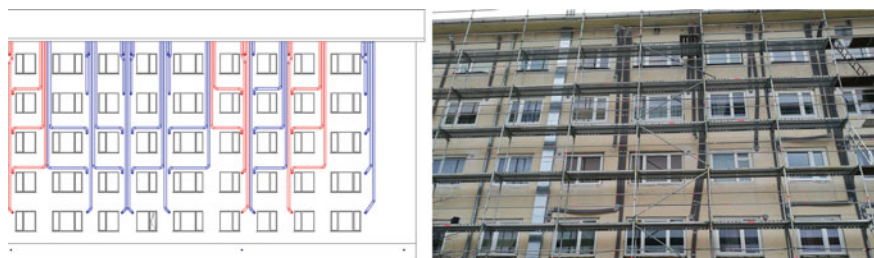
**Fig. 16.6** Ventilation ducts in façade insulation layers: schematic view with red supply air ducts and blue exhaust air ducts (left), and photo (right)

system, and that the requirements and the compliance of the ventilation system could be met. Continuous average ventilation (for each apartment in total) should be 0.51/h. Supply or intake air flow rates are required to be at least 10l/s in bedrooms, with living rooms exhibiting sound levels that are no more than 25 dB (A). Extract air flow rates are required to be at least 10l/s in the WC, 15l/s in the bathroom and 8l/s in the kitchen (or 10l/s in the bathroom and 6l/s in the kitchen in one room flats). A 40% grant required that the ventilation system utilise heat recovery. A supply and extract ventilation system with an apartment-based air handling unit and an exhaust ventilation system with an exhaust air heat pump for heat recovery were previously used in standard refurbishment work practices. A new solution in Estonia which evolved from new ventilation requirements involves the central air handling unit with ventilation ducts inside the facade insulation layer, as shown in Fig. 16.6. This solution has become one of the main ventilation solutions in the current refurbishment work grant scheme.

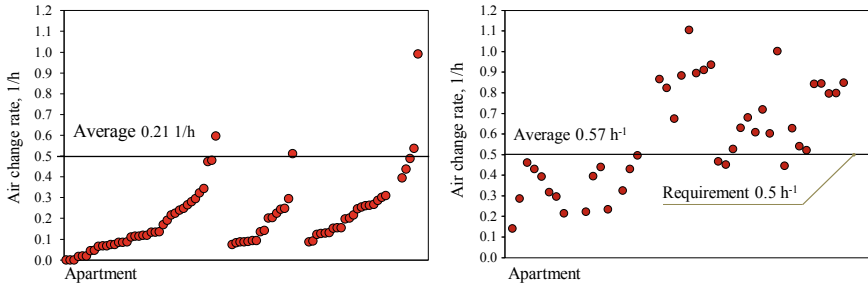
**Fig. 16.7** Measured average ventilation air change rates: previous grant scheme (left) and new grant scheme (right)

that the required ventilation rates are achieved, has significantly improved ventilation air change rates in apartment buildings that have already undergone refurbishment work. Average ventilation air change rates which have been measured operationally—as shown in Fig. 16.7—serve to illustrate the effects of compliance procedures. Under the new grant scheme, even in operational situations in which airflow rates may have been reduced by the inhabitants of apartments, the ventilation system provided values that were close to or higher than  $0.51/h$ .

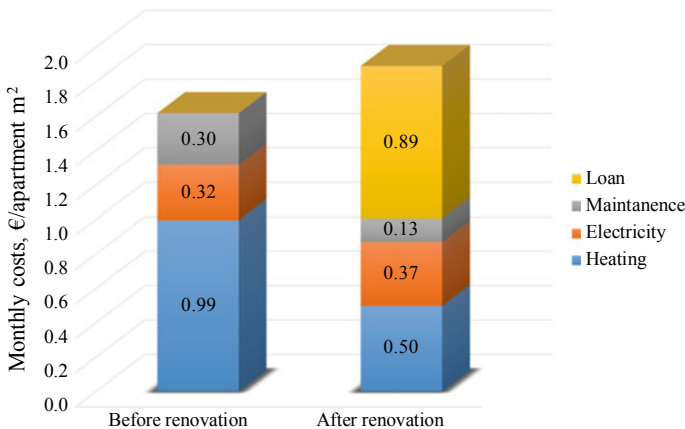
**Fig. 16.10** Monthly costs for households before and after renovation (measured for m<sup>2</sup> of living space in apartments)

A cost analysis for refurbishment work showed heating costs being at 60 €/MWh (including VAT), and an electricity price of 113 €/MWh (including VAT), and for the funding of the refurbishment work a loan period of 20 years and an interest rate of 3%. The results of the cost analysis as shown in Fig. 16.10 allows the conclusion to be drawn that, although work for extensive refurbishment requires fairly high initial investment levels, the reduction in heating energy use and the

financial help from the grant scheme will keep the monthly costs for apartment owners at a fairly reasonable level. Monthly average costs together with loan payments are approximately 20% higher when compared to the situation before the refurbishment scheme had been carried out.

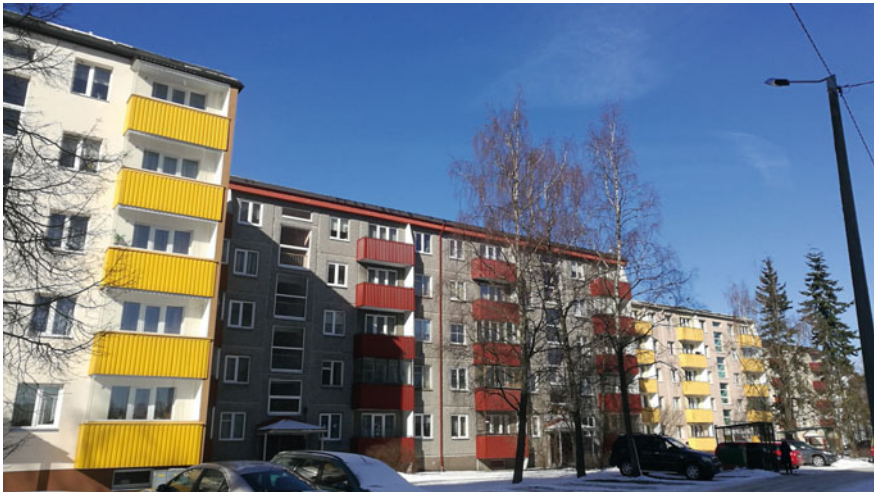
**Fig. 16.11** Various façade treatments on adjacent apartment buildings

Refurbishment work will affect the architectural appearance of the buildings. Housing estates have generally been built as homogenous environments. Taking a building-by-building approach to the refurbishment of apartment buildings has changed that (Fig. 16.11). Every building has its own architectural design and the initial modern homogenous environment is often not followed anymore. Guidance for local the municipality or for a general refurbishment plan for an entire group of buildings would help to prevent that problem.

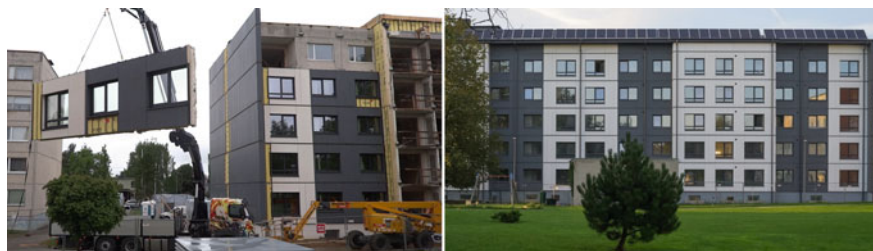
**Fig. 16.12** Installation of modular wall panels (left) and the finished building (right)

higher demand for and limited number of construction workers. Current refurbishment work mainly uses labour-intensive refurbishment technologies. Refurbishment work on one apartment building takes approximately 6 months. In order to increase the rate at which refurbishment work takes place, new technologies are needed. One possible solution is to handle refurbishment work using prefabricated modular panels. The concept of using prefabrication in the refurbishment process involves timber frame external wall elements with insulation, a façade cover, and windows all being pre-assembled at the factory. The quality of the work is higher and installation onsite does not require scaffolding. In 2017, a large-panel apartment building, which was used as a dormitory for Tallinn University of Technology, underwent refurbishment work using prefabricated walls and roof modular panels (Fig. 16.12). The prefabrication solution would allow for a significantly shorter time being taken to handle such refurbishment work. The estimated installation time for external wall elements is 2 weeks for one apartment building. So far this building is the only pilot project in Estonia to undergo refurbishment work using prefabricated façade elements.
