Chapter 1

Refurbishment of Goris Old Bath Building as Tool for Historic Urban Environment Green Traditions Rehabilitation

Nune Petrosyan and Marina Bunatyan

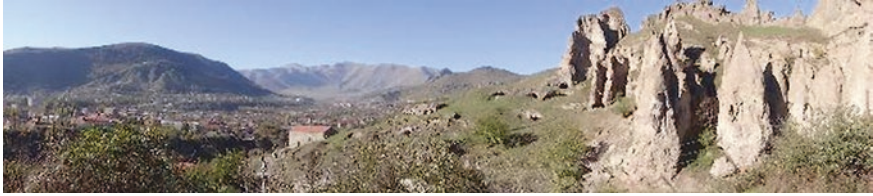
Fig. 1.1 Panoramic view of old (cave) and new (valley) Goris settlements

First references about Goris old settlement go back to the thirteenth century. The old settlement was founded on the left bank of the Vararakh River, in a picturesque area surrounded with hills, rocks, caves, and ravines. For defensive purposes, dwellers used to build their homes—the Goris city, administrative center of the Marz (region) of Syunik—by carving the nearby cone-shaped rocks and in the caves. The neighborhoods were formed along the natural paths connecting the caves (Fig. 1.1).

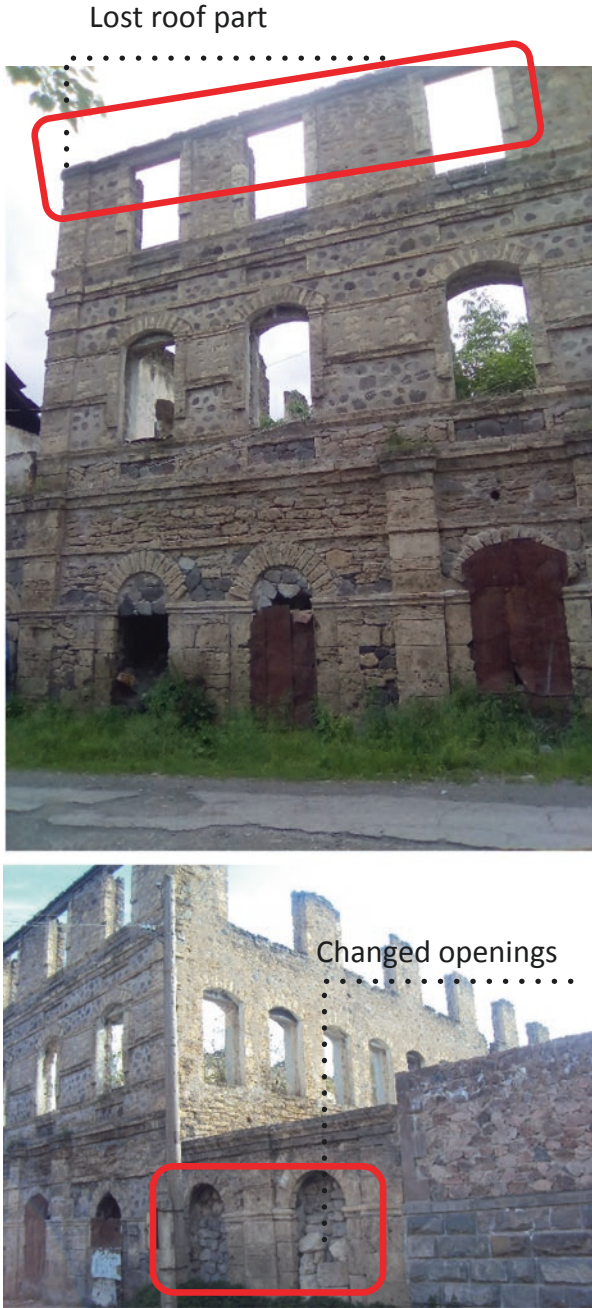
Fig. 1.3 Old bath building current condition

rehabilitation, and refurbishment of the buildings of the historical core, thus keeping the urban identity. This considers evaluation of the buildings via their technical conditions, architectural value, and role in the city structure. A special role is given to the former bath building—a footprint and the only three-story preserved building of old Goris. Nowadays, the preservation via refurbishment of this historic building becomes urgent, as the level of damage caused by fire, which had taken away the roof of the building, is worsened by the precipitation and natural weathering of the materials, which finally can cause gradual and complete demolishment, thus partial loss of urban identity. The whole building itself is at risk. As a result the city can lose the only preserved of 2 three-story buildings and historical performance of the streetscape and silhouette of the city, thus the cultural value of the city as well. Old buildings of the city contain information about the history that happened before—in different times, different societies, and different cultures. So, preservation and rehabilitation play a cultural role and provide cultural continuity. The adaptive reuse of the old bath building is the ultimate form of recycling, which helps reduce construction waste from demolishing and save the energy that is usually spent on manufacturing and transporting building materials and tools (Fig. 1.3). The historical

core buildings make the heritage of Goris unique and recognizable in the world. The former bath house is situated in the middle of the street of Makich, mainly in the historically built district, registered in the monuments list. The building has suffered a major fire. Two main functions—bath and gymnasium—have been applied to the structure at different times, then in different levels of the building in the meantime. The architecture of the building differs greatly from the vast majority of the residential development of the center as by height, as well as by external decoration and material. The difference between the two-storied main buildings of the city's historical core is, firstly, the only three-story building in that segment, the difference in appearance is the combination of sandblast basalt and sandstone, using Goris's special arcade, original shapes of details—the three-centered circle arches of the windows and the special local design fences of the windows—also remained (Fig. 1.4). Currently, the structure is gradually declining with continuous weathering and rainfall, with a high degree of accidental breakdown. Thus, the issue of the resuscitation of the structure becomes urgent.

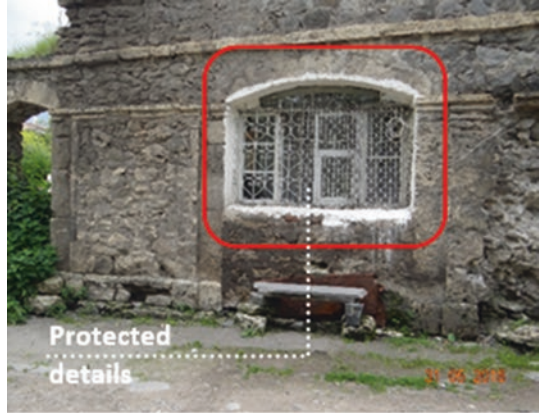
Fig. 1.4 Authentic details
(fences, arch, fire place)

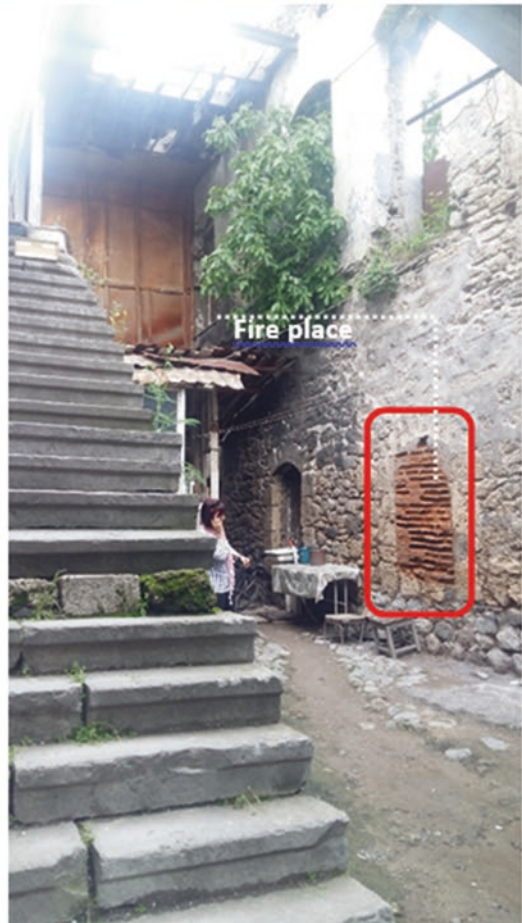
Fig. 1.5 IT center proposal

In this case, some of the properties as of the buildings and also of the street and the built-up environment have been so defaced that they have altogether lost not only their character and beauty but also their significance. All the measures proposed are set to preserve the rich heritage of the historical core, particularly Makich Street architectural character, and to prevent further destruction and devaluation of these historic properties and rehabilitate the building and neighborhoods as green lively centers with tastefully preserved energy-efficient buildings and landscaping, promoting the development of creative technologies (refurbish the former bath and school building to green building of the IT center) [2, 3].
