Exploration of Early Civilization Through Restoring Structural Stability of DJOZER Step Pyramid (Part II)

Abstract. Step pyramid is the major archaeological unit of Djoser complex at Saqqara archaeological site. It is suffering now from various and serious deterioration and degradation features from various sources. Rescue and Restoration studies of the first stone building ever witnessed i.e. pyramid of Djoser, Sakkara site, Egypt, included several aspects. Aspects under consideration in present study are concerned with geotechnical and geo environmental impacts on Djoser pyramid deterioration features of sub-surface units.

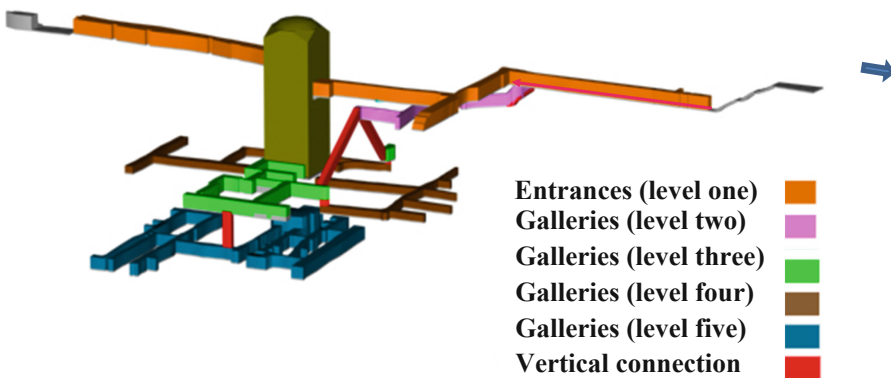
Fig. 1. 3D model of pyramid subsurface units

Step pyramid has three known entrances, all were excavated in rock formation of Saqqara plateau. Their architectural and engineering data are, as shown in integrated plan Figs. 1, 2, 3 and 4, Table 1 summarizes main engineering data of subsurface units.

1. Galleries as shown in Fig. 1 had been excavated at five levels, connected together by inclined or vertical connection (ladder way).
2. Some of these galleries were intersected with burial vertical shaft; others were excavated at level deeper than the burial chamber.
3. Stress and deformation distribution around various sections of galleries have been studied using laboratory testing results and recent software (Flag). Based on results, proper saving and restoration methods have been adopted.

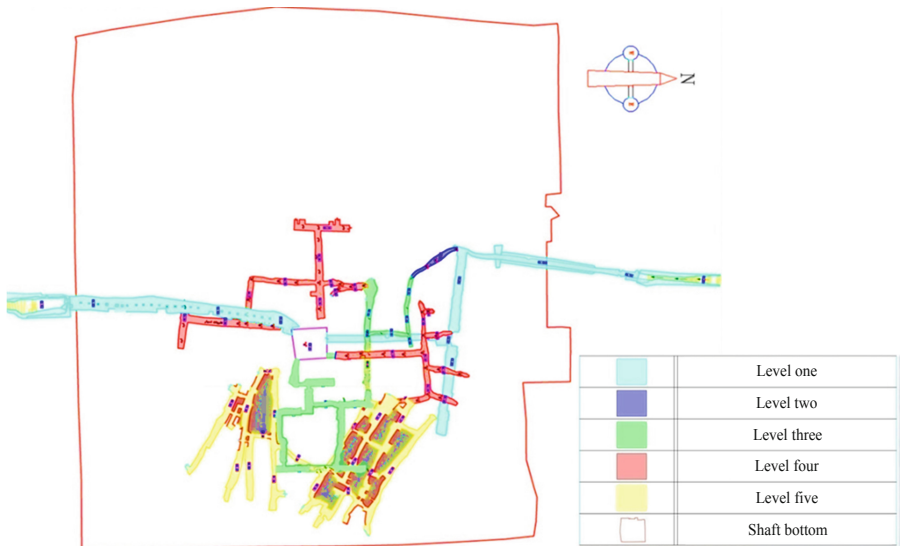
Fig. 2. Subsurface units integrated plan

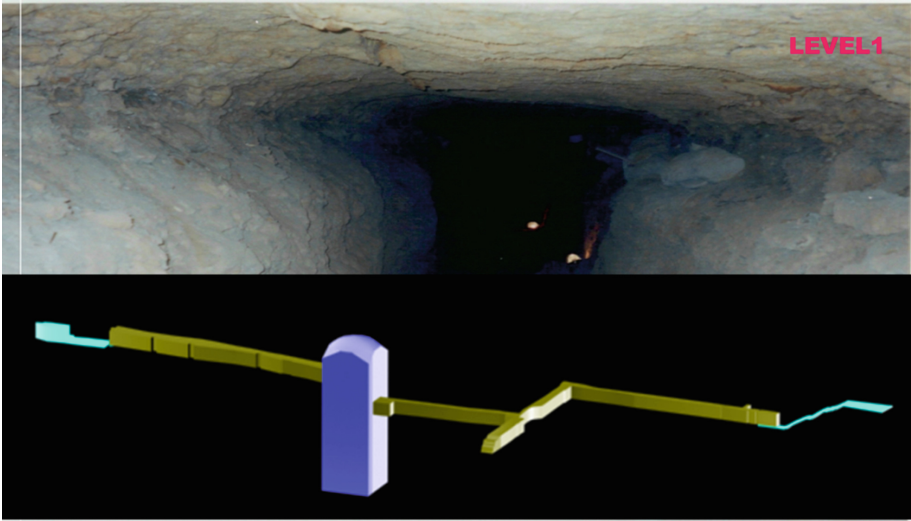
Fig. 3. Northern entrance of the Pyramid – level 1

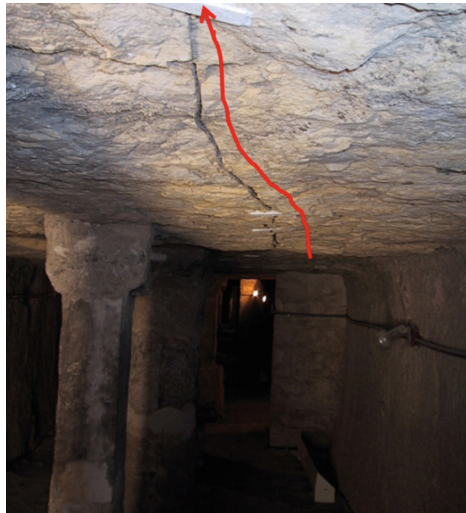
Fig. 4. The critical state of roof layers in the southern entrance roof– level 1

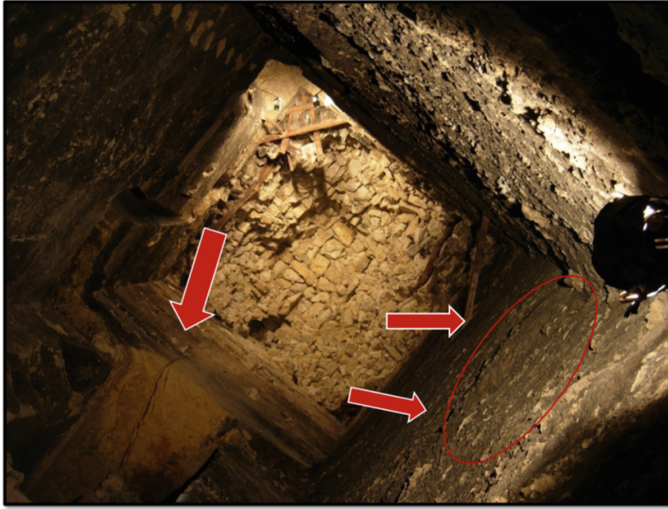
Fig. 5. Burial shaft failure zone

- *Burial vertical shaft. shown in Fig. 5*
- *Burial room. shown in Fig. 6, 7, 8*
- *Galleries shown in Fig. 1*

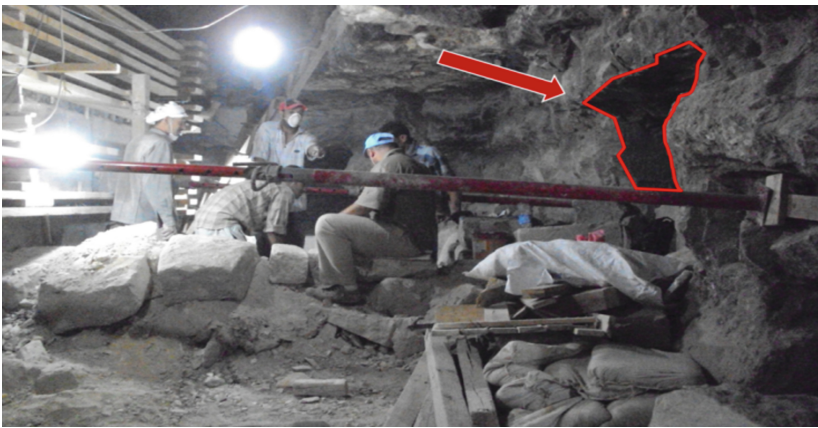
Fig. 6. Burial room when removing debris

1. first insure safety of both monument and workers
2. Removal of debris produced from various partial failures and covered the chamber and all the archaeological contents.
3. Re-discover the granitic sarcophagus (weight 176 ton) and remains of archaeological limestone walls.
4. Remains of three mummies were found embedded in debris.
5. Once reached burial chamber rock floor, insuring stabilization and safety for the sarcophagus started immediately, meanwhile documentation, scientific and engineering studies of status of chamber started, results were considered in restoration project modification.
6. Radiogram survey has been carried out on rock floor of burial chamber to explore the continuity of rock media where scaffold has to be erected to reach the failure zone at top of shaft.
7. Figures 6, 7 and 8 show some of steps mentioned above.

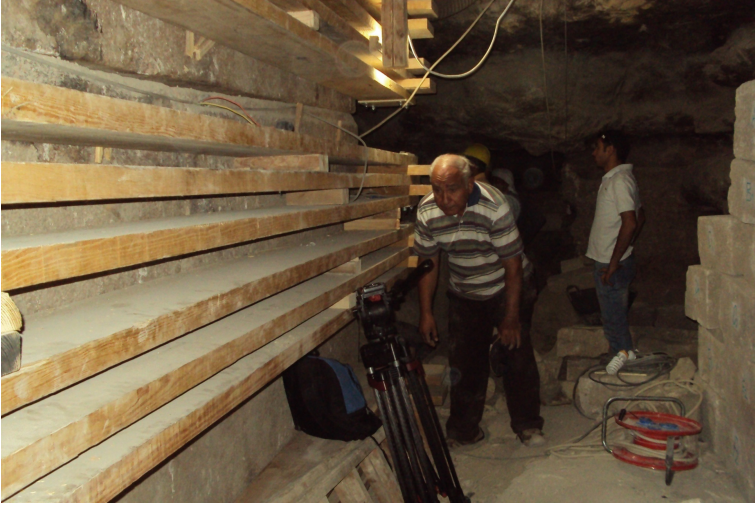
Fig. 7. Burial room after removing debris

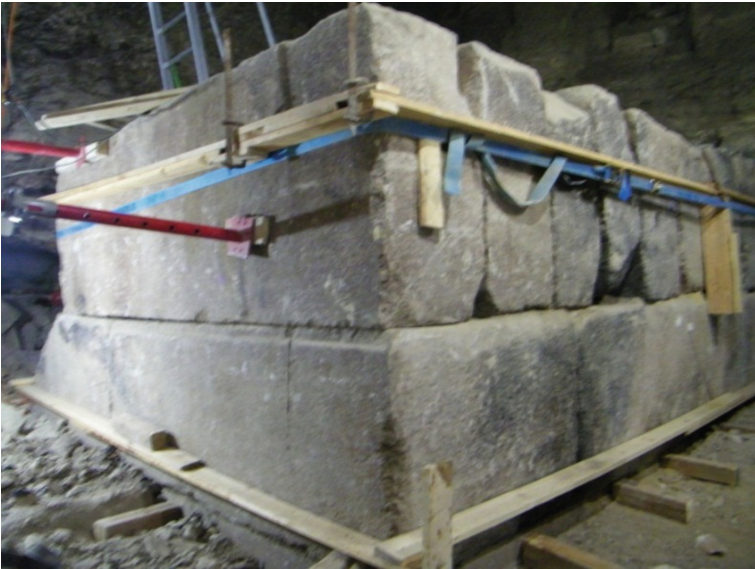
Fig. 8. Granitic sarcophagus after removing debris

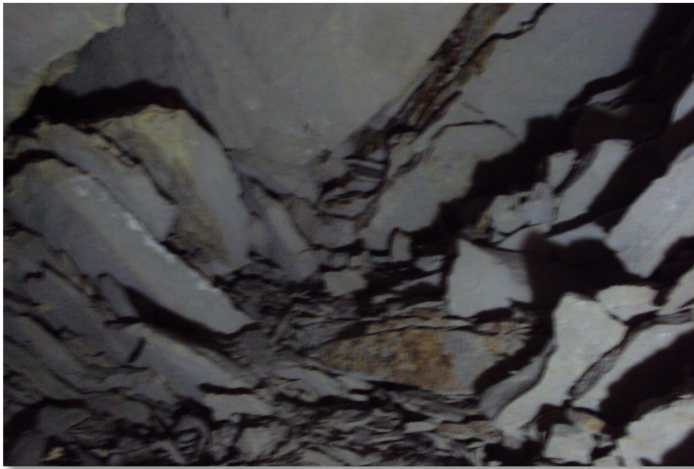
- partial failure and collapses
- deformation of galleries section, shape and dimensions
- separation of roof rock formation layers
- buckling and flaking in galleries rock wall
- failure of rock side wall at the zone of intersection of galleries and vertical shaft
- Failure of exposed layer of swelling clay formation hosting burial shaft walls, galleries, burial chamberetc.
- Figures 9, 10 and 11 shows some of these modes of failure and partial failure.

Fig. 9. Separation and failure of roof formation in galleries

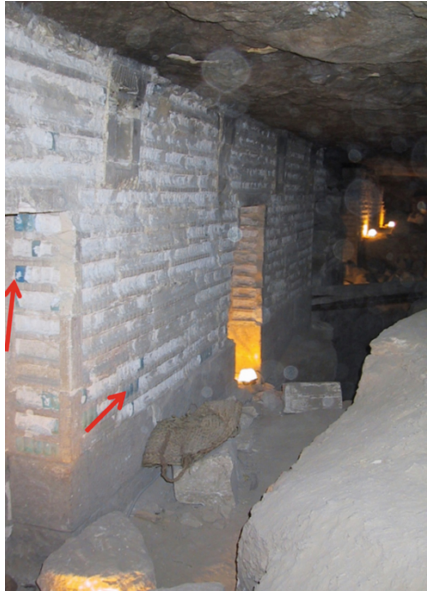
Fig. 10. Ceramic wall panel

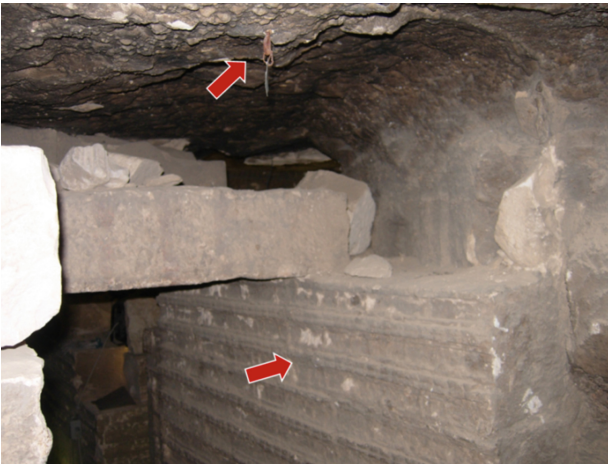
Fig. 11. Gallery ceramic panel, partial failure

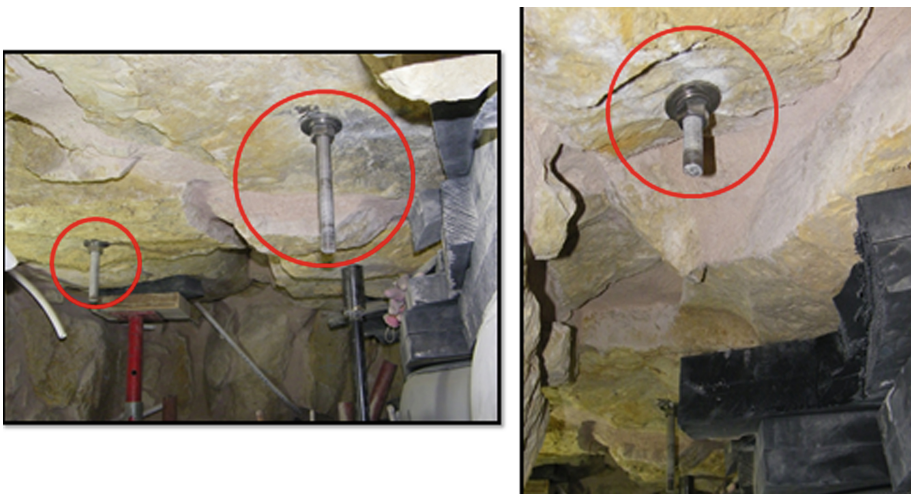
Fig. 13. Steel anchors to support shaft failure zone

- *shaft collapsed zone*
 1. First insure safety of both monument and work team.
 2. Stabilization of ceiling loose stones by carefully fixing with no cementing mortar mix for depth ranging between (25–50 cm) depth replacing disintegrated and/or removed mortar.
 3. Investigating the suitability of using steel anchors (lab. and field experimentation) and examine its suitability to combine ceiling loose stone blocks and to what depth.

4. if unsuitable, injection of suitable natural materials mix will be the alternative solution to create required bonding and stability of stone blocks,
5. If steel anchors are suitable, supporting will continue, and for more safety injection for less depth will follow, Fig. 13.
6. All archaeological measures have been considered whenever possible.

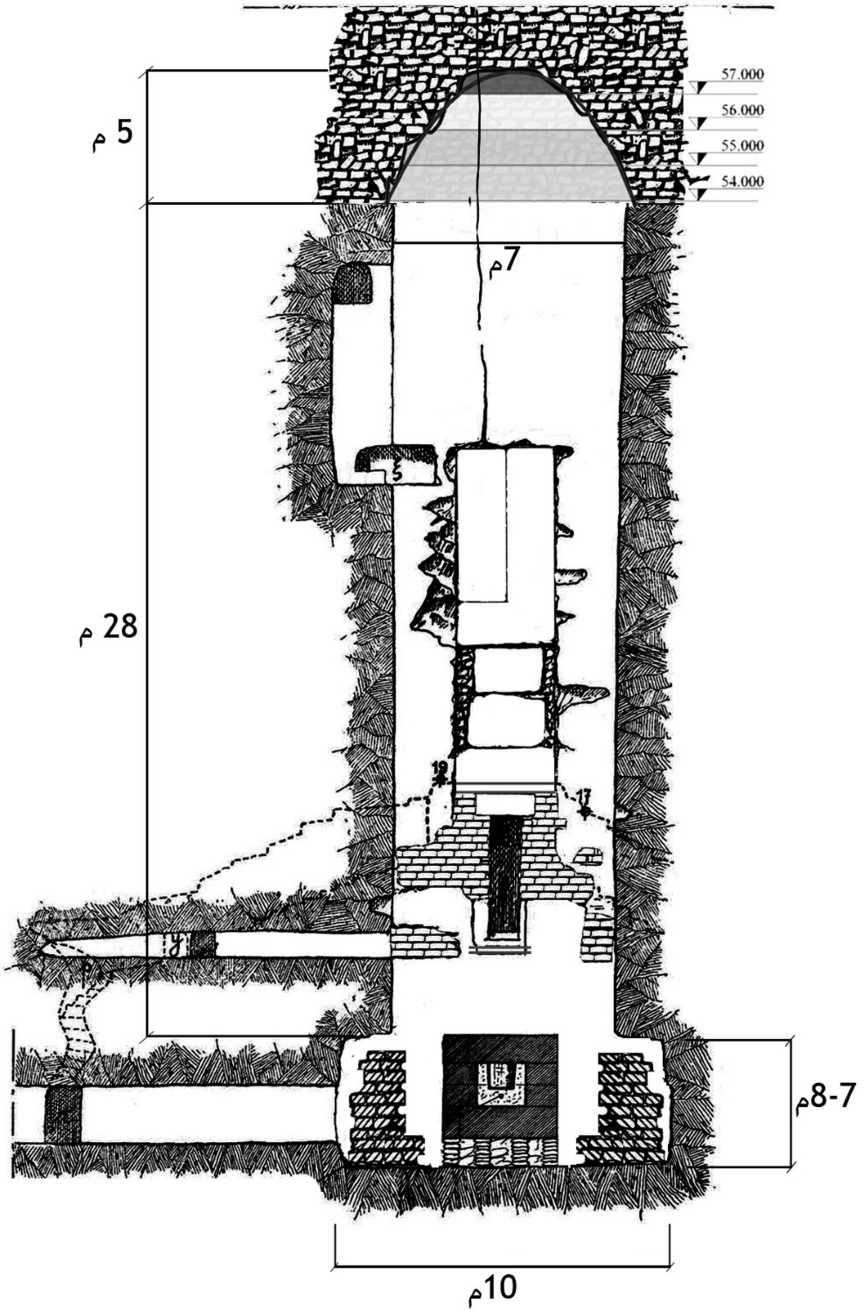
Fig. 14. E-W section of shaft and deterioration features

Figure 14 shows northern wall of vertical burial shaft and all deterioration features including zone, Also the granitic sarcophagus shown as the bottom.

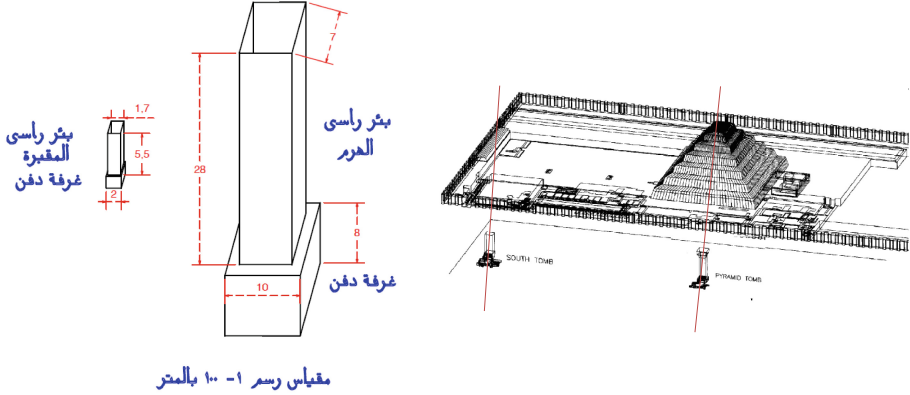
- Before executing the main sub surface units of the step pyramid, old Egyptians made prototype (model) on small scale of the planned units and executed in the same level and geological formation and features in the southern tomb south to the pyramid as shown in Fig. 15.

Fig. 15. Burial shafts of both pyramid and southern tomb
