Role of Non-metallic Inclusions and Twins on the Variability in Fatigue Life in Alloy 718 Nickel Base Superalloy

Abstract

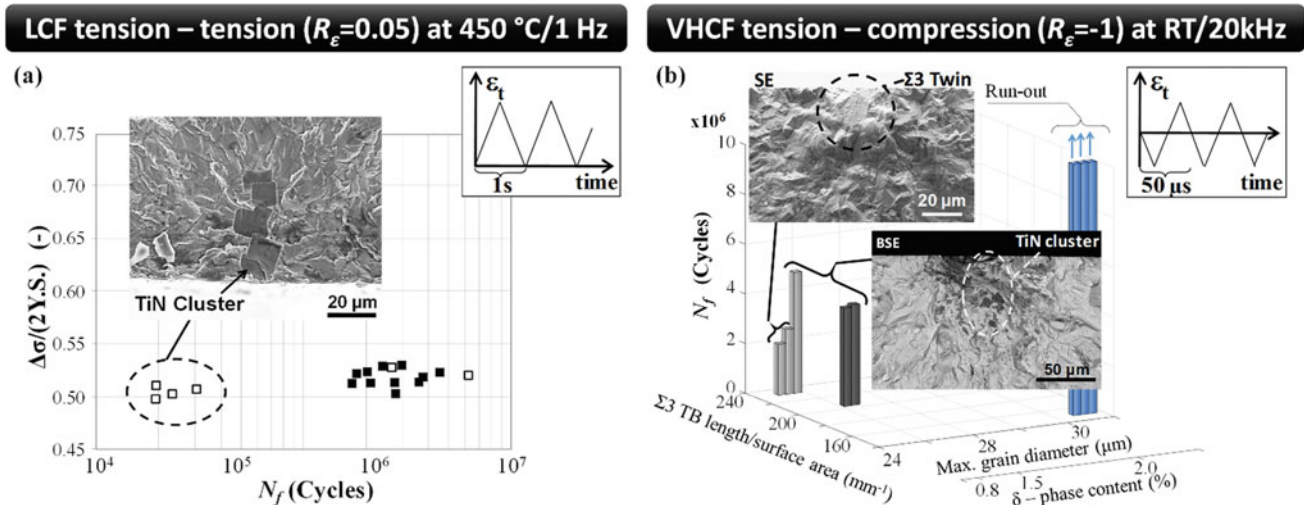
Fig. 1 Influence of microstructural features on the fatigue life of the 718DA showing abnormally low lives and associated crack initiation site: **a** low cycle fatigue (LCF) in tension-tension at intermediate

temperature [5], **b** very high cycle fatigue (VHCF) in tension-compression at room temperature [6]

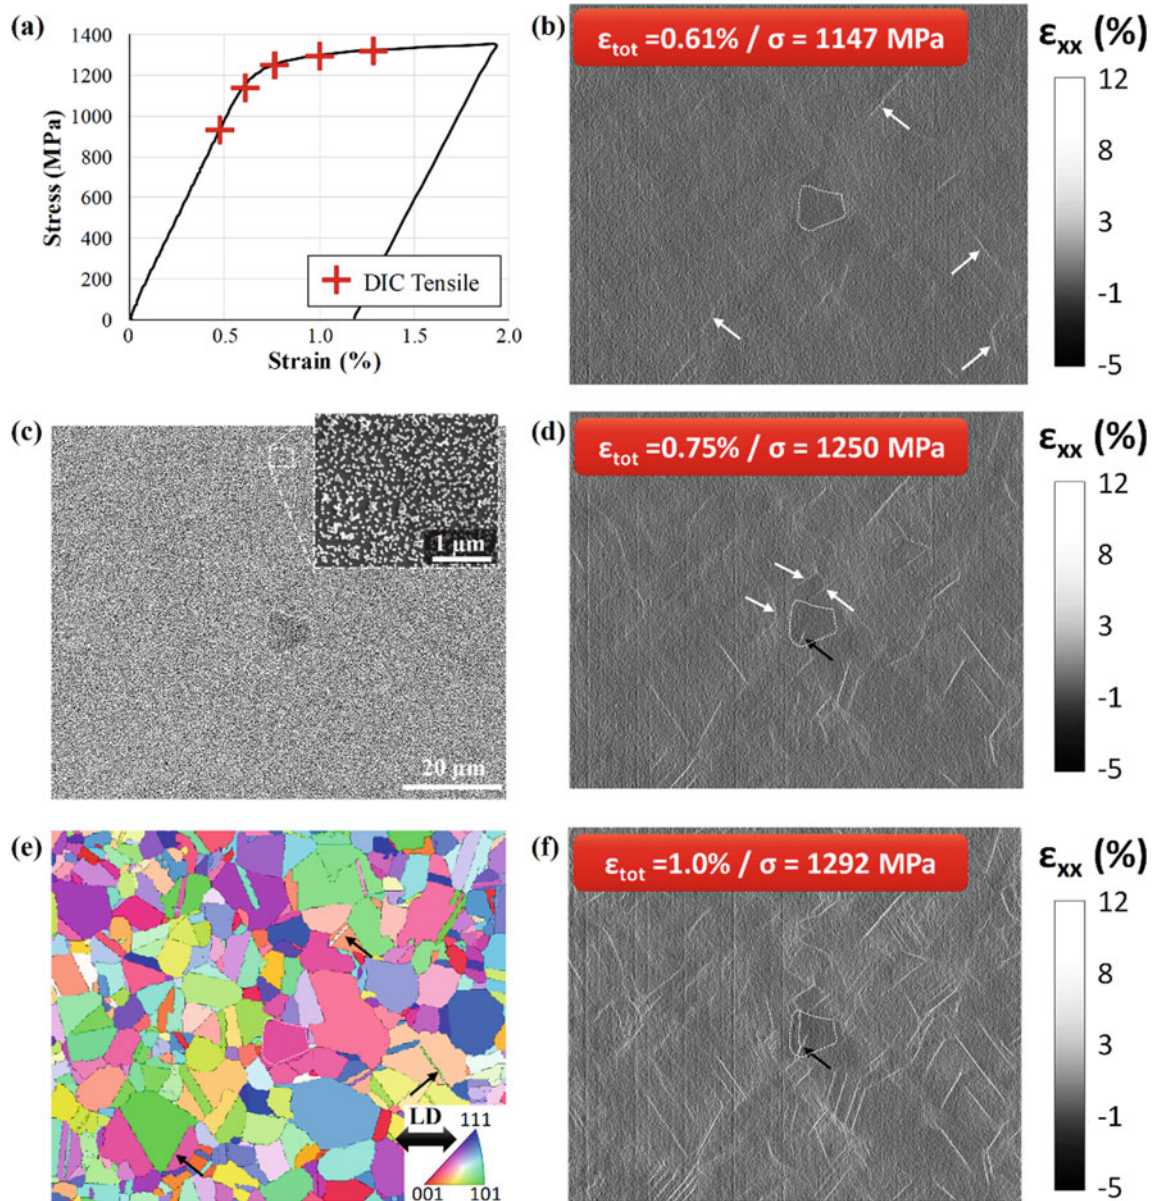
Fig. 2 Evolution of strain localization and cracking under tensile loading: **a** macroscopic stress–strain curve of the tested 718DA and loading steps for high resolution-digital image correlation (HR-DIC) measurements, **c** SEM micrograph used for HR-DIC in the vicinity of a nitride (TiN) inclusion showing the speckle pattern, **e** EBSD map of the ROI colored according the IPF colors with projection along the loading

direction (LD), **b**, **d** and **f** ϵ_{xx} strain maps at different stress–strain levels showing strain localization first in the grains far from the TiN (white arrows Fig. 2b), then strain localization in the grains neighboring the TiN (white arrows in Fig. 2d) and cracking of this NMIs (black arrow in Fig. 2d, f)

loaded in both the macroscopic elastic and plastic deformation domains, as shown with red crosses in Fig. 2a. Macroscopic strain was measured in-situ using fiducial markers located at both ends of the gage length. The loading direction (LD) will be referred as the x -direction and horizontally oriented in all the micrographs and strain fields. High resolution- and Heaviside-digital image correlation (HR-DIC and H-DIC) measurements were performed at macroscopic strain of $\varepsilon_{\text{tot}} = 0.45, 0.61, 0.70, 1.0, \text{ and } 1.3\%$ in regions that display NMIs (detailed in Sect. 2.3). Twenty regions of interest (ROIs) were tracked.

A case study of cracking in a TiN inclusion at an intermediate loading condition is illustrated in Fig. 2. The possibility of assessing slip events in the metallic matrix and cracking in the TiN under loading is demonstrated. A white dashed contour identifies the TiN location in ε_{xx} strain maps and EBSD map for reading conveniences.

The onset of plasticity was observed along a few annealing twin boundaries far from NMIs at 90% of Y.S, i.e., $\varepsilon_{\text{tot}} = 0.61\%$ – $\sigma = 1147$ MPa (white arrows in Fig. 2b corresponding to black arrows in Fig. 2e). No evidence of strain localization was found within the NMI or in its neighborhood. Interestingly, the TiN inclusion appears slightly darker than the matrix in ε_{xx} strain fields, resulting from a higher stiffness regardless of the orientation of the NMIs or the grains. This latter observation is similar for all ROIs, i.e., independently of the nature of the NMIs. This difference in elastic properties is in good agreement with the literature [16, 30, 31]. Calculation of the elastic properties of the TiN and NbC inclusions and the superalloy matrix for various directions have shown that the superalloy matrix along its stiffest direction ($E_{[111]} = 260$ GPa) is softer than NbC and TiN inclusions along their softer direction ($E_{[001]} = 416$ GPa for NbC and $E_{[001]} = 417$ GPa for TiN).

At higher stresses, close to the macroscopic yielding of the material ($\varepsilon_{\text{tot}} = 0.75\%$ – $\sigma = 1250$ MPa), more slip bands developed in the surrounding grains, even in contact with the NMI (white arrows in Fig. 2d). At this macroscopic

strain level, several slip systems are activated near and parallel to TB but intragranular slip events are also observed. This dual participation of intense slip localization close to TB and within grains has also been reported by Liu et al. [15] in conventionally processed 718 alloy. However, strongest strain localizations remain along a few annealing twin boundaries far from NMIs. The TiN inclusion cracked in the bottom region (black arrow in Fig. 2d) but no slip event was detected within the superalloy grain in contact with the crack tip. Thus, the TiN inclusion cracking is not assisted by intense strain localization in the matrix in this case.

For stress–strain conditions in the macroscopic plastic domain, strain localization is more and more intense near TB but a greater number of slip bands developed transgranularly (Fig. 2f). This multiplicity of transgranular slip activity was confirmed by Liu et al. [15]. At this stress–strain level, the TiN inclusion fully cracked with a complex crack path. Slip events are now observed within adjacent grains on both NMI crack tips. This specific ROI is thus a typical case of damage transfer from a cracked NMI to the superalloy matrix but NMI cracking was not assisted by slip deformation in the adjacent grains.

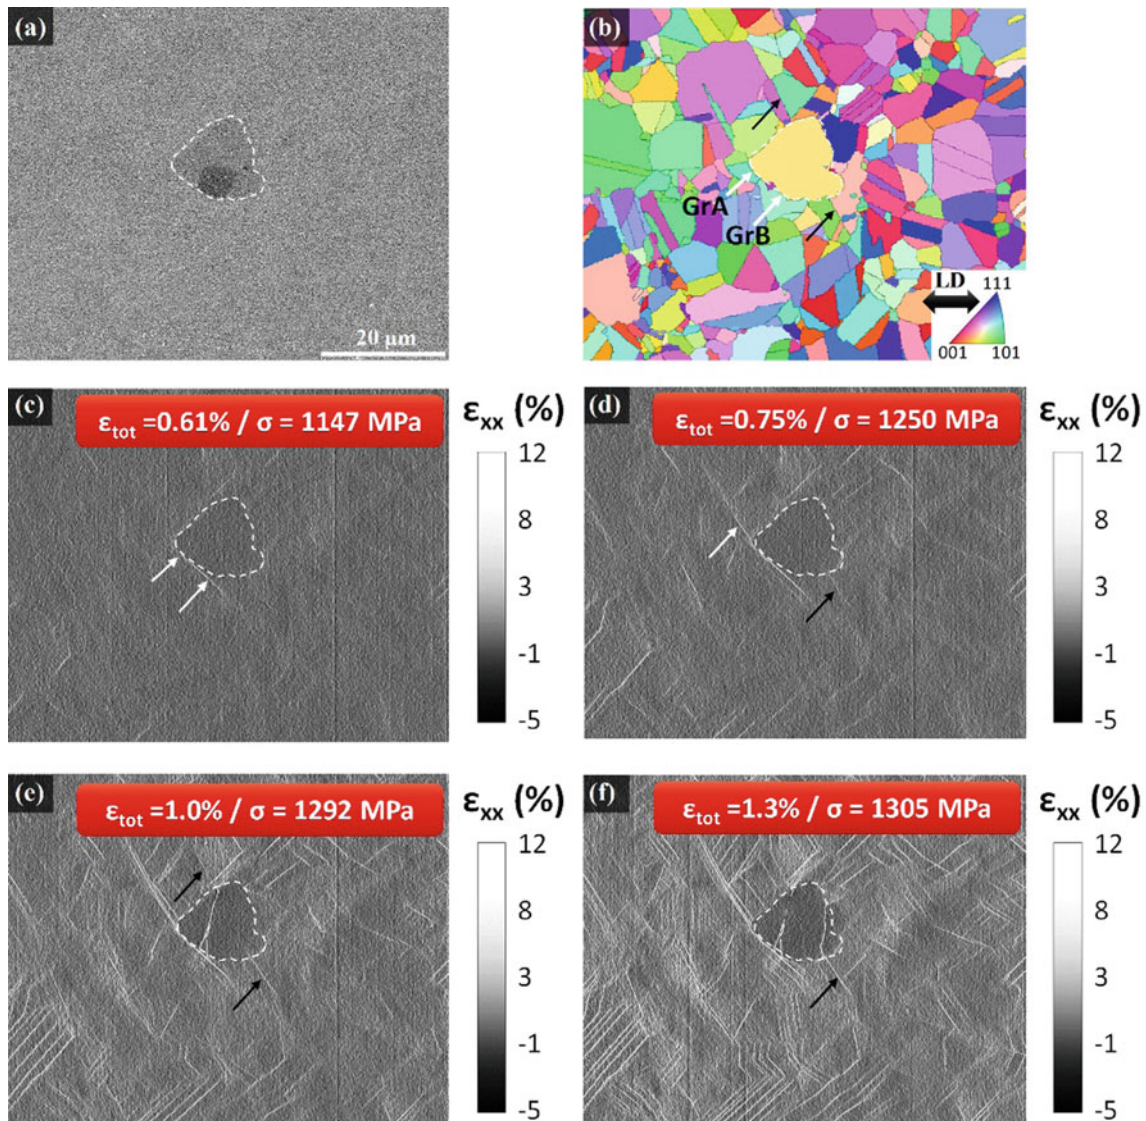
Fig. 3 Evolution of strain localization and cracking under tensile loading: **a** SEM micrographs used for HR-DIC showing the region of interest (ROI) in the vicinity of a carbonitride (NbCTiN), **b** EBSD map of the ROI represented as inverse pole figures (IPF) maps in reference

to the loading direction (LD), **c-f** ϵ_{xx} strain maps at different stress-strain levels showing strain localization parallel to the NMI/matrix interface (white arrows in Fig. 3c), then strain localization near a TB (black arrows in Fig. 3d, e), leading to the NMI cracking (Fig. 3f)

A second case study is presented in Fig. 3 to show a different scenario of slip/cracking interaction for a carbonitride. As for the former case study, a white dashed contour was used to locate the NbCTiN in ε_{xx} strain maps and EBSD map. Despite different compositions (gray contrast in Fig. 3a), NbC and TiN inclusions were found to have very similar orientations (less than 2° misorientation, i.e., same color code on IPF map in Fig. 3b) due to epitaxial growth and similar elastic properties.

Initial microplasticity events were developed in the vicinity of the carbonitride at 90% of YS ($\varepsilon_{\text{tot}} = 0.61\%$ – $\sigma = 1147$ MPa). Strain localization nearly parallel to the NMI/matrix interface was observed within two neighboring grains, as depicted by white arrows in Fig. 3b, c. It is not straightforward to identify in which grain the onset of plasticity started. Therefore, a detailed analysis of both grains will be presented. The two grains were denoted “GrA” and “GrB” and labeled on the EBSD map. The slip traces correspond to the $(\bar{1}11)$ and $(1\bar{1}1)$ planes in GrA and GrB, respectively.

At $\varepsilon_{\text{tot}} = 0.75\%$ – $\sigma = 1250$ MPa, strain localization intensifies within the former slip bands and slip transfer to an adjacent grain occurs (white arrow in Fig. 3d). Interestingly, slip activity is also detected near and parallel to a TB (black

arrow in Fig. 3d). As aforementioned, other slip bands develop in other locations in the superalloy matrix. At 1.0% total strain, the carbonitride cracked in the region where microplasticity started to develop parallel and close to the NMI/matrix interface. Interestingly, a slip band along a TB was observed to develop at the NMI crack tip (upper black arrow in Fig. 3b, e). At this point, it is not possible to identify whether the first event was either slip activity along the TB or NMI cracking. In addition, strain localization intensifies in the former slip bands near the TB (lower black arrow in Fig. 3e).

Slip traces parallel to the NMI/matrix interface were observed as early plasticity events developing near the NMI in the ROI for the case study #2 (Fig. 3c), prior to NMI

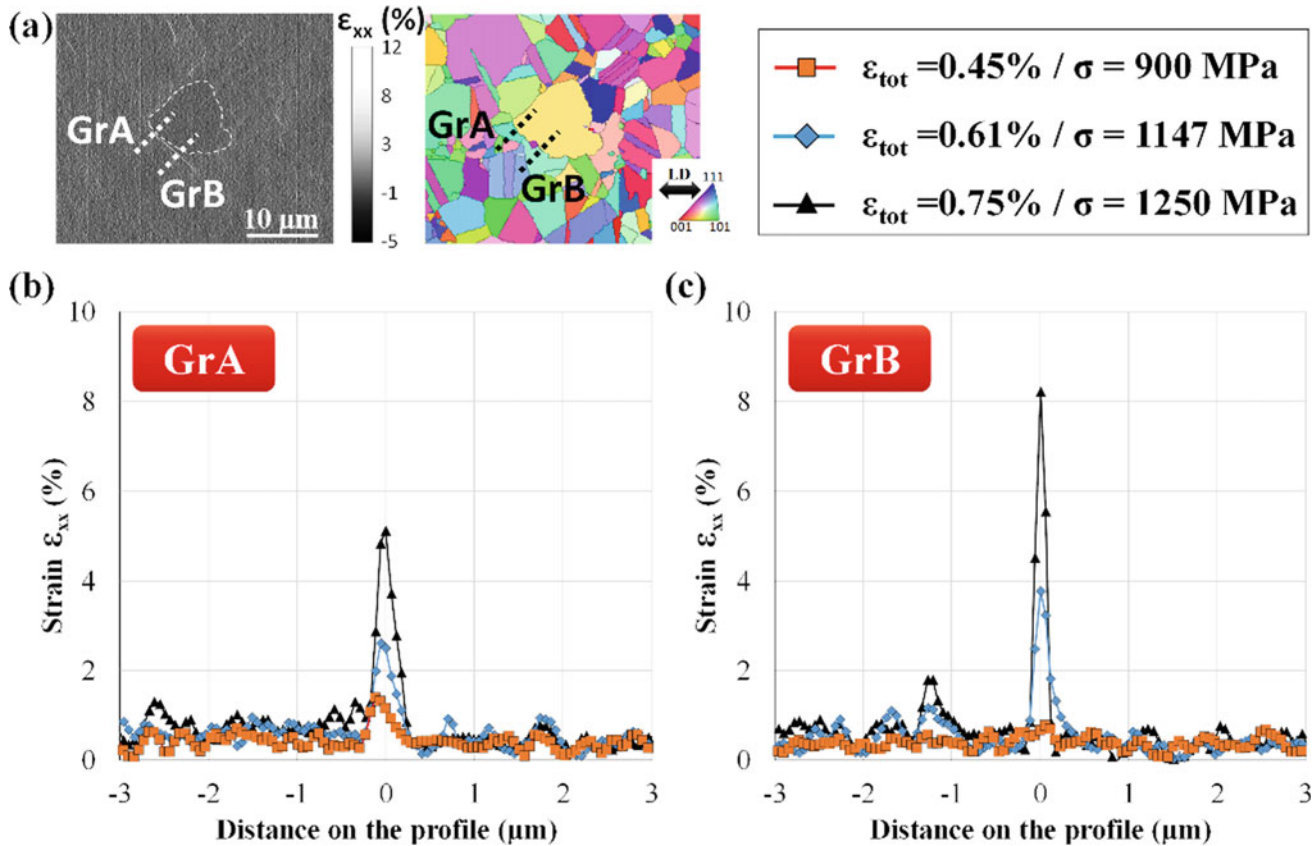
Fig. 4 Profile plot of the strain intensity across slip bands in GrA and GrB near and parallel to the NMI/matrix interface. **a** Illustration of both the profile lines in GrA and GrB in the strain and EBSD maps, profile

plot of the strain intensity (ϵ_{xx}) for the three first stress–strain conditions for **b** GrA, and **c** GrB

cracking. A closer examination of such strain localization is thus needed. Strain profiles (ϵ_{xx}) across the slip bands developing in GrA and GrB (grains labeled in Sect. 3.2) were extracted from ϵ_{xx} maps to document slip activity with the onset of microplasticity (Fig. 4). Interestingly, strain localization is observed in GrA but not in GrB for the stress–strain conditions at 70% of Y.S ($\epsilon_{tot} = 0.45\% - \sigma = 900$ MPa). As aforementioned, slip traces observed on the ϵ_{xx} maps correspond to the $(\bar{1}11)$ and $(1\bar{1}1)$ planes from GrA and GrB, respectively.

At 90% of Y.S ($\epsilon_{tot} = 0.61\% - \sigma = 1147$ MPa), strain localization intensifies across GrA slip band, but the slip band across GrB produced more intense strain localization than for GrA. Similar slip system analyses of GrB slip band were conducted using HR-DIC and H-DIC measurements. The $(\bar{1}\bar{1}1)[\bar{1}01]$ slip system was activated with a μ equal to 0.382, i.e., not the highest μ of the $(\bar{1}\bar{1}1)$ plane (green column in Table 1). The scalar products between the Burgers vector identified in GrA and the three possible Burgers vectors in GrB were calculated and reported in Table 1. Interestingly, the Burgers vector of the active slip system in GrB, i.e. $(\bar{1}\bar{1}1)[\bar{1}01]$, was less misoriented from the initial slip

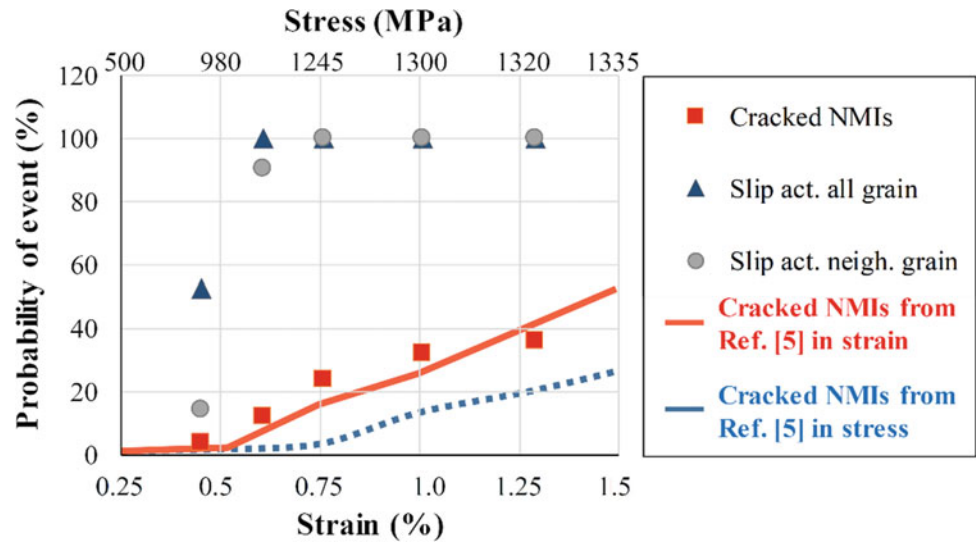
Fig. 5 Probability of slip events near and far from NMIs as well as NMI cracking, denoted as probability of event (POE) for all the loading conditions. Comparison with POE from Ref. [5]

NMI cracking and slip events within the metallic matrix far and near NMIs were investigated. As aforementioned, “grains near NMI” refers to “grains adjacent to NMI.” The probability of slip events near and far from NMIs as well as NMI cracking was investigated for all the ROIs and all the loading conditions (Fig. 5). The probability of an event (POE) at a given strain level is defined by the sum of occurrence of the event for a given category, i.e., slip activity far from the NMI, slip activity within the grains adjacent to the NMI and NMI cracking, divided by the number of ROIs. For instance, if five ROIs exhibit slip activity within at least a grain adjacent to the NMI, the POE for “Slip act. neigh.

grain” is 25% (5 ROIs over 20 ROIs in total). POE increased for the three events with the stress–strain increase. POE for slip rapidly saturates at 100% at 0.2% offset yield strength while POE for NMI cracking gradually increases. POE of NMI cracking is equal to 24 and 36% at 0.75 and 1.3% total strain, while all ROIs exhibit slip activity in grains adjacent to NMIs. For comparison, POE curves for cracked NMIs taken from Ref. [5] were added in Fig. 5. Owing to the higher yield strength of the 718DA in Ref. [5], the POE was plotted as a function of the macroscopic stress (blue dashed curve) and of the total strain (red unbroken curve). The good agreement between the present results and the POE representation as a function of the strain from Ref. [5] demonstrates the strain-controlled mechanism to crack NMIs. In other words, the sensitivity to crack NMI is directly correlated to the macroscopic yield strength of the Alloy 718. This point is crucial since it shows the damage density present after the first cycle in fatigue depending on the stress–strain amplitude. Despite a huge difference in stiffness between NMIs and the metallic matrix, the probability of slip within grains is higher far from the NMIs compared to the grains adjacent to NMIs at low stress–strain levels. This difference in POE could arise from the sampling method, taking into account more grains in the region far from NMIs.
