Experimental Study of Compressed Ceramic Hollow Brick Masonry Structures Strengthened with GFRP Meshes

Lviv National University, Lviv 79013, Ukraine
serhii.s.bula@lpnu.ua

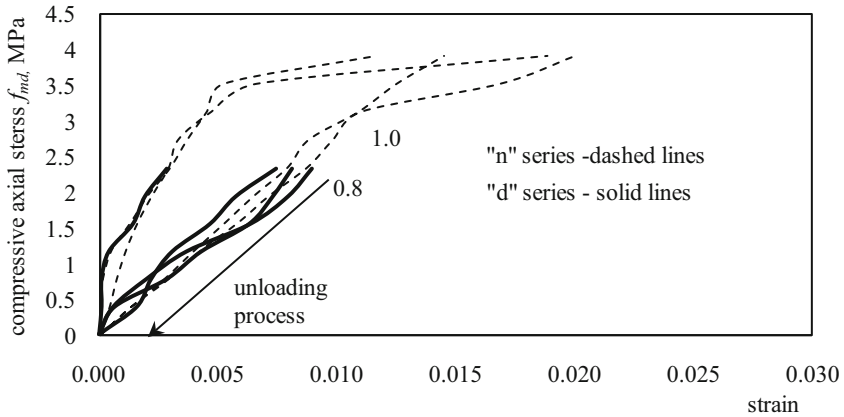
Fig. 3. Experimental “stress-strain” diagram for unconfined specimens (“d” series)

Using f_{md} value as control compressive strength target loading level for the next series ($f_{0.8md} = 2.4$ MPa) has been obtained. Specimens included to “d” series were subjected to this compressive loading due to the testing program. To justify such an approach and to avoid using samples with significantly different mechanical properties “stress-strain” curves for these two series (“n” and “d”) were compared (Fig. 3). Related curves were similar thus it could be stated that further reference between those two series is reasonable. After specimens’ unloading crack patterns for each column’s side were investigated Fig. 4.

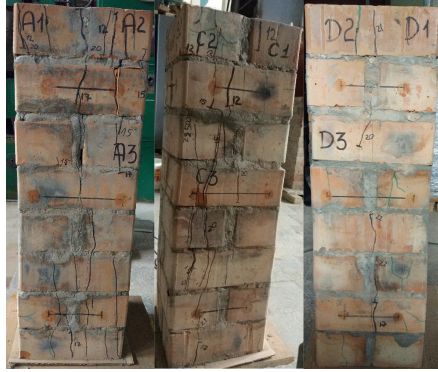
Fig. 4. Crack patterns after damaging by axial loading

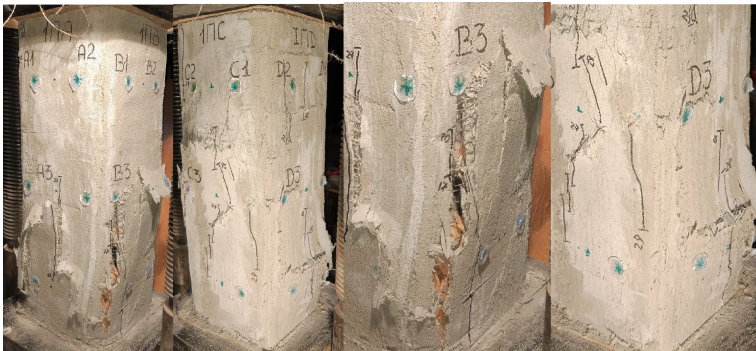
Fig. 6. Failure mode and appearance of strengthened specimens

The model’s appearance after testing is presented in Fig. 6. Strengthened samples had been showing slow and plain damage process until the moment when confinement lost integrity. Mesh rupture started in the most concentrated zones near to the column’s corners following jacket mortar separating initiated from the sample’s mid-height (Fig. 6). Subsequently, the failure process progressed more sharply due to no

restrictions for abandoned masonry core expansion. Such kind of failure mode was typical for all specimens.
