Development of Resident Participation-Type Slope Measurement/Monitoring System in Mountain Region

In this paper, the authors proposed the “resident participation-type slope measurement and monitoring system” to detect the premonitory symptoms of sediment disasters in the mountainous area (Takasu Town, Fukui City, Japan). The key concepts of resident participation-type slope measurement/monitoring are (1) visualization, (2) daily routine, and (3) voluntary/proactive involvement. The residents will not only monitor the danger slopes and notice unusual events, but also try to establish a system to grasp the slope deformation/displacement quantitatively. For this purpose, some different types of sensors based on the on-site visualization (OSV) concept were introduced to the dangerous slopes and retaining walls selected by the residents and geotechnical experts. The OSV sensors are low cost and visually excellent measuring device with simple measurement principle.

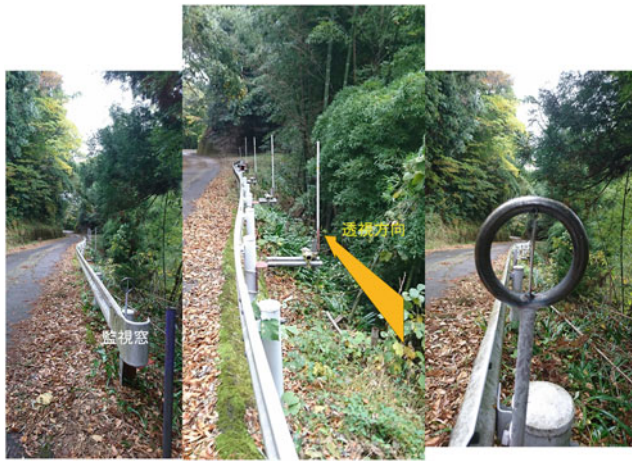
Fig. 3 “See-through poles” using observation poles and reference pole with a viewing window

“A see-through pole” is a method in which a reference pole with a viewing window and several observation poles for measuring displacement are arranged in a straight line, and the movement (gap) of the observation pole is checked from the reference pole. In other words, the displacement of the slope and/or shoulder of roads causes the observation pole to fall and/or shift, so that the line of sight from the reference pole is not straight, and the residents visually notice the deformation of the slope or shoulder of roads easily. If the grasp of quantitative behavior of the observation pole is required, the displacement can be quantitatively confirmed by measuring the mounting position at the beginning of the installation and performing the survey again when the deformation occurs.

Since the road alignment at the measurement position was close to a straight line and the street of the pole could be seen, “a see-through pole” was adopted. The observation pole was attached to a guardrail column installed on the shoulder of the road. However, the reference pole, which should not be affected by the slope displacement, was installed off the slope and away from the guardrail support. Slope deformation measurement is performed through a viewing window installed on the reference pole to measure whether the street on the observation poles hold a straight line.

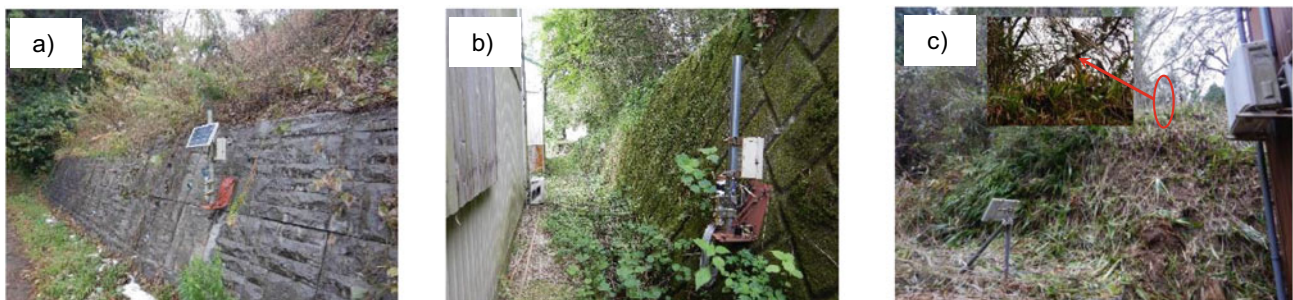
Fig. 6 Slope measurement/monitoring using POCKET, **a** block retaining walls along farm roads, **b** block retaining walls behind elementary school gymnasiums, and **c** slopes behind houses

The block-retaining wall along the farm road was collapsed once in the past. After the collapse, the slope above the top of the retaining wall has been reinforced by ground improvement. However, it is necessary to monitor the stability of the slope and check the soundness of the retaining wall, and therefore selected as a measurement point (see Fig. 6a).

evacuation place at the time of disaster. At present, there is a block retaining wall behind the gymnasium, and a natural slope is approaching above the retaining wall. Groundwater is constantly leaking from the retaining wall. Since the distance between the gymnasium and the retaining wall is about 1.5 m, the gymnasium may be damaged by flooding during torrential rainfall and the collapse of the retaining wall. Therefore, we decided to measure the deformation of the block-retaining wall behind the gymnasium (see Fig. 6b).

be measured mainly for the residents living there (see Fig. 6c).

For these measurement points, slope inclination measurement using POCKET was performed to measure the deformation of the retaining wall and slope, and the power supply of the measuring instruments was secured using solar panels at all three measurement points. In POCKET, the color of the light at the head of the measuring instrument changes depending on the inclination, so when displacement occurs on each retaining wall and/or slope, the color can be used to visually judge the situation. In this study, the lighting color of POCKET is set to be green when the tilt angle does not change, and to be yellow and red when the inclination angle changes by 0.2° and 0.4° , respectively. The thresholds for the set color and angle were set with reference to past slope failure experiment results (Toyosawa et al. 2007). When the residents confirmed the change in emission color, the slope was measured and surveyed separately by geotechnical experts to check the stability of the slope. The block retaining wall on the back of the gymnasium has a long depth, so three POCKETs were installed.

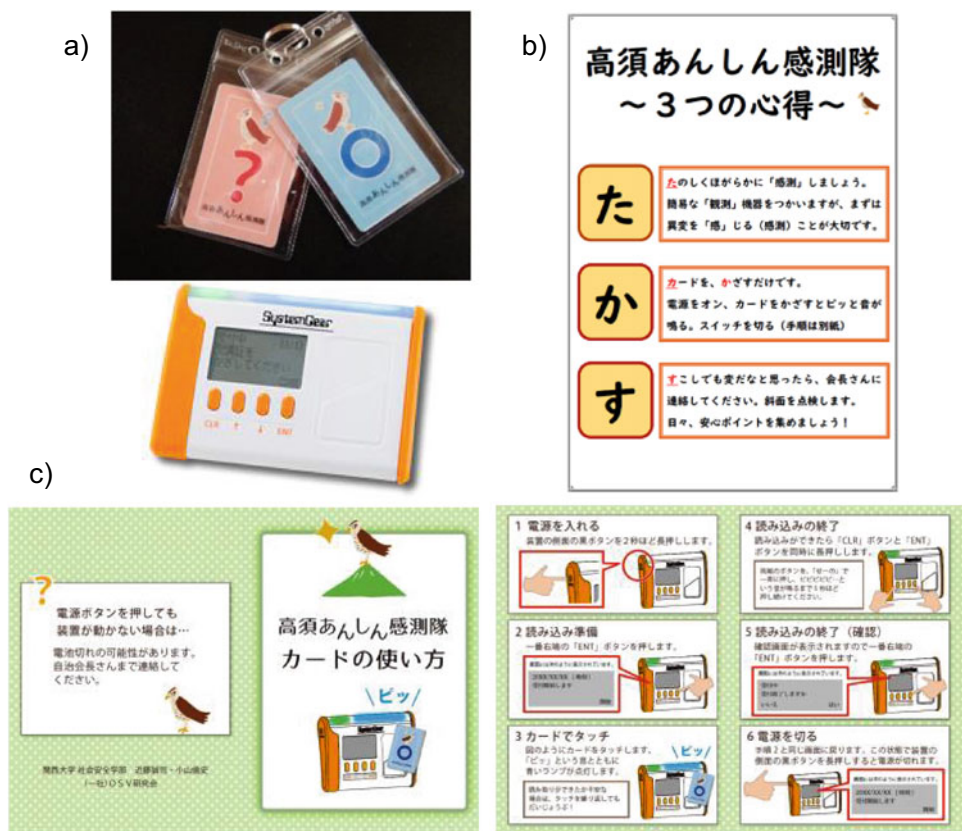
Fig. 7 a IC cards printed “normal” and “abnormal” and IC card reader, b “Takasu voluntary slope observation team -three hints” and c a card reader handling manual

Regarding the method of recording observation results, some people commented that the handwritten measurement record in ledger at the beginning of the installation. Significant simplification was required so that measurement and monitoring could be performed frequently. Therefore, management of observation records using an IC cards and a card reader was examined (see Fig. 7a).

In the observation, for all OSV measuring equipment, the observer hold IC cards printed “normal” or “abnormal” as observation results over the card readers that placed near the OSV measuring equipment.
